23-25 High Street Marlow Buckinghamshire

Historic Building Investigation and Recording

July 2008

Client: Comland Ringlead Ltd.

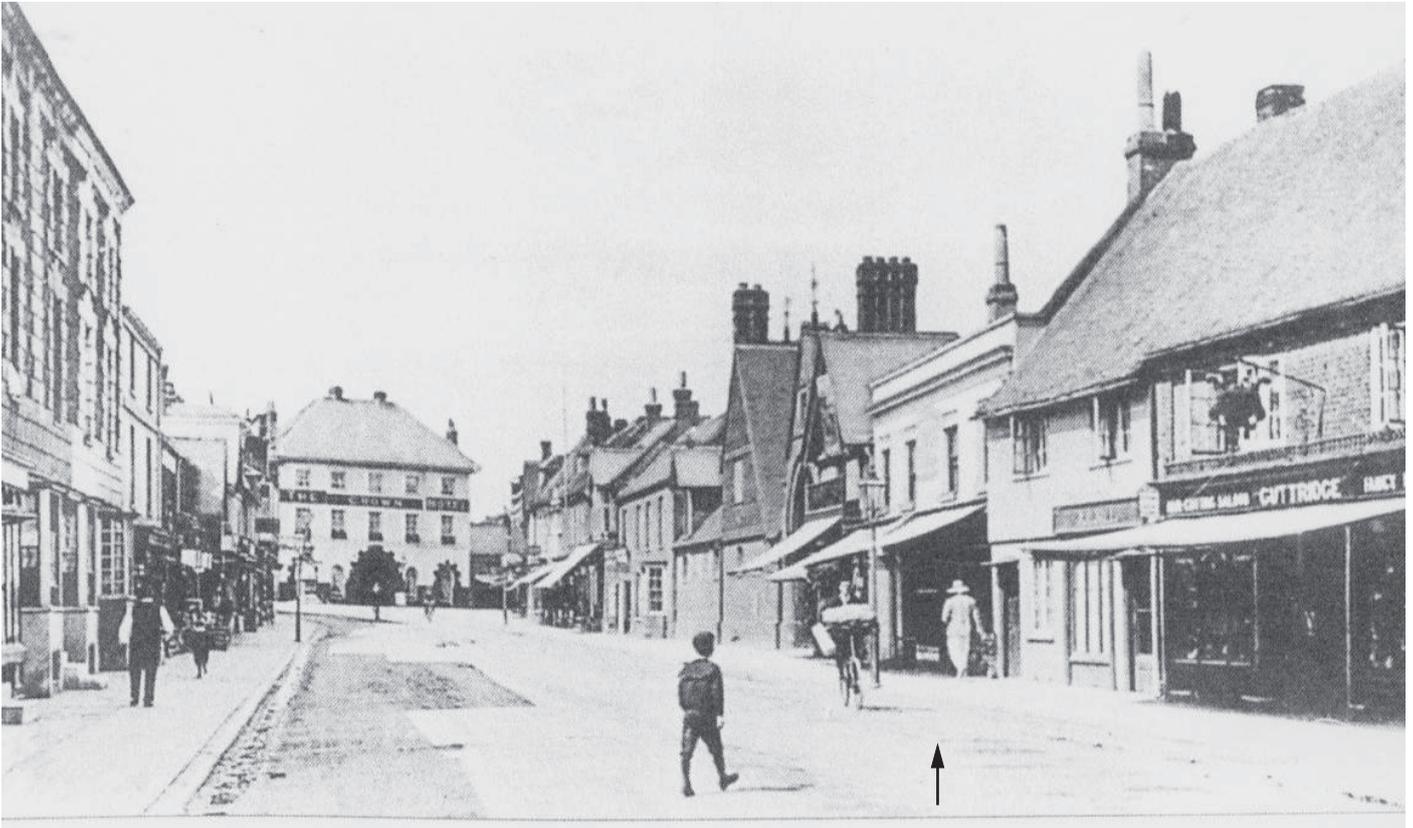
- 1.5.6 A photograph of 1912 (Plate 1) shows the property with awnings over a shopfront, but it is not possible to distinguish the number or nature of the businesses occupying the premises. Prior to this development the property was occupied by a fishmongers and a florists and it is thought that the premises had been used for the sale of fish for over a century.

Plate 1: The High Street in 1912 (No. 23-25 indicated by arrow)

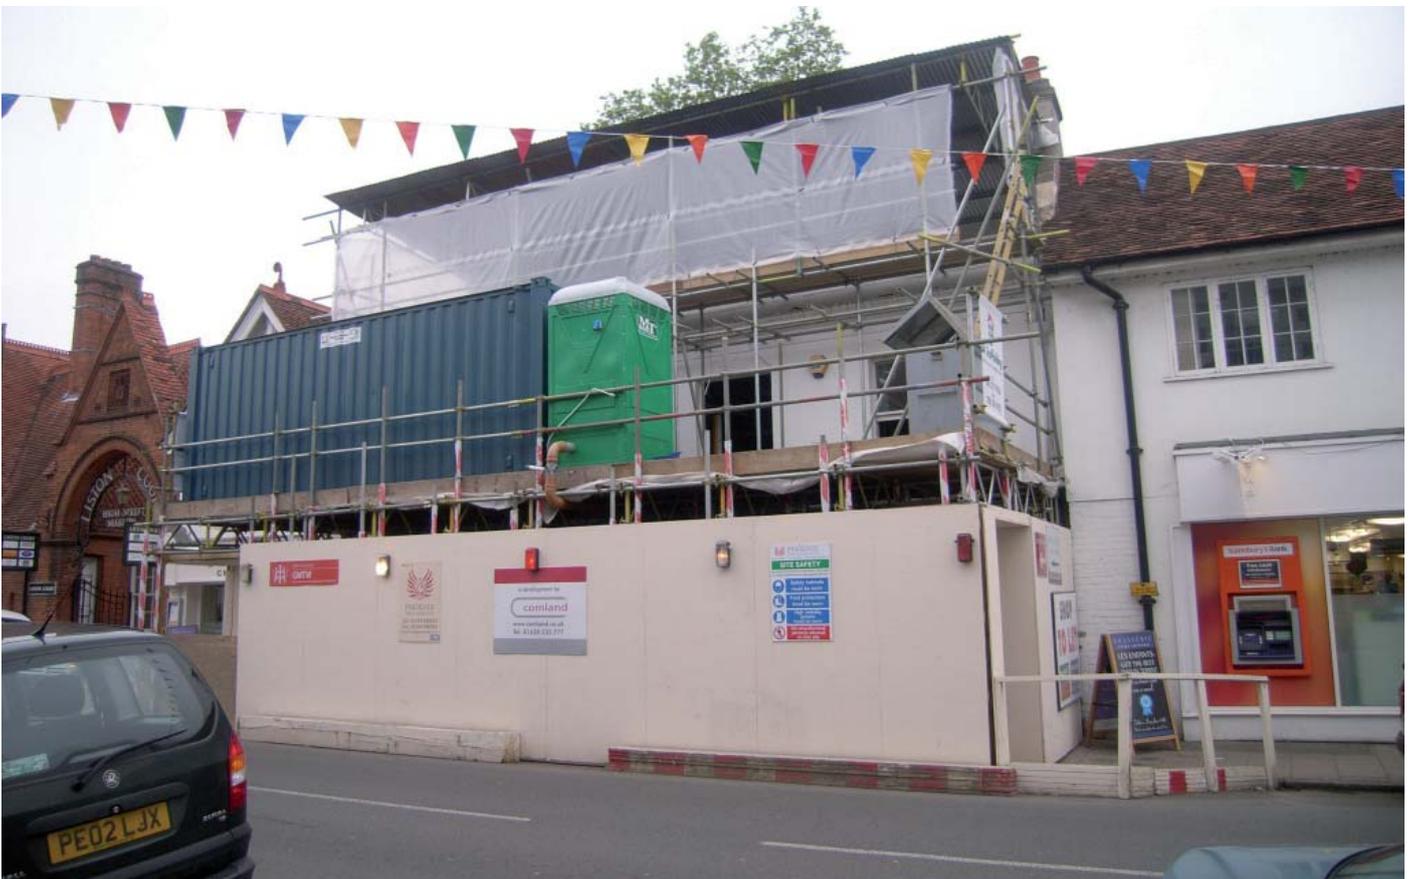
3.2.1 The street front façade (Plates 2 & 3), is in rendered whitewashed brick with four first floor windows and a moulded cornice and coped parapet above. Unfortunately the render hides details of the brickwork and window heads that may have helped refine the dating. The parapet hides the roof in views from the street. The four window openings were regularly placed to give a symmetrical façade which belied the three bay rhythm of the earlier building behind. The square windows contained vertical sliding sash casements with large, two over two, panes with horns on upper and lower sashes. The style of the casements is possibly later than the construction of the façade, the larger panes suggesting a mid to later 19th-century date. The ground floor of the façade consists of a modern shopfront and no historic fabric appears to survive here.

Plate 2: High Street facade during works

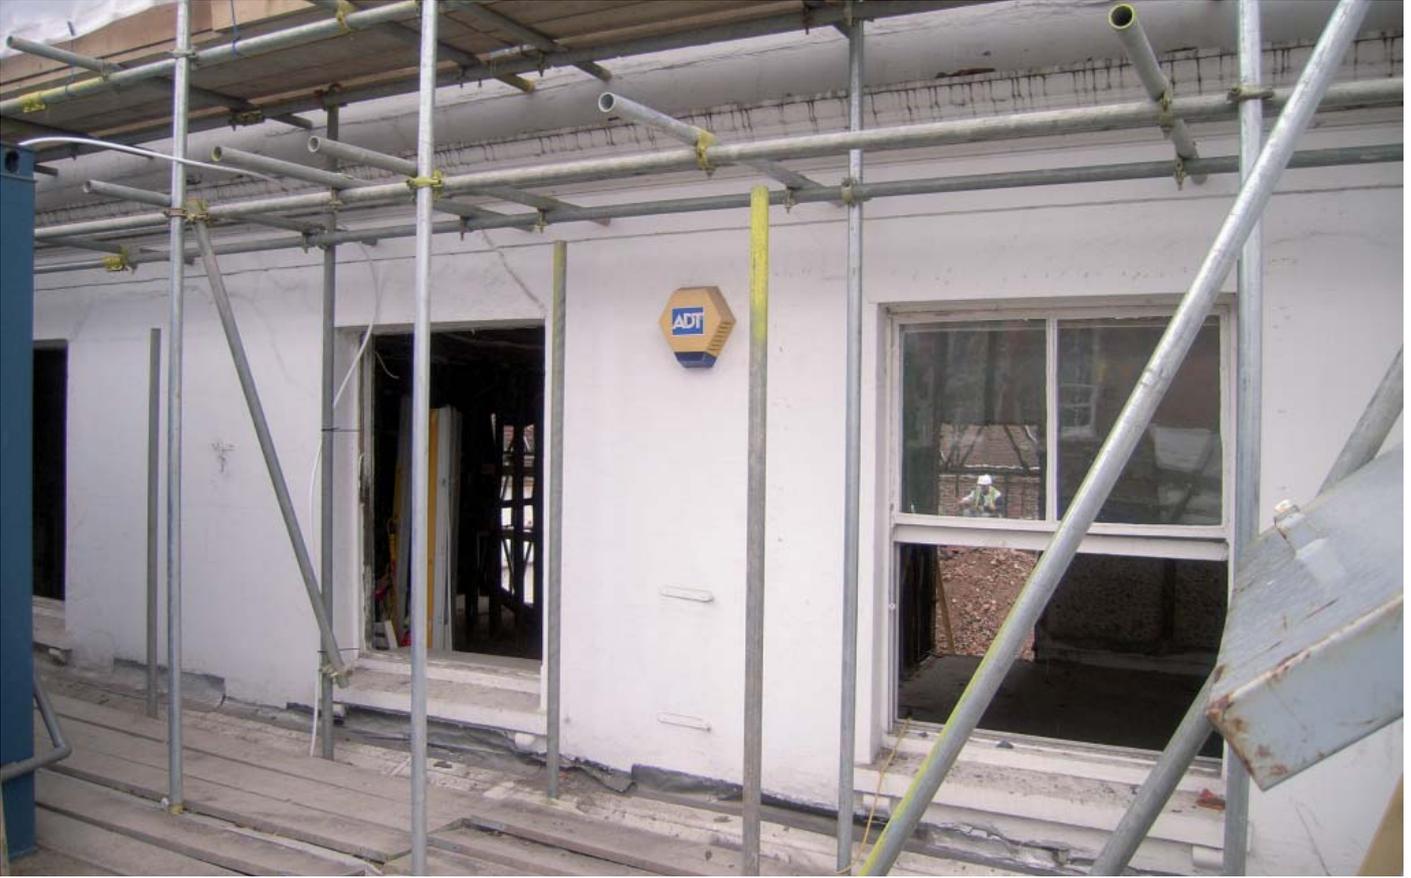
Plate 3: Section of first floor facade showing windows

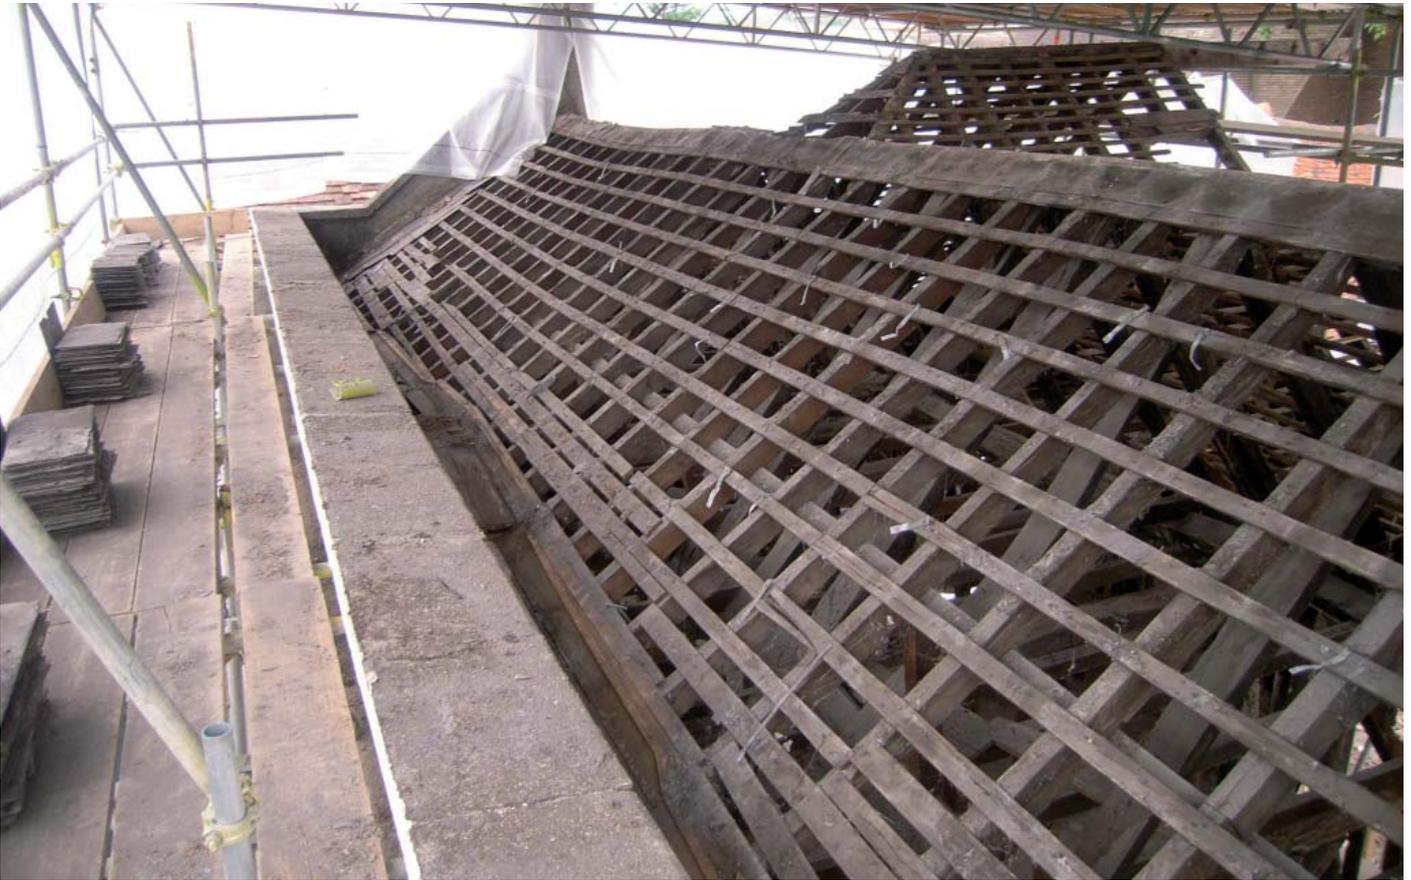
3.6.1 A new front slope was added to the roof probably at the same time that the facade was added (See plate 4). The added rafters are of softwood and are seated in the front wall about 1.5m above the tie beam and the former eaves level; they sit at a lower angle than the original rafters and rest on boards set on the ridge line of the early roof. At the rear the wall was rebuilt and heightened and the roof extended by means of three gables perpendicular to the main roof; a large central one with smaller ones either side.

Plate 4: Front slope of roof looking north

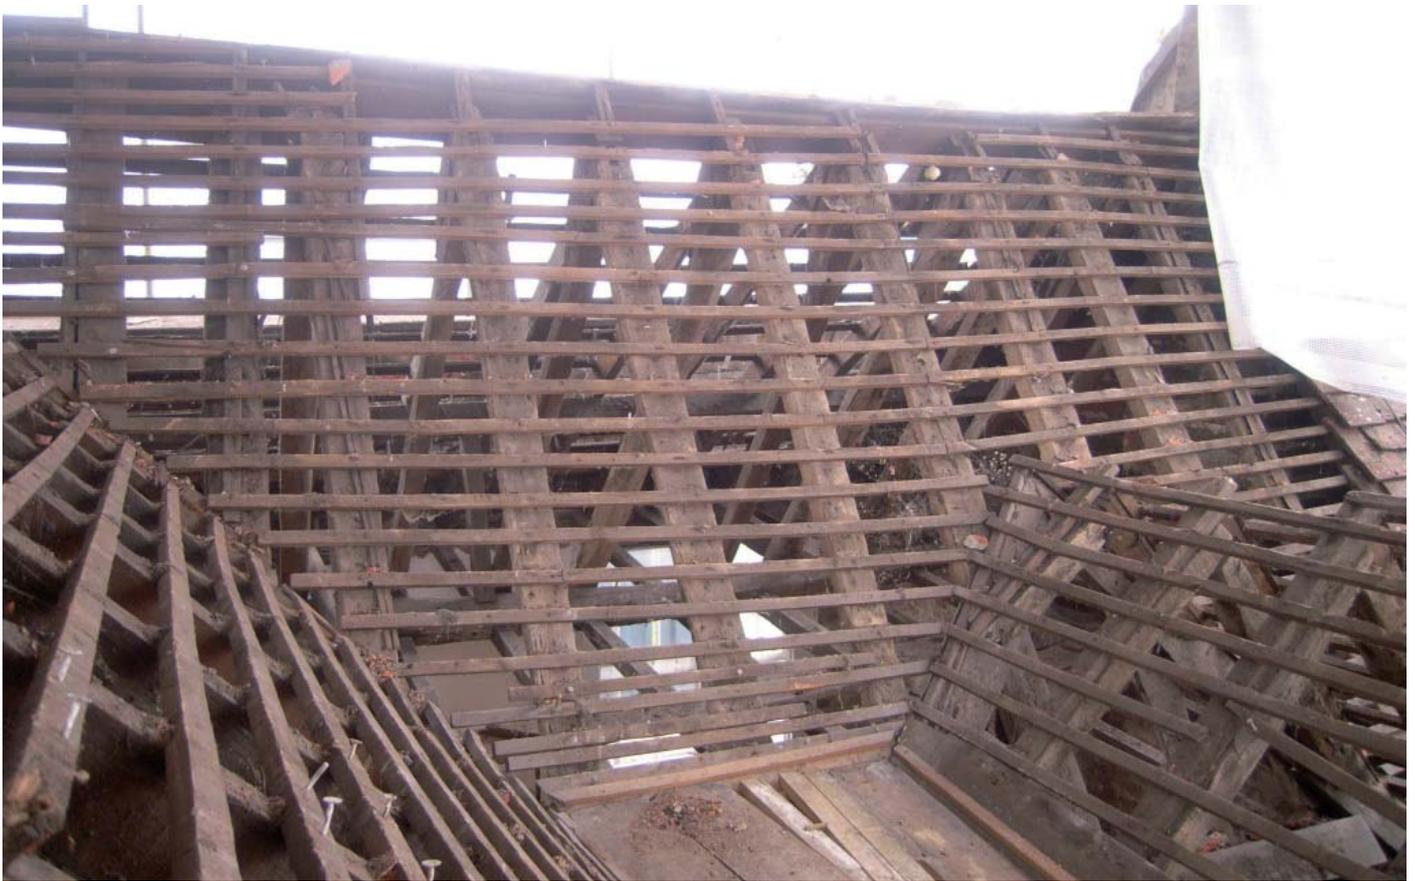
3.3.1 The main roof is a pitched roof aligned north-to-south along the street; the front slope of the roof was clad in large slates which were mostly removed before the survey was undertaken (Plate 4). The rear slope of the roof has three later gables projecting eastwards from it, these rear roofs were clad in plain clay tiles, again mostly removed prior to the survey (Plate 5).

Plate 5: Rear slope of roof at north end with later gable extensions

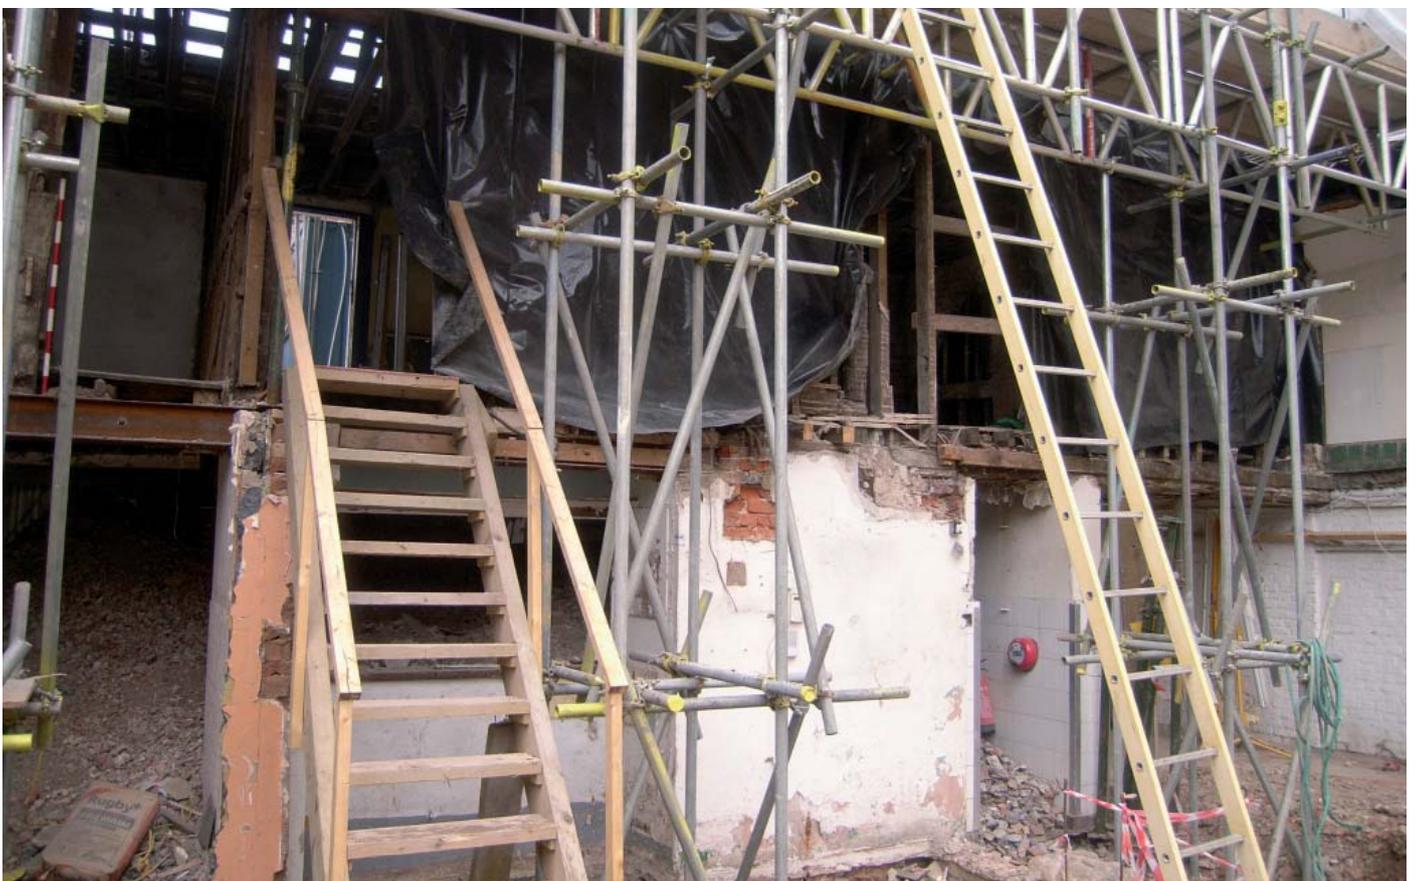
3.4.1 Access to the ground floor was very limited as it was being used as a temporary storage for demolition materials. The ground floor consists of the modern shop front and, at the north and south ends, of older brick walls. At the rear the ground floor is largely open due to the demolitions (Plate 6). Any former internal ground floor

Plate 6: Rear view of building during works

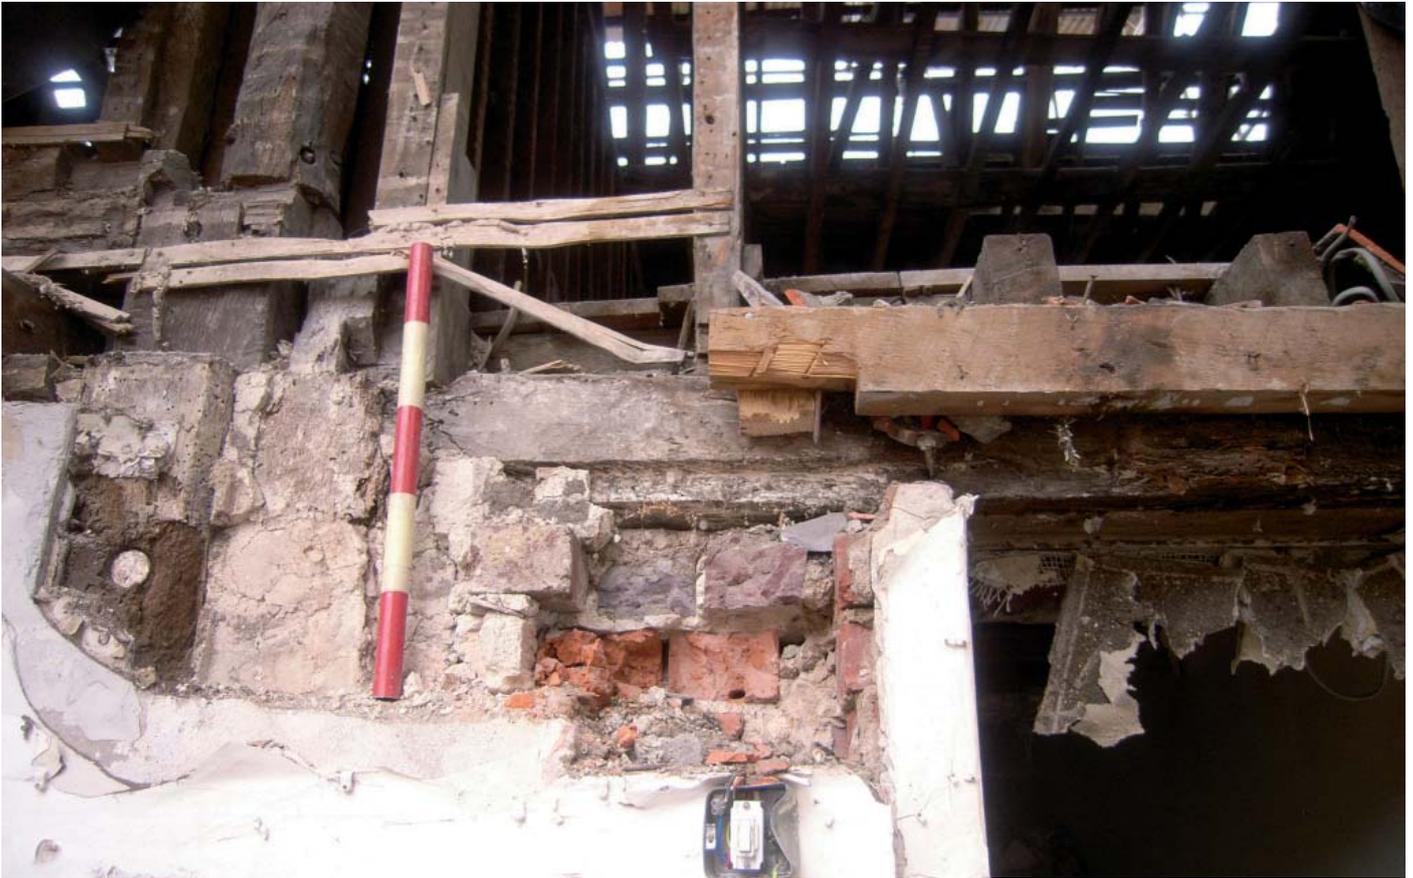
divisions below the crossframe/trusses have been removed and replaced with girders. The south wall is of brick and is shared with the adjacent property and continues on the first floor where it contains a chimney breast and fireplace. The north wall divides the shop room from the passage from the street to the yard and runs under the north first floor room. The upper structure is now mostly supported by a steel framework of vertical and horizontal girders. There is a section of brick wall towards the north end of the rear ground floor and this contains the only surviving element of historic timber frame that was seen below the first floor; a mainpost below the central truss or crossframe above. A girding beam runs north from this post and supports the upper wall over the passage way, there is a rebate in the outer face of the plate immediately north of the post and this was probably for the top of a door, and would thus have been the former rear entrance to No. 23 (Plate 7).

Plate 7: Main post and plate with rebate in rear wall exposed during works

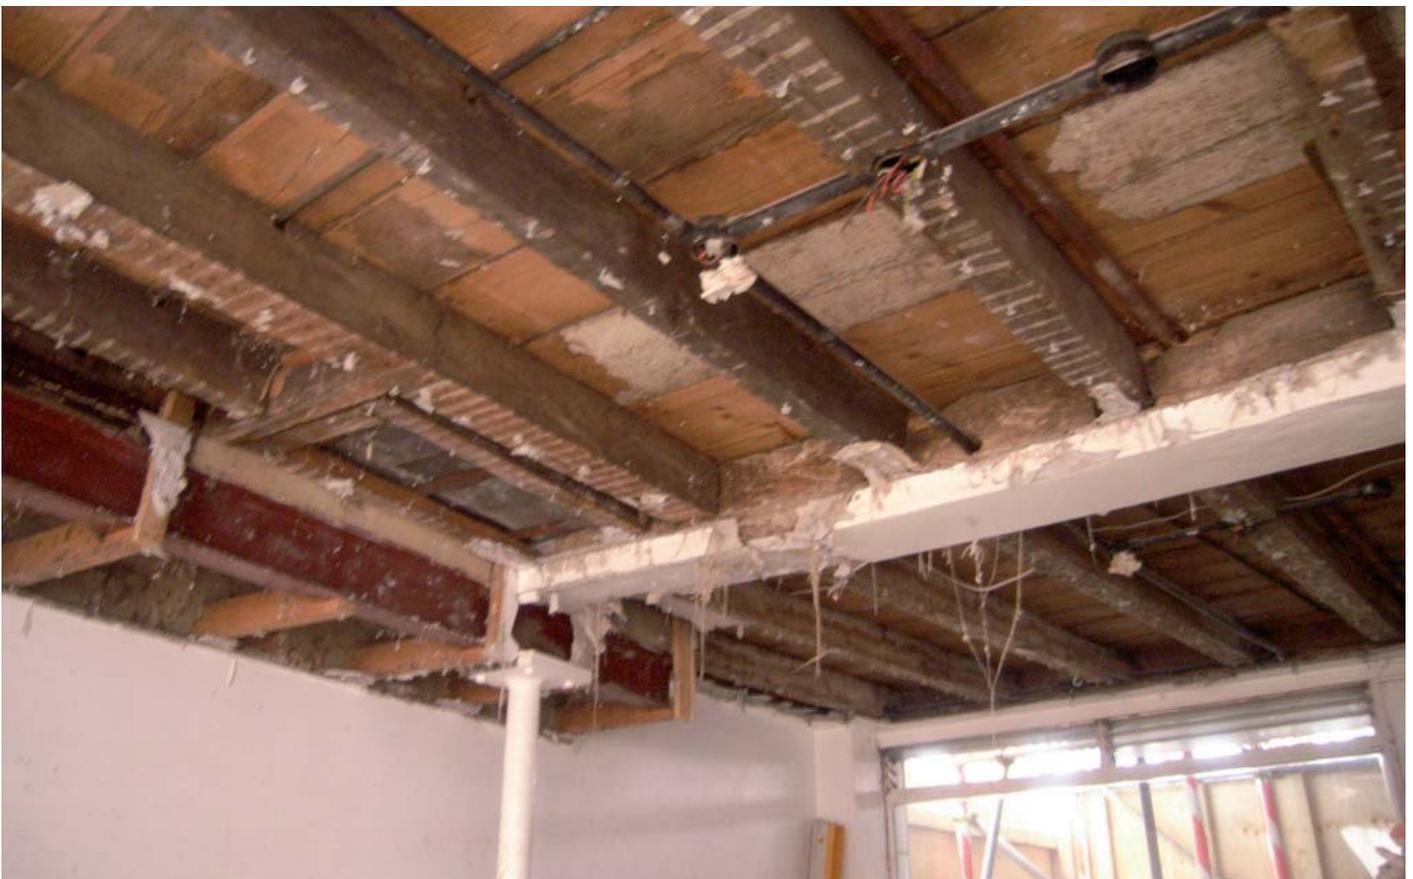
3.5.17 The floor structure of phase 1 consists of a central south-east to north-west aligned spine beam with transverse common joists tenoned into either side of it. The south-west and north-east ends of the joists are supported in the front and rear walls by modern girders.

Plate 8: Floor structure; note girder and stanchion supporting bridging beam and chimney breast

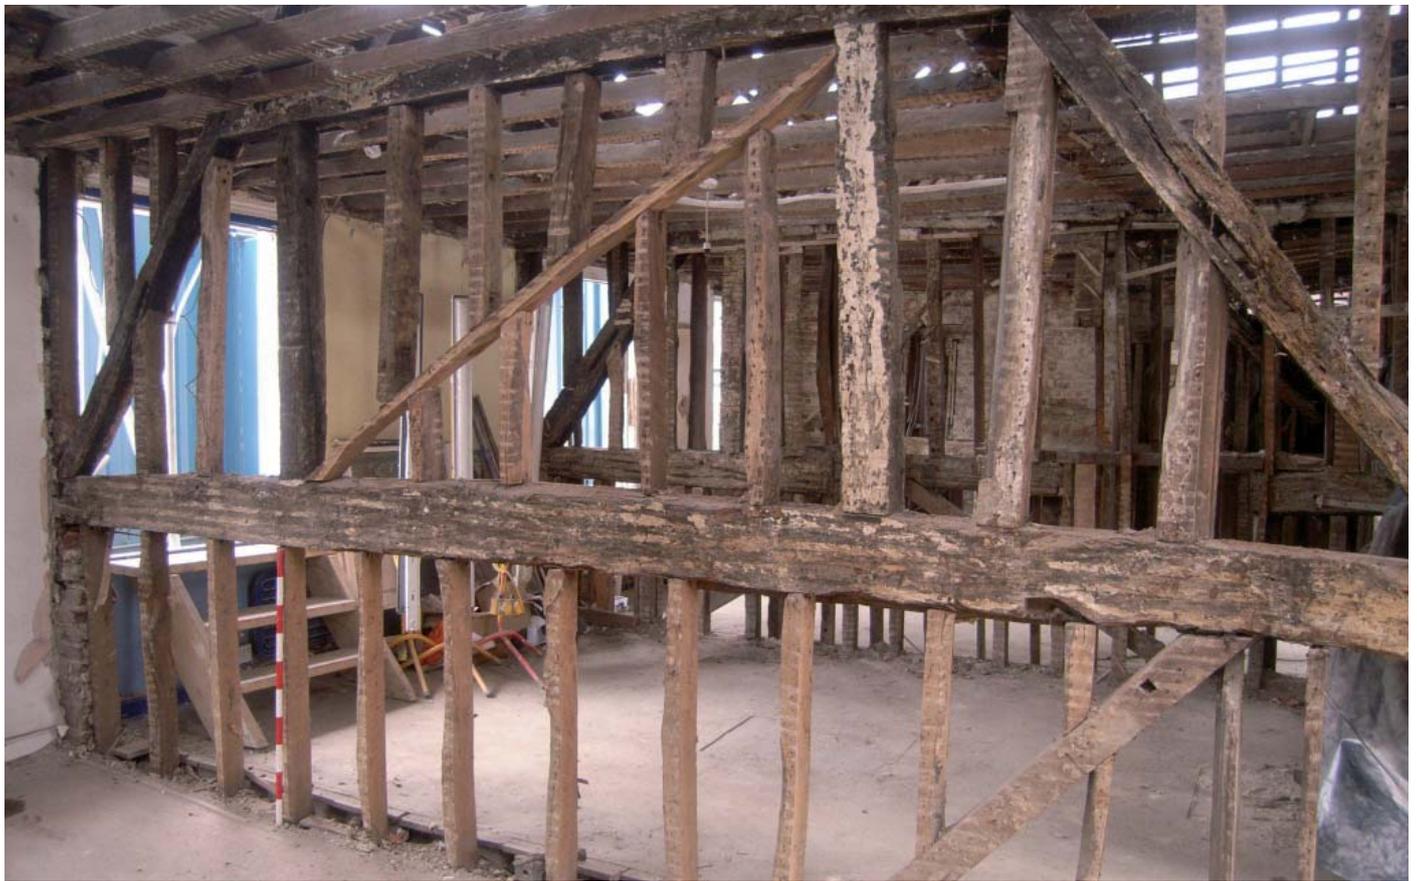
3.5.4 The primary form of the trusses in this phase consisted of a cambered tie beam supporting principal rafters with vertical queen struts rising from the tie and supporting a collar. Single side purlins are clasped between the collars and soffits of the principals which are trenched to take the purlins (Plates 9 & 10).

Plate 9: South side of truss one

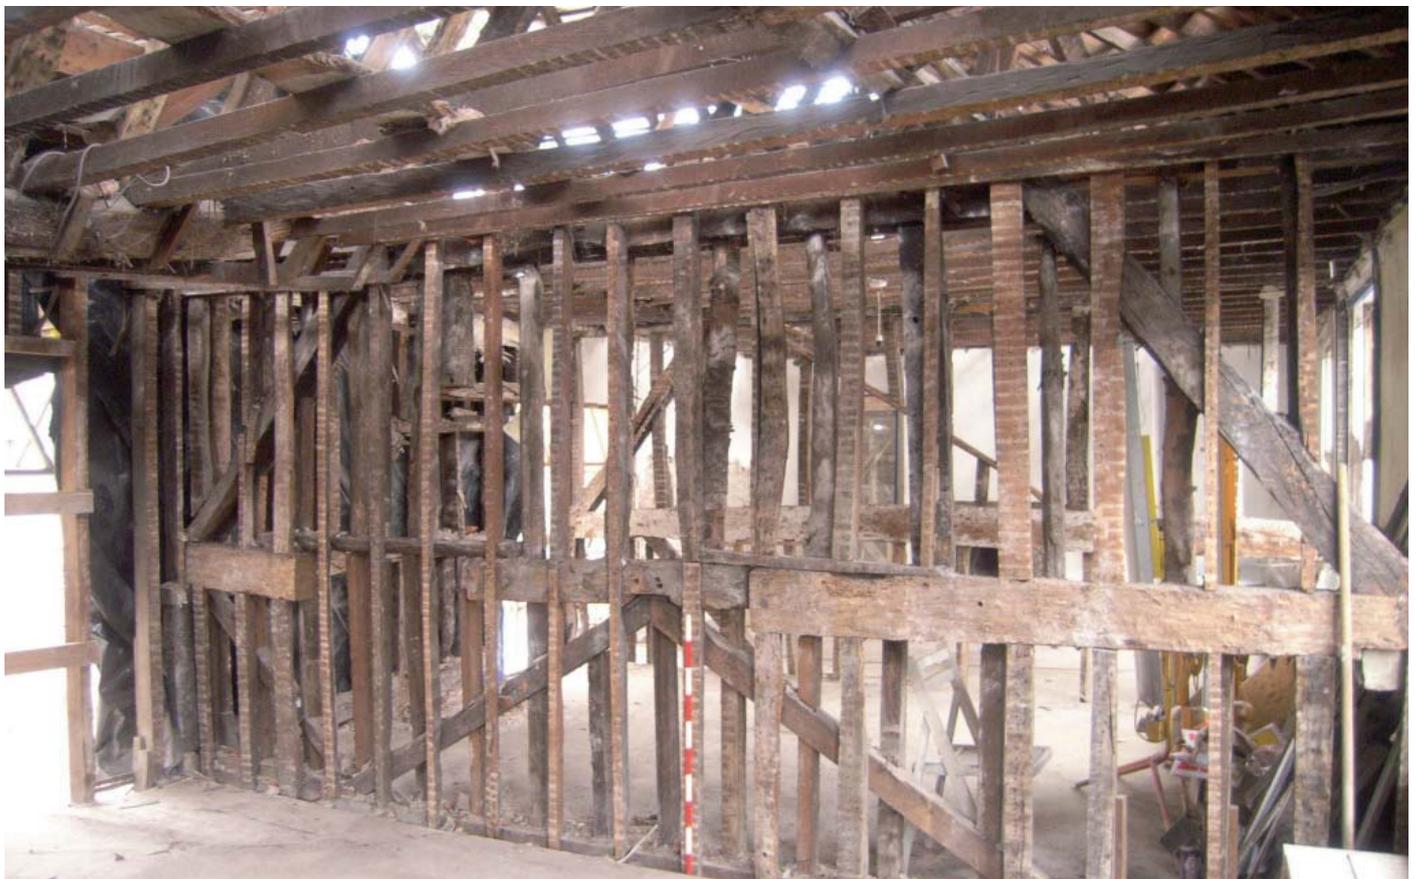
Plate 10: North side of truss two

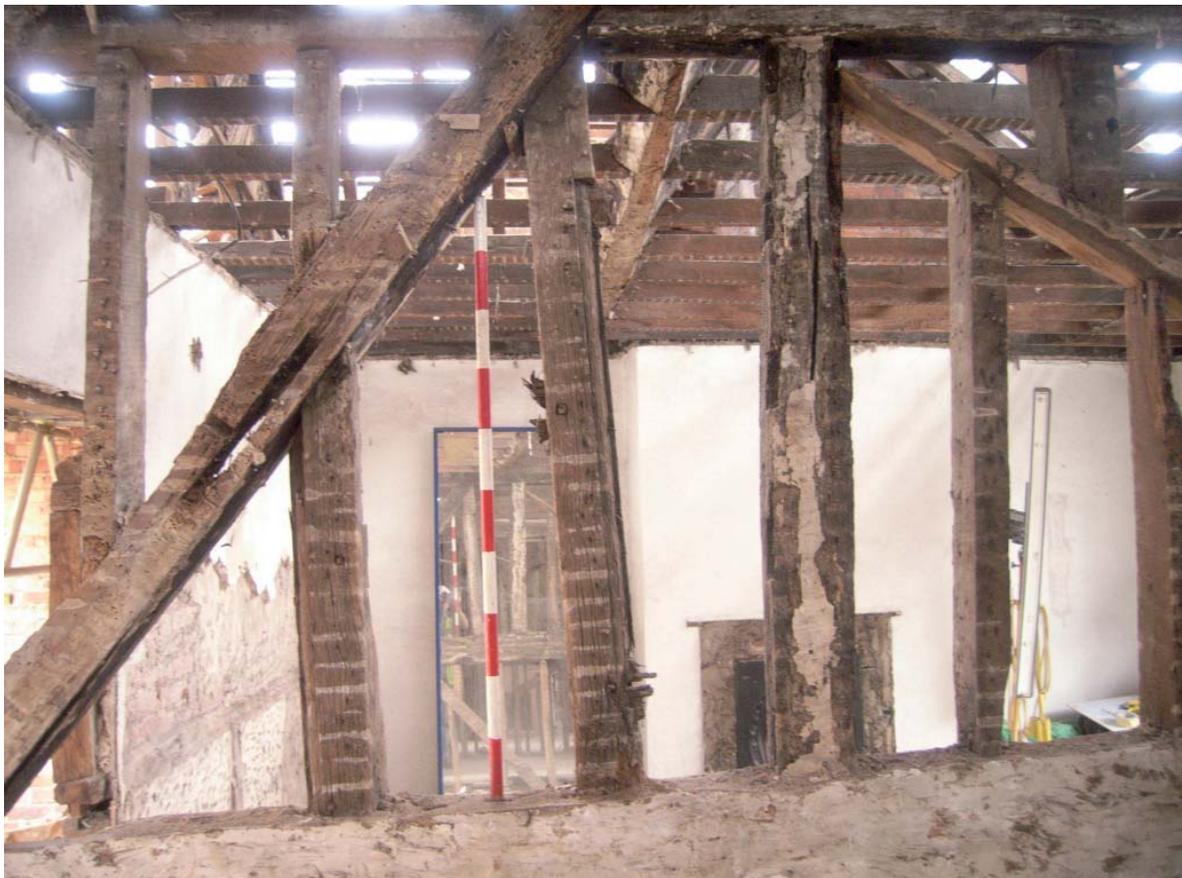
- 3.5.6 The east queen strut in Truss One is part of a reused wallplate having mortices for studs or staves in the west face and V section rafter seats in the east face. The truss has small empty mortises in the soffits of the collar and tie and V grooves in the upper surfaces of these members for staves or studs for lost earlier wattle and daub infill. This truss, and Truss Two, have been closed later with some nailed hardwood studding consisting of some reused from removed medieval and later elements of the frame and some 'new' waney studding. The two studs between the collar and tie east of the east queen are pieces of reused ovolo moulded window jambs (Plate 11). The western one contains the entire height of the ovolo moulding with the mortises for the top and bottom rails of the window with broken tenons still *in situ*. Both exhibit much greater weathering on the side of the moulding that was exposed to the elements outside. One further central stud below the collar has ovolo moulding and empty mortices. This was probably a window sill or lintel and the mortices were for the mullions. Below the tie one other stud is made from a reused piece of moulded timber..

Plate 11: Reused ovolo moulded window jambs and east queen strut in truss one, note also mortice for windbrace in principal rafter

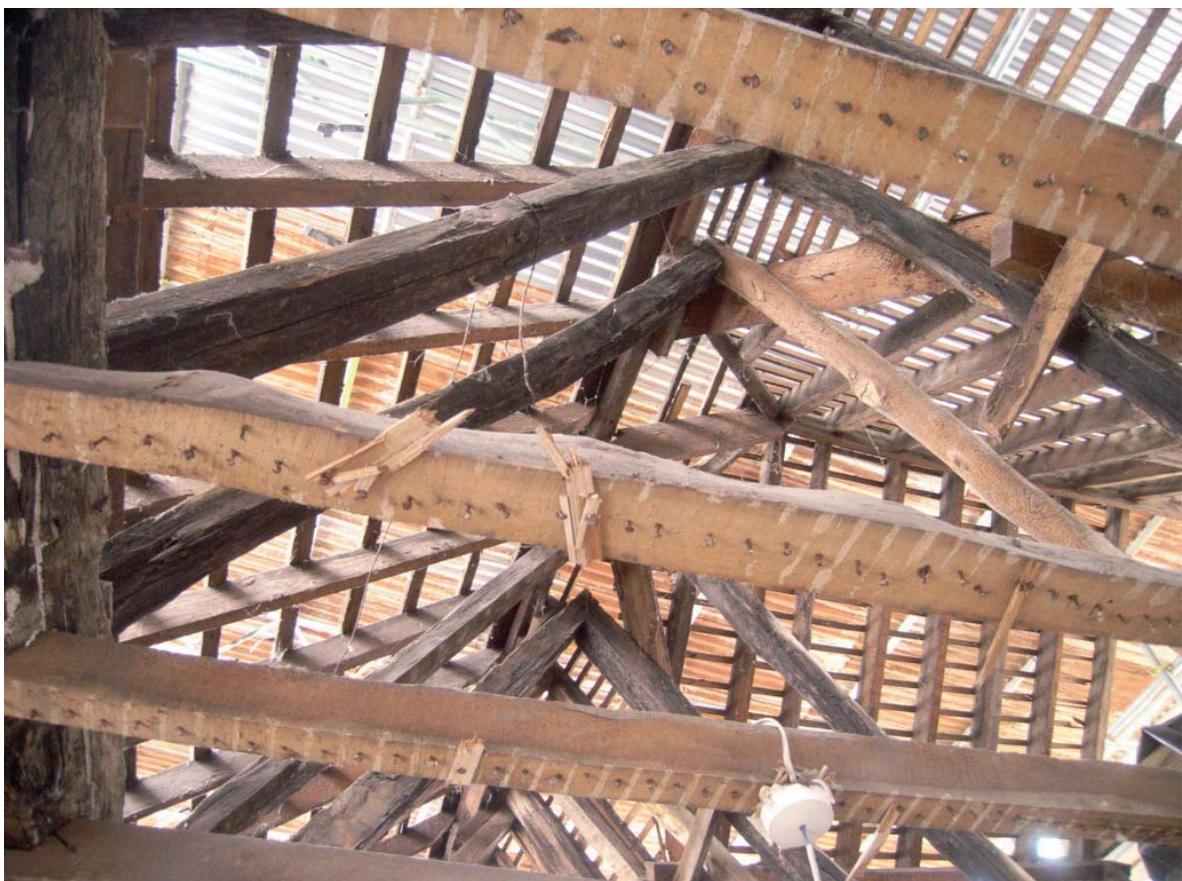
- 3.5.8 Both trusses and the rafters of this phase are heavily blackened with a residue of what is presumably soot from an open fire suggesting both bays of this building were originally open from the ground up to the roof (Plate 12). In Truss One, the central truss of these two bays, the blackening covers the soffits of the collar between the open mortises and the principals showing that the first phase of infill in this truss was secondary to the construction. There is a similar situation in Truss Two which is more difficult to understand, as if this was the end truss it would have been infilled from the start and therefore the blackening should not extend to soffits of principals and collars where the infill would protect them.

Plate 12: Smoke blackened rafters above later ceiling joists

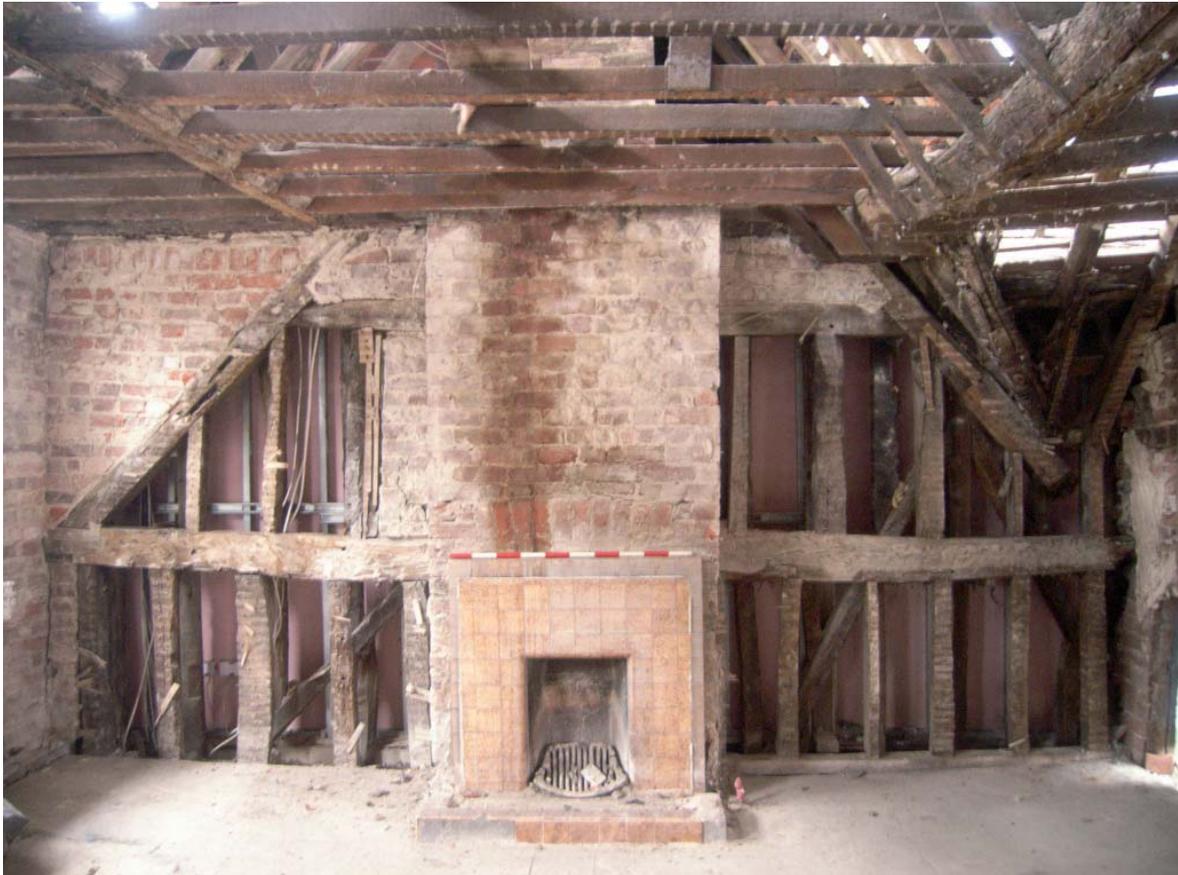
3.5.11 Truss Three (Plate 13) at the north end represents a separate construction phase which consists of the truss and roof over the north bay between this truss and truss two. This was presumably built on the adjacent plot which was possibly in different ownership at that time

3.5.14 The south ends of the purlins are not joined to the principals of the adjacent truss two but supported by other roof members. The eastern purlin is sagging and in poor condition and is supported by being bolted to a later softwood purlin beam which has been inserted above the rafters and which sits at its south end on the principal rafter of truss two. The rafters and purlins show no discolouration due to smoke and this phase was probably floored from first construction.

Plate 13: North wall incorporating truss three and later chimneybreast and additions; note empty joints for original clasped purlins

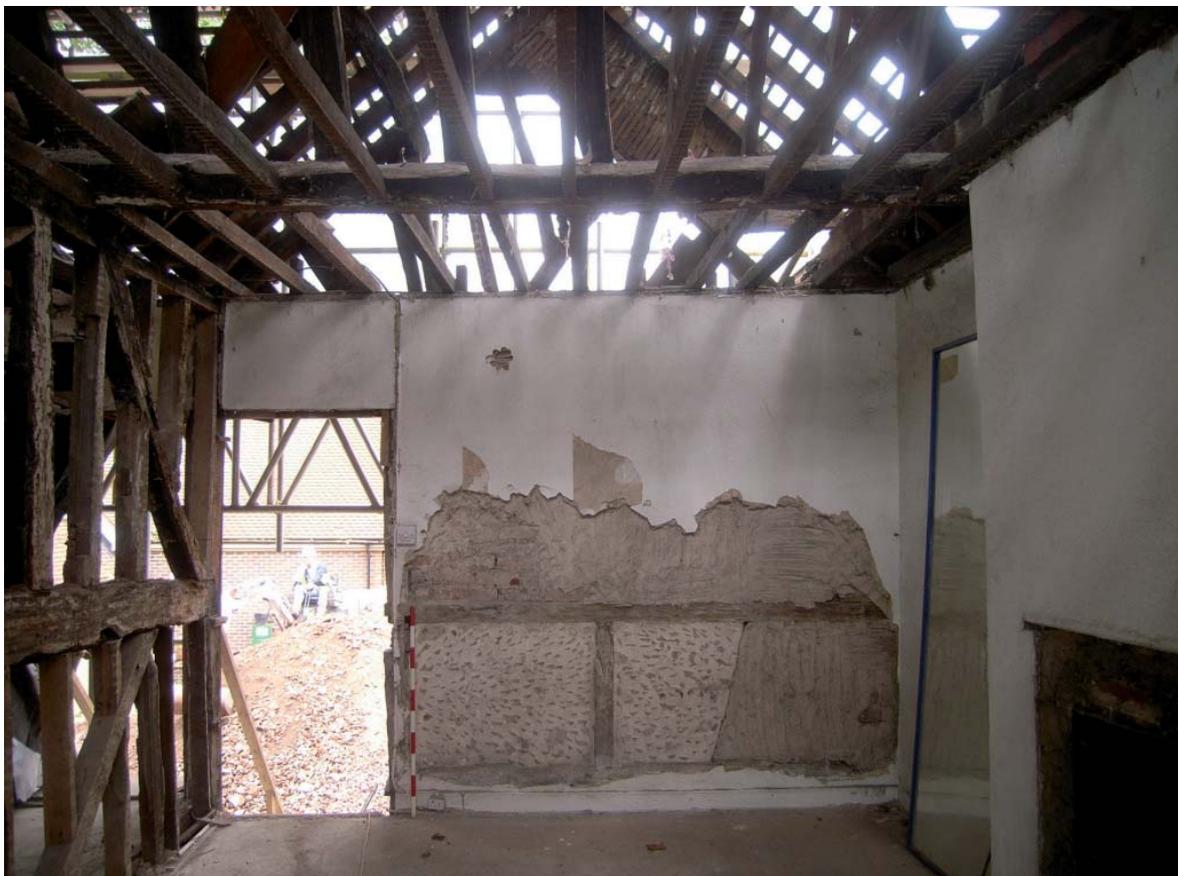
Plate 14: East wall in south bay showing old wallplate and earlier infill in lower panels

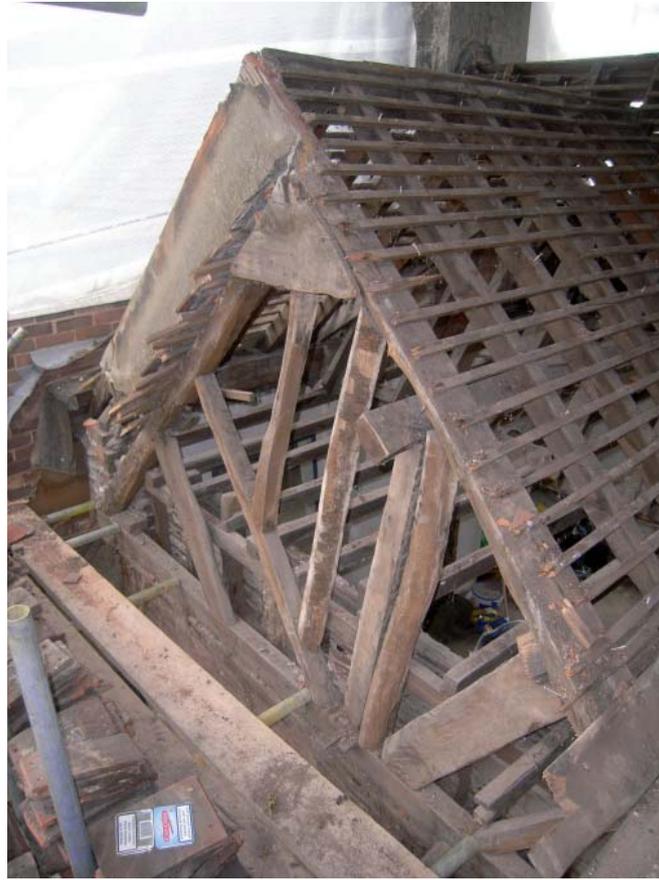
3.6.2 There are two phases at least to these rear additions. The first phase may have only involved the south bay, here the wall is infilled externally in brick above and below what is probably the original wallplate. Internally there are two phases of lime infill, the two panels below the old wallplate containing earlier render which may be daub over stave and wattle work. The south part of the south lower panel and the entire wall above the old wallplate has later lime render applied straight to the brickwork (Plate 14). Above this the gable is of two phases; an earlier one in reused hardwood, which incorporates a smoke blackened timber as the north purlin, later extended to the south in softwood later (Plate 15).

Plate 15: External view of south rear gable

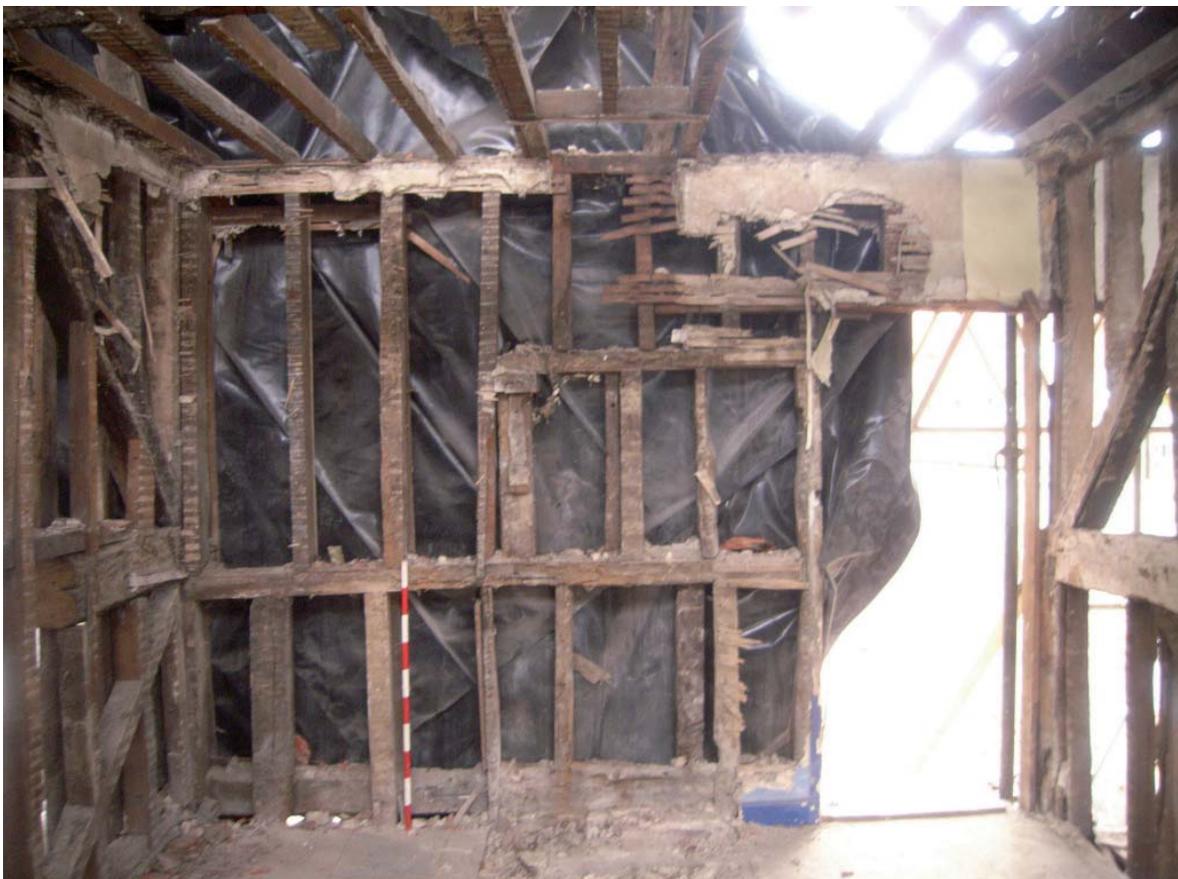
Plate 16: Framing of east wall in central bay

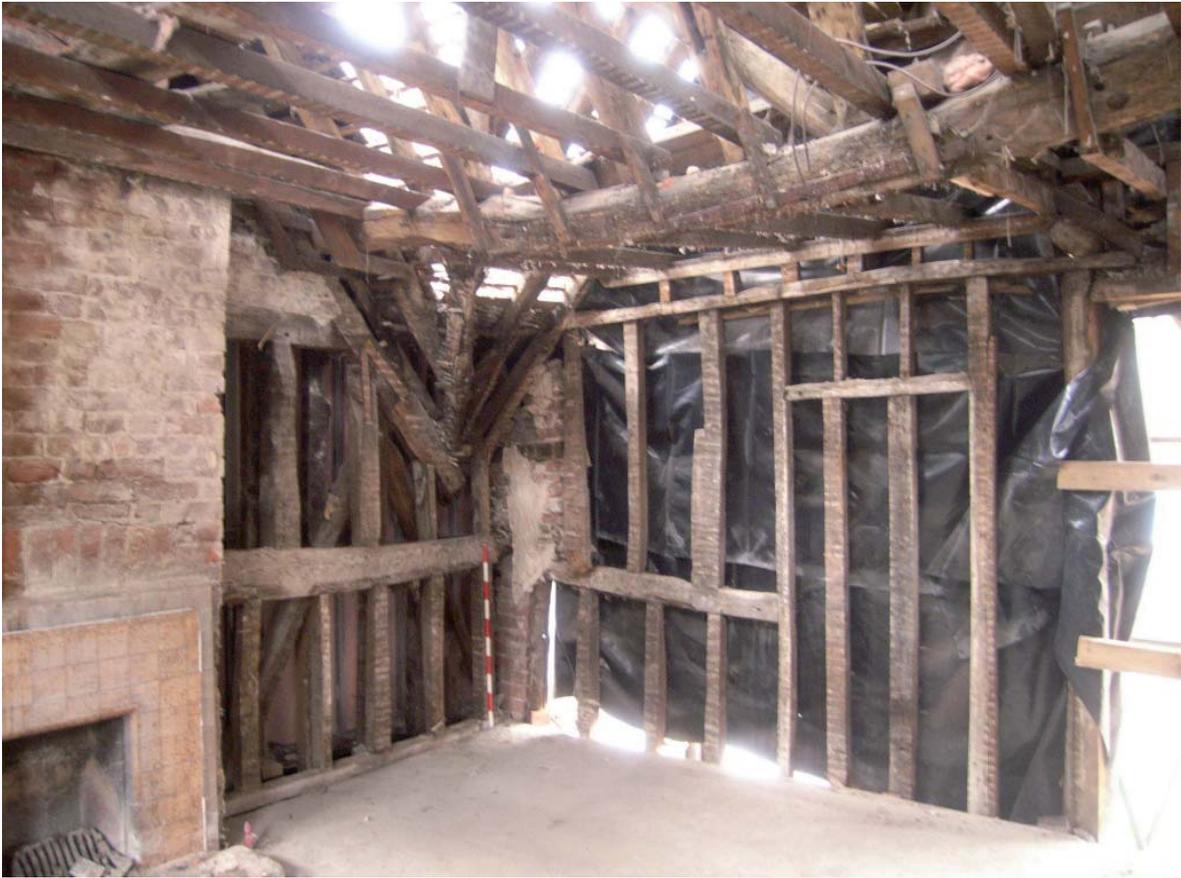
3.6.3 The east wall in the other two bays has been rebuilt and heightened with reused hardwood and some softwood studs and plates and the only possibly *in situ* primary material are sections of wallplate now within the wall framing. In the central bay the wallplate has had a section removed at the south for a door into the heightened room (Plate 16) and in the north bay, there are two phases of doorway; an earlier central one which appears to date from the initial rebuilding of the wall and was later blocked with studding and a the present doorway inserted at the south end (Plate 17)

Plate 17: North east corner showing framing of east wall in north bay on right

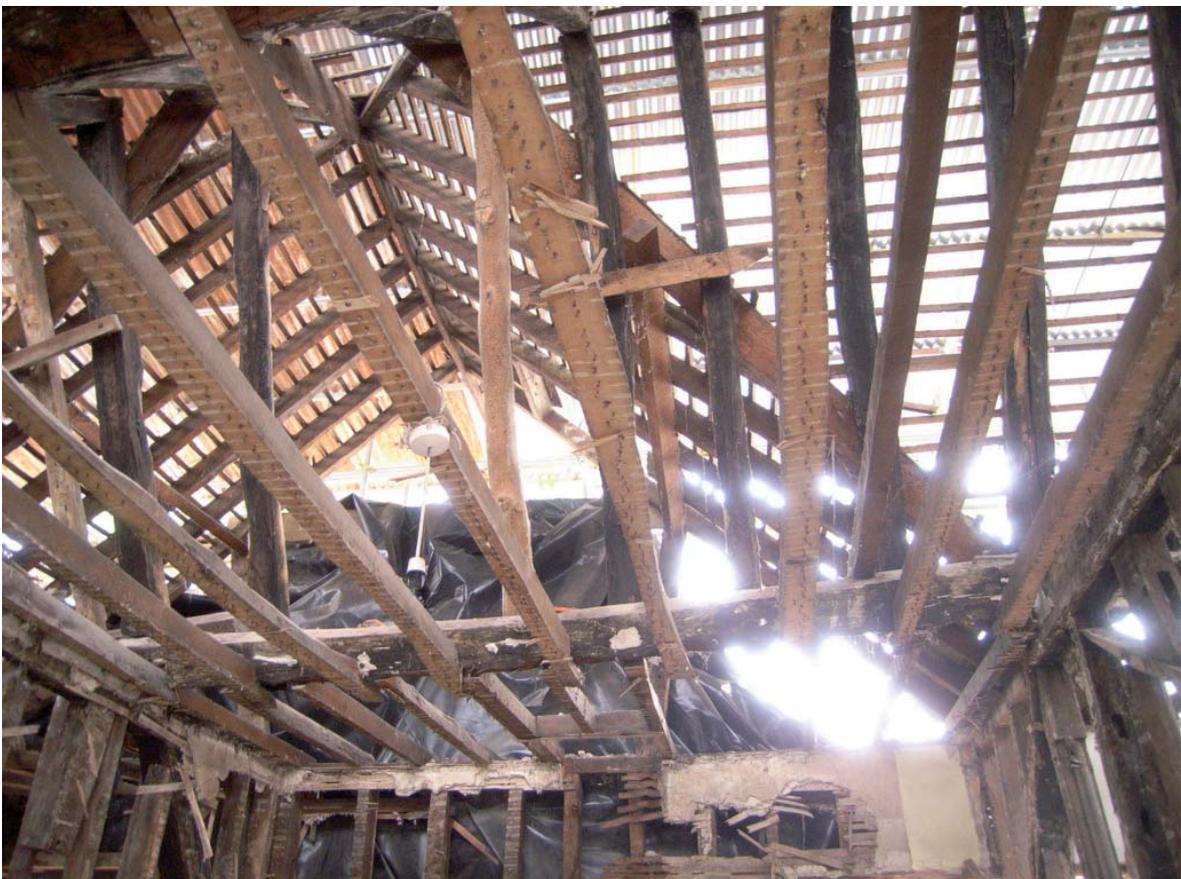
Plate 18: View of roof east from central bay showing early smoke blackened rafters and later gable and ceiling joists
