PN2420

RYECOTE CHAPEL, GREAT HASELEY, OXON - WATCHING BRIEF

Introduction

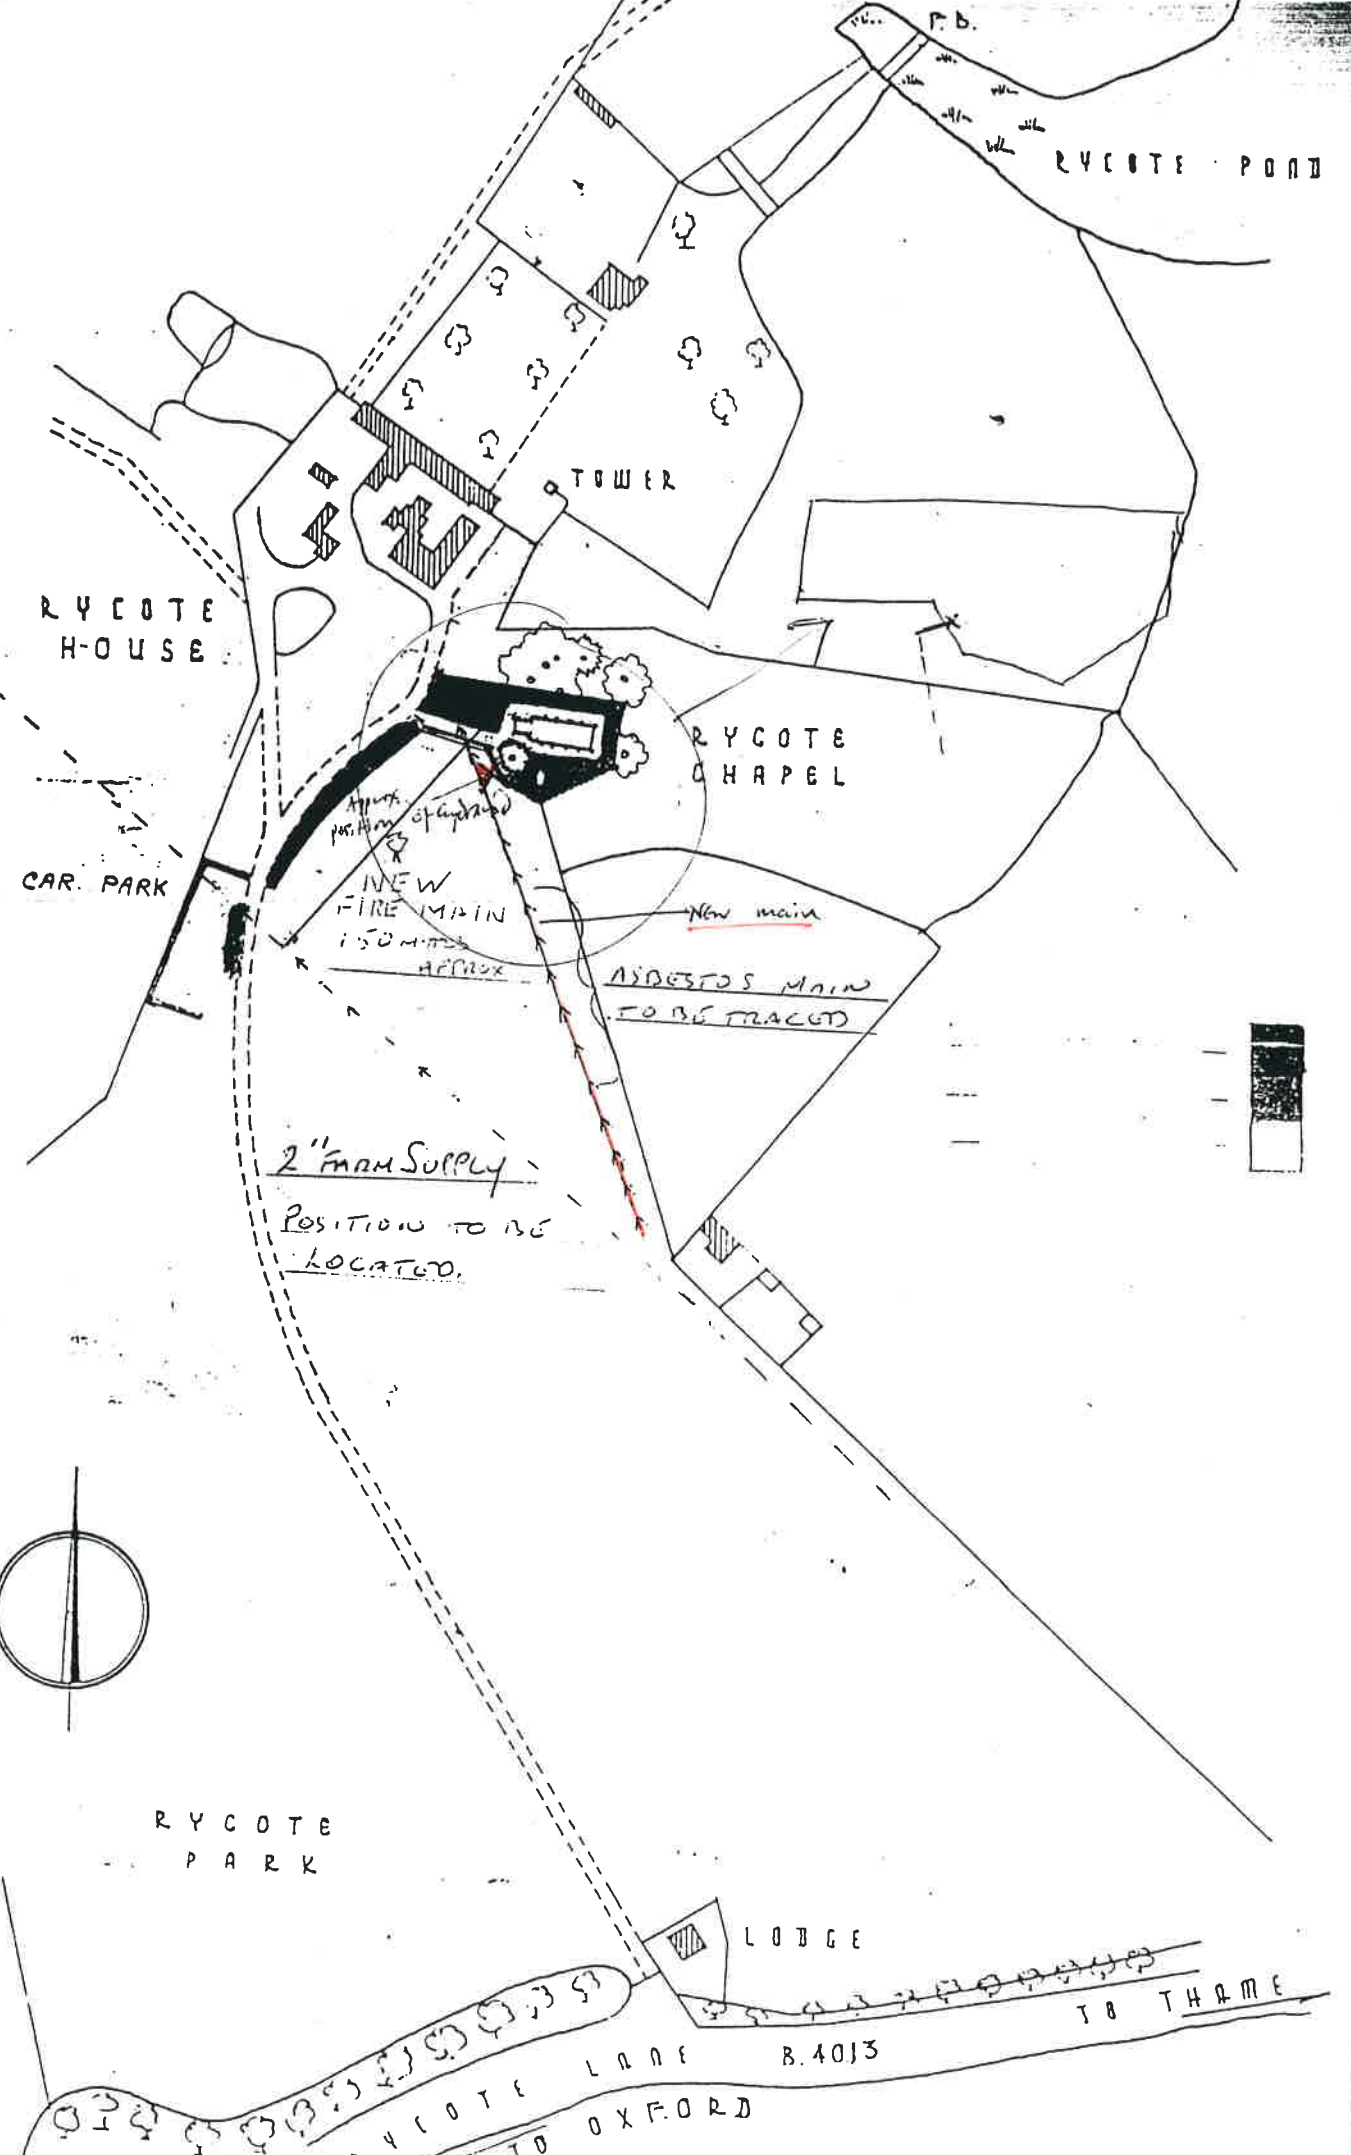
ENLARGED FROM CIVIL ENGINEERING PLAN

- The fire hydrant pit (into which the fire hydrant had already been fitted at the time of inspection) had apparently been dug at the junction of an asbestos main, which ran along the inside of the hedge (rather than outside it as indicated on the plan.) It seems likely therefore that the ground in this particular area had been recently disturbed.
