Hungerford Park Estate Hungerford Berkshire

Archaeological Evaluation Report

April 2004

Client: Edinmore Properties

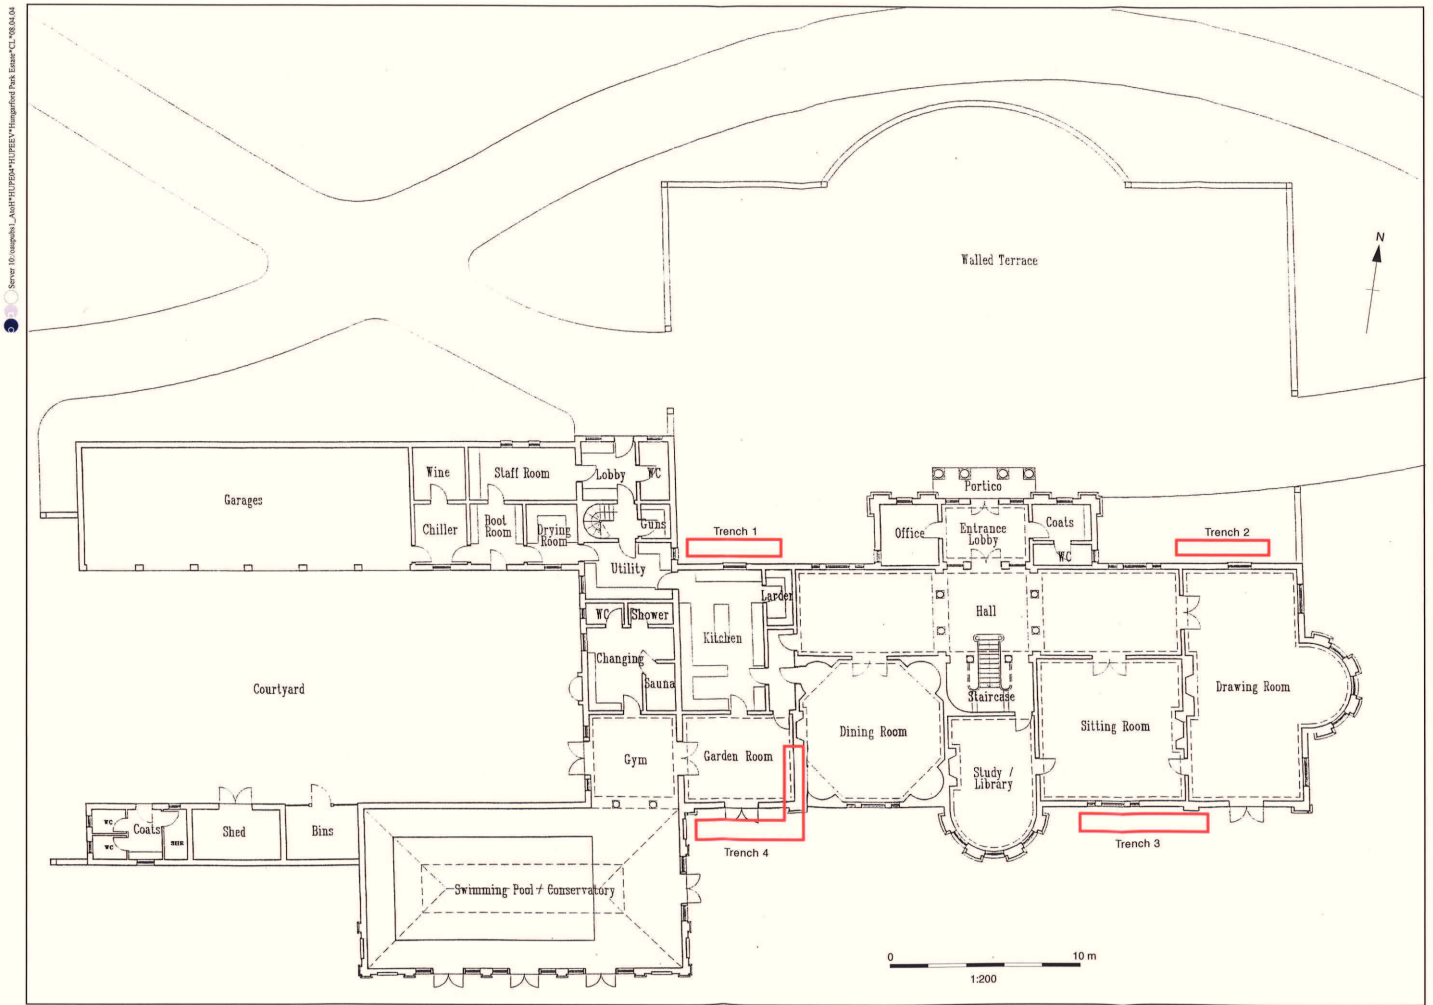
Figure 2: Hungerford Park Estate: Trench location plan

- 3.1.1 Four trenches measuring 5 m in length by 1.6 m wide were excavated adjacent to and parallel to the original Manor footings (Fig. 2).
- 3.1.2 The trenches were located on the exterior of the original footprint. Trenches 1, 2 and 4 were located adjacent to the original corners of the original Manor.
- 3.1.3 Trench 3 had to be moved due to standing saplings and was located close to the centre of the original south wall. Trench 4 was extended 4 m into the footprint of the former house on a north-south axis at its eastern end.

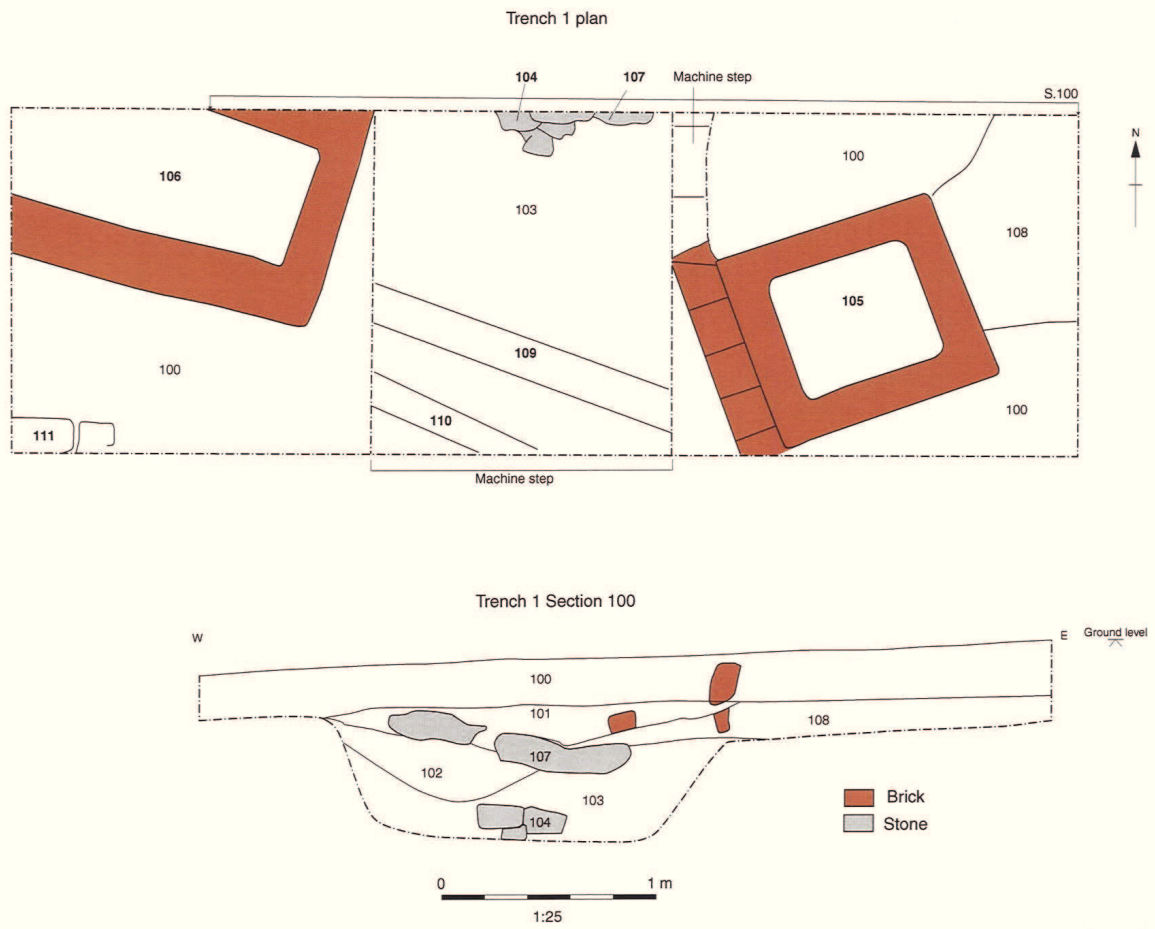
Figure 3: Trench 1, plan and section

- 5.1.1 The trench measured 5 m long by 1.6 m wide and was excavated to a maximum of 0.6 m below ground level.
- 5.1.2 Two brick Soakaways (105 and 106) occupied the eastern and western ends of the trench immediately underneath the topsoil (100). A sondage was excavated in the centre of the trench to a depth of 0.6 m at which point machining was halted due to the presence of two cast iron pipes (109 and 110) running approximately north-east to south-west.
- 5.1.3 A portion of concrete paving (107) was noted immediately under the topsoil in the northern edge of the trench, below this was a fragment of limestone walling (104) on a north-south alignment that appears to have been truncated by the placement of the cast iron pipes.
- 5.1.4 A fragment of a brick and concrete kerb (111) was also noted immediately under the topsoil (100) at the west end of the trench against the southern edge.

- 6.2.3 Of note was a fragment of dry-stone wall (104) in Trench 1, which may represent a garden or terrace wall located to the north of the house. This wall was clearly not of a size to be load bearing as there was no evidence of any bonding material having been used in its construction.

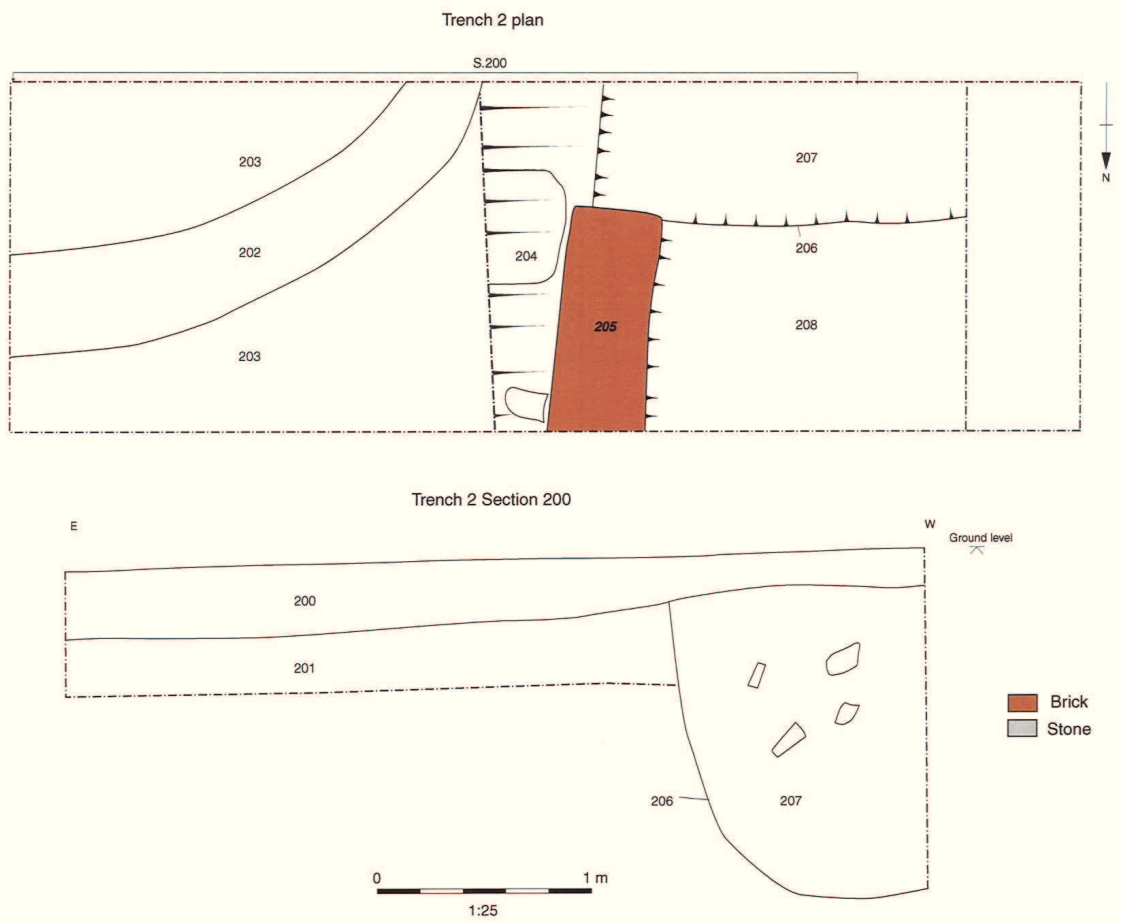
Figure 4: Trench 2, plan and section

- 5.1.5 This trench measured 5 m long by 1.6 m deep and was a maximum depth of 1.6 m. Natural comprising the red/brown sandy clay (208) of the Reading Beds was encountered at 1.5 m below the present ground surface.

- 5.1.6 The natural was impacted by a portion of brick walling (205) 0.4 m wide extending into the trench on a north south alignment from the north for a distance of 1 m. The top of the wall was at 0.9 m below the present ground surface. The wall (205) appeared to abut a chalk feature (204) that ran on an east-west axis. This feature was also 0.4 m wide, although only its extreme western end was visible within the trench.

- 5.1.7 A red/brown sandy clay with gravel and brick fragments (203) was observed overlying 204 and was cut by a curvilinear chalk filled service gully (202). This feature measured 0.4 m in width and curved across the eastern end of the trench. Overlying 202 was a friable layer of red/brown gravel and sand (201) containing brick rubble and modern bottle glass, measuring up to 0.3 m in thickness. Two cast iron pipes, 0.2 m in diameter, resting on a concrete plinth cut 201 on a north-south alignment. These were broken at their southern end within the trench and the alignment of these pipes suggested that they led to a drain inspection cover observed 3 m to the north of the trench.

- 5.1.8 A pit (206) was encountered in the western half of the trench. This was filled by loose flint nodules, brick rubble and a steel mesh (207) over 1.4 m deep, extending for a distance of 1.6 m within the trench. Due to its unstable deposits, this pit was not fully excavated depth.

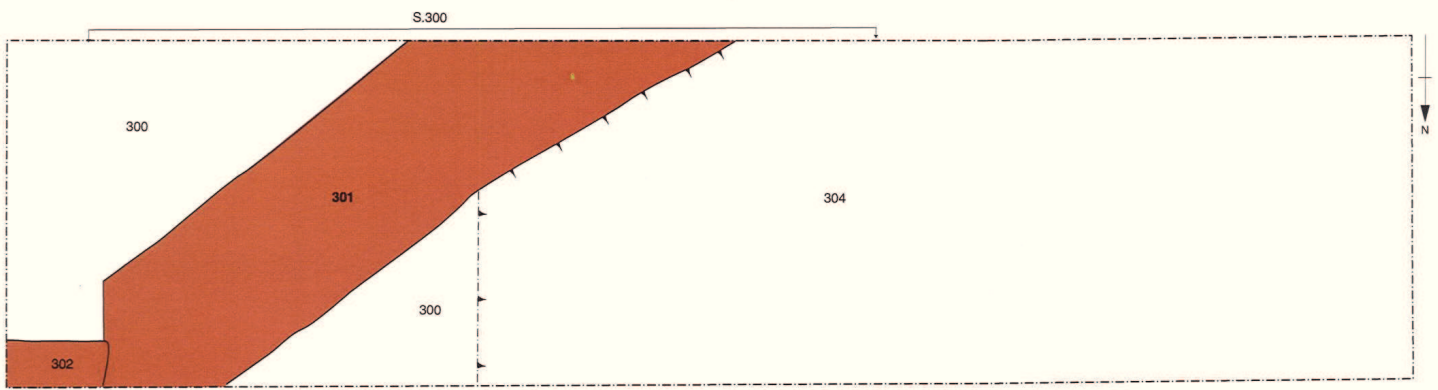
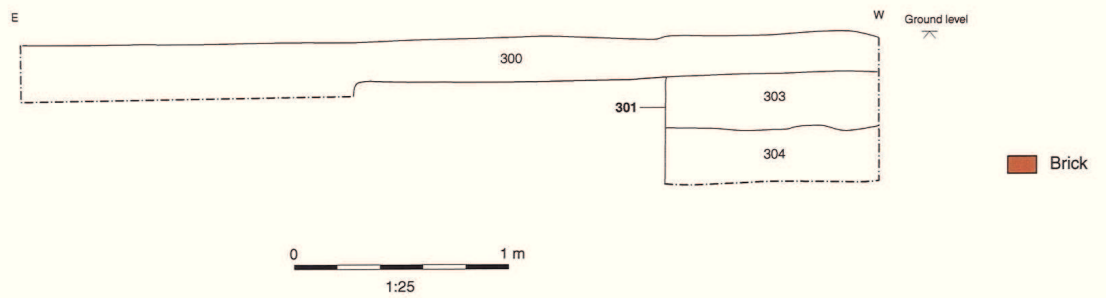
Figure 5: Trench 3, plan and section

- 5.1.9 Trench 3 measured 6.7 m long by 1.6 m wide and was a maximum depth of 0.6 m. The natural red/brown sandy clay (304) was encountered at the base of the trench at its west end.
- 5.1.10 A substantial brick wall (301) measuring 0.9 m wide and extending over 2 m across the trench was observed cutting the natural. The wall was orientated north-east/south-west and curved slightly on a more westerly course against the southern edge of the trench. The wall survived to a height of 0.5 m above the natural. Wall 301 was sealed by a friable grey humic rich deposit (303) containing brick and limestone rubble. Fragments of window glass and brass curtain rails were also noted within this deposit. A fragment of worn brick surface (302) was observed abutting 301 on its east side at the east end of the trench. All features and deposits were then sealed by a modern topsoil (300).

- 6.2.2 A possible exterior feature of the former manor was noted in Trench 3, where a substantial brick wall (301) was seen extending from the external wall of the former manor on a diagonal alignment. The position and width of the wall suggests this may have been part of a former bay or apse of the house.

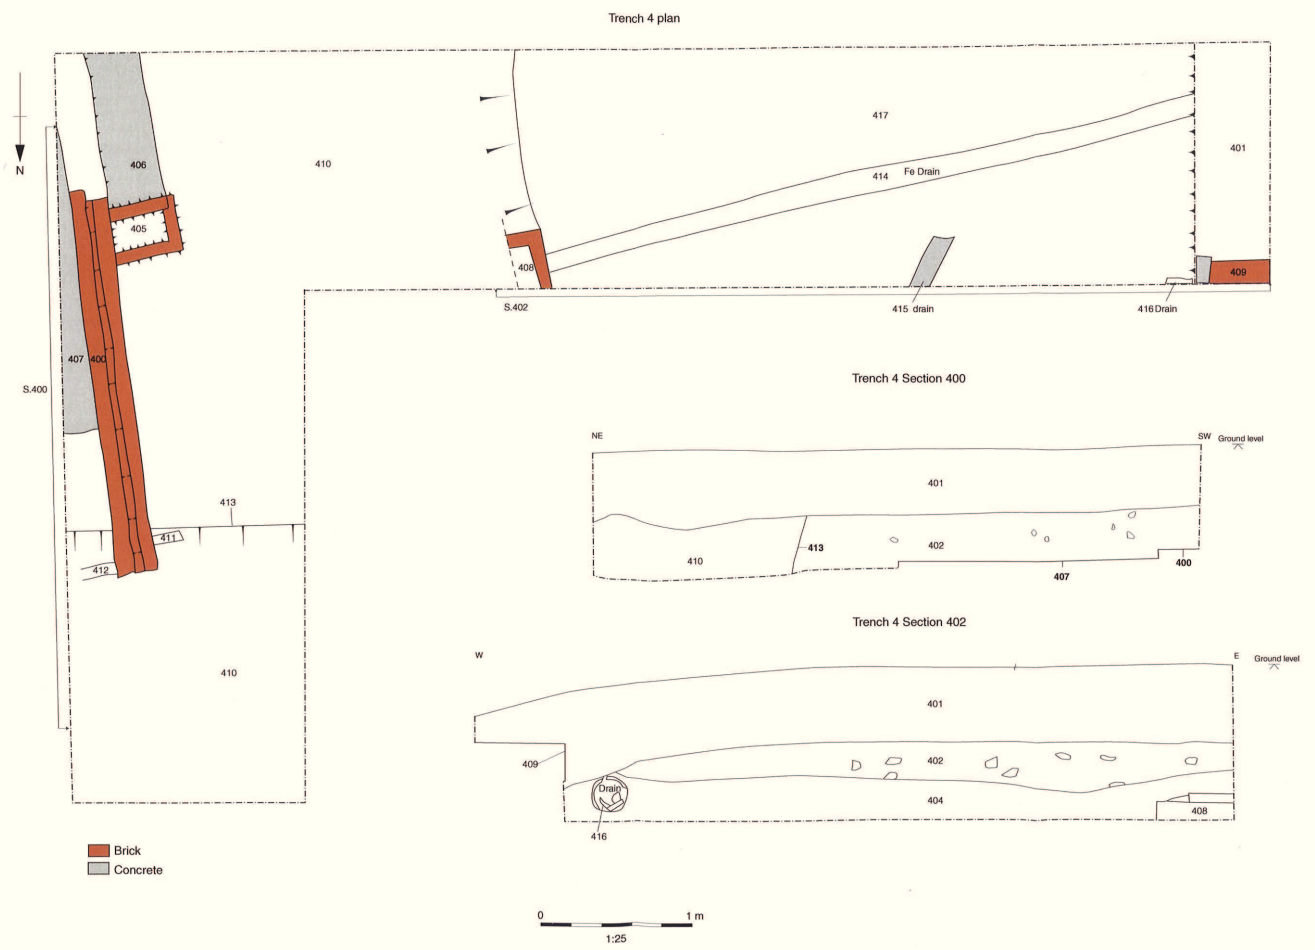
Figure 6: Trench 4, plan and sections

- 5.1.11 Trench 4 was excavated as an 'L' shape with the east-west section 6.1 m long and the north-south section extended a further 4 m in length. The natural (417) was noted 0.8 m below the present ground surface at the west end of the trench.

- 5.1.12 At the west end of the trench the natural was cut by an east-west aligned cast iron pipe (414) and two north-south aligned ceramic pipes (415 and 416). Pipe 414 appeared to lead to a square brick soakaway (408) that was partially exposed at the centre of the trench and lay 0.8 m below the present ground surface.

- 5.1.13 A layer of dark grey brown sandy clay with brick and tile rubble (404) overlay pipes 414, 415 and 416 and brick structure 408 to a depth of 0.24 m. Layer 404 was overlain by 0.25 m of demolition rubble (402), comprising brick and limestone fragments.

- 5.1.14 A brick and concrete structure (409) was observed at the west end of the trench. This cut the topsoil (401) to a depth of 0.3 m to the base of the trench.

- 5.1.15 At the east end of the trench, layer 404 was overlain by a thin demolition deposit of broken black tiles and slate (403), which was sealed by rubble 402. Deposit 402 also sealed a brick drain channel (400/405) and associated paving (406/407). These features may have been associated with the kitchen area of the original manor house.

- 5.1.16 The brick drain (400) was seen to extend for 3.4 m roughly north-south within the trench. This drain had a shallow paving stone capped channel along its southern end. Two further paving stones (406 and 407) flanked 400, as did 405. All these structural elements were overlain by demolition rubble (410) consisting of brick and concrete rubble, which extended over the fills of pit 413 at the north end of the north-south arm of the trench.
