# Archaeological Watching Brief

## The South Porch All Saints' Church Cuddesdon Oxfordshire

### Archaeological Watching Brief Report

April 2013

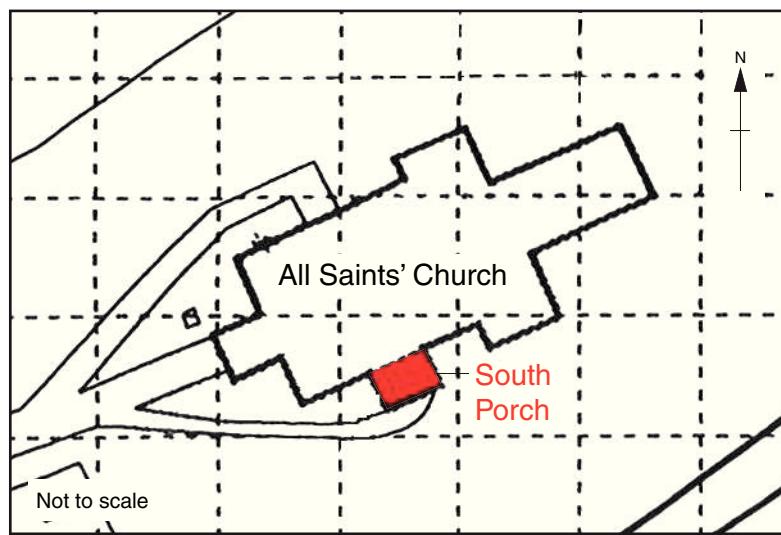
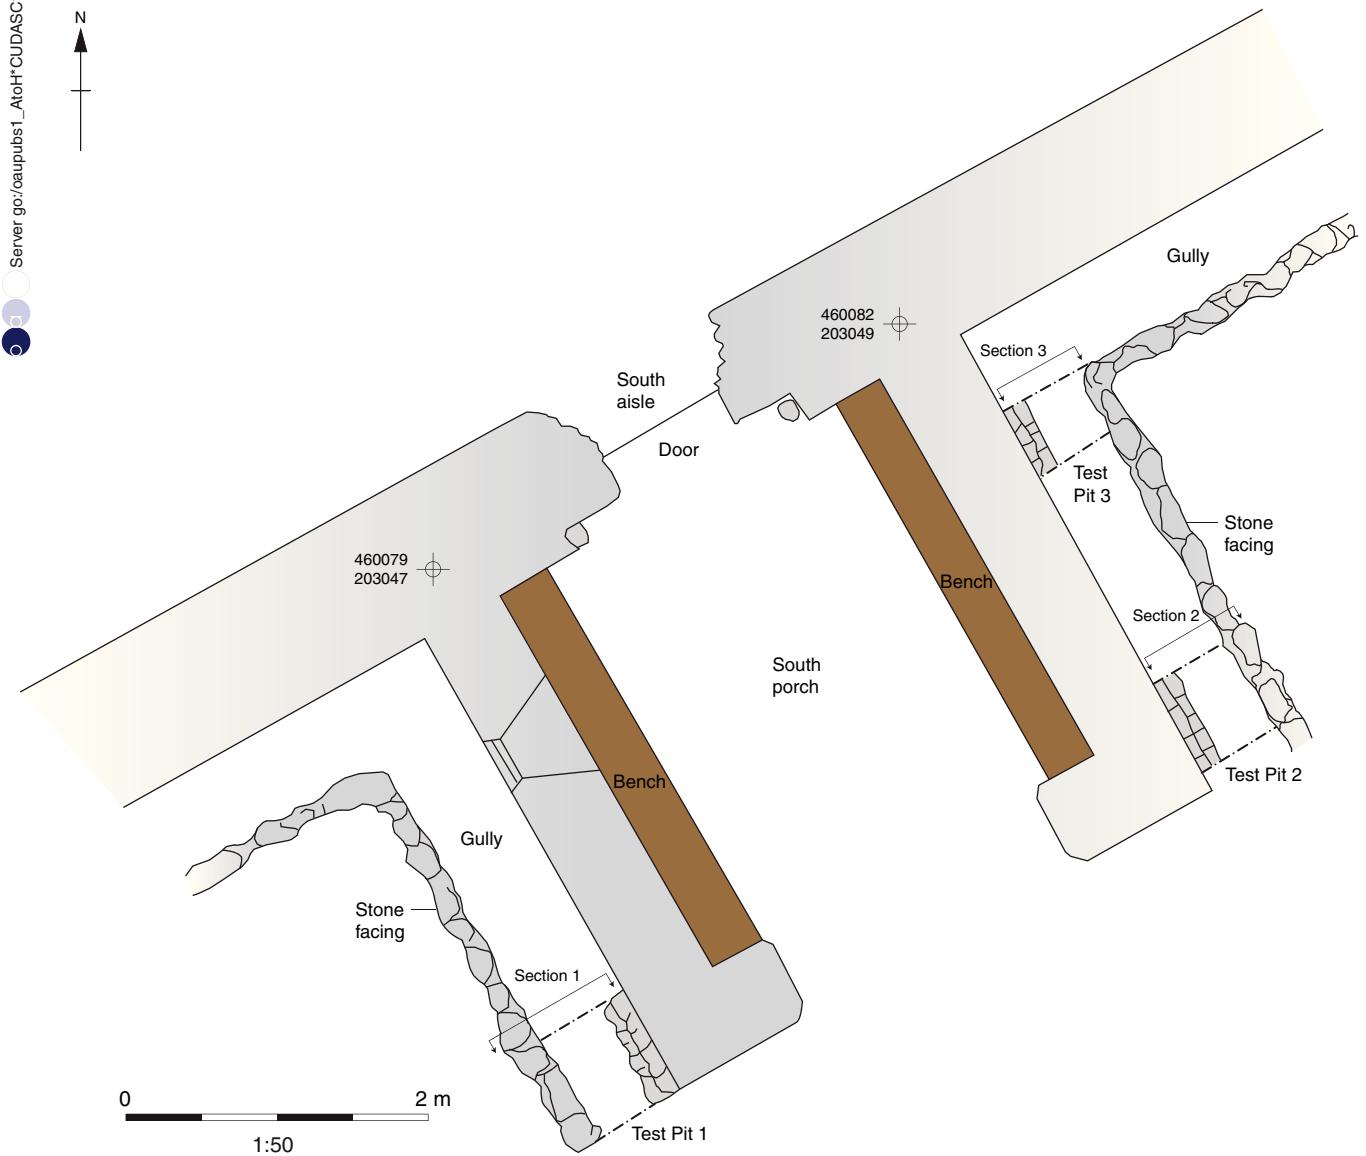
Figure 2: Location of the south porch and test pits

2.2.1 The watching brief observed all groundworks that had the potential to affect or reveal archaeological deposits. These works consisted of the excavation of three test pits, each measuring approximately 0.6m x 0.6m and up to 0.8m in depth (Fig. 2).

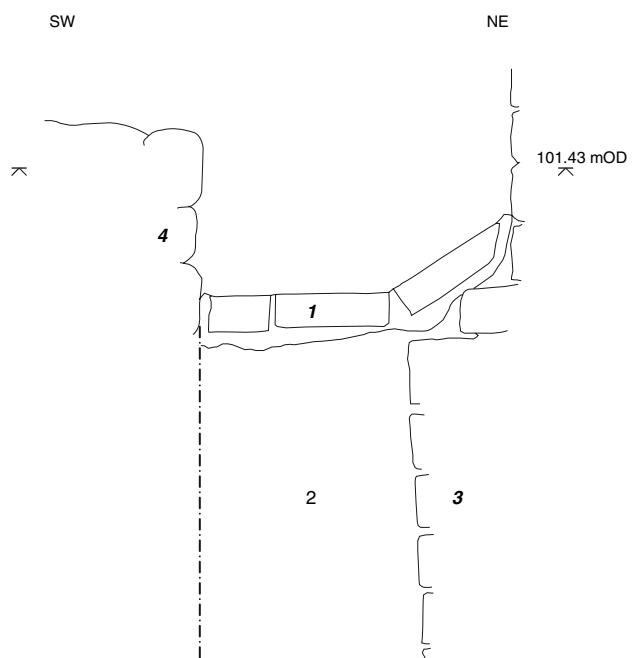
Section 1

3.1.2 This test pit was located adjacent to the south-west corner of the porch (Fig. 2 and Fig. 3, Section 1). The top of the foundations of the west wall of the porch (3) was exposed on the eastern side of the pit. This had been constructed using roughly dressed and squared blocks of local limestone bonded with lime mortar. Two outward steps and six courses of stonework were observed, but the bottom of the foundations was not exposed at a depth of 0.8m below ground level.

3.1.3 No evidence of a construction cut could be observed and a layer of yellow-brown silty clay loam (2) could be seen to butt directly onto the stonework. This layer could be seen to be in excess of 0.6m deep within the section and contained fragments of sub-angular stone.

3.1.4 Constructed directly upon layer 2 and abutting the east wall of the porch was a drainage gully. This had been constructed by excavating a channel approximately 0.4m deep and 0.6m wide along the outside of the west wall of the porch and the south wall of the south aisle. The western and southern sides of this channel were lined with a stone retaining wall built of three courses of roughly dressed stone laid without mortar (4).

- 3.1.5 Covering the base of the channel and butting up to the stone facing 4 and the walls of the porch and aisle 3 was a brick surface (1). This was composed of dark red bricks 0.22m x 0.145m x 0.06m in size laid on a bed of cement mortar.

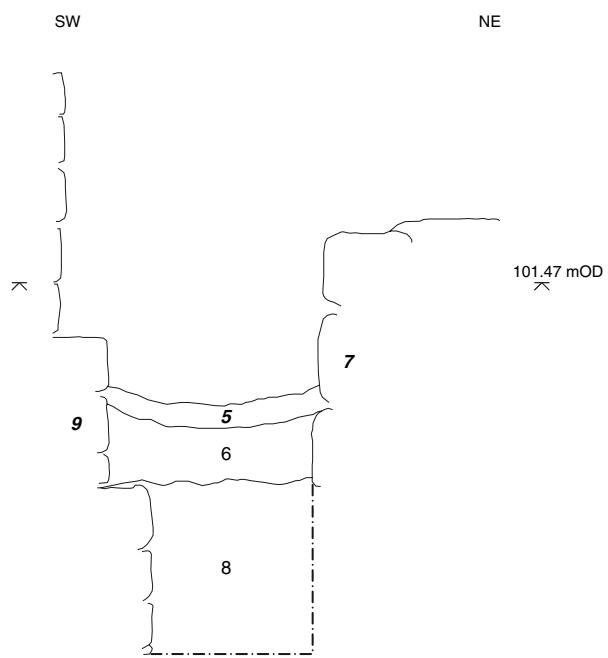
Section 2

- 3.1.6 Test Pit 2 was located on the north-east corner of the porch (Fig. 2 and Fig. 3, Section 2). The top of the foundations of the east wall of the porch (9) was exposed at approximately the same level as on the western side of the porch in Test Pit 1. Though this had been constructed using similar roughly dressed and squared blocks of local limestone bonded with lime mortar as wall 3, the second outward step was an additional two courses below that observed in Test Pit 1. As in Test Pit 1, two outward steps and six courses of stonework were observed, but the bottom of the foundations were not exposed at a depth of 0.8m below the existing ground level.

- 3.1.7 Again, as with Test Pit 1, no evidence of a construction cut could be observed and a layer of yellow-brown silty clay loam (8) could be seen to butt directly onto the stonework. This layer was in excess of 0.35m deep within the section and contained fragments of sub-angular stone (as in Test Pit 1).

- 3.1.8 A drainage channel had also been excavated against the porch wall and also alongside the south wall of the south aisle. This measured approximately 0.5m deep and 0.4m wide. As within Test Pit 1 The eastern and southern sides of this channel were lined with a stone retaining wall built of three courses of roughly dressed stone laid without mortar (7).

- 3.1.9 Laid in the bottom of the channel and butting up to both 7 and 9 was a 0.15m deep layer of broken brick and crushed mortar (6). Built directly upon this layer was a concave cement channel (5) sloping down towards the south.

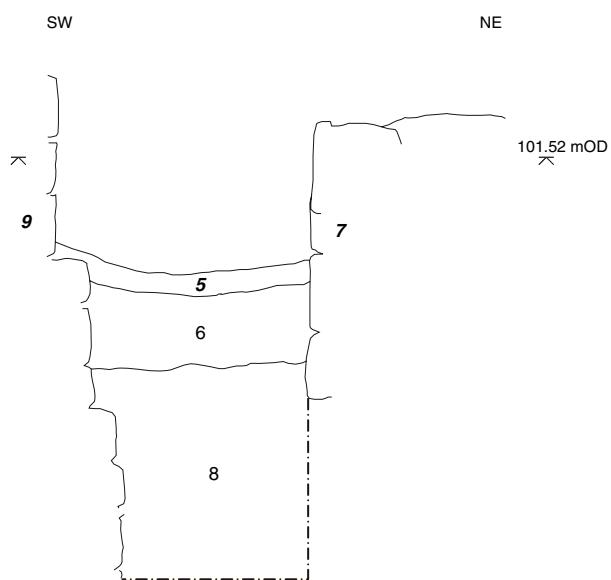
Section 3

- 3.1.10 This was located adjacent to the north-west corner of the porch approximately 0.5m out from the aisle wall (Fig. 2 and Fig. 3, Section 3). The stratigraphy (Section 3) exposed was the same as that recorded within Section 2. The maximum depth of excavation was 0.9m below the current ground level but did not expose the base of the foundations.
