TY NANT A5 GLYN BENDS IMPROVEMENTS

Archaeological Survey

September 2007

Issue No: 2007-08/716 OAN Job No: L9788 NGR: SH 9930 4430

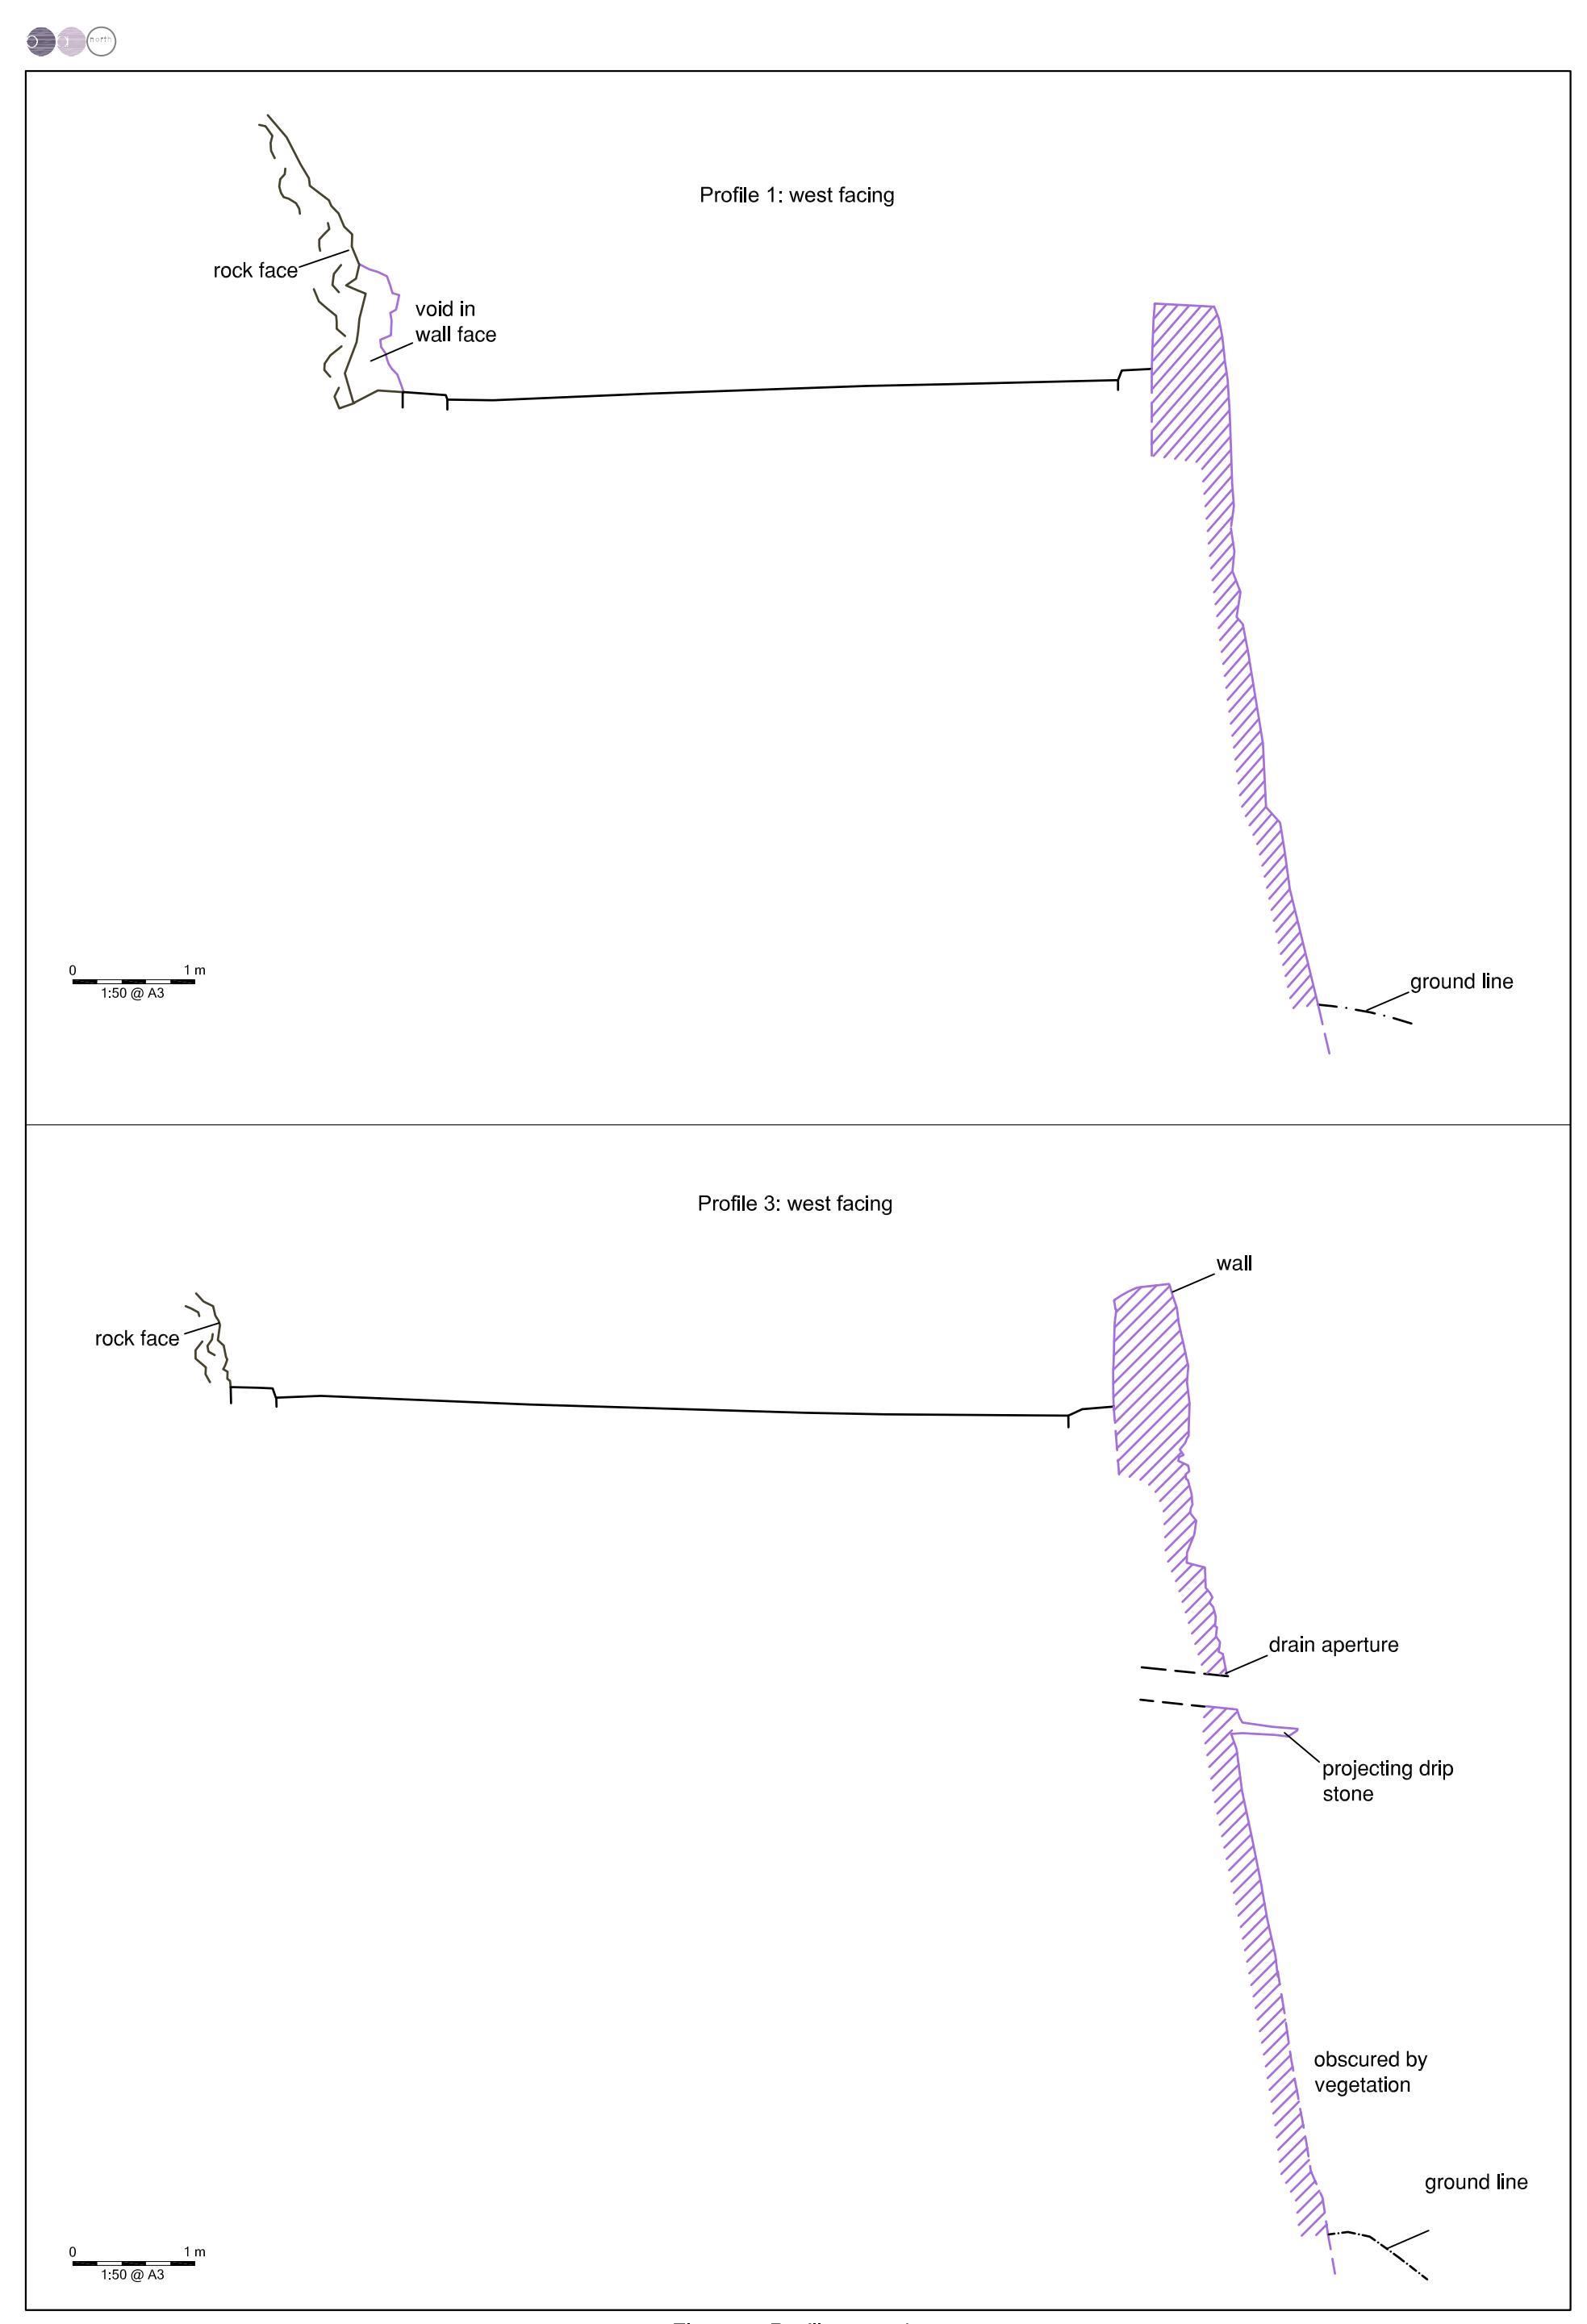
Figure 7: Profiles 1 and 3

- 5.1.4 Each of the walls contains areas of loose stones and hungry joints, too numerous to mention, although the condition of each wall overall is fair. Many of the voids are associated with the tree stump damage, or particularly dense areas of ivy, or with drains. Many of these do not project far enough through the wall to empty beyond the angle of batter, resulting in run-off directly down the wall face. This is not only a problem with later drains inserted at the parapet base, but also with the original drains, which only had sills projecting slightly beyond the face (Fig 7).

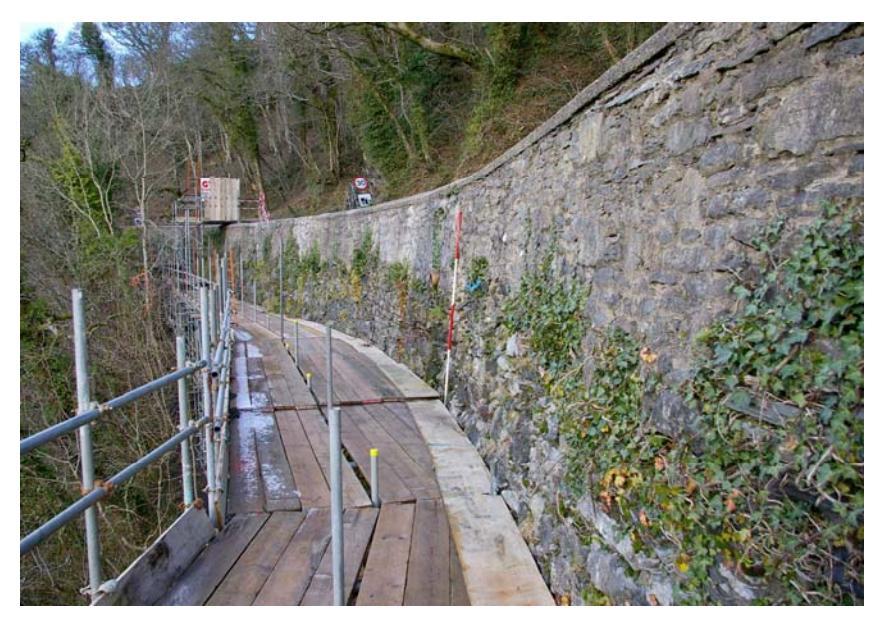
Plate 2: The random rubble build of the embankment wall (Section Site 01)

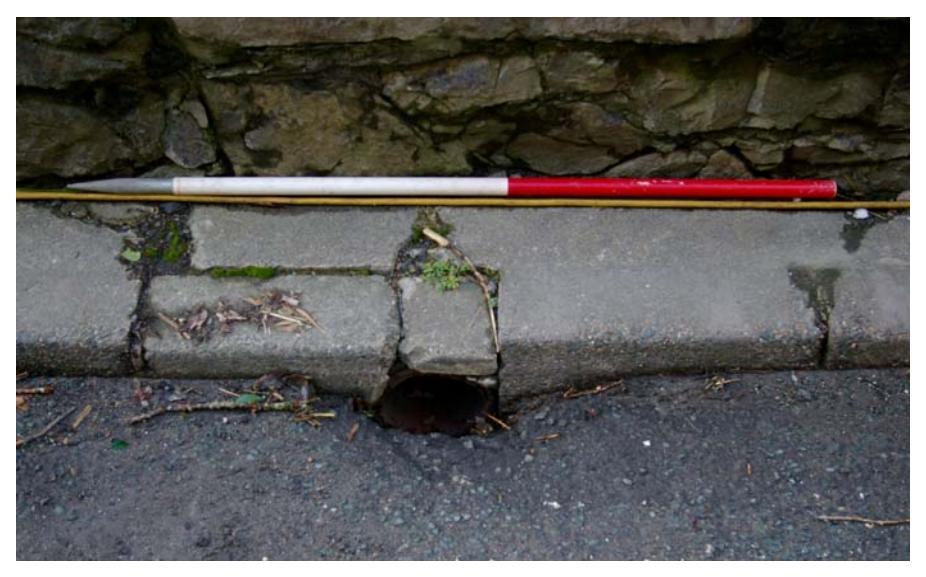
aperture was observed in the southern face of the wall (123), which measured 0.25m wide, 0.45m high, and had a projecting drip stone, to prevent water gushing down the wall face. It is positioned approximately 1.5m below the level of the present road, at which level a later, 0.2m diameter, cast iron pipe projects slightly from the wall (124). It is unclear whether the original drain relates to the level of the original road surface, or was a sub-surface drain, possibly located at the base of the rubble bed, which, if the construction followed the specifications, overlies earth infill above the bedrock level. Two further later drains, 106 and 125, were located approximately 20m and 45m to the west, both at present road surface level (Plate 3). Both had slight gullies on their northern, internal face, with cast-iron and ceramic pipes respectively projecting from the southern side of the wall. Approximately 11m from the eastern end of wall 01, a turret (10) projects from the southern face of the embankment wall (*Section 4.3*, below). The parapet to either side (113 and 114) has been rebuilt, but the turret appears to have been keyed into the embankment wall at lower levels.

Plate 3: An example of a drain aperture (Site 01)

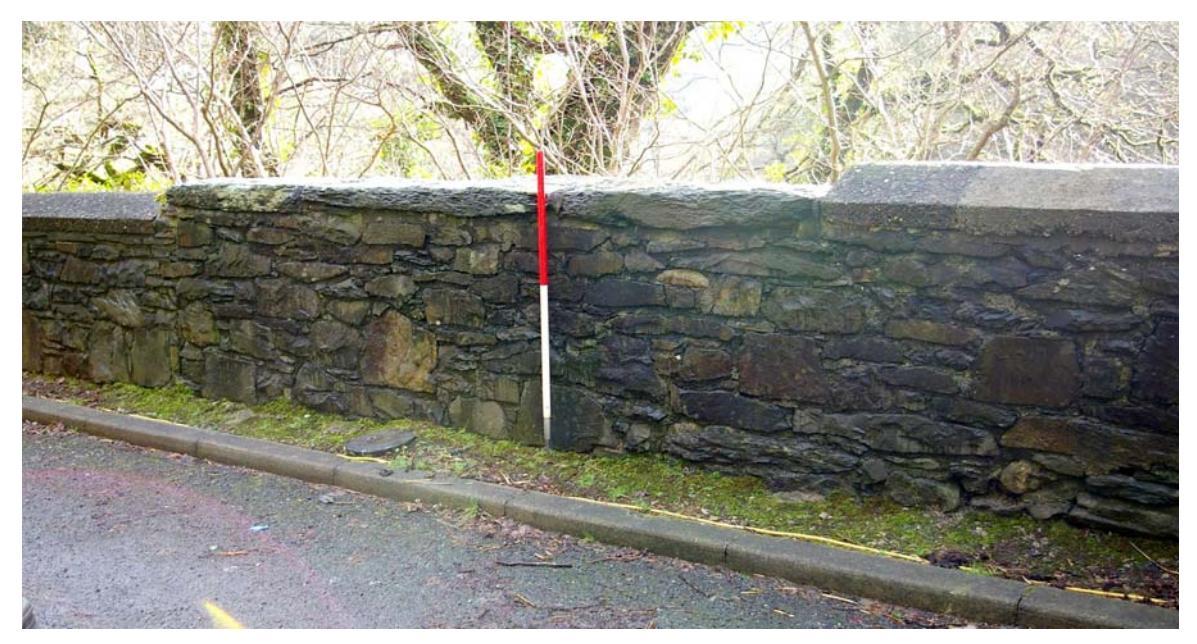
- 4.2.3 *Feature 02, Embankment Wall, western central section* (Figs 4 and 5): the western central section of the embankment, **02**, is the shortest, measuring only 15.75m in length. It also has the lowest retained height, up to 4.23m above ground level on its external face. It spans a short section between two large areas of natural outcropping slate, demonstrating the use of the local topography in the positioning of the route of the road. It is of similar construction and fabric to wall **01** to the west, and is heavily overgrown below road level, the parapet being entirely rebuilt, with the exception of a 4.3m length (**201**) which retains its original slate copings, one course below the present concrete saddleback capping. A further section of parapet wall, **203**, between embankment walls **02** and **03**, appears to have had the original slate topstones replaced on a later rebuild (Plate 4).

Plate 4: The original slate topstones have been replaced on a later rebuild of the parapet (Site **02**)

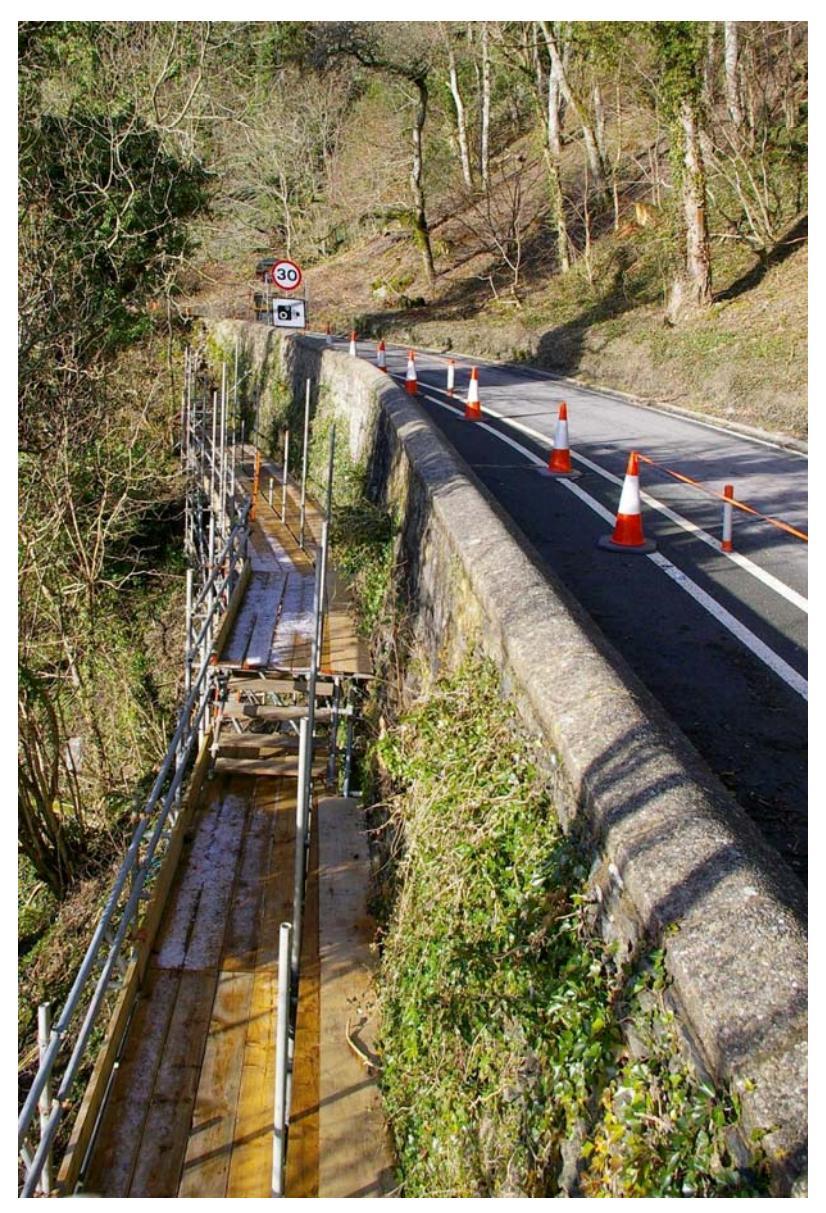
Plate 5: Section **03** of the embankment wall showing the concrete copings on the rebuilt parapet wall

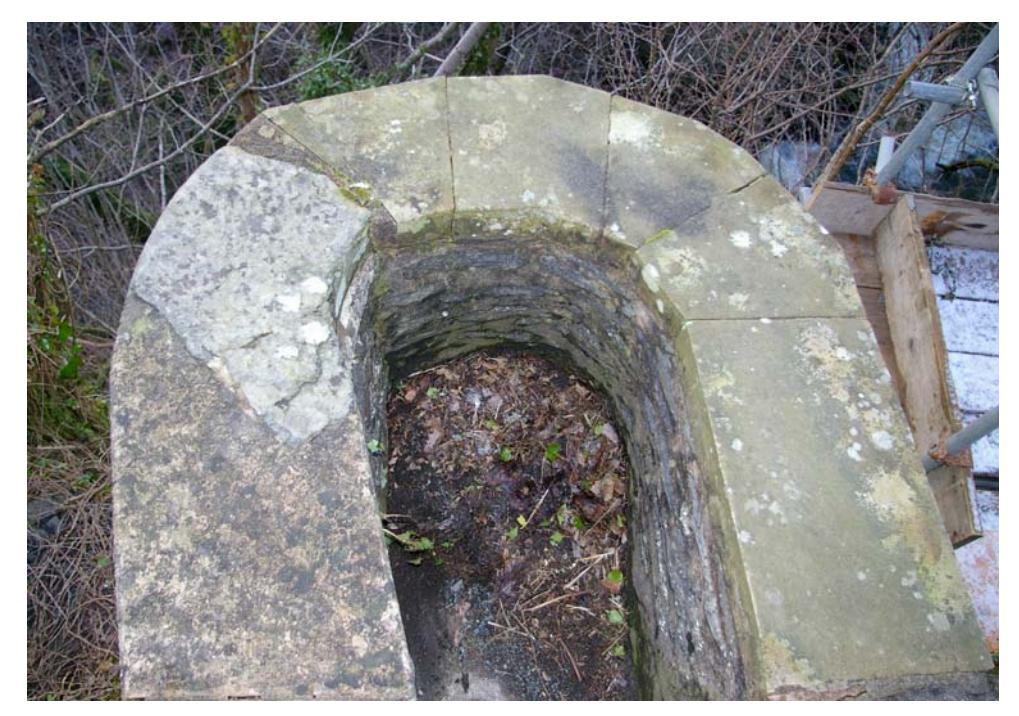
- 4.3.2 *Feature 10, western Viewpoint Turret:* within the western retaining wall (01), a viewing turret was constructed, affording views of both the Glyn Dyffwys gorge and the bridge constructed over it (05). Positioned 11m from the eastern end of this section of the embankment wall, at the northern end of the most pronounced bend in the road, it gave the traveller the best view of the bridge (Plate 9), and the waterfall in the Glyn Dyffwys gorge below. The turret has a horse-shoe shaped plan, open on the road side, with externally battered walls, and was constructed on a natural projection of bedrock, and would also have served to buttress the embankment wall. It was built to the same height as the adjacent parapet walls, and has a single original, slightly projecting, dressed sandstone capping surviving on its southern side (Plate 10).

Plate 10: The horse-shoe shape of the western viewpoint turret (Site 10) with an original coping stone to the south

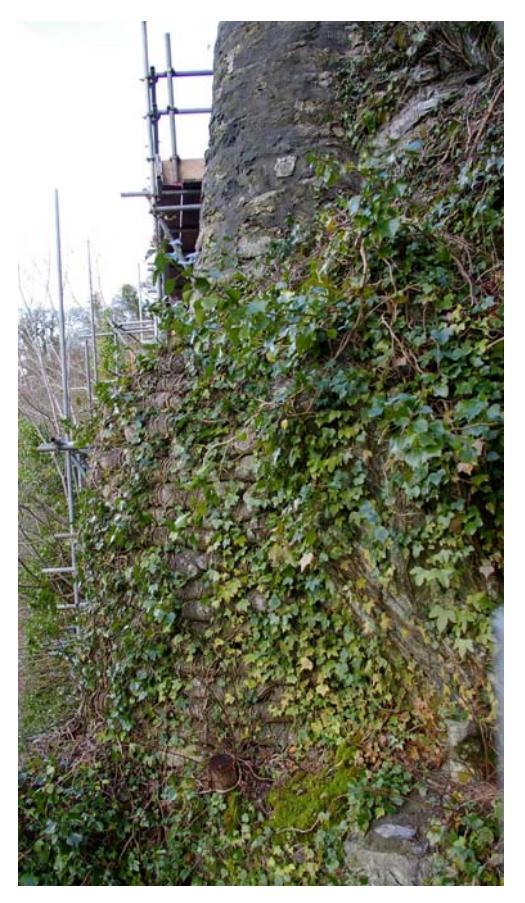
- 4.3.3 *Feature 23, eastern Viewpoint Turret:* the eastern viewpoint turret is similar in construction and style to that to the west (Plate 11), but is considerably taller, and the retained height of the wall is 5.35m at this location. The feature makes considerable use of the local topography, being sited on a natural outcrop of slate, which is partially incorporated within the construction of the turret, not only saving on materials, but also providing a firm foundation. This is most especially noticeable on the western face of the turret, where the almost vertically-bedded outcrop has been incorporated into the turret from 3.5m below its top (Plate 12). The turret is footed on the outcrop from around 4.9m below the parapet, but this footing has been bolstered on the southern and eastern sides by a layer of concrete, comprising a 2.1m height of concrete-filled sandbags laid around the base of the

turret and the outcropping bedrock beneath (Plate 13). At its upper level, the turret has been extended, presumably for safety reasons, increasing the parapet height by 0.5m. The original slate cappings were retained within the wall face, subsequently forming an attractive corbel band (Plate 14). The extension was constructed in a similar material, to the width of the original cappings, but has been topped with rough, pebbled concrete. Examination of the profile of the road bed in this position (Fig 8), reveals that it was not cambered, and instead sloped uniformly down towards the inside of the curve. It is probable that this represents a deviation from the original profile, with extra material added on the southern side of the road, rendering the parapet wall too low.

Plate 13: Turret **23** bolstered on the southern and eastern sides by a 2.1m height of concrete-filled sandbags laid around the base of the turret

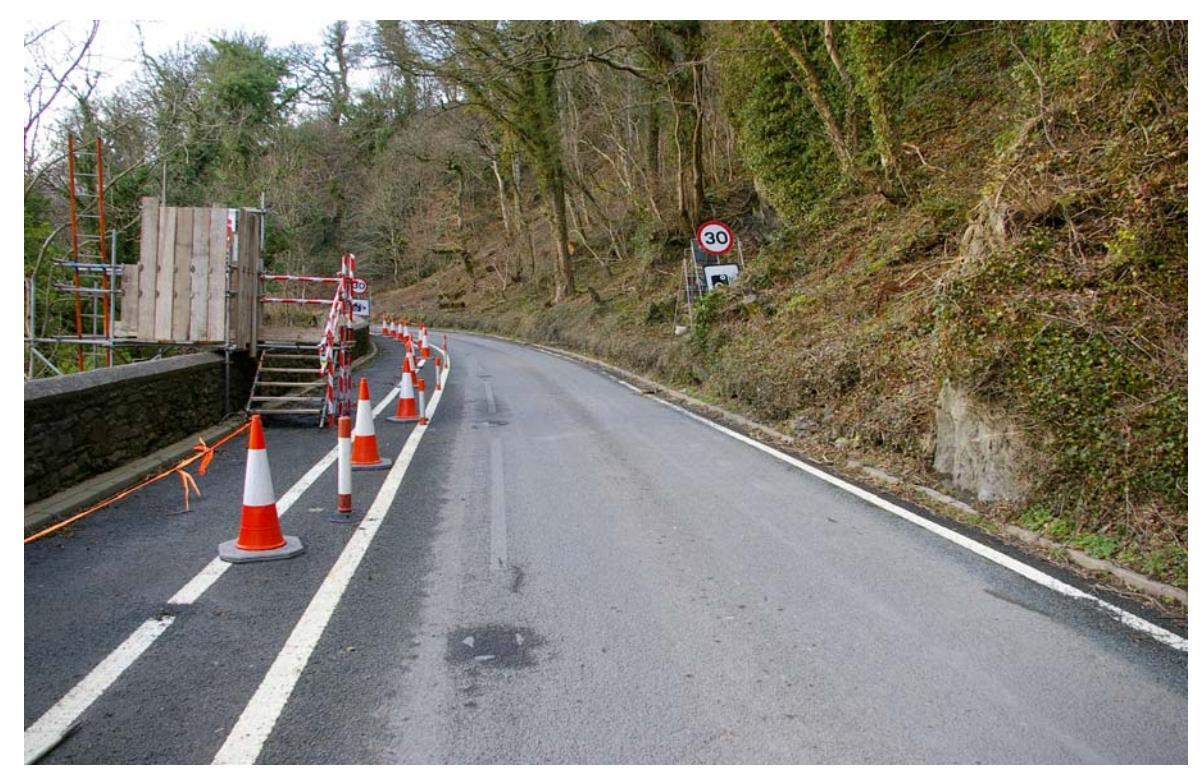
- 4.4.9 *Feature 18, Retaining Wall:* a well-preserved section of retaining wall, 33m in length, that forms a continuation of wall **17**, beyond a small outcrop of rock (Fig 5). Its preservation is better at its western end, where five courses of slate rubble were observed. There was only a single course below edge-set cappings at its eastern end (Plate 16).

Plate 16: The well-preserved section of retaining wall - Site **18**, separated from Wall **17** by a small crag

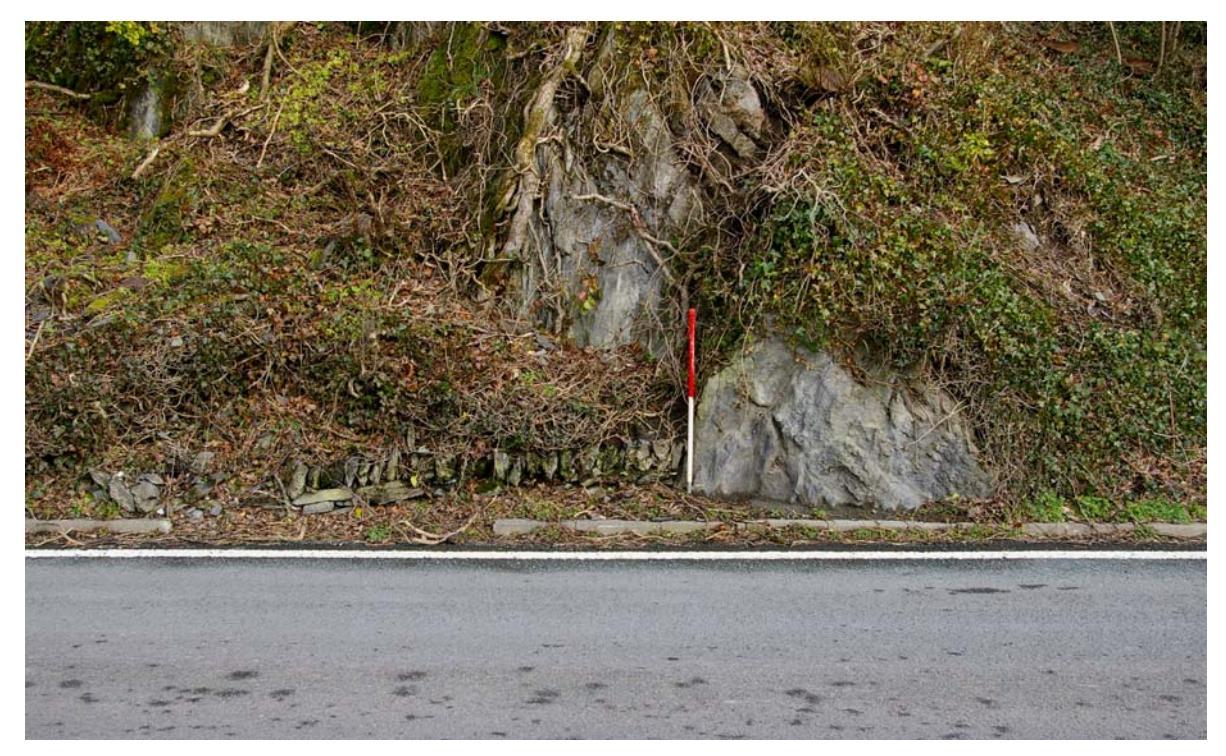
- 4.4.10 *Feature 21, Retaining Wall:* this is a 10.7m section of retaining wall between two outcrops of rock (Fig 5; Plate 17). At its north-western end, the wall appears to have a northern return, forming the entrance to a possible depot (20), but at the south-eastern end it is obscured by vegetation and overgrowth. Although the retained face measures up to 0.8m in height (Fig 7), only the lower 0.25m comprises the wall, the rest being solid earth overburden, suggesting that the retained part of the wall may have been insufficient in this position to hold back the soil.

Plate 17: A short section of retaining wall (Site 21) at the base of a small quarry (Site 20)

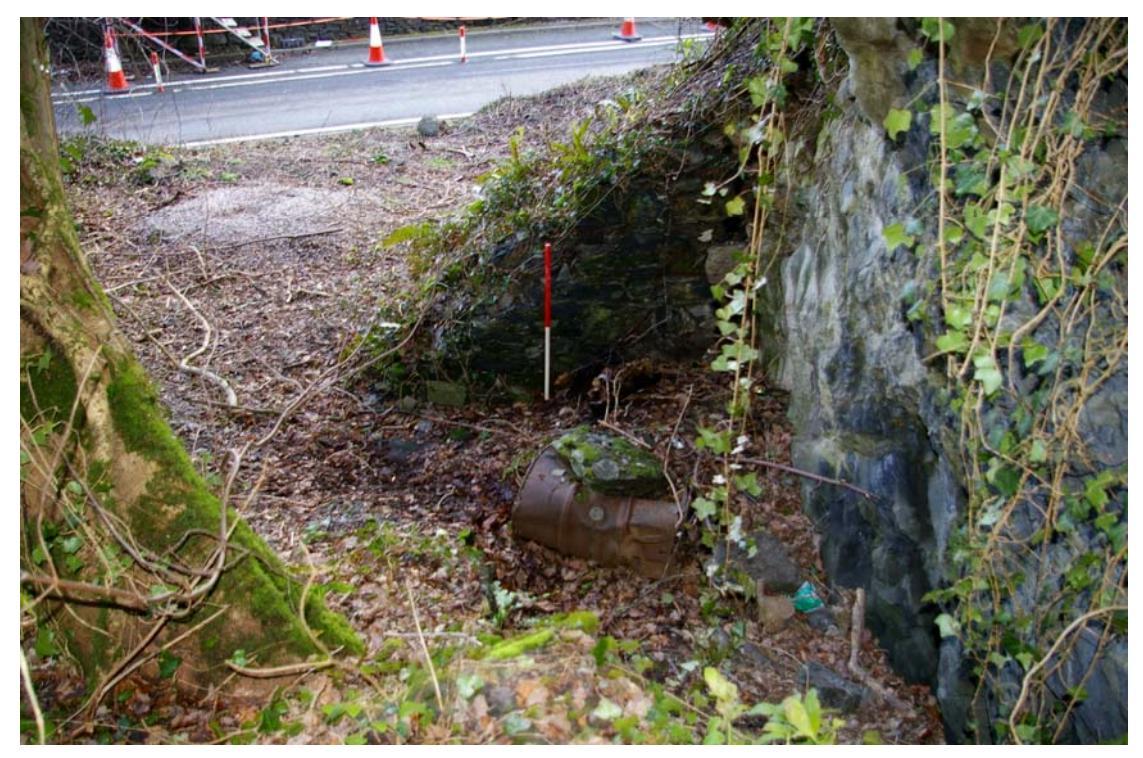
- Feature 13, Structure: this feature represents the only visible extant remains of any 4.5.4 buildings associated with the road in the Glyn Dyffwys bends, and is located in the south-western corner of possible quarry 12, against natural rock outcrop 09. It comprises three sections of what appear to be dry-stone rubble walling, forming an internal area of 4.0 x 2.4m (Fig 4). The south-western wall is the best preserved element (Plate 20) and is extant to a height of six courses (0.9m) at its junction with the rock-face. It is of double-faced construction, 0.7m wide, with loose rubble infill, and appears to have a return to the south-east at its southern end, where it only survived at ground level. The south-west facing, front wall, 1.6m in length, only survived for a single course above ground level; it was offset from the previous wall by 1.4m, which presumably reflects the entrance into the structure. At its eastern end the return to the rock-face was observed, and survives up to only two courses and is within an earthfast bank. The structure was possibly a shelter for both quarrymen and other workers involved in the construction of the road, or alternatively may have served as a gang master's 'office'.

Plate 20: Decayed dry-stone structure (Site 13), set within a quarry (Site 12)
