# CHASTLETON HOUSE

Archaeological Evaluation of Stables/Brewhouse Courtyard

Oxford Archaeological Unit  
February 1993

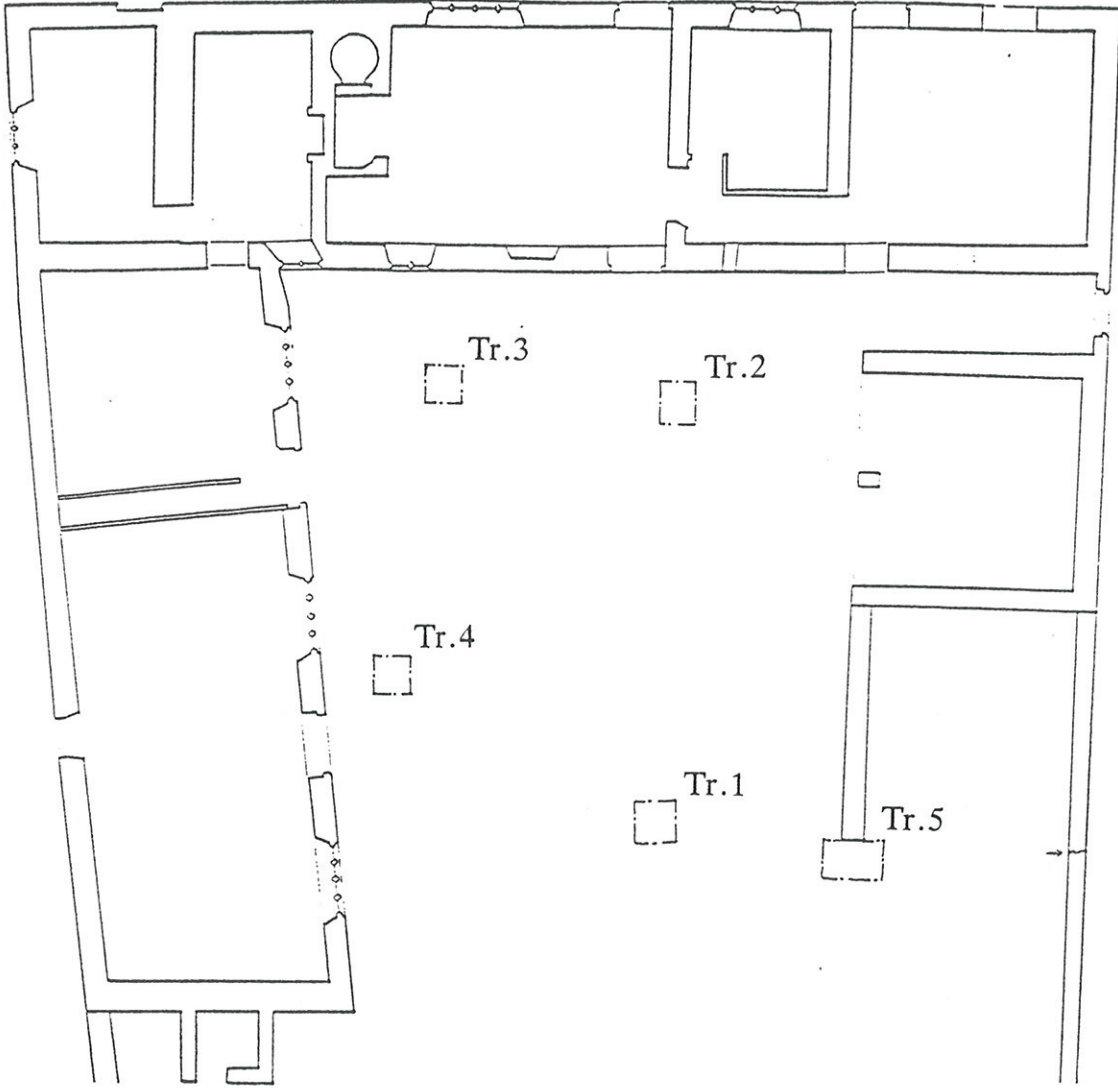
Fig. 1 Location of evaluation trenches (scale 1:200)

Trench located within central area of courtyard. The trench was excavated by hand to reveal a well compacted surface comprising smooth rounded cobbles up to 0.10m in diameter with occasional flat semi-angular limestone pieces of similar size within a matrix of pale grey mortar and gravel. The cobbled surface was overlaid by a fairly well compacted pale grey chalky layer containing pea grit and small gravel, this in turn being overlaid by modern turf and topsoil. The cobbled surface was located at a height of 174.10m OD.

Trench located within central area of courtyard. Turf and topsoil directly overlie a well compacted cobbled surface similar in nature to that encountered in Trench 1. In the southern half of the trench the cobbled surface has been disturbed by the laying of a brick paved area which appears to extend most of the way across the courtyard terminating just short of the garage/coach house on the eastern edge of the yard (fig. 2). The cobbled surface was located at a height of 173.98m OD.

Trench located within central area of courtyard. Turf and topsoil directly overlie a well compacted cobbled surface similar in nature to that located in Trench 2. The northern half of the exposed surface appeared to be stained by cinders or coal ash. The cobbled surface was located at a height of 173.91m OD.

Trench located within central area of courtyard. The topsoil was mixed with substantial amounts of building debris (predominantly stone tile fragments). This layer overlaid a further deposit of building debris which appears to disturb the cobbled surface in this trench which only appears in the north-east corner of the excavated area. The precise nature of the disturbance was not apparent within the limited area of excavation, though the proximity of modern services (electricity and water) was noted. The cobbled surface was located at a height of 173.85m OD.

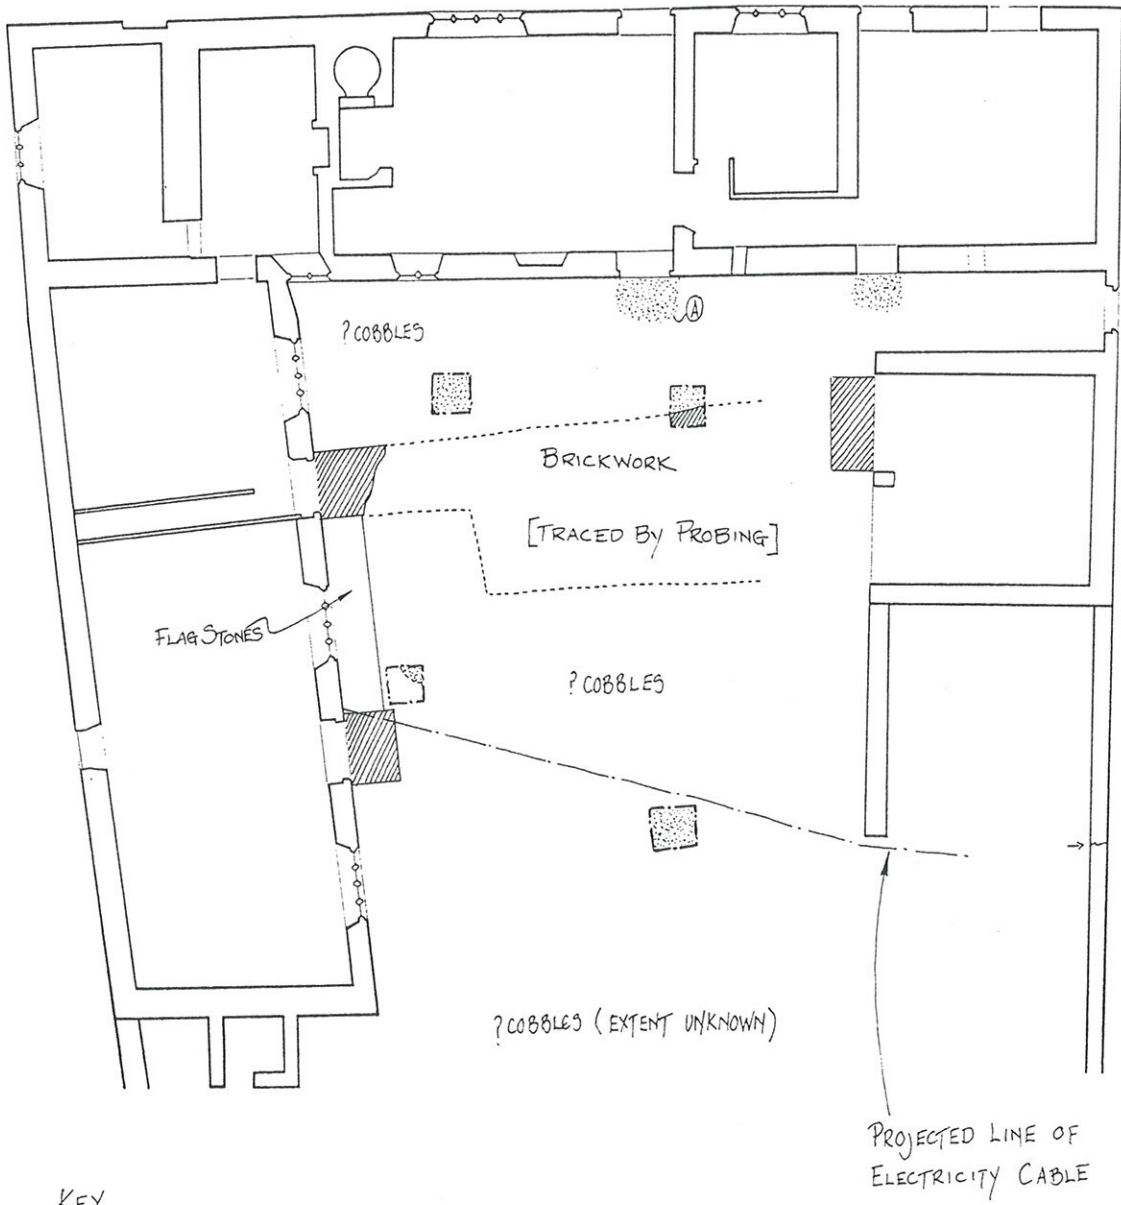
Fig. 2 Location of visible courtyard surfaces (scale 1:200)

In addition to the five hand-excavated trenches described above, a visual survey was undertaken to record any visible surfaces. These surfaces were plotted onto an existing 1:50 plan and the results are summarised in Fig.2. As has already been stated, a small amount of probing was involved in defining the limits of identified surfaces. The north-west corner was obscured by scaffolding at the time of the survey, apart from a concrete patch outside the Brewhouse window that is related to water services. This end of the yard is probably all cobbled, since cobbles were found in Trench 3, and in distinct areas outside the two doors into the north range. These last consisted of patches of larger cobbles than those observed in the trenches.

The brickwork uncovered in Trench 2 is also visible outside the stable door, and was traced by probing in a broad path across the yard leading towards the cartshed, where it may reach the brick paving that is also visible round the north entrance of the shed. The south door to the stable also has a patch of brick outside the door, and this is linked to the north door by a flagstone path.

The cobbled surface found in Trenches 1 and 4 were of small stones, and a similar surface probably extends across the southern end of the yard, though its exact extent was not discovered. It is understood that the extent of this surface is visible on early aerial photographs.

The cobbled courtyard surfaces, where located, were overlaid by an average of c.0.10m of turf and topsoil and it is felt that unless heavy machinery is to be manoeuvred within the courtyard area during building work, this depth of overburden will be sufficient to protect the surfaces from damage from normal traffic. However, in the immediate vicinity of the brewhouse, where scaffolding, ladders and building activities are likely to be more intensive, some protection with planking may be necessary to preserve the cobbling from damage. Similarly, the brick surfaces next the stable doors should be protected from damage from traffic and heavy gear.

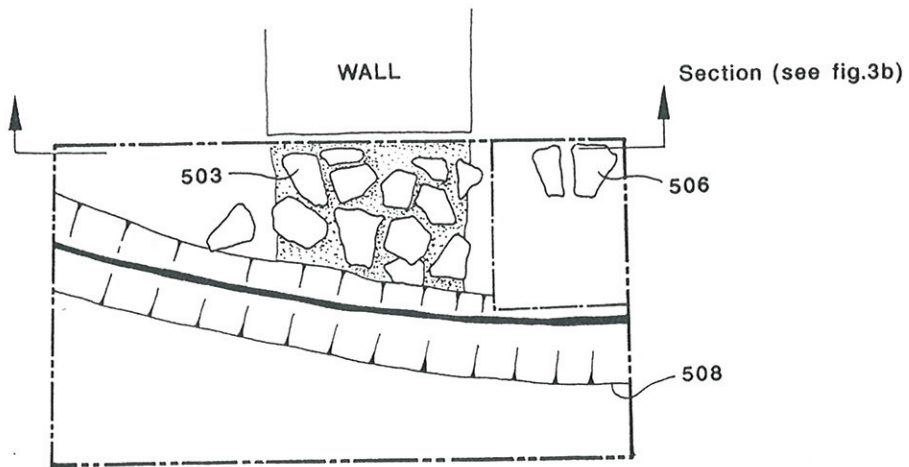
Fig. 3a Trench 5 Plan (scale 1:20)

Trench 5 was positioned to investigate the relationship of the courtyard surface to any surviving floor layers within the supposed barn on the east side of the courtyard. A rubble foundation (503) for the extant wall was located at a depth of 0.15m below the present ground surface, and the construction trench for this wall (502) would have destroyed any surviving floor layers within the limits of the trench. A metal pipe 0.02m diam. containing an electricity cable (508) was exposed running east-west across the trench, cutting the rubble foundation and further disturbing any deposits

relating to the supposed barn. A possible flat stone surface (506) was located in the extreme north-east of the trench at a height of 174.07m OD, but the limited area exposed within the trench makes positive identification of this feature as a floor layer very tentative. No cobbled courtyard surface was encountered within this trench, and so no relationship between courtyard and floor layer could be defined.
