St Michael's Church Barford St Michael Oxfordshire

Archaeological Watching Brief Report

May 2008

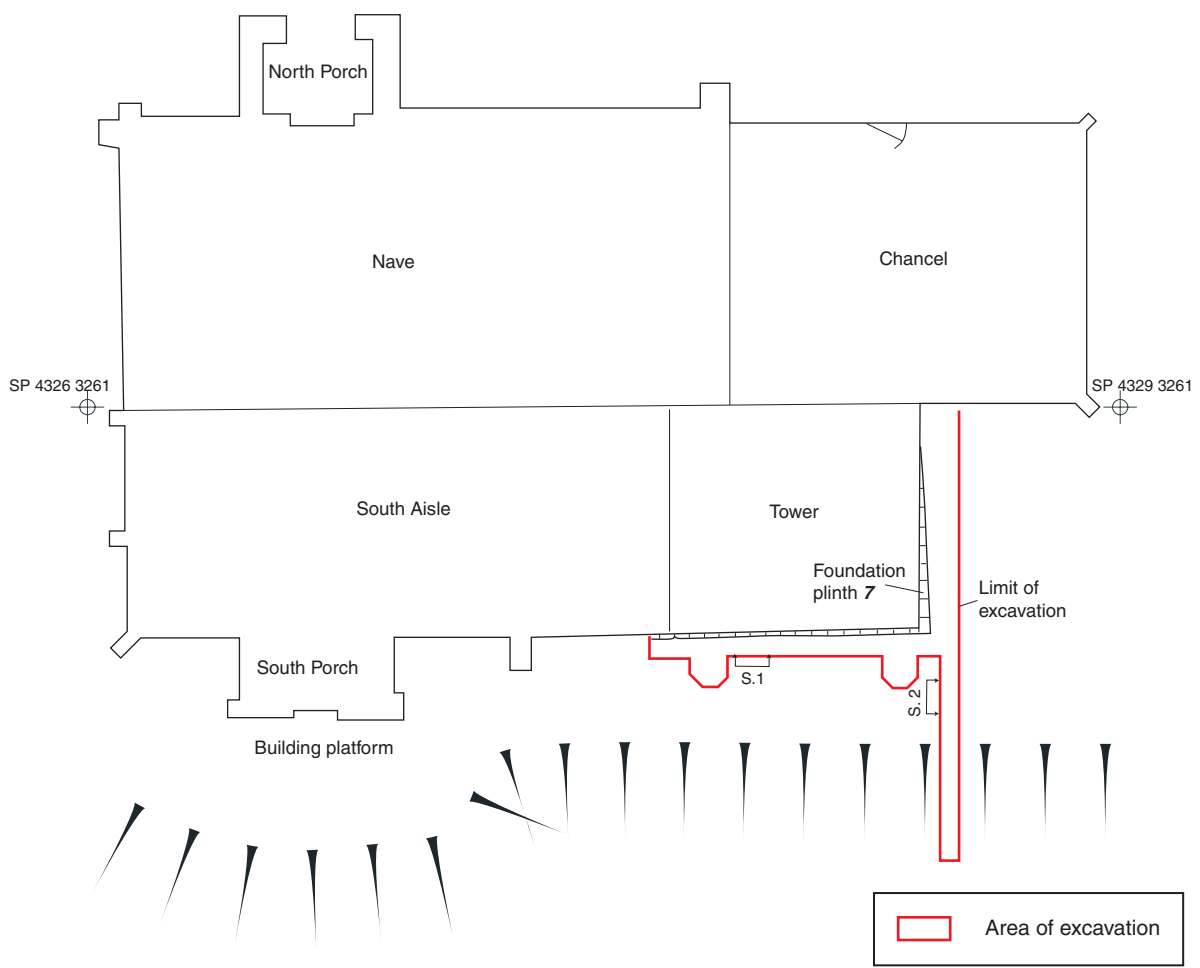
St Michael's Church Groundplan showing extent of excavation

- 3.1.5 These works consisted of the removal of the existing stone drainage channel adjacent to the tower base, excavation of a 0.5 m wide trench, 0.4 m deep at the corner between the chancel and the tower, lowering to 0.5 m at the south-east corner of the tower, and the excavation of a 5 m long trench running southwards down over the edge of the building platform to contain a discharge pipe (Fig.2, Site plan).

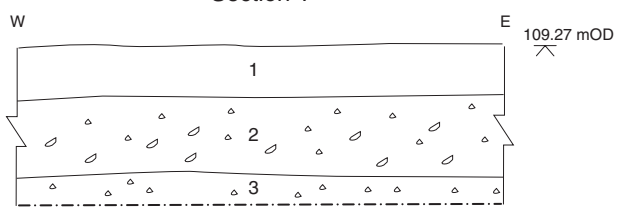
Section 1

- 3.1.1 These excavations consisted of a 0.5 m wide by 0.5 m deep trench along the base of the tower for the installation of a "French Drain", and 2 tapered pits each measuring 1 m by 1m located south of the trench directly underneath the downspouts projecting from the south side of the tower (Fig: 2, Site plan).
- 3.1.2 At the base of the western end of the excavation a layer of orange brown clay silt containing many sub-angular ironstone fragments (3) (Fig. 2, Section 1) was exposed. This deposit produced occasional fragments of slate but no dating material. This material butted up to the base of the tower rather and did not appear to be cut by any foundation trench.
- 3.1.3 Layer 3 was overlaid by a 0.25 m - 0.35 m deep layer of dark yellow brown clay loam which also contained many sub-angular ironstone fragments (2). This layer produced a single fragment of earthenware pottery.

- 3.1.4 Sealing layer 2 was a 0.18 m deep layer of dark grey-brown silt loam (1). This deposit had few inclusions but produced fragments of bottle glass, creamware pottery and 2 fragments of clay pipe.

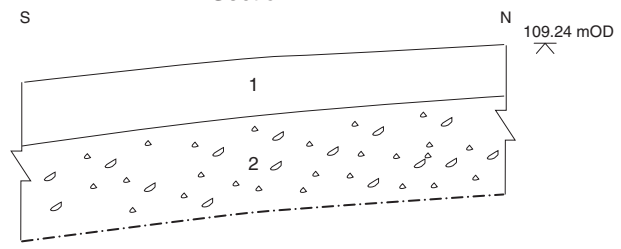
Section 2

- 3.1.6 A continuation of layer 2 was encountered in both the trench adjacent to the tower base and in the trench leading to the south at a depth of 0.15 m below the current ground level (Fig. 2, Section 2). Immediately adjacent to the base of the east wall of the tower this deposit had been disturbed by a 0.25 m deep by 0.6 m wide cut (4). This contained a cement mortar bed upon which the stone drainage channel (5) had been laid and also a concrete edging (6), alongside the stone channel.

- 3.1.7 Exposed when the drainage channel had been removed was the foundation plinth for the east wall of the tower (7). The upper courses of stonework for this plinth appear to be contemporary with the towers construction, however at the interface between the plinth and Layer 2 a course of sawn cut stones had been inserted. It is surmised that this was done to replace frost damaged stonework.

- 4.1.1 The use of cement mortar to bed the stone drainage channel (5), and the use of concrete for the edging (6) indicates that the channel has been relaid during the 20th-century. The presence of the replacement course of sawn stone blocks within the base

of the east wall of the tower suggests that possibly a poorly maintained drain had caused dampness to occur at the base of the tower in the past, leading to frost damage of the bottom course of stonework. It is probable that both the replacement stonework and the rebuilding of the channel were part of the same action.
