**TONDU IRONWORKS
BRIDGEND COUNTY BOROUGH**

ARCHAEOLOGICAL EVALUATION ON GROUND
TO SOUTH-EAST OF CALCINING KILNS

OXFORD ARCHAEOLOGICAL UNIT
SEPTEMBER 1998
GROUNDWORK BRIDGEND

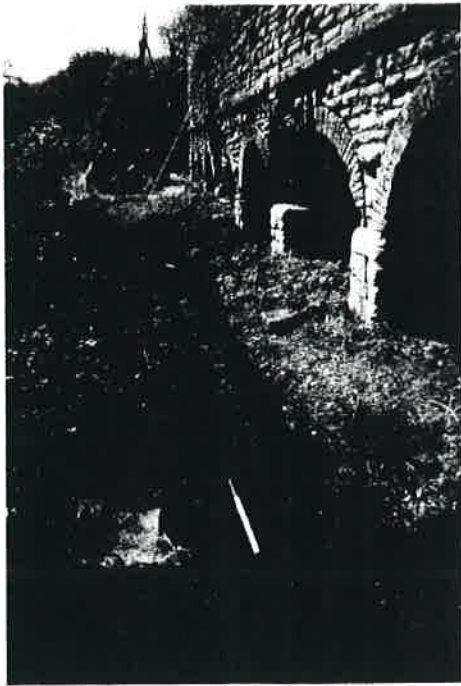
- 3.3.4 Truncating deposits 401- 404 was a linear service trench (406). The northern edge of the cut sloped down at 70° for 0.6 m and then vertically for a further 0.4 m. The southern edge and the base of the cut were not identified within the excavation. A thick iron pipe (407) of some 0.17 m diameter was recorded within the cut, 1.2 m from ground present surface. The exterior of the pipe was in a good state of preservation and it was unclear whether it carried gas or water. The cut for this pipe was filled by a grey brown sandy silt (408) with a 20% inclusion of sandstone and brick. This deposit was some 0.7 m thick and it was overlain by a 0.09 m thick layer of black gravel (409) containing coal waste and patches of mortar and sandy silt. The top of the cut was sealed by a 0.08 m thick compacted layer of brown sandy silt with a compacted upper surface (405). It was this surface that was exposed along the length of trench 4. The layer sloped upwards from east to west, rising by 0.3 m over the length of the trench. Set into this surface were two rows of yellow stock bricks laid flat (dimensions 230 mm

x 105 mm x 60 mm), their upper faces level with the compacted surface. The bricks appeared to follow the alignment of the iron pipe (407) and may represent a capping or a method of permanently defining its alignment on the (then) surface of the ground.

Plate 1: General view of trench 4 from the North-east, showing surface 405 with inset bricks apparently following the line of pipe 407.

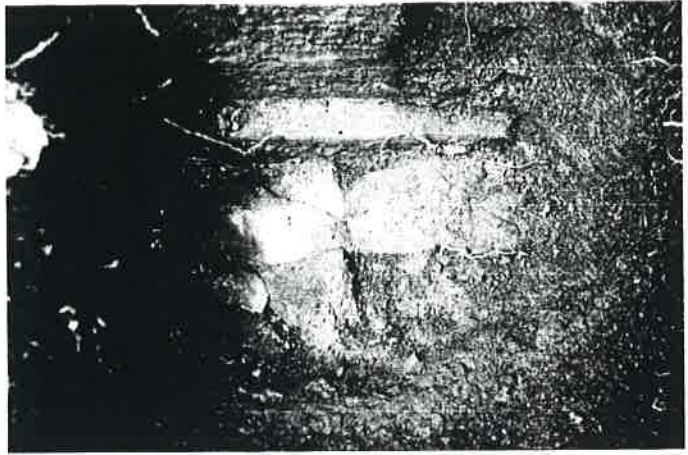
- 3.3.3 Overlying the spreadstone and butting the offset was a layer of sandstone slabs (404). The layer was burnt and had evidence of heat cracking. A 0.03 m thick deposit of sandy clay (402) with a 20% inclusion of mortar and fired clay covered the sandstone. A layer of gravel and powdered iron oxide (401) overlay deposit 402. This deposit was up to 0.4 m thick. Contained within this deposit was a disused narrow gas pipe (403) with an open upturned end. It appeared that this would have originally connected to a vertical pipe feeding a gaslight on the corner of the kiln. The mortices cut into the stonework for the supporting bracket were still clearly visible.

Plate 2: Truncated and broken layer of sandstone with possible evidence of heat-cracking (402). This layer appeared to have been cut by feature 406.

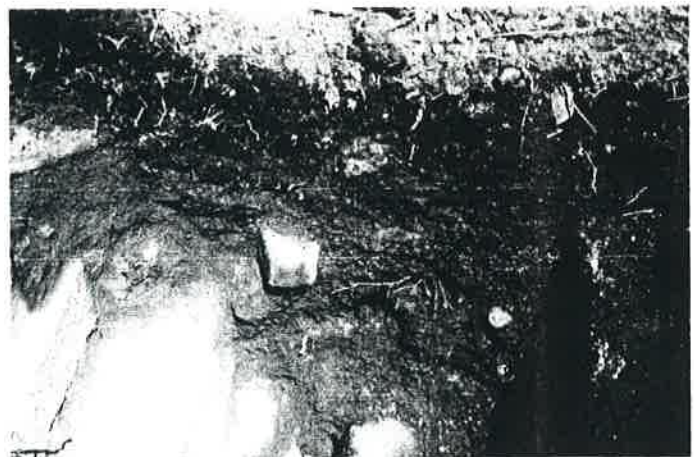
Plate 4: Test pit 4. Note calcining kiln foundation and red deposit 401 with small gas pipe 403 to the left. This deposit appeared to have been cut by feature 406.

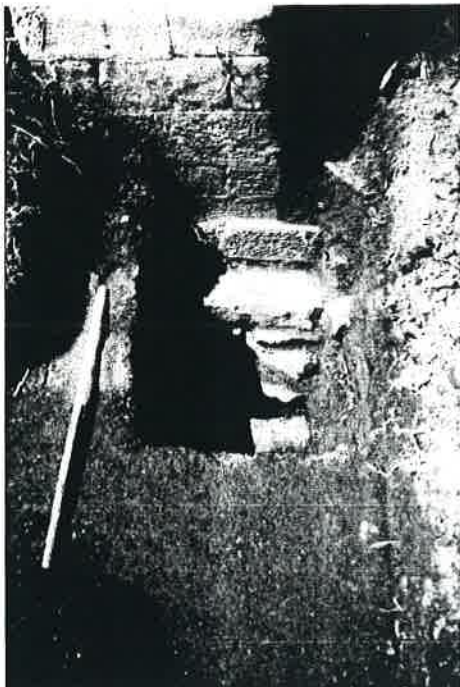
- 3.3.2 The principal purpose of test pit 4 was to investigate the nature and depth of the foundation of the calcining kilns. The test pit revealed that the kilns rested on a foundation of sandstone rubble (416). The sandstone was typically irregular and unfinished. The rubble was well bonded with a strong whitish mortar and it extended to at least 1.2 m from present ground surface. The excavation was terminated at this depth due to health and safety considerations. Probing by the engineer suggested that the foundations continued at least 0.5 m further, i.e. to at least 1.7 m from current ground level at this point. The rubble foundation was overlain by a large sandstone spreadstone (415). This was 0.13 m thick and extended 0.32 m from the face of the kiln wall. Above the spreadstone was a single offset course of well-dressed sandstone (414), with exceptionally well-preserved tooled face and drafted margins, matching the few remaining un-eroded quoins of the kilns themselves. This course was offset by some 0.06 m from the wall and it was 0.2 m thick.

Plate 3: Calcining kiln foundation showing large spreadstone 415 overlying mortared rubble-stone foundation 416. Note pipe 407 in the bottom of the trench, surface 405 with inset bricks on the left and red deposit 401 with small gas pipe 403 to the upper right.

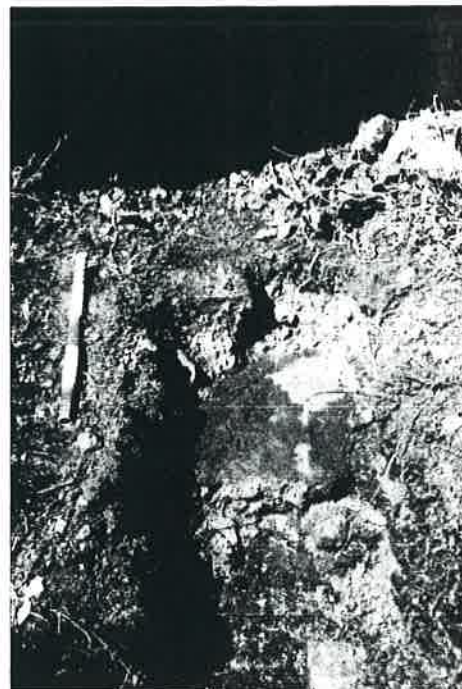
- 3.3.6 A small side trench was excavated off trench 4, extending towards the central arch of the calcining kilns. A buried structure (417) was located. This structure was composed of very hard reddish brown mortar/cement with some iron ore inclusions. The upper face of 417 bore imprints which appeared to show that slabs of stone or more probably iron, forming a floor surface, had been pressed into the deposit when it was laid. The surviving part of this structure had been truncated by cut 406.

Plate 5: Feature 417 revealed by the small side trench off trench 4.
