ALSCOT PARK HYDRO-ELECTRIC GENERATING STATION, WARWICKSHIRE

Archaeological Survey

Archaeological Survey Report

Report no 1997-98/002/7714

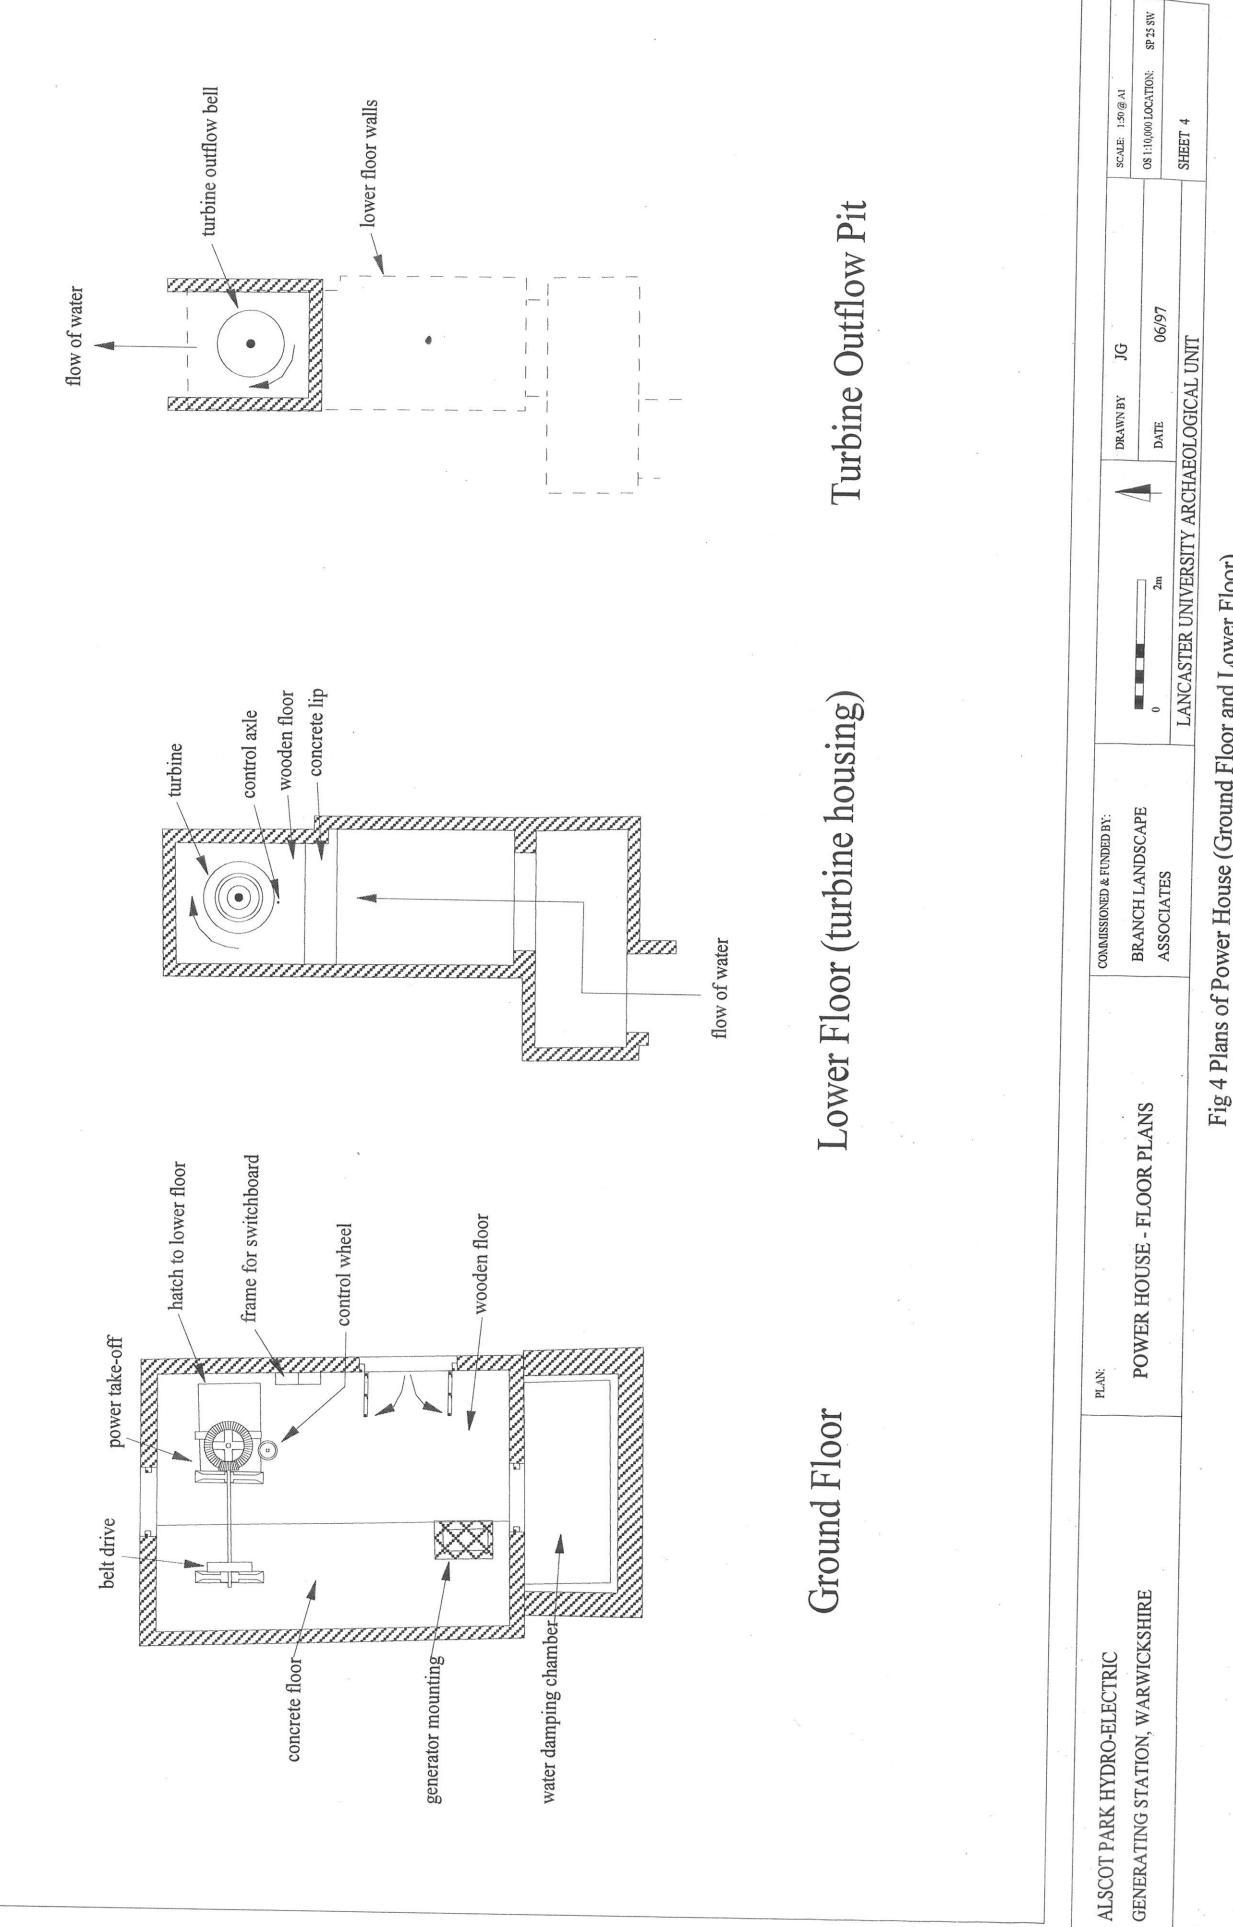
Fig 4 Plans of Power House (Ground Floor and Lower Floor)

Ground Floor: The floor construction divides in two: the western half (on which sit the belt drive and generator mounting) is concrete. The eastern half, over the basement-level turbine chamber, is of tongue and groove floorboards set over east/west laid wooden joists. At the north end of the room is a surviving power take-off (with 'J131' inscribed on the underside), a drive shaft and a belt-drive pulley. The power take-off is supported on a pair of 'H'-section steel joists and a two-piece wooden hatch here gives access to the turbine below. A substantial wooden beam at purlin level was presumably to aid with lifting this machinery for maintenance purposes. A control wheel (or 'regulator') for opening and closing the turbine guide vanes, stands immediately south of the power take-off. Adjacent to this, against the east wall, is a metal frame of jointed tubing that would have held the distribution board (a pair of cables under the east wall remain in place). At the south end of the building, opposite the doorway, is a rectangular concrete block with four holding-down bolts. This aligns with the belt-drive pulley and would have held the generator.

Lower Floor: The lower floor consists of a single rectangular chamber with, at its south end, an arched opening from the water damping pit. At the north end, around the *in situ* turbine,

The building has substantial subsidence cracks in its north and west walls. Otherwise it is water-tight and the fabric and plant appear to be in very good condition.

- Turbine base and outfall pit (1) Access here was largely blocked by the floor of the turbine chamber (taped measurements were taken through a gap on the west side). The profile of the draught tube and pit should be checked and photographed. The turbine should also be inspected for a manufacturer's plate or mark.
