Chesterton Station Sidings, Cambridge

Archaeological Watching Brief And Test Pit Evaluation Report

OA East Report No: 1401

Report Number: 1401
Site Name: Chesterton Station Sidings
HER Event No: ECB 3796
Date of Works: 17-25 September 2012 and 19 December 2012 – 03 January 2013
Client Name: Cambridgeshire County Council
Client Ref: 14705
Planning Ref: Pre-application
Grid Ref: TL 4745 6061
Site Code: CAM CSS 12
Finance Code: CAM CSS 12
Receiving Body: CCC Stores, Landbeach
Accession No: N/A

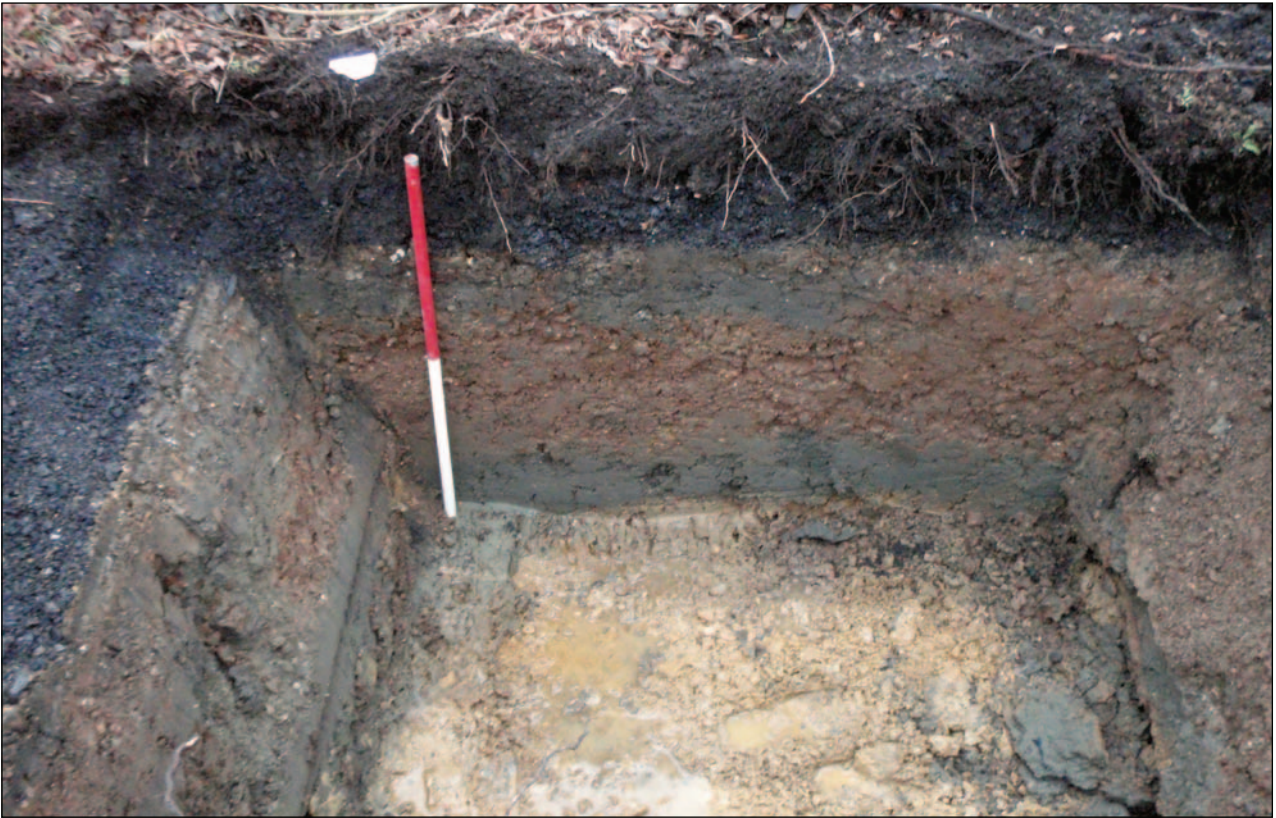
- 3.3.7 Located in the south of the site, towards the western boundary, Test Pit 7 measured 1.5m wide, 2m long and 1.2m deep (Plate 1). Natural geology, comprising river terrace gravel, was encountered at the base. The test pit contained four layers of made ground. Above the natural was a dark grey silty sand with patches of redeposited clay (13), which measured 0.2m thick. Sealing it was layer (12), a reddish brown silty sand measuring 0.5m thick with frequent inclusions of small stones and gravel. This was sealed by a very dark blueish grey silty sand (10), measuring 0.3m thick, with frequent inclusions of gravel and clinker. The sequence was completed by topsoil layer (9), a dark greyish brown sandy silt measuring 0.2m thick.

Plate 1: Test Pit 7, east facing section. 1m scale.

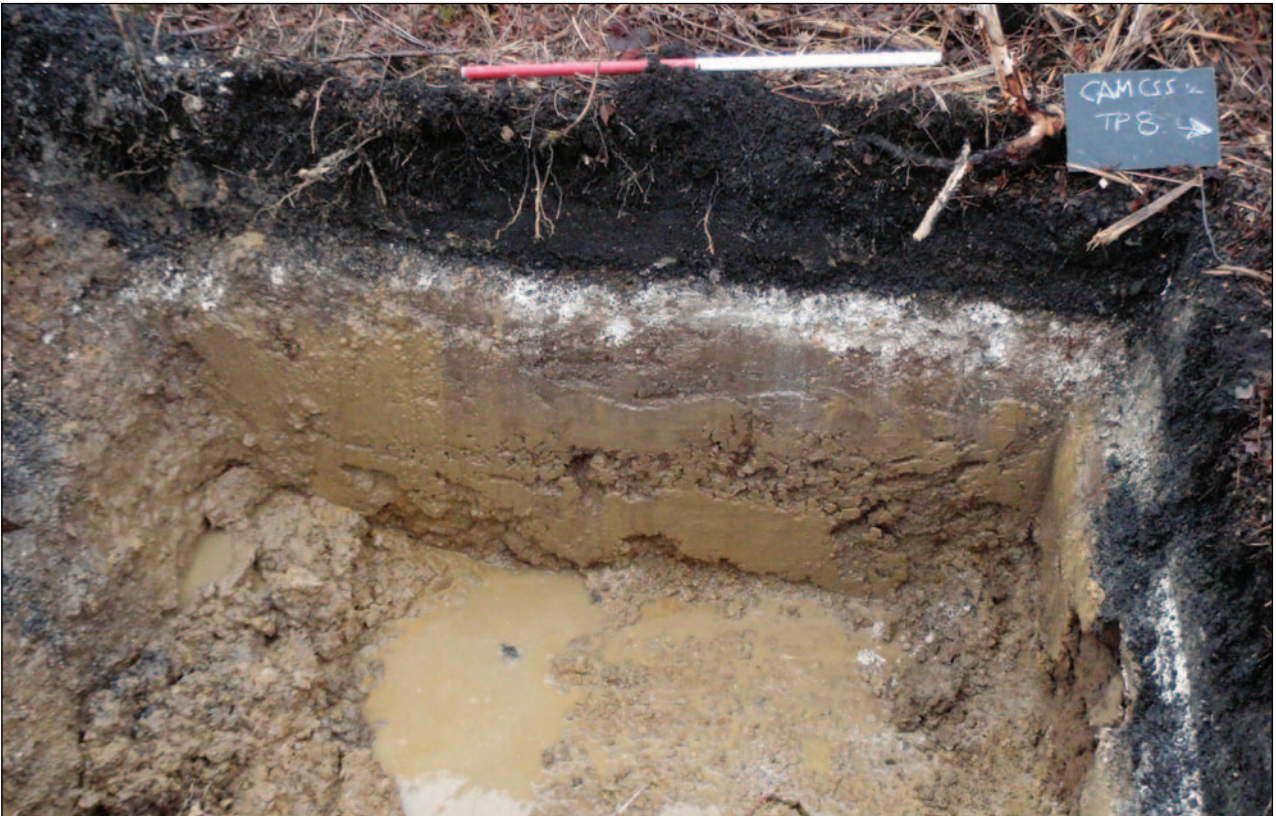
- 3.3.8 Located in the south of the site, Test Pit 8 measured 1.5m wide, 2.4m long and 1.2m deep (Plate 2). As with Test Pit 7, it contained natural gravel in the base. Sealing the natural was layer (35), a mid brown sandy silt measuring 0.3m thick and layer (34), a yellowish brown silt measuring 0.3m thick. These two layers may represent an intact subsoil which pre-dates the use of the site for railway sidings. Layer (34) was sealed by a dark greyish brown silt (33) measuring 0.2m thick with occasional charcoal inclusions. This was sealed by a layer of redeposited chalk measuring 0.15m thick (32), which had presumably been used as levelling material. Above the chalk was a layer of very dark greyish brown silty sand with frequent inclusions of ash and clinker (31), measuring 0.15m thick. The sequence was completed by topsoil layer (30), a dark greyish brown sandy silt measuring 0.1m thick.

Plate 2: Test Pit 8, east facing section. 1m scale.

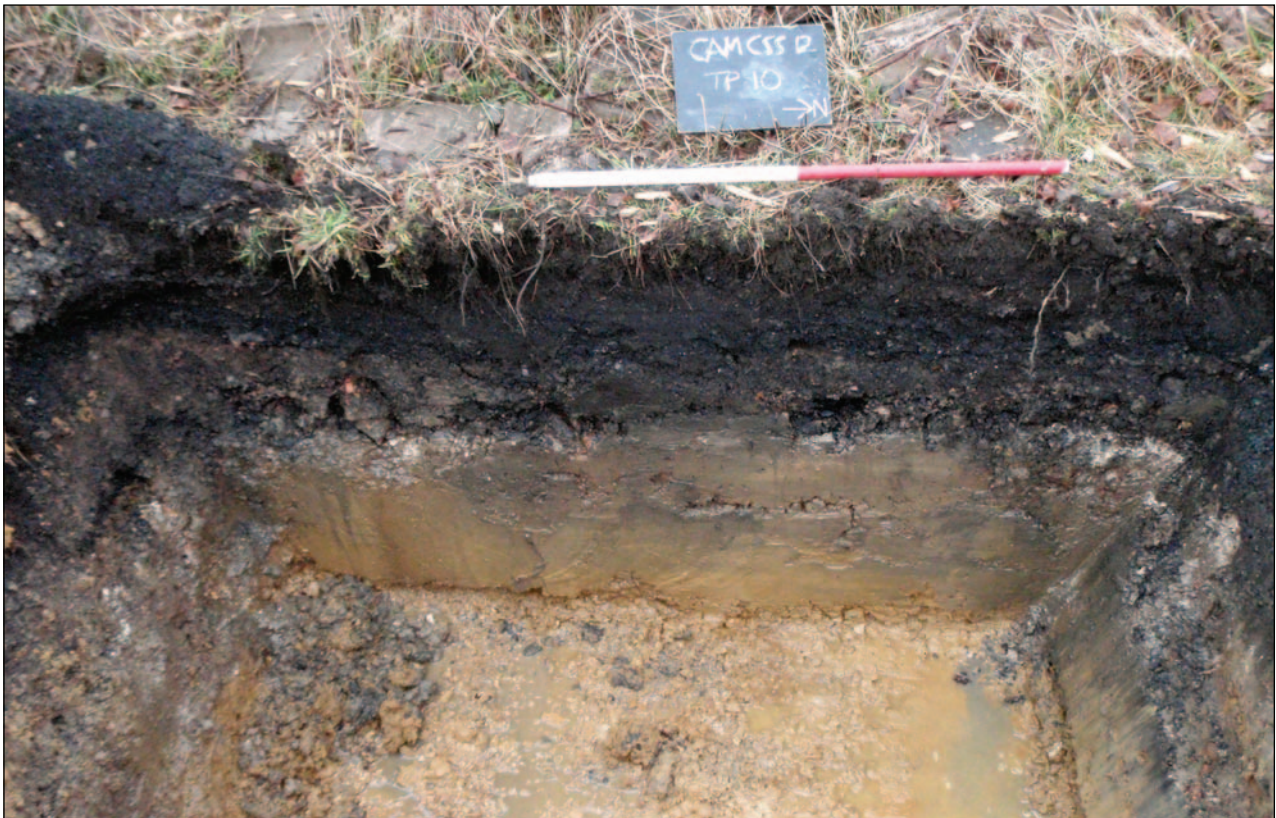
- 3.3.10 Located in the south of the site, Test Pit 10 measured 1.5m wide, 2m long and 1.2m deep (Plate 3). The base of the trench was natural river terrace gravels, which accounted for the bottom 0.3m of the trench. The natural gravel was sealed by layer (44), a reddish brown clayey silt, possibly the remnants of a subsoil, measuring 0.25m thick. This was sealed by a dark brown clayey silt (43) measuring 0.25m thick, with inclusions of modern brick. Layer (43) was sealed by a very dark greyish brown mixture of silt, ash and clinker (42), measuring 0.2m thick, equivalent to layer (31) in Test Pit 8 and layer (37) in Test Pit 9. The sequence was completed by (41), a thin layer of dark brown topsoil measuring 0.1m thick.

Plate 3: Test Pit 10, east facing section. 1m scale.

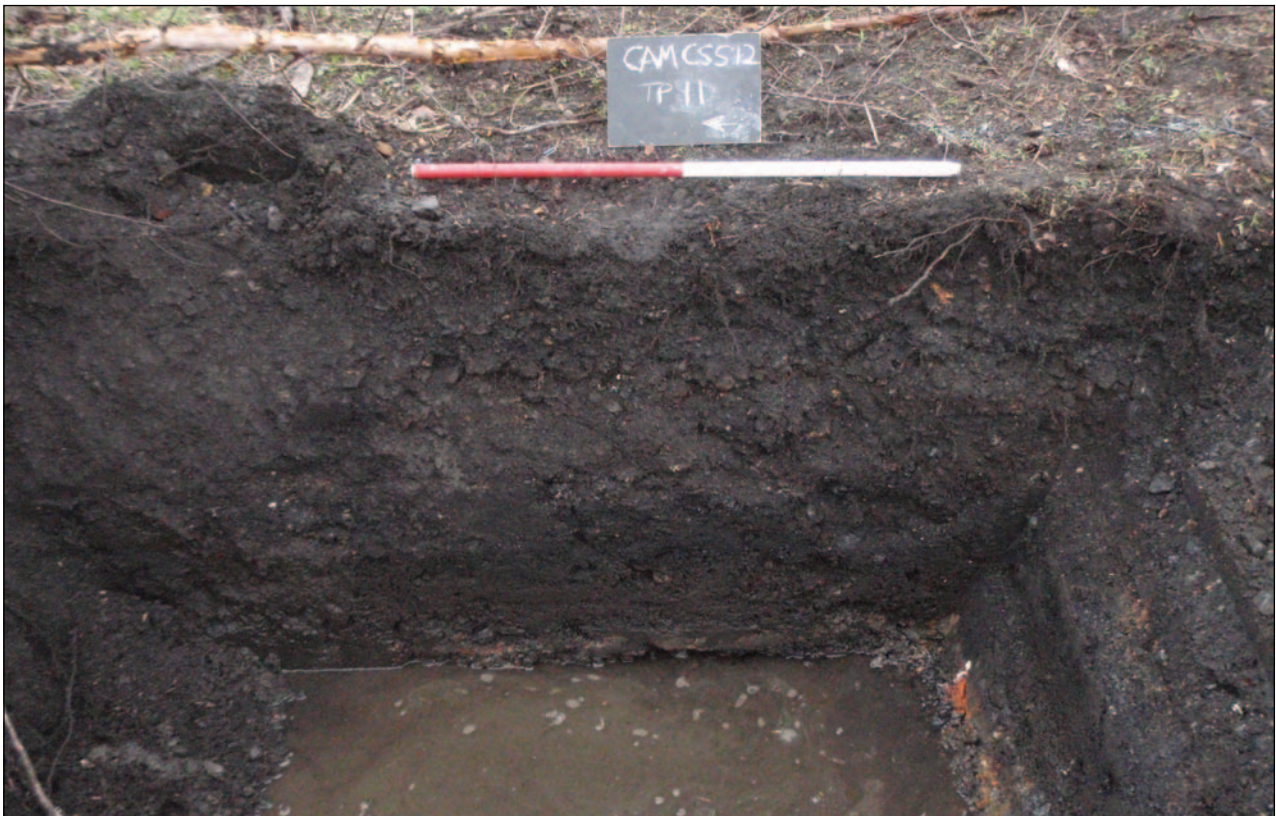
- 3.3.11 Located in the south of the site, Test Pit 11 measured 1.5m wide and 2m long (Plate 4). Excavation stopped at a depth of 1m because of incoming water. The test pit contained

four layers, all of which were modern made ground containing high levels of ash and clinker. Layer (50) was a dark greyish brown silty clay measuring at least 0.3m thick, with inclusions of modern brick. It was sealed by a very dark greyish brown clayey silt (49) measuring 0.35m thick. This was sealed by another layer of dark greyish brown silty clay (48), which measured 0.25m thick. The sequence was completed by (47), a thin layer of dark brown topsoil measuring 0.1m thick.

Plate 4: Test Pit 11, west facing section. 1m scale.
