# St Helen's Church Abingdon Oxfordshire

## Archaeological Watching Brief Report

February 2012

**Client: St Helen's Church**

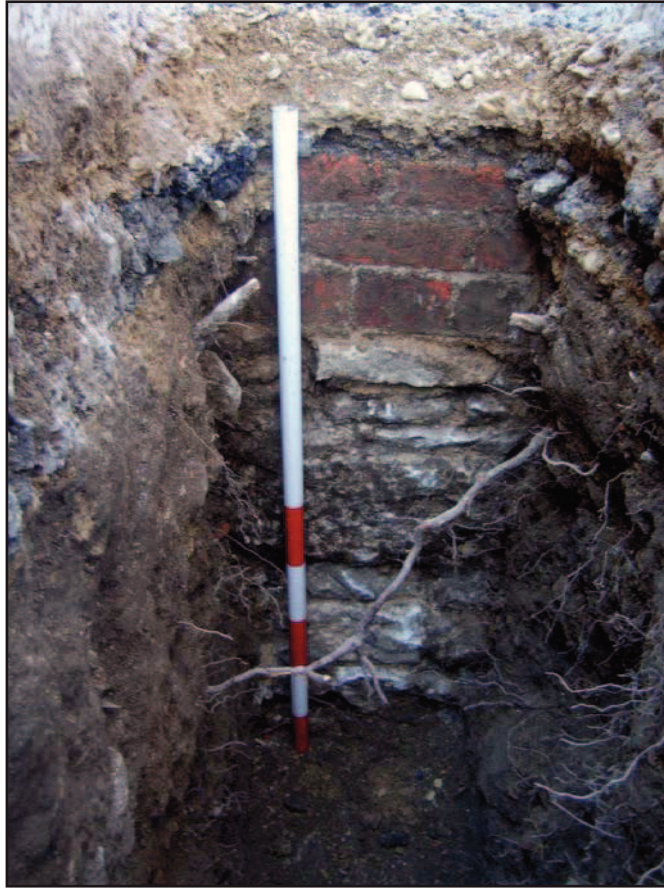
Plate 1 - Walls 3 and 6 (above)  
view to west

- 3.1.7 Wall 6 sat directly on top of a earlier limestone wall foundation (3) that was similarly orientated, randomly coursed and bonded with a creamy lime mortar. The edge of Wall 6 followed that of Wall 3 on the east side although on the western edge Wall 3 protruded by a further 0.18m. The truncated upper surface of Wall 3 survived at 52.17 m OD. This structure was at least 0.64m deep and continued below the base of the service trench (Plate.1).

- 4.1.2 Wall 6 is likely to be a foundation remnant of the current extant western churchyard wall which sits upon and follows the alignment of the earlier limestone Wall 3. The depth and thickness of this earlier wall is indicative of an external supporting wall of a substantial building of potentially more than a single storey rather than a simple precursor of a boundary wall.

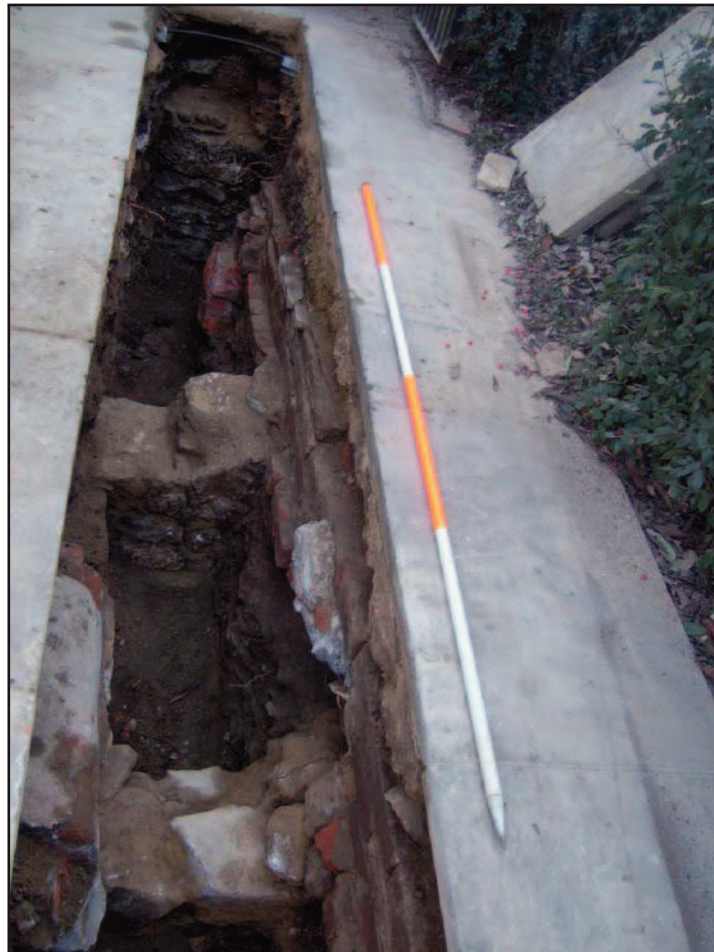
Plate 2 - Walls 5 (foreground), 4 and 3  
view to south east

- 3.1.9 Wall 5, a further limestone built wall, lying 0.8m to the west of Wall 4 was of an identical thickness to Wall 4 and a similar construction and orientation. However, the lime mortar used in Wall 5 was of a noticeably lighter, more yellow colour. Both walls had been truncated to a height of 51.93m OD (Plate.5).

- 4.1.3 Walls 4 and 5, dated from brick and tile fragments retrieved from their fabric to the 16<sup>th</sup> to 17<sup>th</sup> centuries or later would appear to have formed a contemporary structure with Wall 3 in terms of their alignment and build. It seems likely that they were leveled at the same time being backfilled in a single event with deposit 10. Whether Wall 3 pre-dated Walls 4 and 5 is unclear.

- 4.1.4 These walls appear to represent the remains of a building that pre-dated Mr Twitty's Almshouse (1709) situated immediately to the south and it is probable that they run beneath the almshouse building. Unlike the later almshouse the structure implied by these walls follows the orientation of the church itself in terms of its north-south alignment and presumably represents the remains of an earlier building related to the church.
