The Vicarage White Horse Lane Whitchurch

Archaeological Evaluation Report

January 2012

Client: The Diocese of Oxford

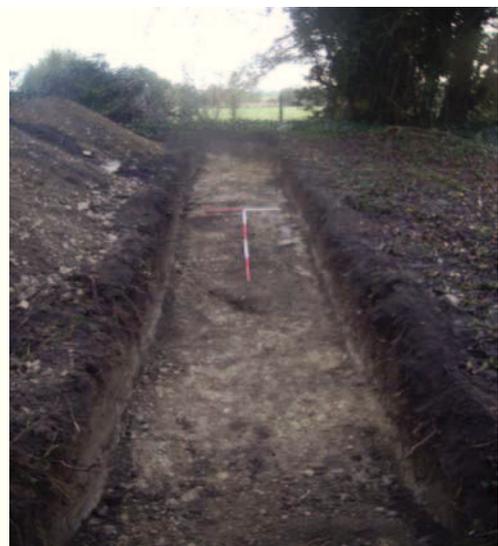
Plate 1: Trench 1

- 3.4.1 Situated to the north of the Vicarage, between the house and the church, the trench was positioned within an overgrown garden area planted with mature trees and shrubs. The trees and shrubs had been cleared within the trench footprint prior to excavation. The ground sloped noticeably from a high point of 138.70m above Ordnance Datum (OD) to the east dropping rapidly to 138.32m OD. The location of Trench 1 was modified from that proposed in the written scheme of investigation in order to assess whether this rapid change in elevation could be associated with former garden features, such as the remains of a wall. Subsequent excavation demonstrated that this change in elevation was not associated with any archaeological features and appeared to be of natural origin.

- 3.4.2 No archaeological remains were discovered within Trench 1. Overlying the natural clay and limestone was a mid green brown clayey silt, interpreted as subsoil which was overlain by the present topsoil consisting of a dark greyish brown silt.
- 3.4.3 Two areas of bioturbation were recorded within the trench: a small circular patch of root disturbance to the east (103) and the remains of a large tree hole extending beyond the trench limits to the west (105). Context 103 contained a single fragment of modern

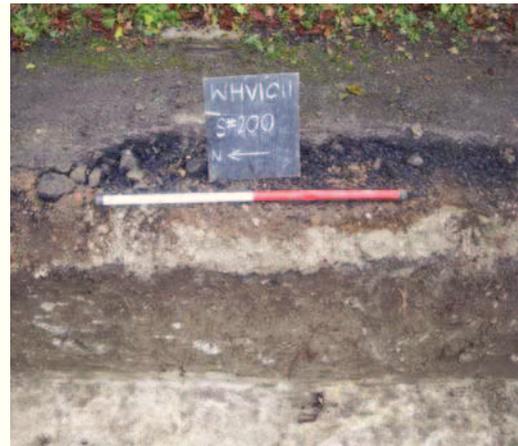
Plate 2: Trench 2, section 200

- 3.5.1 Trench 2, situated within the current car park area for the existing Church Hall, contained no archaeological remains. The natural geology, a light yellow grey sandy clay (200) encountered at approximately 0.64m below current ground level, was overlain by subsoil (201) consisting of mid green grey silty clay with occasional fragments of limestone. Overlying the subsoil was a thin remnant of the former topsoil comprising mid brown grey sandy clay with occasional small fragments of CBM and fine roots. This deposit had been truncated by the foundation base layer for the current car park (203) which consisted of firm light cream sandy clay with frequent fragments of crushed limestone. The base layer was overlain by a thin layer of dark orange yellow silty sand with occasional fragments of crushed brick (204), which was sealed with the modern tarmacadam layer.

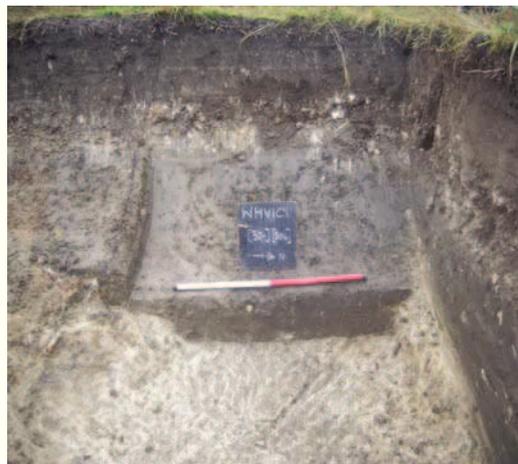
Plate 3: Trench 3, section 301

- 3.6.1 Situated in the grassed area at the rear of the existing Church Hall, Trench 3 was excavated as a 3 x 3m square test-pit and was targeted upon the footprint of the proposed carport. The natural geology was encountered at 137.19m OD, approximately 0.70m below the current ground level.

- 3.6.2 The trench contained a single feature, probably a ditch with a re-cut. The 2.10m wide flat-bottomed feature extended just beyond the northern limit of the excavation area (304/306). Ditch 304 contained a single firm light grey brown silty clay with frequent flecks of limestone and charcoal. The ditch appeared to be re-cut on its northern side (306) and contained a single dark grey brown silty clay with occasional flecks of charcoal and limestone fragments. Both fills contained fragments of animal bone and pottery. Fragments of late medieval pottery were recovered from both ditches, along with four sherds of residual Anglo-Saxon pottery.

- 3.6.3 A 40 litre palaeo-environmental sample was taken from deposit 307 for further finds retrieval and an assessment of any charred plant remains (See Appendix C). An additional eight fragments of late medieval pottery were recovered from the sample.
- 3.6.4 The upper fills of ditch 304/306 appeared to be truncated by 0.24 m thick deposit of loose light grey silty clay with frequent fragments of crushed limestone (303). An inactive six-inch diameter glazed ceramic pipe was observed within this layer. Deposit 303 was overlain by 0.23m of friable mid green grey silty clay interpreted as subsoil, which was in turn, overlain by 0.22m of topsoil. In total, approximately 0.70m of overburden sealed the medieval ditch.

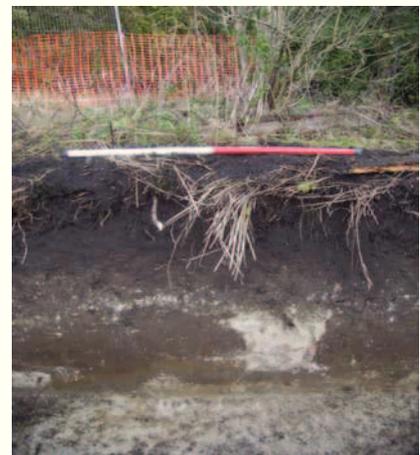
Plate 4: Trench 4, posthole 405

- 3.7.5 Posthole 405 was observed in the south-west facing trench section (Plate 4). This square-cut posthole was filled with a firm light yellow white mortar, probably used to set the post in place. No remains of a post survived.

- 3.7.6 The posthole cut subsoil 402 and was sealed by deposit 401/411. No finds were recovered from the feature. Pottery recovered from the sealing layer 401/411 dates to the 17th-18th century suggesting a tentative date prior to this for the posthole.

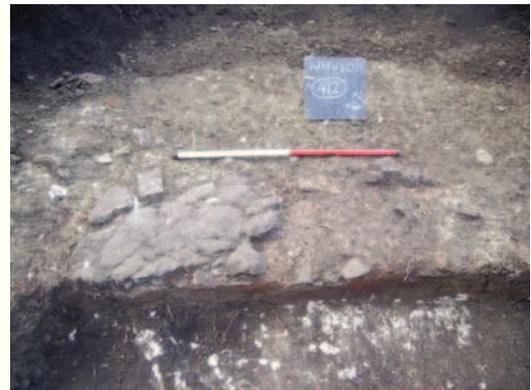
Plate 5: Trench 4, hearth group 414

3.7.7 Group 414, visible only in the trench section, was interpreted as a possible hearth. The area around the feature was extended for further clarification and investigation at the request of Eliza Alqassar. An area of approximately 23m² was opened around the feature in an E-W extension to the trench which revealed the limits of group 414 and demonstrated that there were no associated features within the area. Group 414 was completely excavated as a result of the further works.

3.7.8 Context 412 consisted of a series of limestone cobbles and a number of fragments of tile which were confined to the south-eastern edge of the feature (Plate 5). None of the stones appeared to be worked. The stones were set into a bedding layer clay onto the natural underlying clay which had subsequently become fire-reddened. A representative sample of the stones were retained for assessment, although no additional information could be ascertained (see Appendix B6).

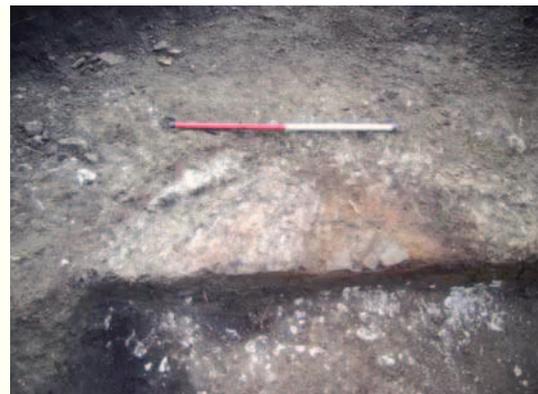
Plate 6: Trench 4, hearth with stones removed

3.7.9 Examination of the underlying heat-affected deposit did not reveal the presence of a cut for the hearth. The feature appeared to have been constructed directly onto the underlying subsoil. The red colouring of the heat-affected clay dissipated away from the source of the heat, towards the edges of the feature. The most intense red colouring, potentially identifying the source of the heat, was slightly off centre in the area and contained no overlying stones.

3.7.10 The absence of stones in the northern half of the feature was initially thought to have been the result of later robbing when the hearth fell out of use. However, as excavation proceeded it became apparent that this area of the feature did not contain the bedding layer of clay in which the stones in the southern half had been set (Plate 6). Rather than the stones being robbed out, it appeared that they were never present. The absence of stones and/or ash deposits may suggest that some kind of container or grate, was originally placed here.

- 4.2.4 Although the stones had clearly been subjected to heat intense enough to cause the underlying clay to become fire-reddened, no charcoal or ash deposits were observed overlying the stones. This may suggest the fire was contained within a metal grate that retained the ash deposits.

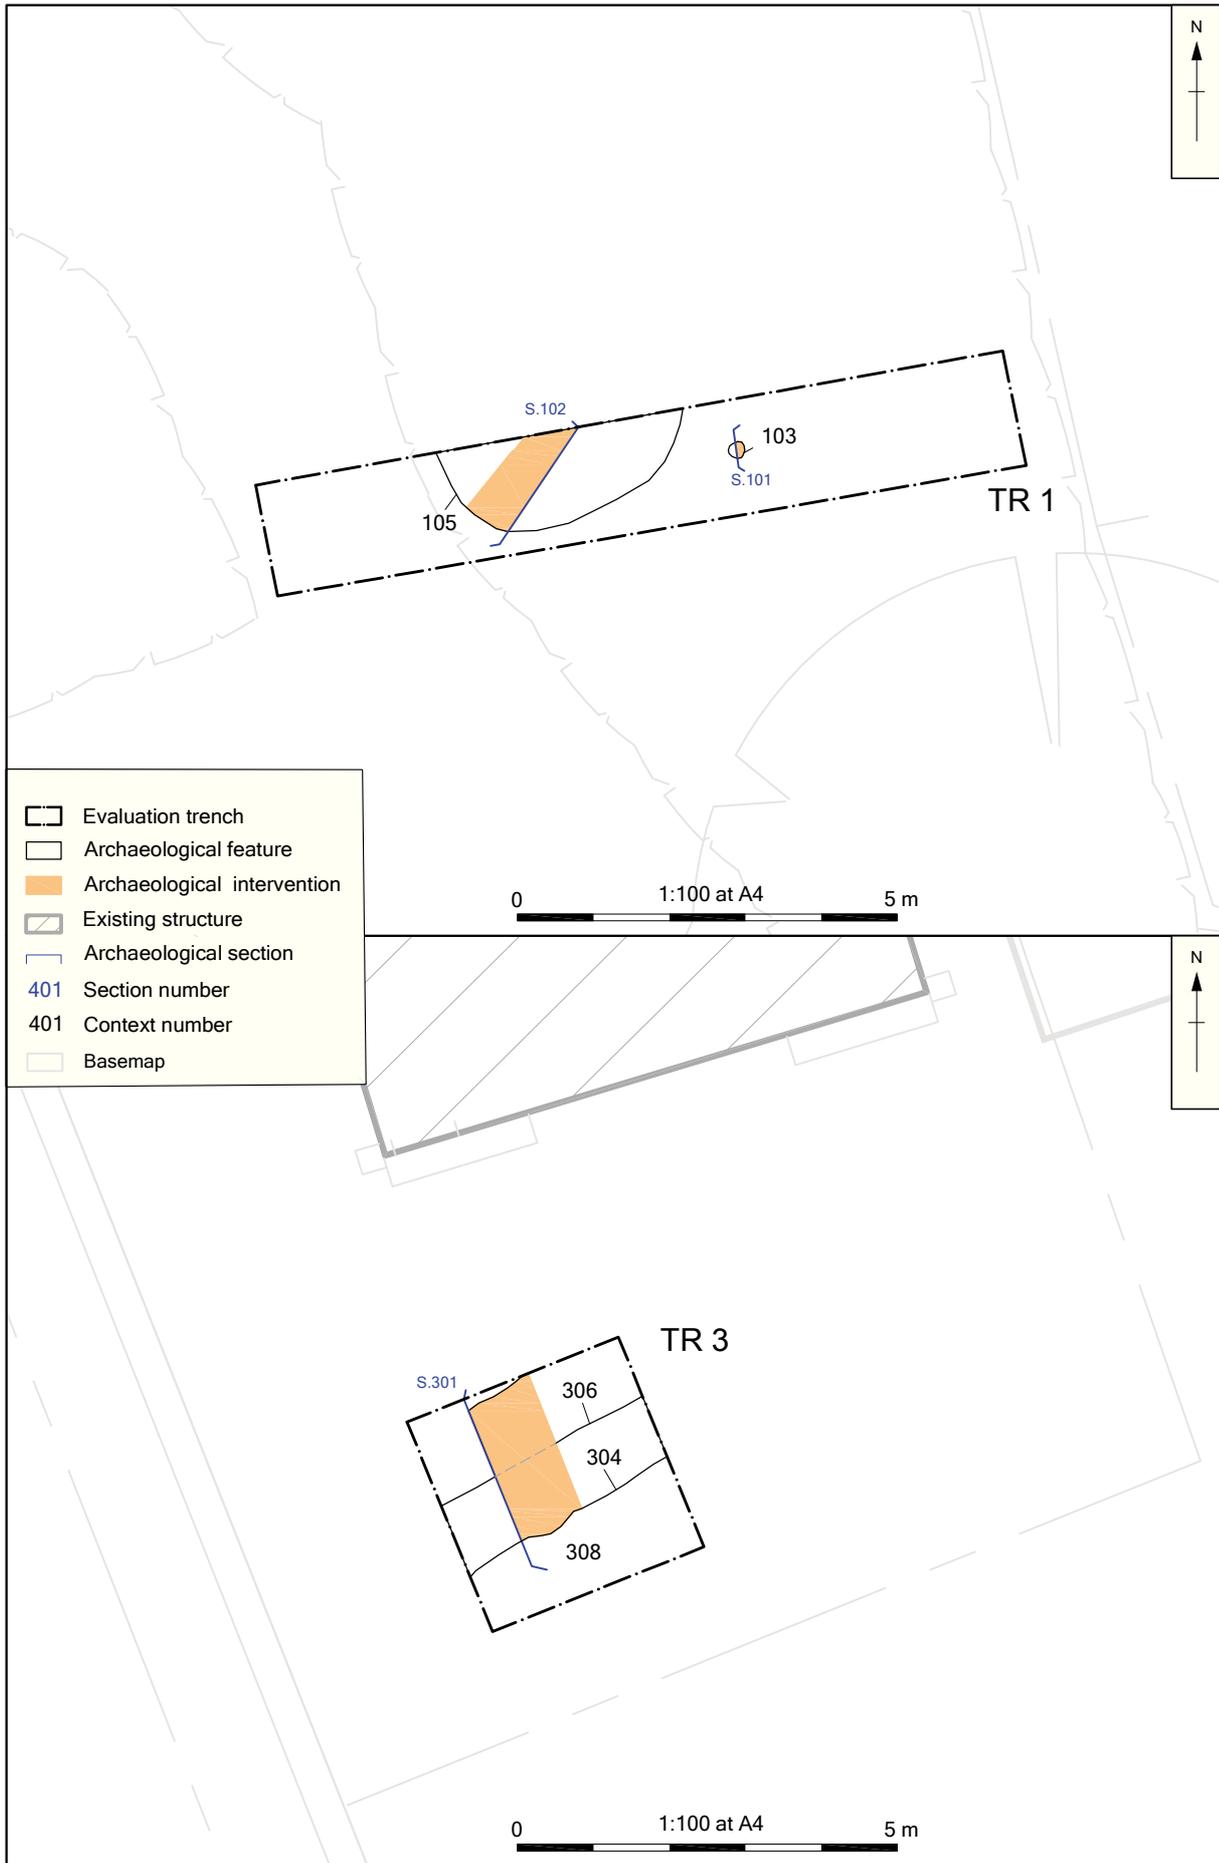
Figure 3: Trenches 1 and 3

3.4 Trench 1 (*Figs 3 and 5: Section 101 and 102; Plate 1*)

3.6 Trench 3 (Figs 3 and 5: Section 301; Plate 3)

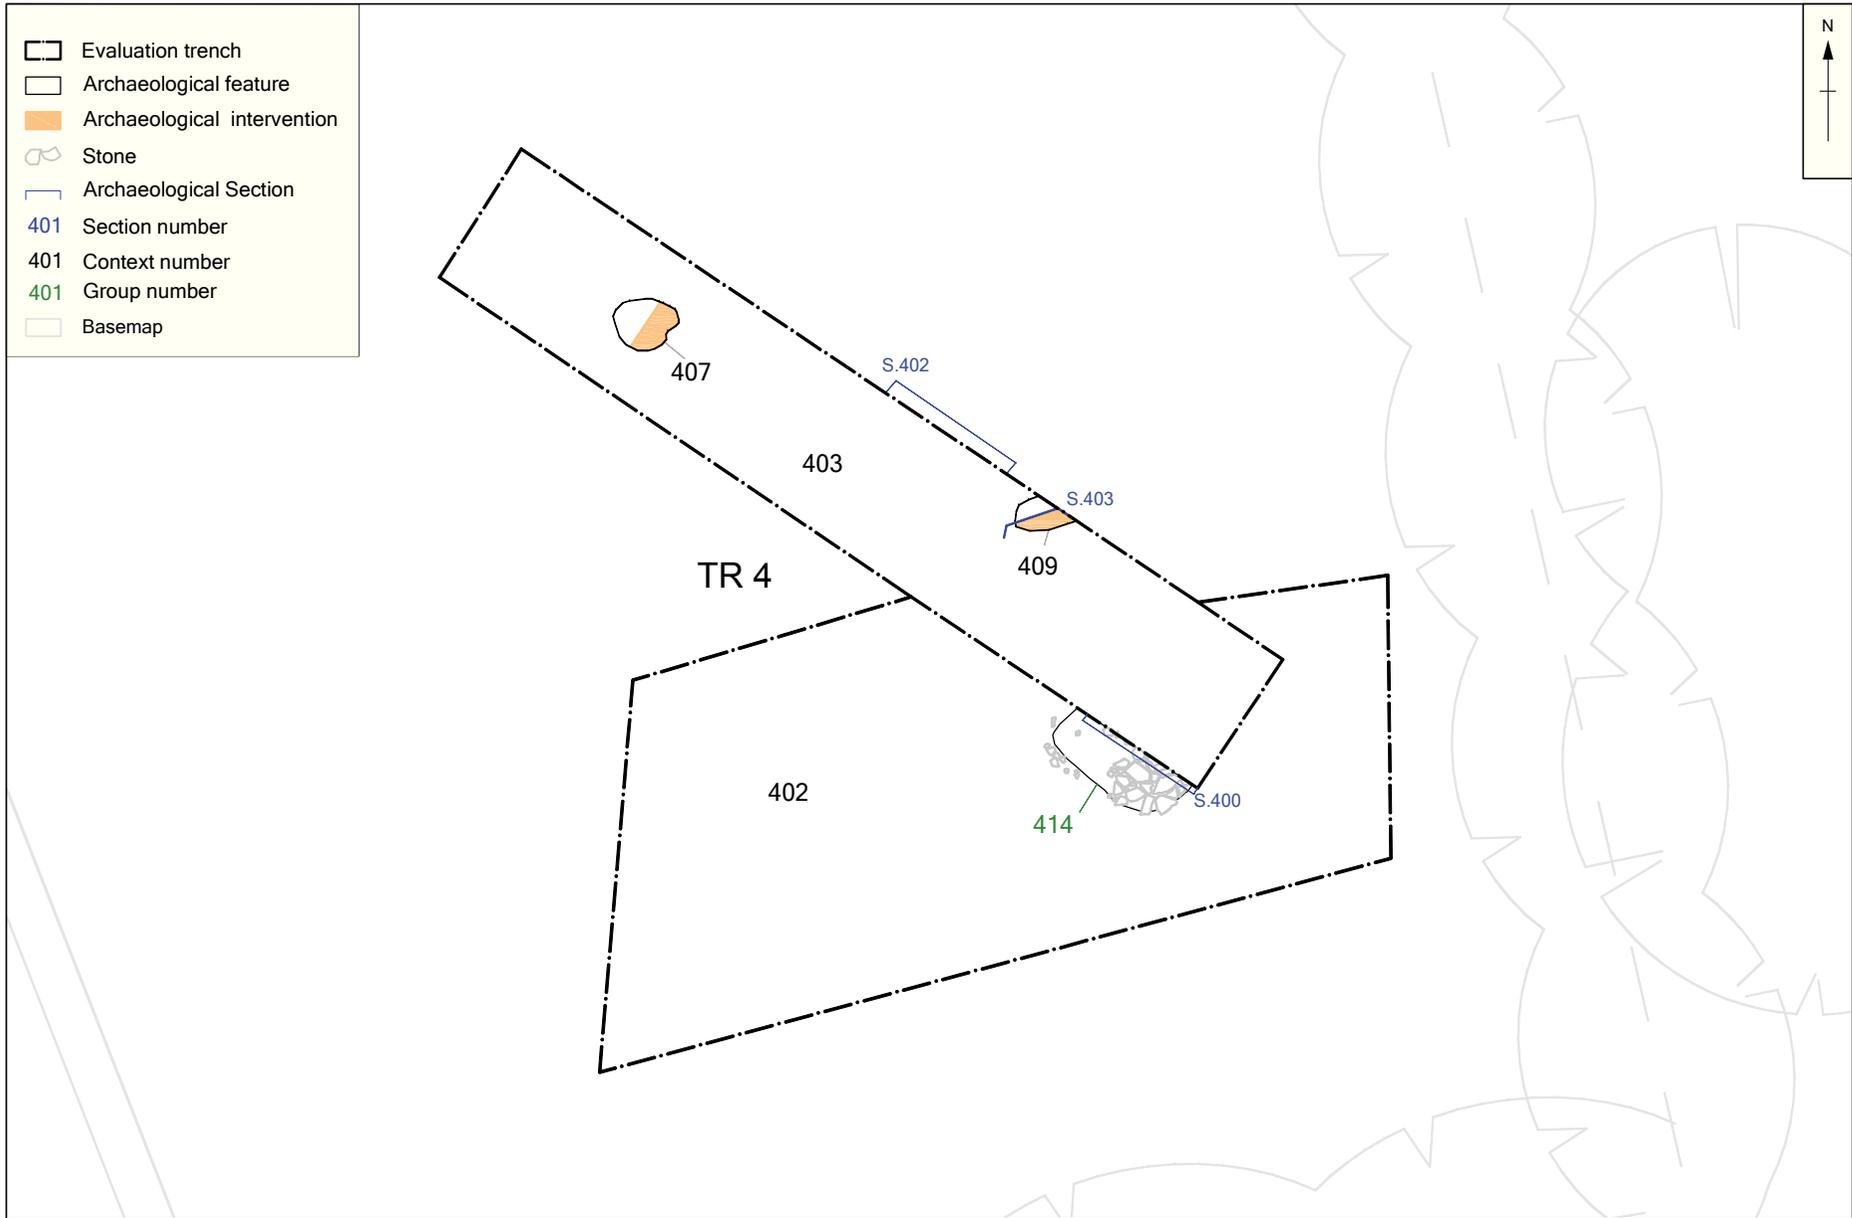
Figure 4: Trench 4

- 3.7.3 Four features were observed within Trench 4; two areas of bioturbation, a posthole and an area of heat-affected stones, possibly representing a hearth.

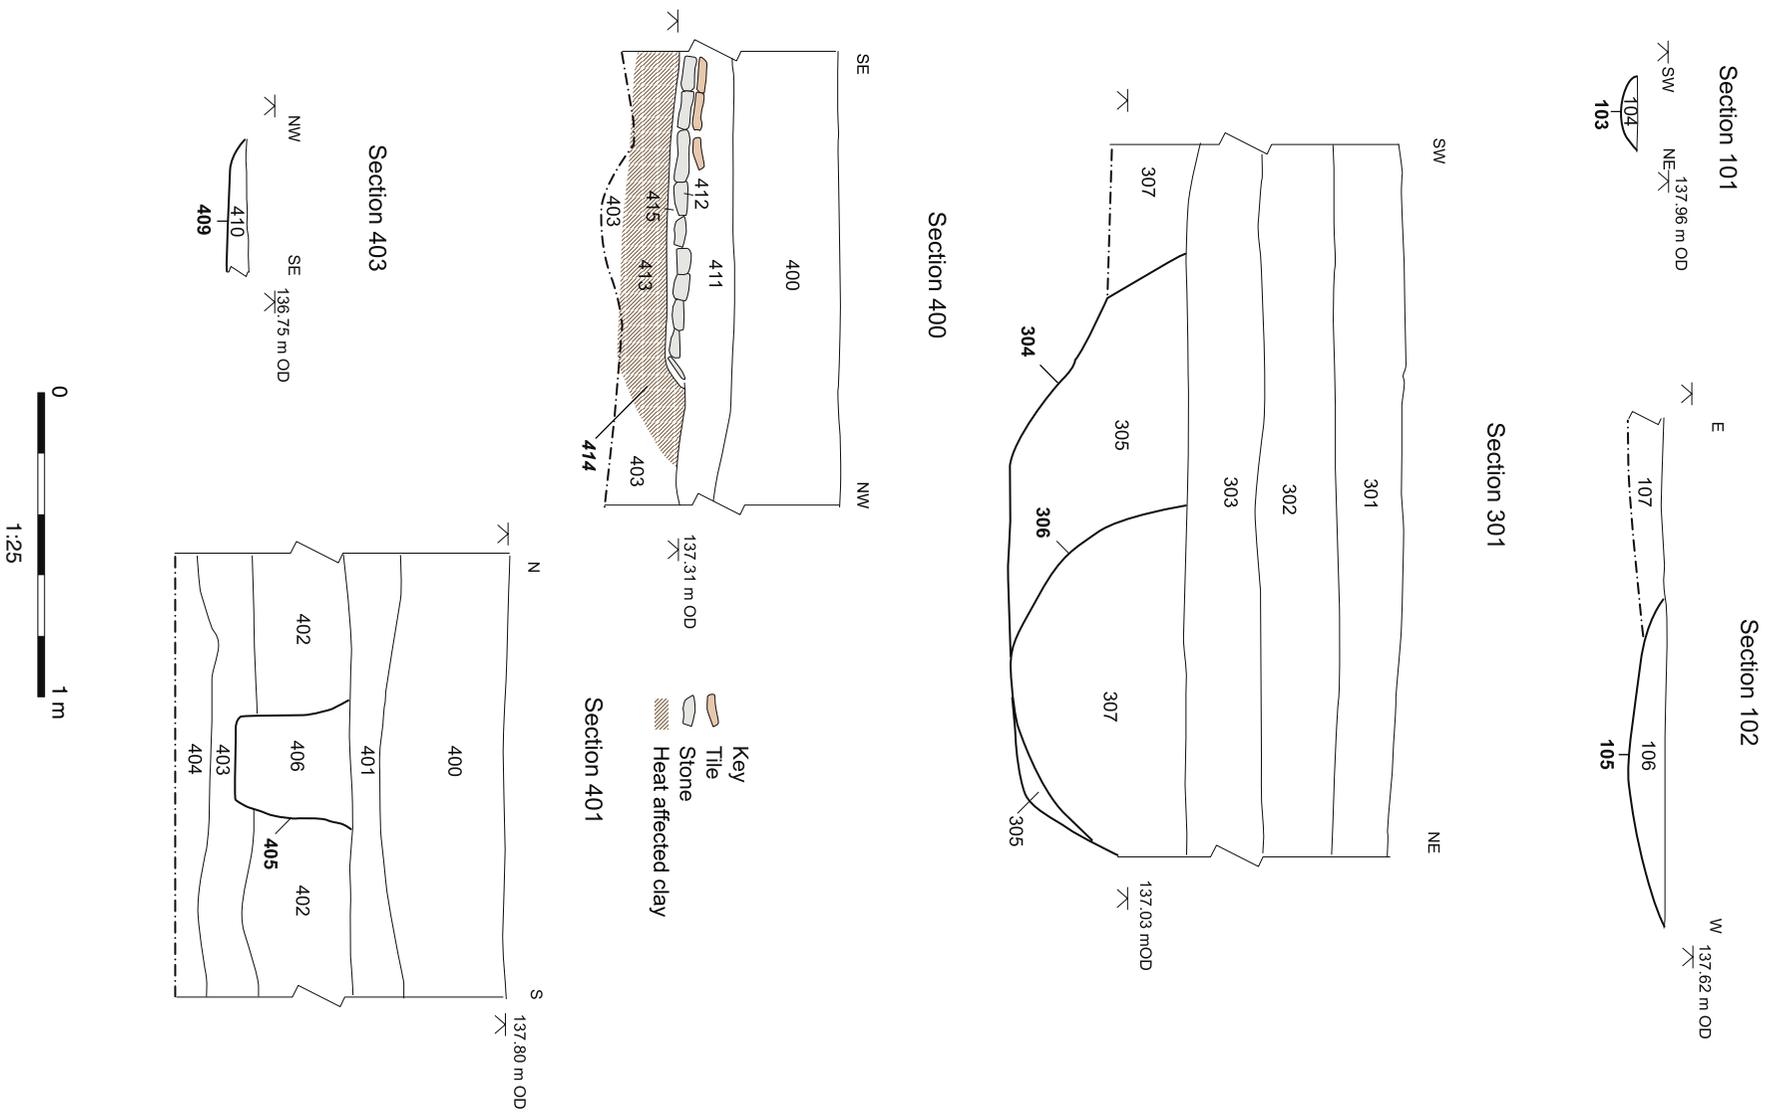
Figure 5: Sections

A discrete feature (group 414) was situated at the south-eastern end of the trench (Fig. 5, section 400). A layer of limestone cobbles (412) was set into the
