**'RIVERSIDE', 15 BRIDGE END, DORCHESTER,
OXFORDSHIRE**

ARCHAEOLOGICAL BUILDING INVESTIGATION
IN ADVANCE & DURING RENOVATION

OXFORD ARCHAEOLOGICAL UNIT
DECEMBER 1999

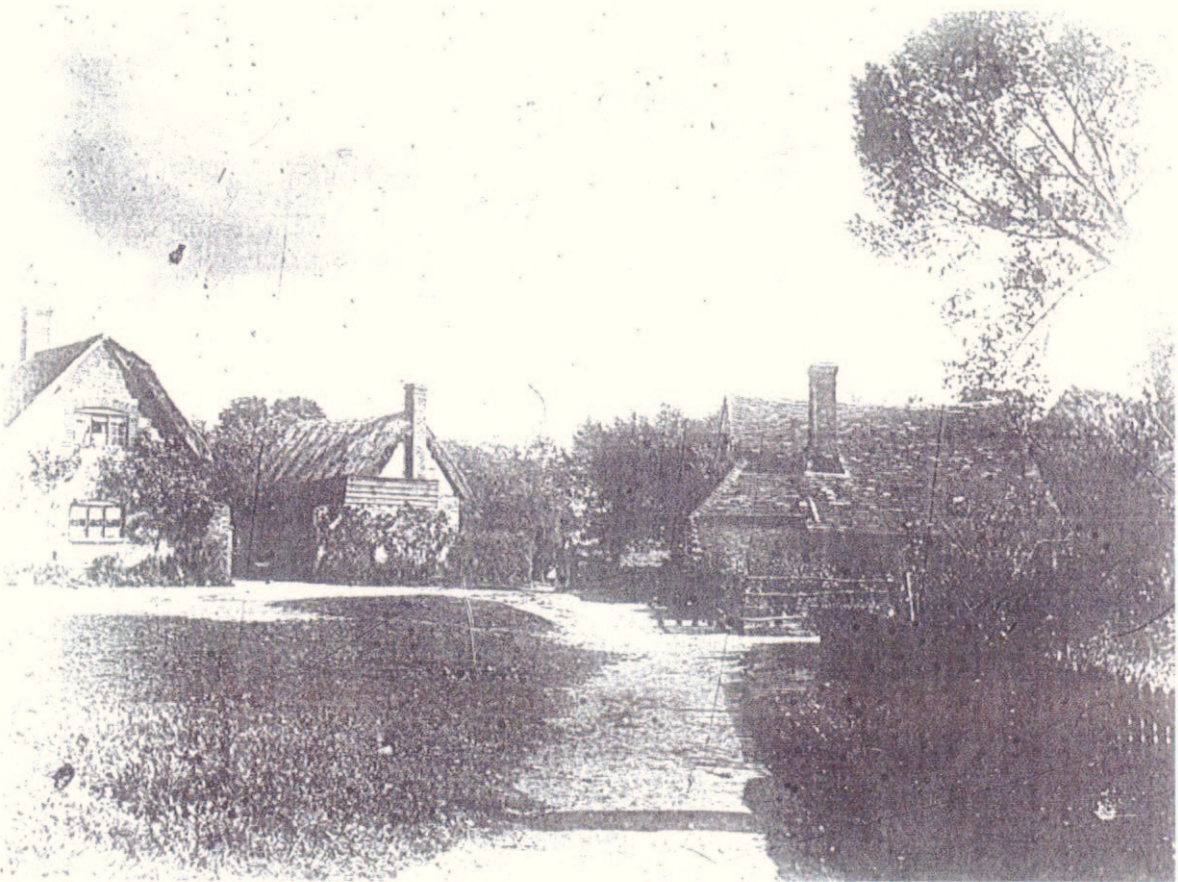
- 3.3 Surprisingly for such a picturesque setting there are few historic illustrations or photographs of Bridge End, underlining the fact that without the road and its river crossing the area really did become a bit of a backwater (VCH, 41, 1962). One image from 1907 shows the west elevation of the building (Plate 2, see below 4.2.4).

Plate 2: 1907 historic photograph of Riverside, prior to the addition of the secondary chimney (Centre for Oxfordshire Studies)

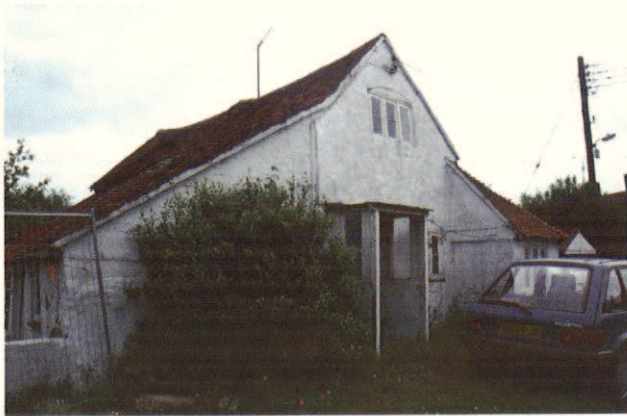
Plate 3: Front elevation (North)

- 4.2.1 The elevations of the building are very simple (see Plates 3-7). The north façade fronts onto the green showing the primary structure flanked by two later phases of extensions to east and west. Brick work on all elevations is rendered and painted white. The front elevation has two three-light windows with segmental heads, one to each floor, with front door and later timber porch construction to the west. The single storey projecting extension to the west has a three-light window, while the western kitchen extension has a high level square light.

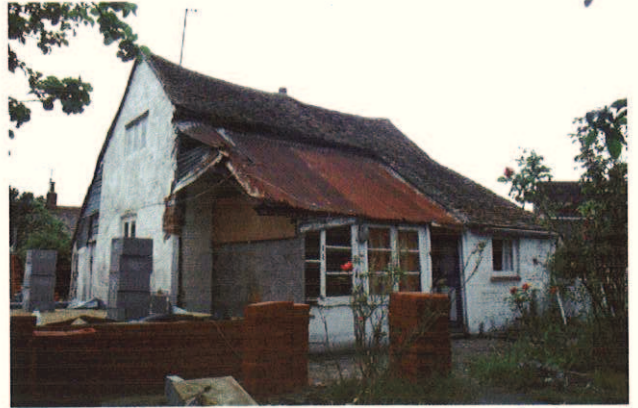
Plate 4: East elevation

- 4.2.2 The east elevation comprises of two phases of extension; to the north a brick built kitchen is lit by a window and roofed under a cat-slide with clay tile and to the south is a 20th-century 'sun room' with lower walls of breeze block and upper walls of glazing under a corrugated iron roof.

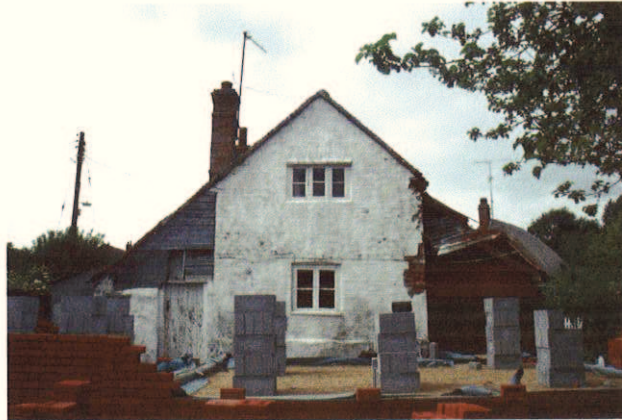
Plate 5: Rear elevation (south)

- 4.2.3 The southern elevation, that most affected by the new extension, again shows the main building flanked by later extensions. The primary house is lit by two windows, the first floor of three lights and the ground floor example of two lights. A projecting plinth is the only other feature on its elevation. To the west is a lean-to extension of mixed clunch rubble and brick construction with the area above the doorway of rendered stud work under a clay tiled roof.

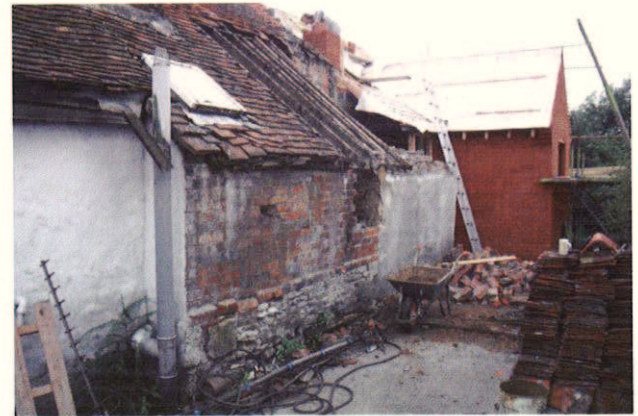
Plate 6: West elevation

- 4.2.4 The western elevation is blank with the rubble and brick built extensions rendered to the south and north extremes and red brick walling with rubble plinth in-between, possibly blocking an earlier door. A 20th-century asbestos garage obscures this elevation.

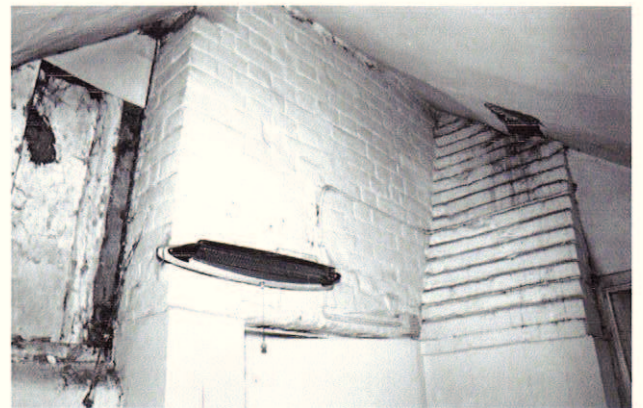
Plate 12: Previously external north-west corner with brick chimney stack

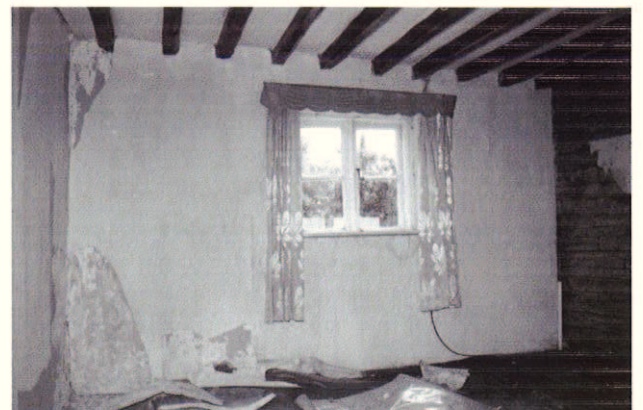
Plate 14:
Ground floor, back room
south wall

4.3.1.2 The back room is lit by a two-light window in its south wall (Plate 14). The north side of the room is dominated by the rising staircase which is finished with beaded tongue-and-groove panelling as in the front room (Plates 15-16). The fireplace furniture in the west wall is a late 20th-century replacement and the fireplace itself is also a 20th century insert (Plate 17). As with the front room fireplace it is also served by a substantial external stack which rises within the west extension. The wall around the stack is obviously packing material filling in the hole in the wall that was made to insert the second fireplace (Plates 18 & 19). An historic photograph of 1907 (Plate 2) shows the west elevation of the building without this stack providing some dating evidence for its addition. A blocked door was observed in the east wall of the room, visible from the east extension it has a thin timber lintel above it and is blocked with modern bricks and cement mortar (Plate 20). The historic plaster ceiling has previously been removed in this room, exposing north-south ceiling joists which have been painted black and filled between with plasterboard. The joists are framed into a east-west beam also framing the stair case and sit on a timber let into the southern brick wall.

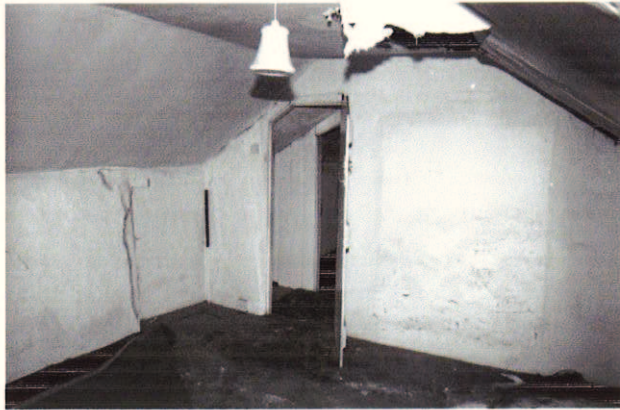
4.3.2.1 *First floor:* The first floor comprises the two-unit plan of the primary c1815 building. As in the ground floor it is divided between two front and back rooms with the stair rising between them. All the external walls are of brick, with the offset in the eastern wall of the front room

very clear in plan and elevation (Plates 21 & 22). The internal walls are of stud construction with lath and plaster finish to the front room, south wall and tongue-and-groove boarding to the rear room, north wall. Both rooms are lit by three light windows of the same design seen throughout the structure. Plates 23 - 25 illustrate the front room before and after stripping out works and Plates 26 - 28 show the back room. The rooms are within the roof pitch with wall plate level at 1.22m above floor level. The plastered ceilings follow the pitch of the roof with laths applied to the under side of the rafters and collars of the roof construction. The roof of paired rafters (100 x 50mm), with collars (60 x 80mm), ridge purlin and clasped purlin at collar level has nailed joints. The clay tiles are then pegged to laths between the rafters. The roof structure uses a mixture of materials with softwood timbers of a relatively small scantling, many still in their round wood condition, to more substantial reused timbers of elm which are pegged into the wall plate (seen in the rear room, east side) (Plates 29 - 32).

Plate 21: First floor, front room, south-east corner
Showing offset in the east wall

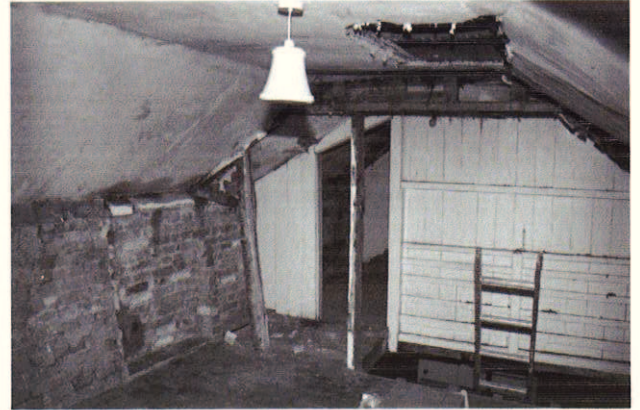
4.3.3.1 *Evidence seen after stripping out works:* When the walls were stripped of plaster some slight differences in the build of the previously external brick walls of the original building were observed. The southern half of the east wall and the south wall of the building were seen to be slightly different from the rest as they included distinctive yellow stock bricks and some of the internal faces of the bricks were whitewashed. The builder also confirmed that the pointing on the exterior of these walls was distinctive. This change in build was also seen at first floor level in both walls. It corresponds with the step visible in the east wall of the first floor front room. As the west wall of the building is of one build throughout its length it is unlikely that this difference in fabric represents an extension phase to the building but that it shows a rebuilding of the original wall using the original materials (hence the similarity of materials and the originally external whitewashed faces of the bricks being reused internally). To support this interpretation the south wall is clearly toothed into the pre-existing west wall at the south-west corner of the building. This rebuild may explain the step in the line of the eastern wall of the building with the northern length of the wall being original build and the southern end rebuilt. The surviving northern length of wall leans dramatically into the kitchen which may be why the southern half had to be taken down and rebuilt. Further evidence of poor construction technique was seen in the first floor front room after the plaster was stripped. Although the north and west walls are keyed in together at the north-west corner of the room this is not the case at the north-east corner. The two walls, although of the same fabric, are not keyed in together, hence the alarming spreading of the east wall.

Plate 22: As Plate 21 after plaster stripped

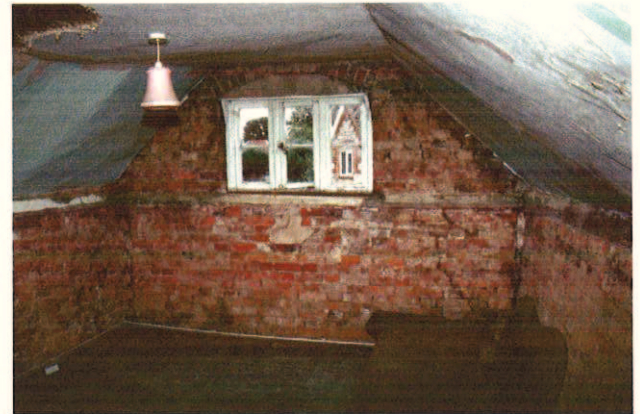
Evidence was seen during the investigation that suggests the south wall and the southern half of the east wall have been rebuilt, reusing the original materials. The remaining original northern half of the east wall is not keyed into the north wall at first floor level and is visibly spreading eastwards. It is likely the walls were rebuilt following a similar structural failure.

Plate 24: As Plate 23 after plaster stripped

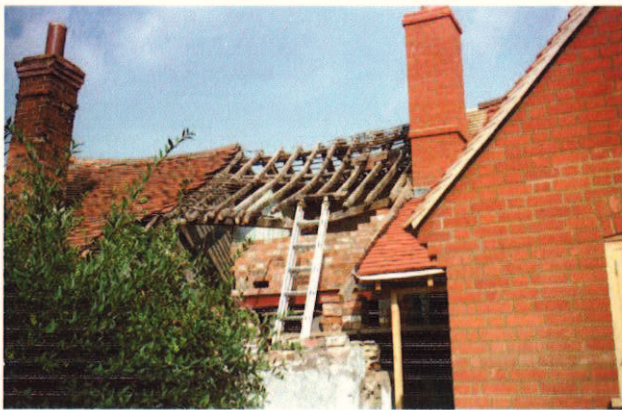
Plate 29: Exposed roof structure of back room, with New extension to the south (C A Cheal)

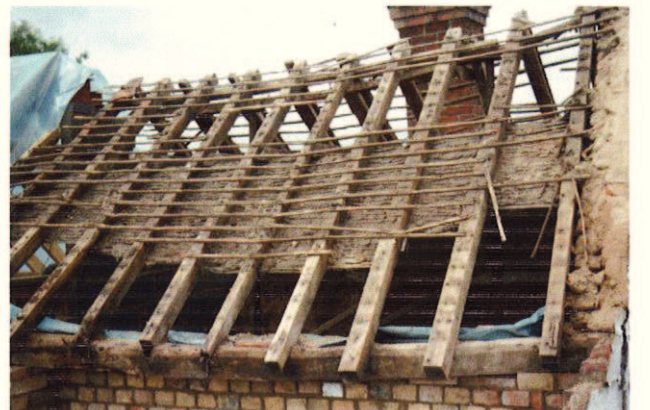
Plate 30: Detail of east side of exposed roof structure over front room (C A Cheal)

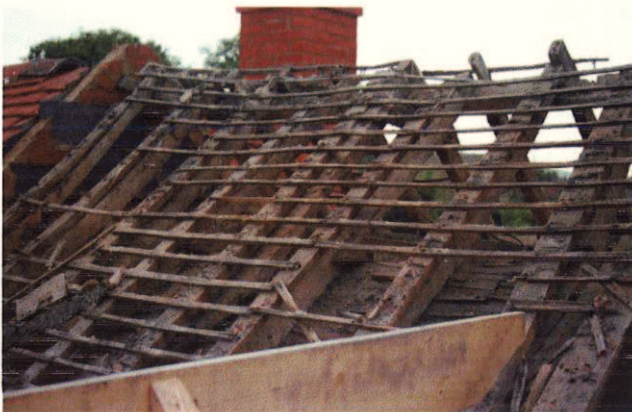
Plate 31: Detail of east side of exposed roof structure Over back room (C A Cheal)

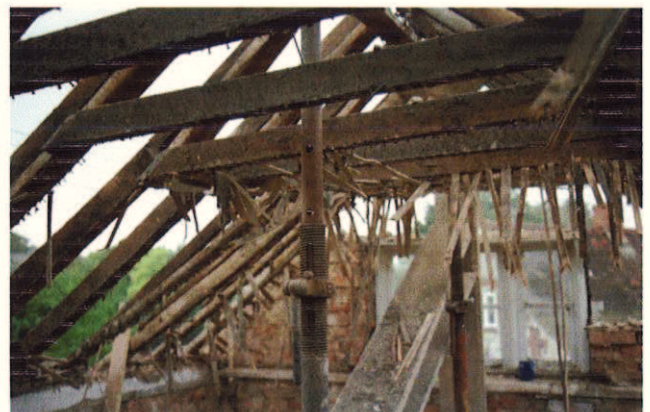
Plate 32: Detail of roof construction – front room, looking north (C A Cheal)

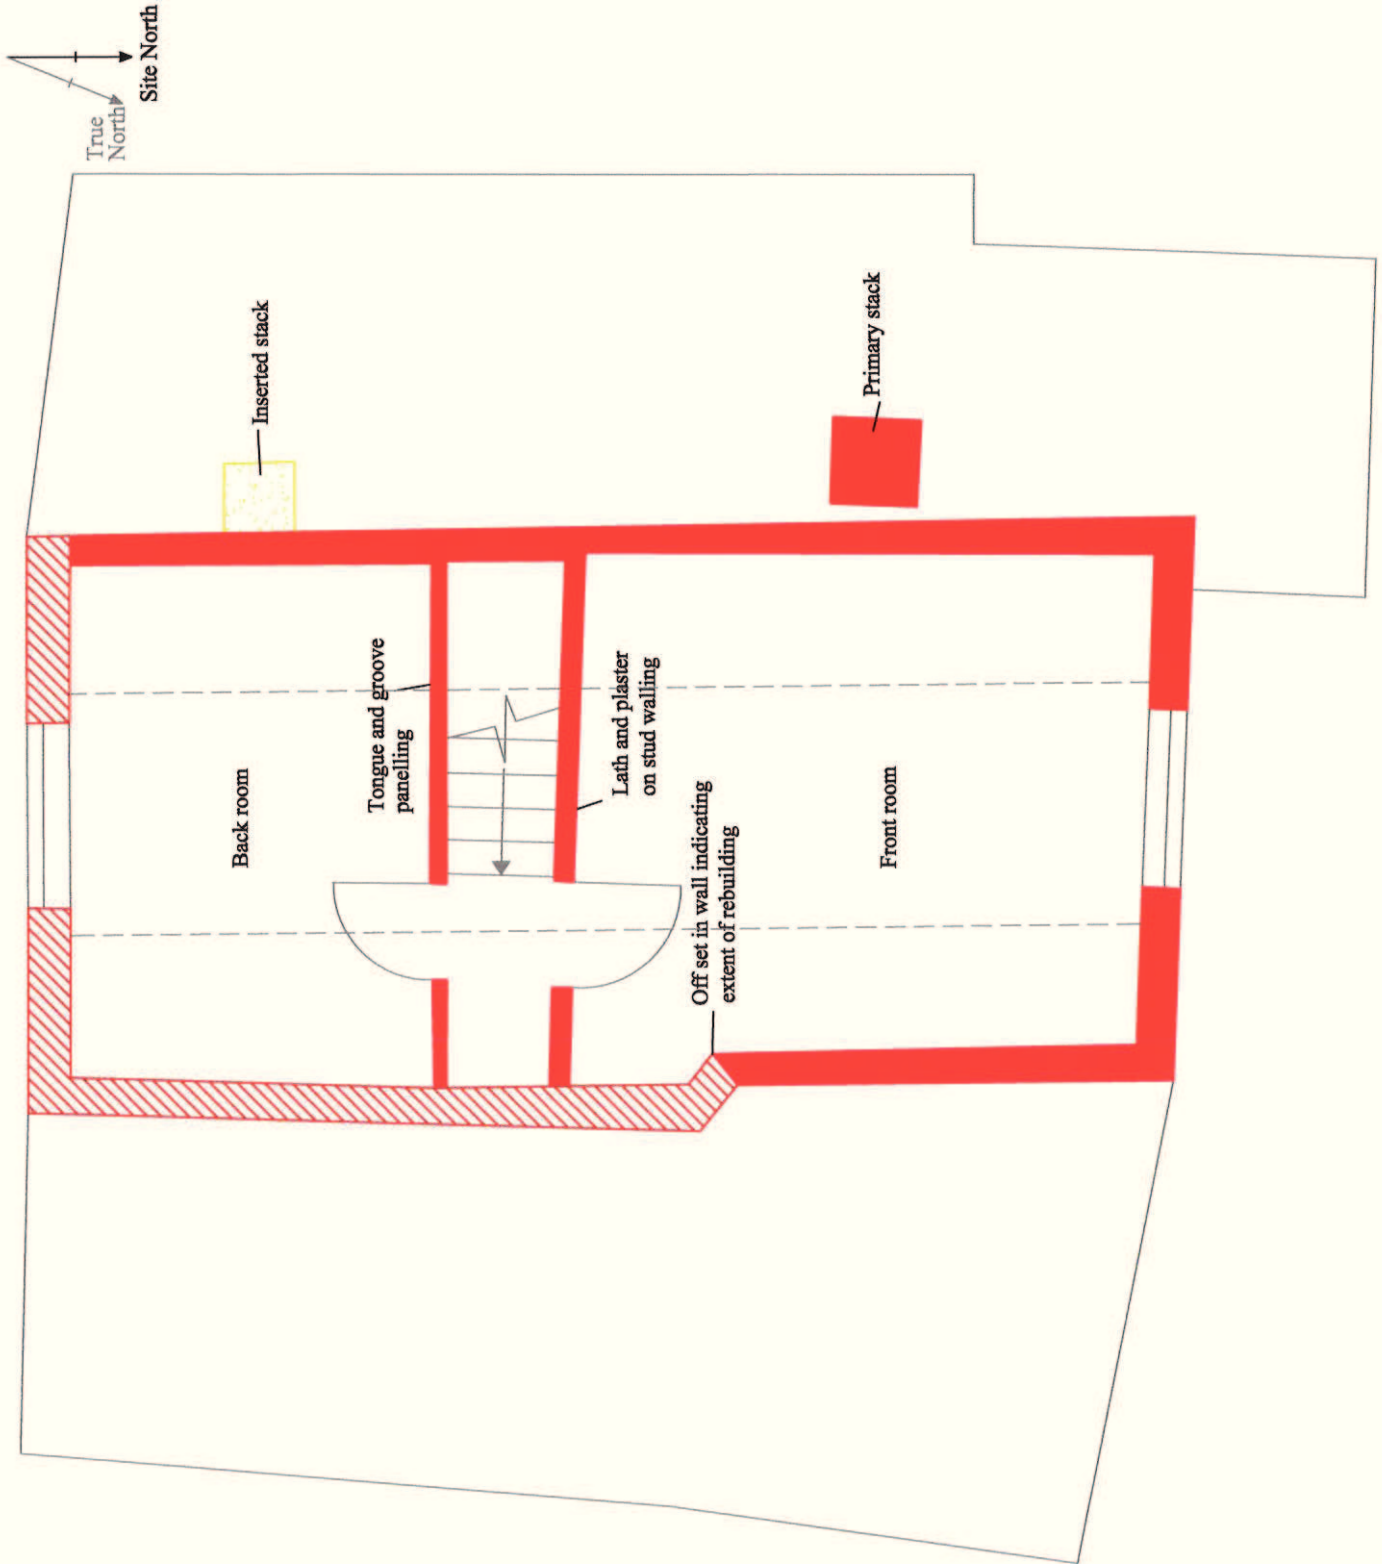
Figure 7: Phased first floor plan

- Surviving primary fabric - c1815
- Rebuilt walls of primary building
- 20th century fabric
- Ceiling line / roof pitch
