Undated ditch at 53 London Road Harston Cambridgeshire

Archaeological Evaluation Report

Undated Ditch at 53 London Road, Harston, Cambridgeshire

Archaeological Evaluation

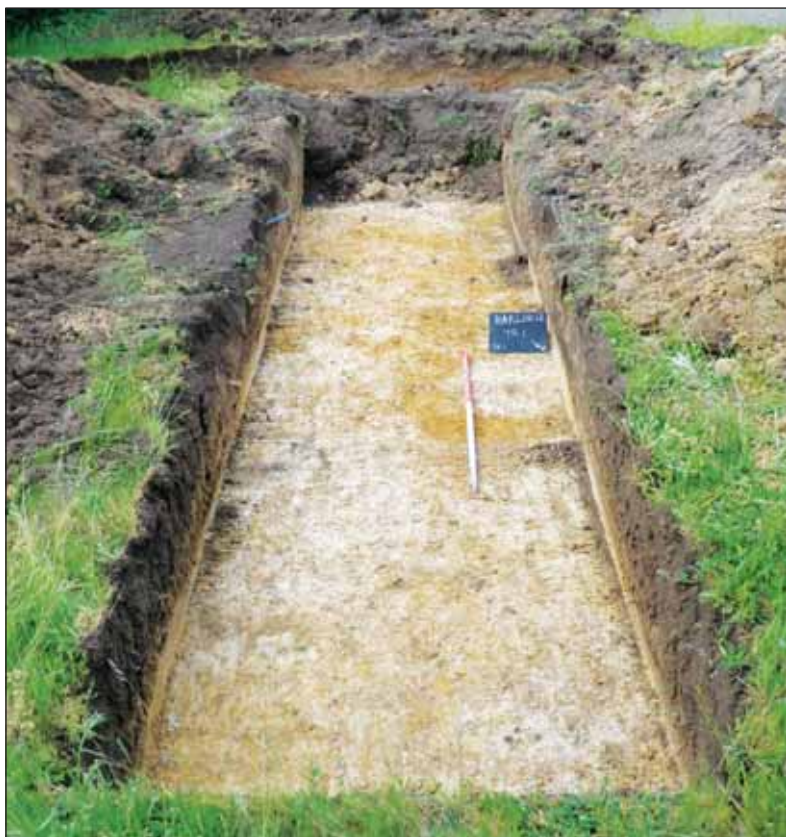
Plate 1: Trench 1, taken from north-east

- 3.2.1 Trench 1 was located in the front garden area of the site (Figure 3). It was orientated approximately north-east to south-west and measured approximately 5.85m in length, 1.5m wide and 0.50m deep. This trench contained 0.30m of topsoil and 0.20m of subsoil overlying a natural, undisturbed chalky marl (Plate 1). There were no surviving archaeological features in this trench.

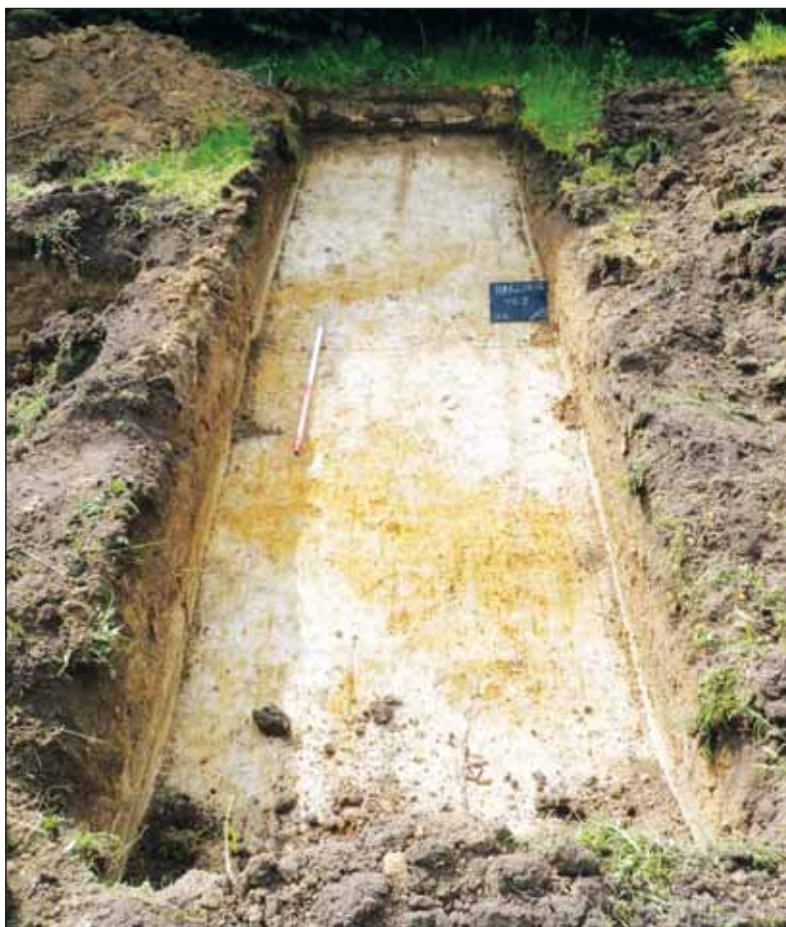
Plate 2: Trench 2, taken from north-west

- 3.2.2 Trench 2 was located in the front garden area of the site (Figure 3). It was orientated approximately north-west to south-east and measured approximately 5.60m in length, 1.5m wide and 0.65m deep. This trench contained 0.25m of topsoil and 0.40m of subsoil overlying a natural, undisturbed chalky marl (Plate 2). There were no surviving archaeological features in this trench.

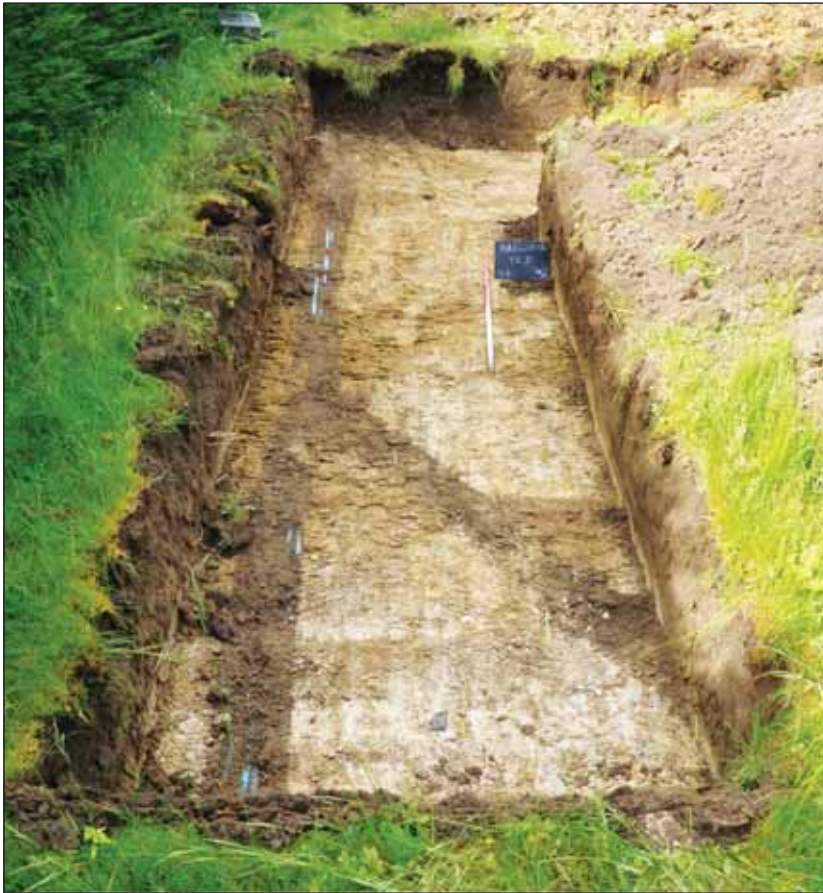
Plate 3: Trench 3, taken from north-east

- 3.2.3 Trench 3 was located in the rear garden area of the site (Figure 3). It was orientated approximately north-east to south-west and measured approximately 5.90m in length, 1.5m wide and 0.56m deep. This trench contained 0.40m of topsoil and 0.16m of subsoil overlying a natural, undisturbed chalky marl. Several water pipes leading to the pond were encountered (Plate 3), however there were no surviving archaeological features in this trench.

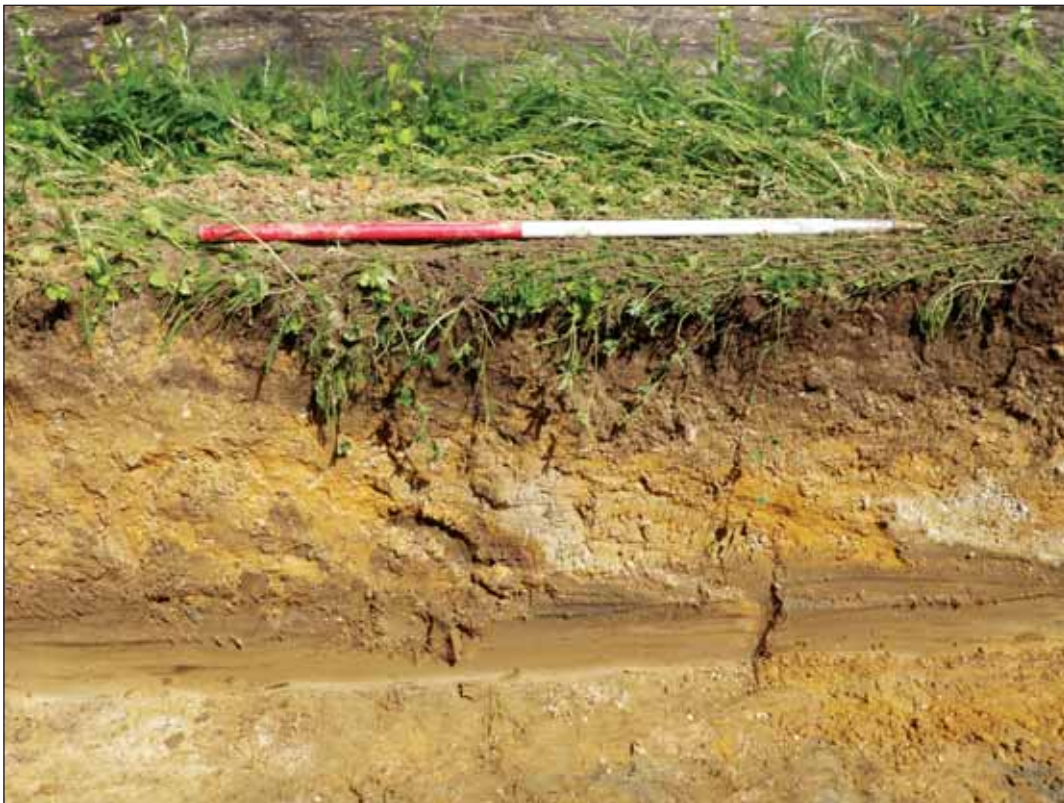
Plate 4: North-west facing section, Trench 5

- 3.2.6 Trench 5 was located in the rear garden area of the site (Figure 3). It was orientated approximately north-west to south-east and measured approximately 10.13m in length, 1.5m wide and 0.73m deep. This trench contained 0.30m of topsoil, 0.23m of re-deposited natural (from the excavation of the pond) and 0.20m of subsoil overlying a natural, undisturbed chalky marl. There were no surviving archaeological features in this trench.

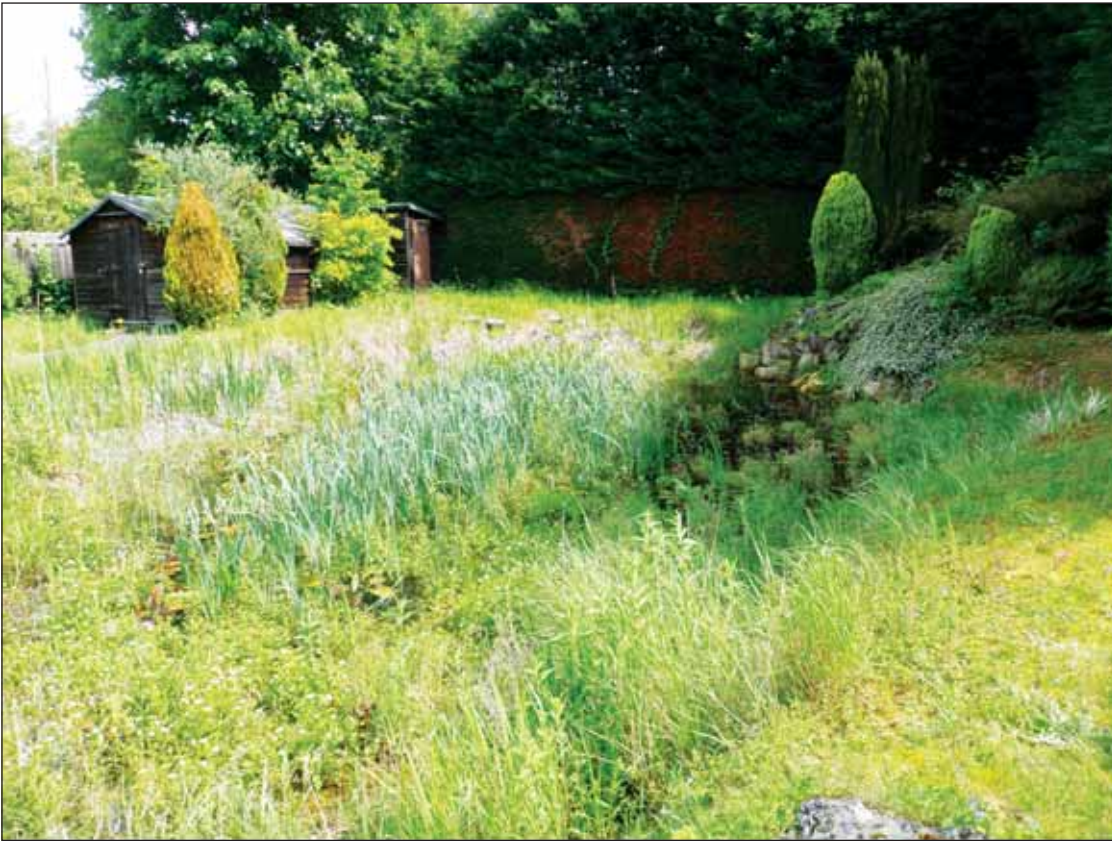
Plate 5: Large pond at rear of the garden

- 3.2.4 Trench 4 was located in the rear garden area of the site (Figure 3). It was orientated approximately north-west to south-east and measured approximately 5.75m in length, 1.5m wide and 0.65m deep. This trench contained 0.30m of topsoil, 0.20m of re-deposited natural and 0.15m of subsoil overlying a natural, undisturbed chalky marl. The layer of re-deposited natural (Plate 4) is thought to have derived from landscaping following the excavation of the large pond at the rear of the garden (Plate 5).

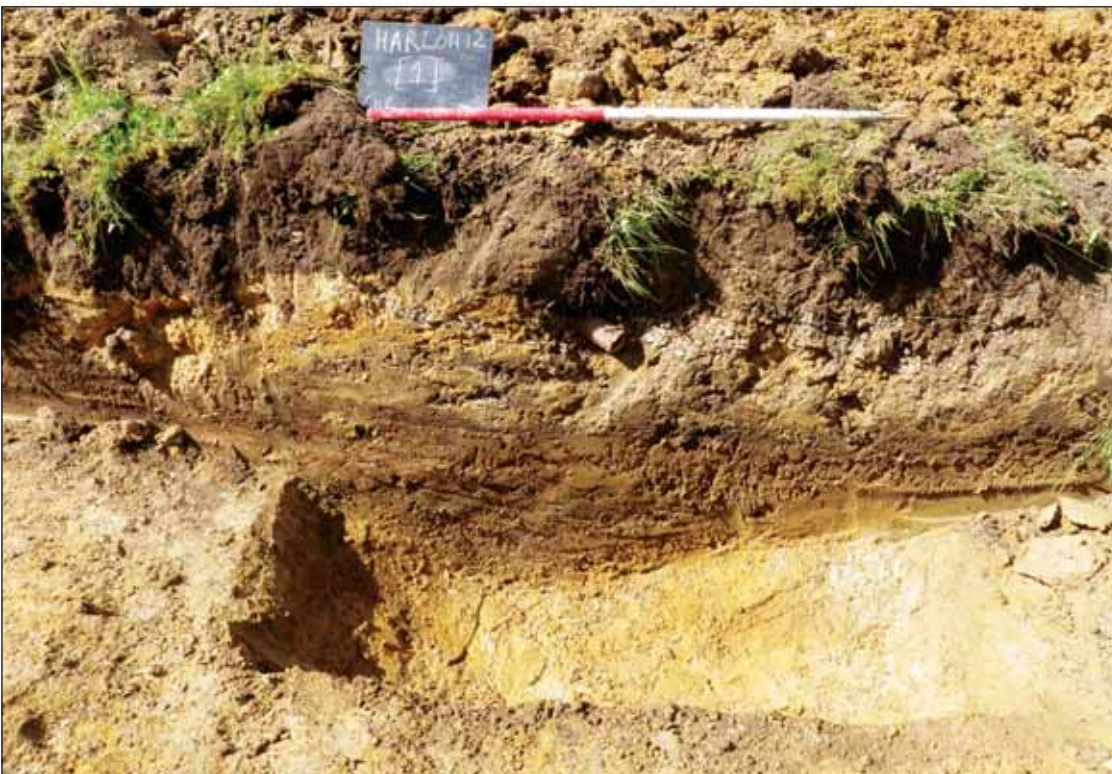
Plate 6: Ditch 01, Trench 4, taken from north-east

- 3.2.5 This trench contained a single ditch. Ditch **01** measured 1.10m wide and was orientated approximately north-south, continuing beyond the trench edges (Figure 3). It had moderate sloping edges and a concave base, measuring 0.50m in depth and containing a single fill (Plate 6). The ditch fill (02) was a firm, light brownish grey sandy clay with rare flint inclusions. No dating evidence was retrieved from this deposit. A 10l sample was taken for environmental analysis which was devoid of any plant remains other than sparse charcoal. Occasional mollusc shells were noted. The sample taken does not contain anything that could assist with interpretation of this deposit (Appendix A).

- 4.1.2 The recorded ditch is on a north-south orientation which does not correspond with the the layout of London Road or the current house plots. Consultation of the First Edition Ordnance Survey Map dated 1886 (www.old-maps.co.uk) confirms that this is not a recent ditch as the existing boundaries at that time are broadly as they appear today – on a north-est to south-orientation.

- 4.1.3 It is not possible to say with any certainty if this ditch is associated with the undated features recorded in the investigations at 15 London Road less than 300m to the north-west of this site (ECB2837 / MCB17873) or the cropmarks of an enclosure 250m to the south-east (08942) however, it confirms a continued survival and presence of remains within this part of Harston.
