Denny Abbey Waterbeach Cambridgeshire

Archaeological Test Pit Evaluation Report

OA East Report No: 1292

Denny Abbey, Waterbeach, Cambridgeshire

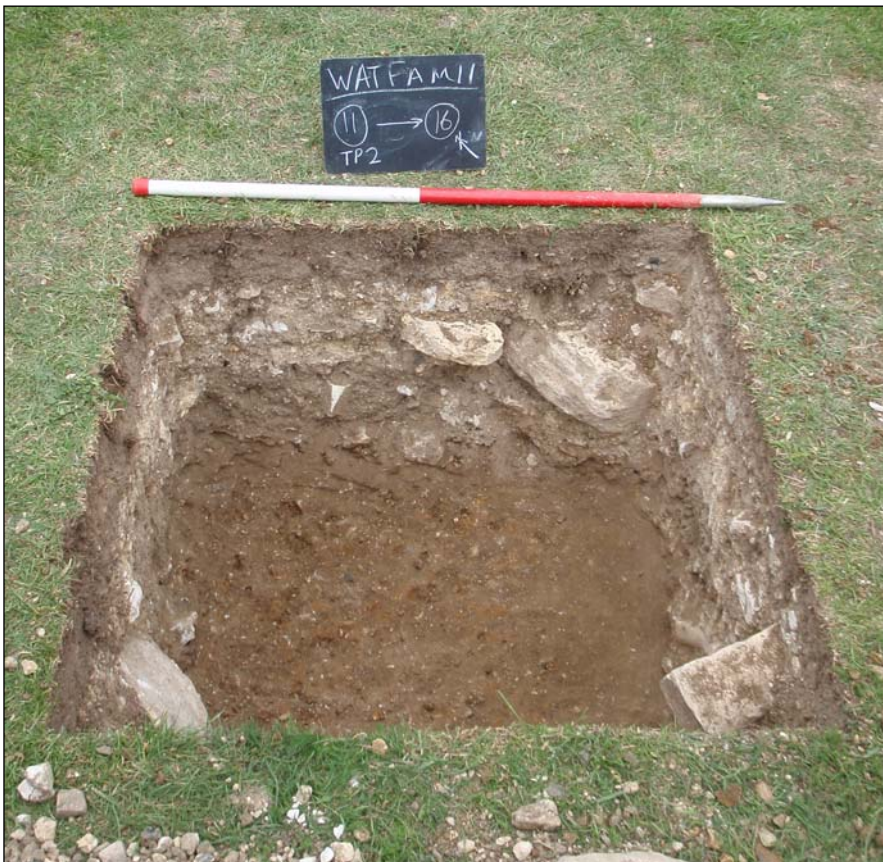
Plate 2: Test Pit 2 from the south

- 3.3.1 A series of layers, which appeared to represent late post medieval or modern dumped deposits, were revealed in Test Pit 2. The earliest deposit recorded comprised a mid orangey brown clayey loam (15) which was up to 0.04m thick and lay directly above the natural clayey gravel. Above this was layer 14, a dark greyish brown clayey loam, with a maximum thickness of 0.12m. This was in turn sealed by layer 13, a mid greyish brown silty loam, with a maximum depth of 0.26m.
- 3.3.2 A pale greyish brown, silty loam, with frequent mortar inclusions and a depth of 0.26m (12) overlay layer 13. Above this was layer 11, a mid grey slightly silty clay, with a maximum depth of 0.08m. This was overlain by the topsoil (10).
- 3.3.3 Ceramic building material was recovered from the majority of these deposits, this showed them to be of 19th century, or later, date.

- 4.2.1 The layers excavated in Test Pit 2 were largely 19th century in date. This suggests that any archaeology that was present in this location has been truncated by later activity. The latter probably relates to when the abbey was used as a farm. It is of note that a distinct drop is visible in the ground surface roughly halfway between Test Pits 1 and 2, with Test Pit 2 being in the lower ground. It is possible that this drop represents the point at which disturbance to archaeological remains begins.
