Trenching in the Ise Valley, Northamptonshire. Kettering East Trunk Sewer Pipeline

Archaeological Evaluation Report

Archaeological Evaluation

Cranfield Forensic Institute Report No. 2011/0502

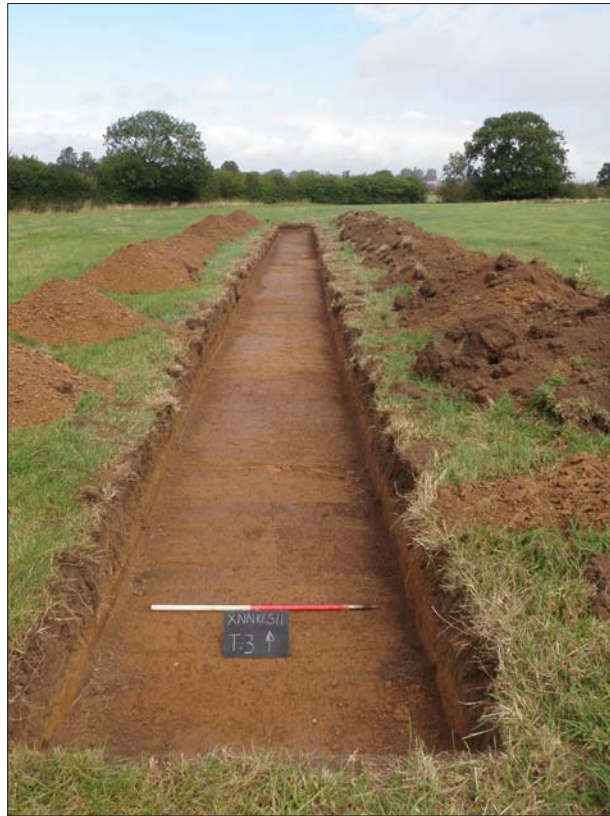
Plate 1: Trench 3

- 3.3.1 Artefacts recovered by the evaluation included modern pottery, brick fragments and a small quantity of slag. These were found in the field immediately to the north of the A510, on the flood plain where Trenches 6-9 were located. A single piece of probable Late Iron Age pottery was recovered from a furrow in Trench 3.

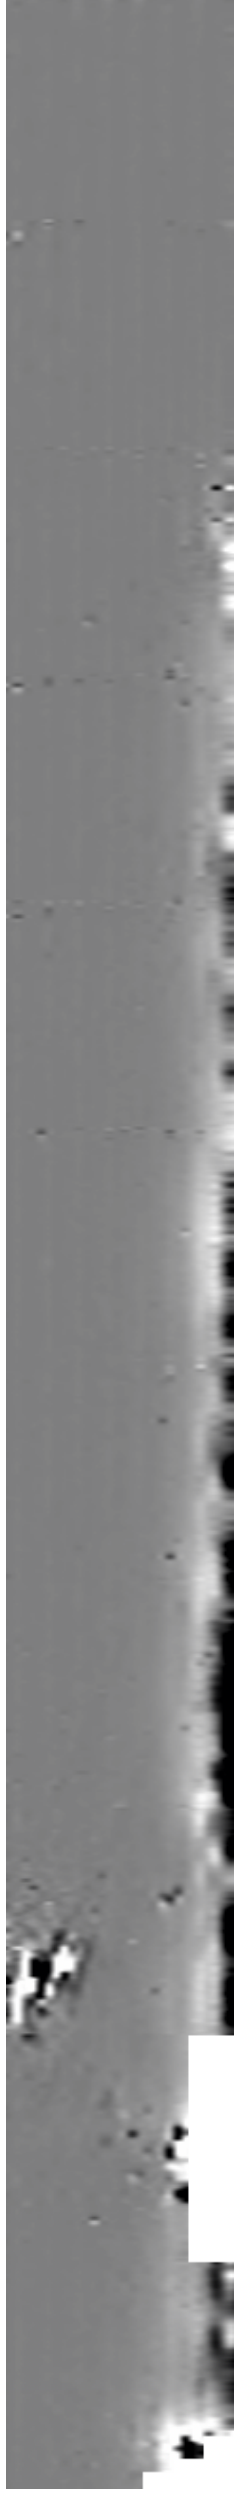
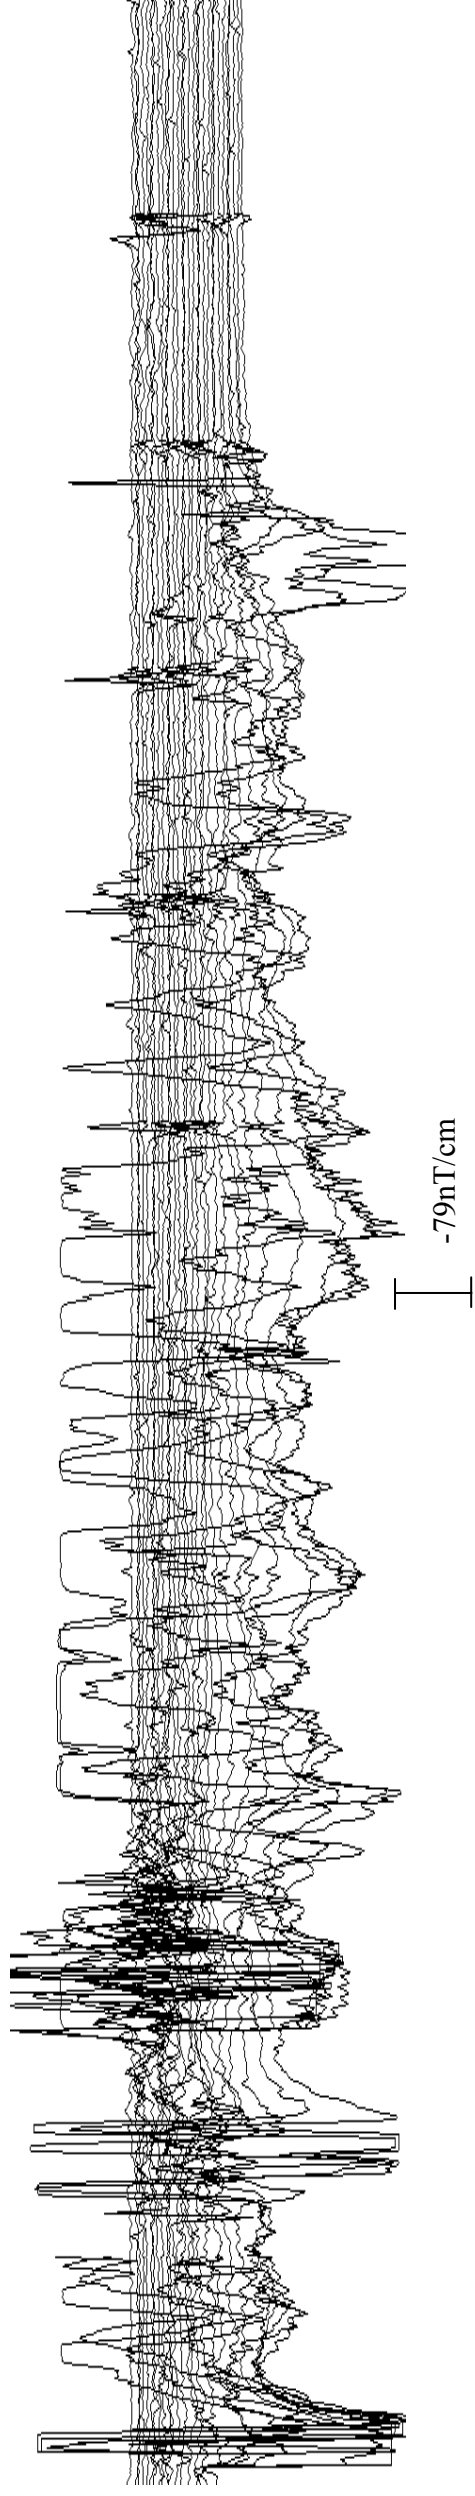
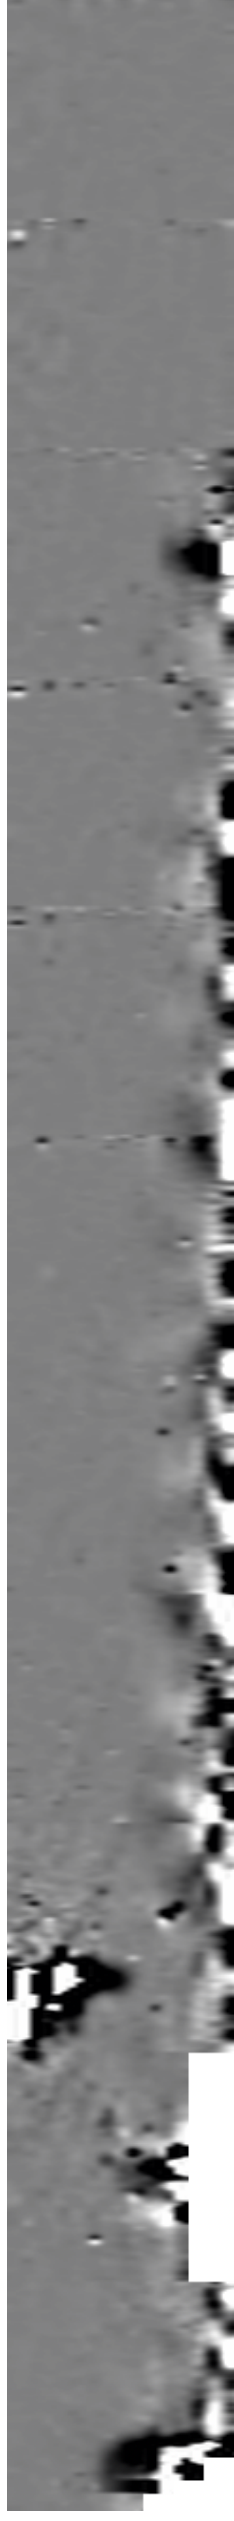
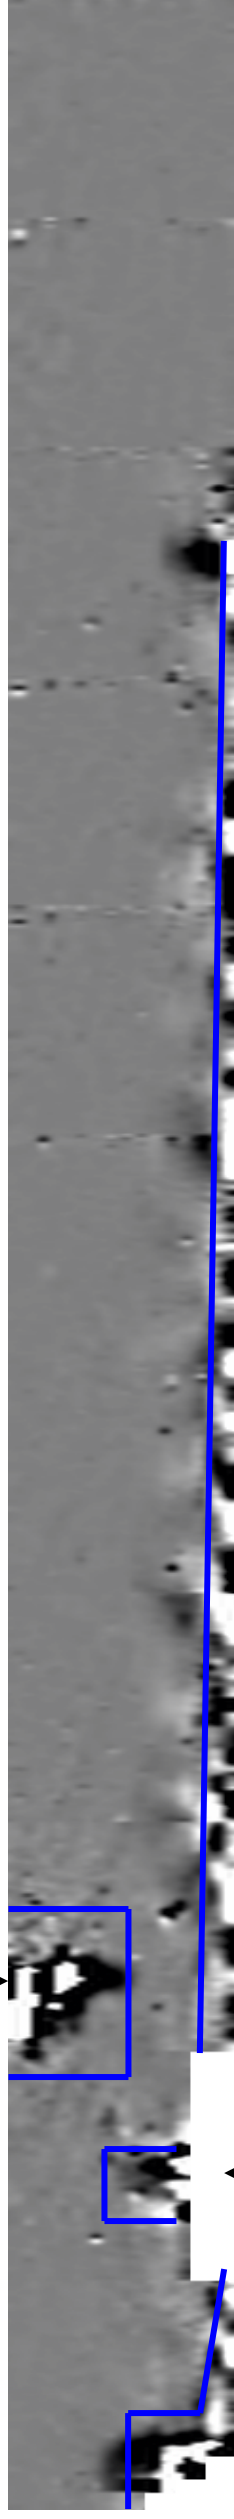
Figure 14: Greyscale and trace plots of raw and enhanced data for field 11a. Scale 1:1000

The survey area in this field was largely affected by the modern service pipe (blue lines). In Field 13a (Figure 14, 1) a discrete area of high magnetic variation has been observed. Due to the magnetic signature of this it is most probably associated with modern ferrous debris.

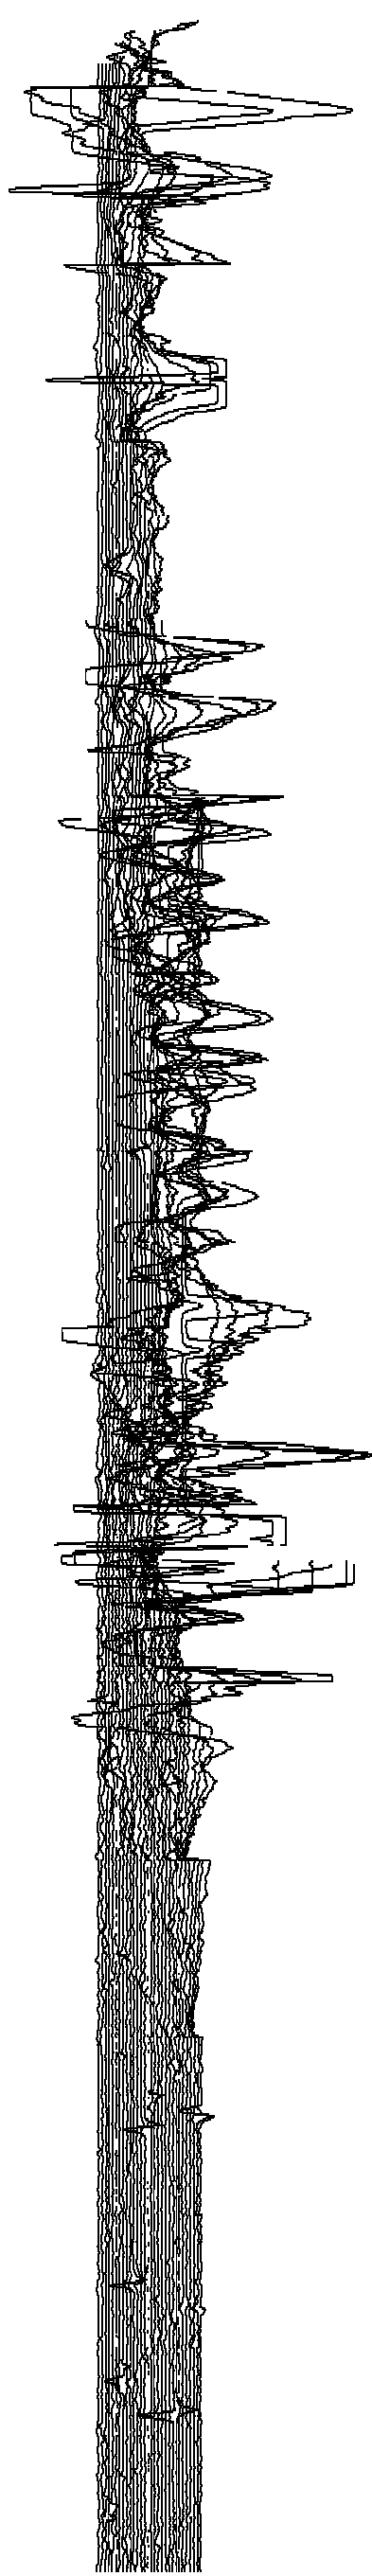
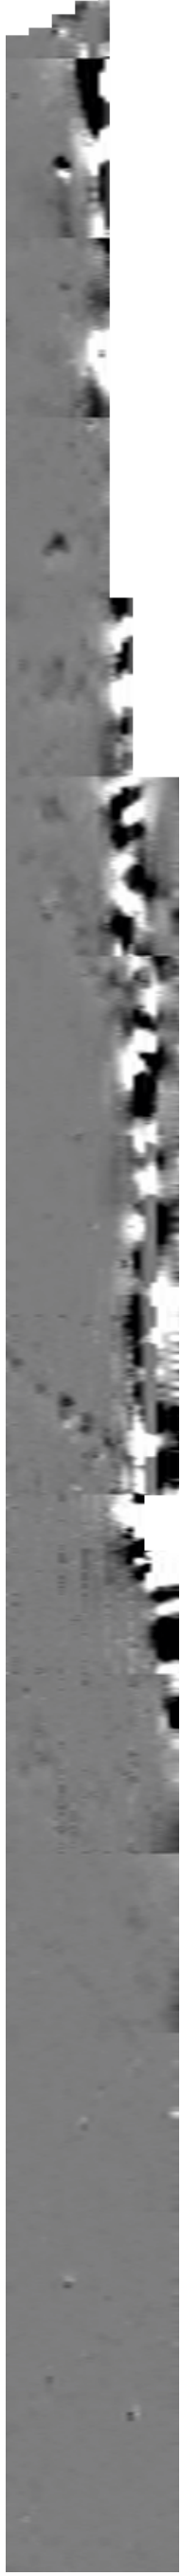
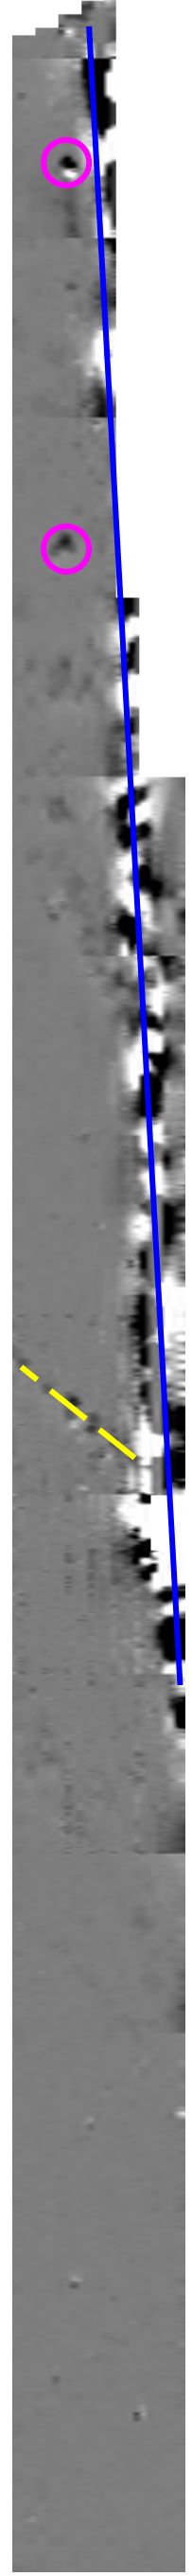
Figure 15: Greyscale and trace plots of raw and enhanced data for field 11b. Scale 1:1250.

In the second half of this survey area (Field 13b, Figure 15) magnetic interference from the modern service continues to be observed. At the mid section a faint linear feature orientated in a south/east to north/west trajectory (yellow dashed line) has been detected. The signature of this anomaly is faint and may represent a ephemeral feature such as a track way or field boundary.

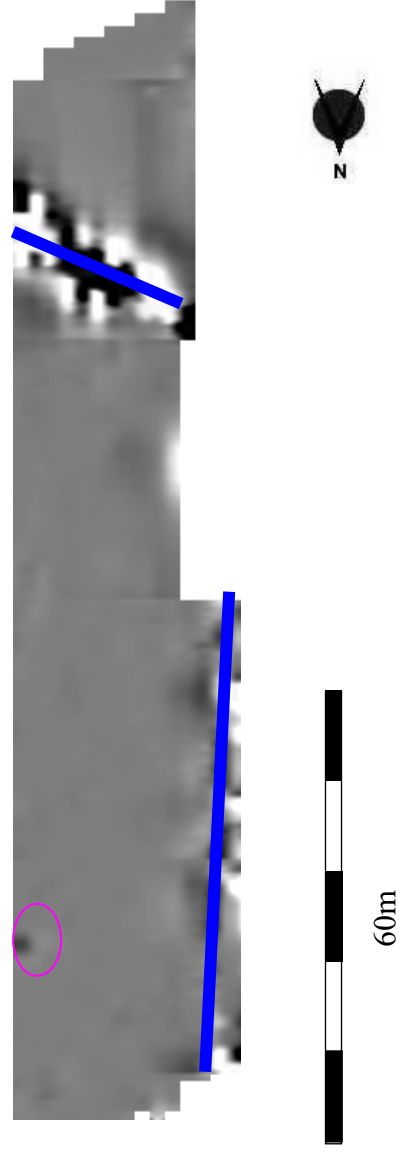
Figure 17: Greyscale and trace plots of raw and enhanced data for field 13. Scale 1:1000

- Geology
- Pit like
- Ferrous debris
- Ditch or possible paleochannel
- Modern Service
- Track way or former field boundary

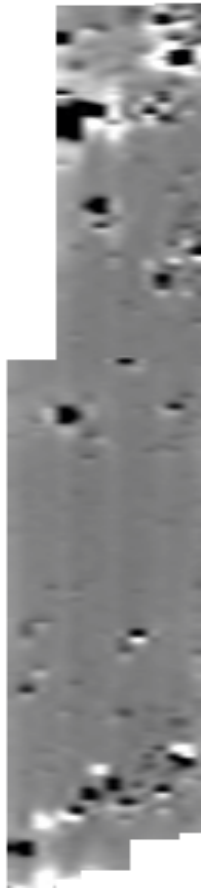
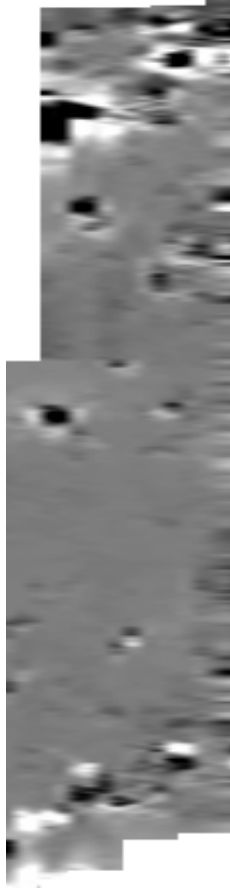
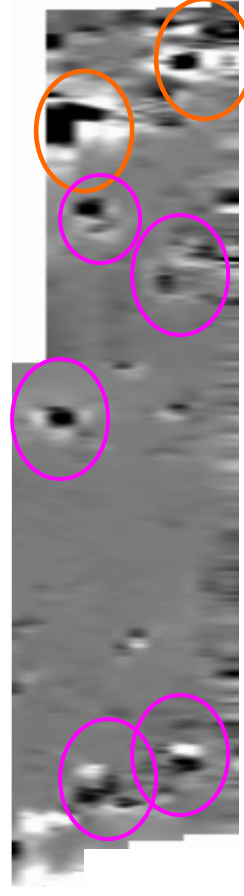
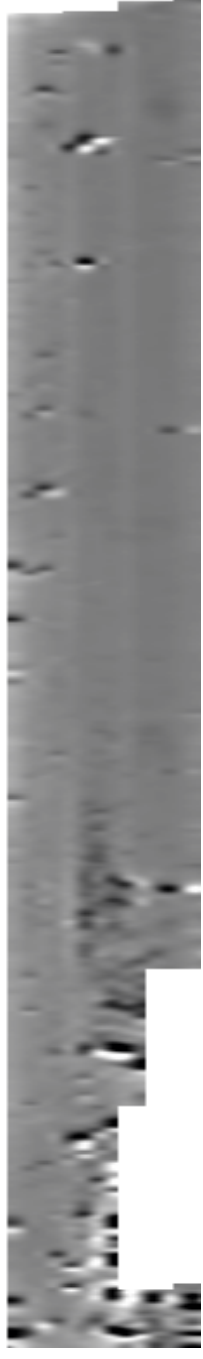
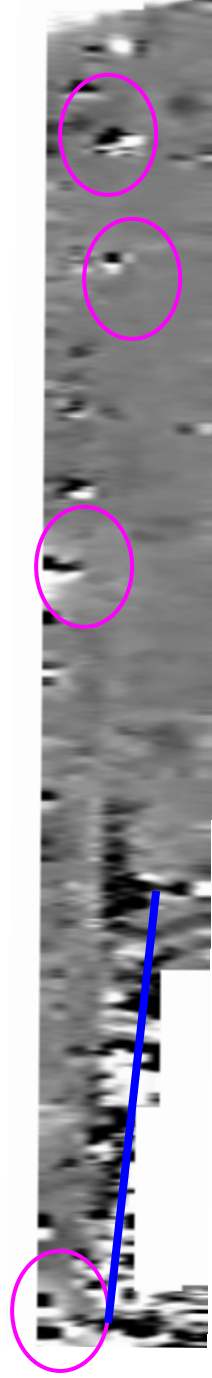
Figure 28: Greyscale and trace plots of raw and enhanced data for field 23 Scale 1:1000

- Geology
- Pit like
- Ferrous debris
- Ditch or possible paleochannel
- Modern Service
- Track way or former field boundary
