Platt's Brewery, Everland Road, Hungerford, Berkshire

HISTORIC BUILDING RECORDING

OXFORD ARCHAEOLOGICAL UNIT
APRIL 2000

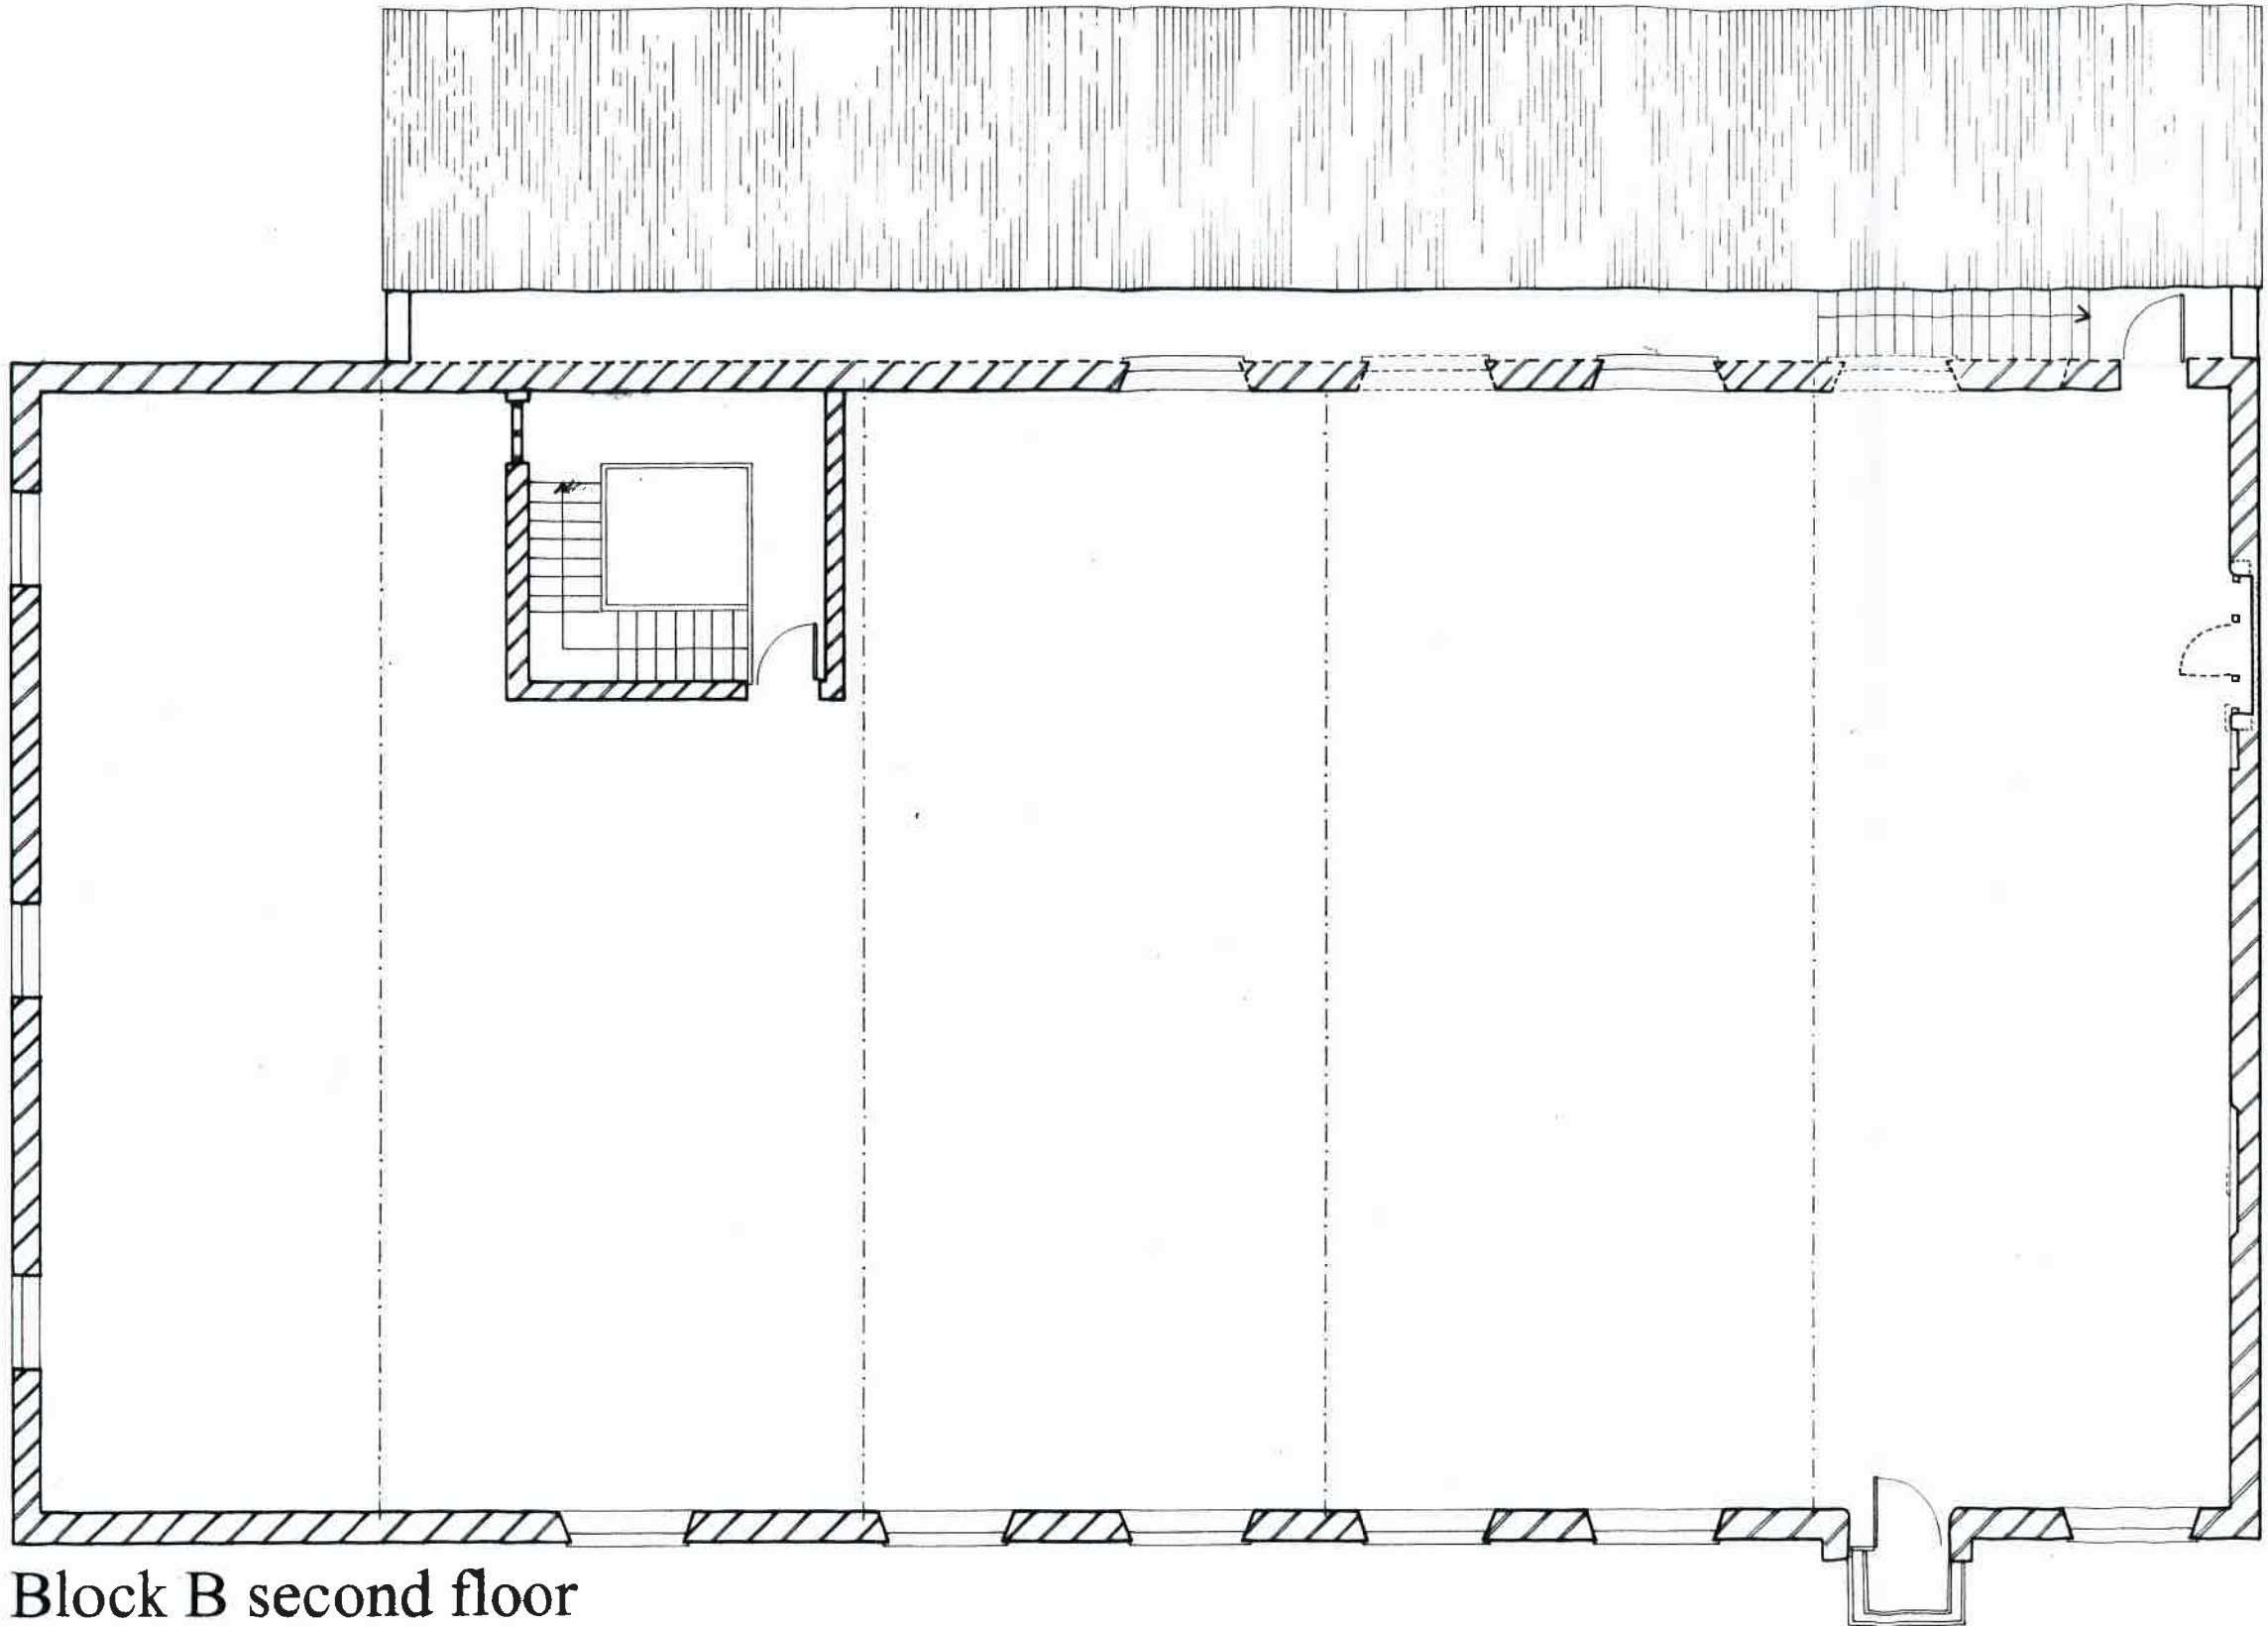
Oxford Archaeological Unit
Platt's Brewery, Hungerford, Berks
FIGURE 6: Block B second floor plan
Survey: May 1998 Scale 1:50 at A1

6.7.2 The primary roof, which from infilled patches to the southern elevation appears to have consisted of four trusses 6 m apart, had been removed and replaced by a mid-twentieth century, light-weight steel roof. The secondary roof had four trusses with slightly raised central sections and was covered with asbestos (?) panels above visible purlins. Skylights within the panelling illuminated the space. A pair of brick piers projected from the internal face of the east gable (above a shoulder in the wall at 2.15 m above floor) which would have been logically located to support a single purlin to each slope of the primary roof. Each of the modern trusses rest on what appears to be a primary ledge (1.72 m above floor) which would probably also have supported the primary trusses, with three courses of recessed brick infilling rising to eaves height.

- 6.7.8 Each of the three modern sash windows to the west wall were found to have concrete block infilling to the internal face beneath the opening. The outer face of the wall had been refaced beneath the openings to avoid straight joints. It is likely that each was a taking-in door although the fact that the windows were beneath secondary concrete lintels means that the heights of the previous openings are not known and they may have been lower windows. As detailed above this end of the building did not share that same regular floor heights of the eastern side.

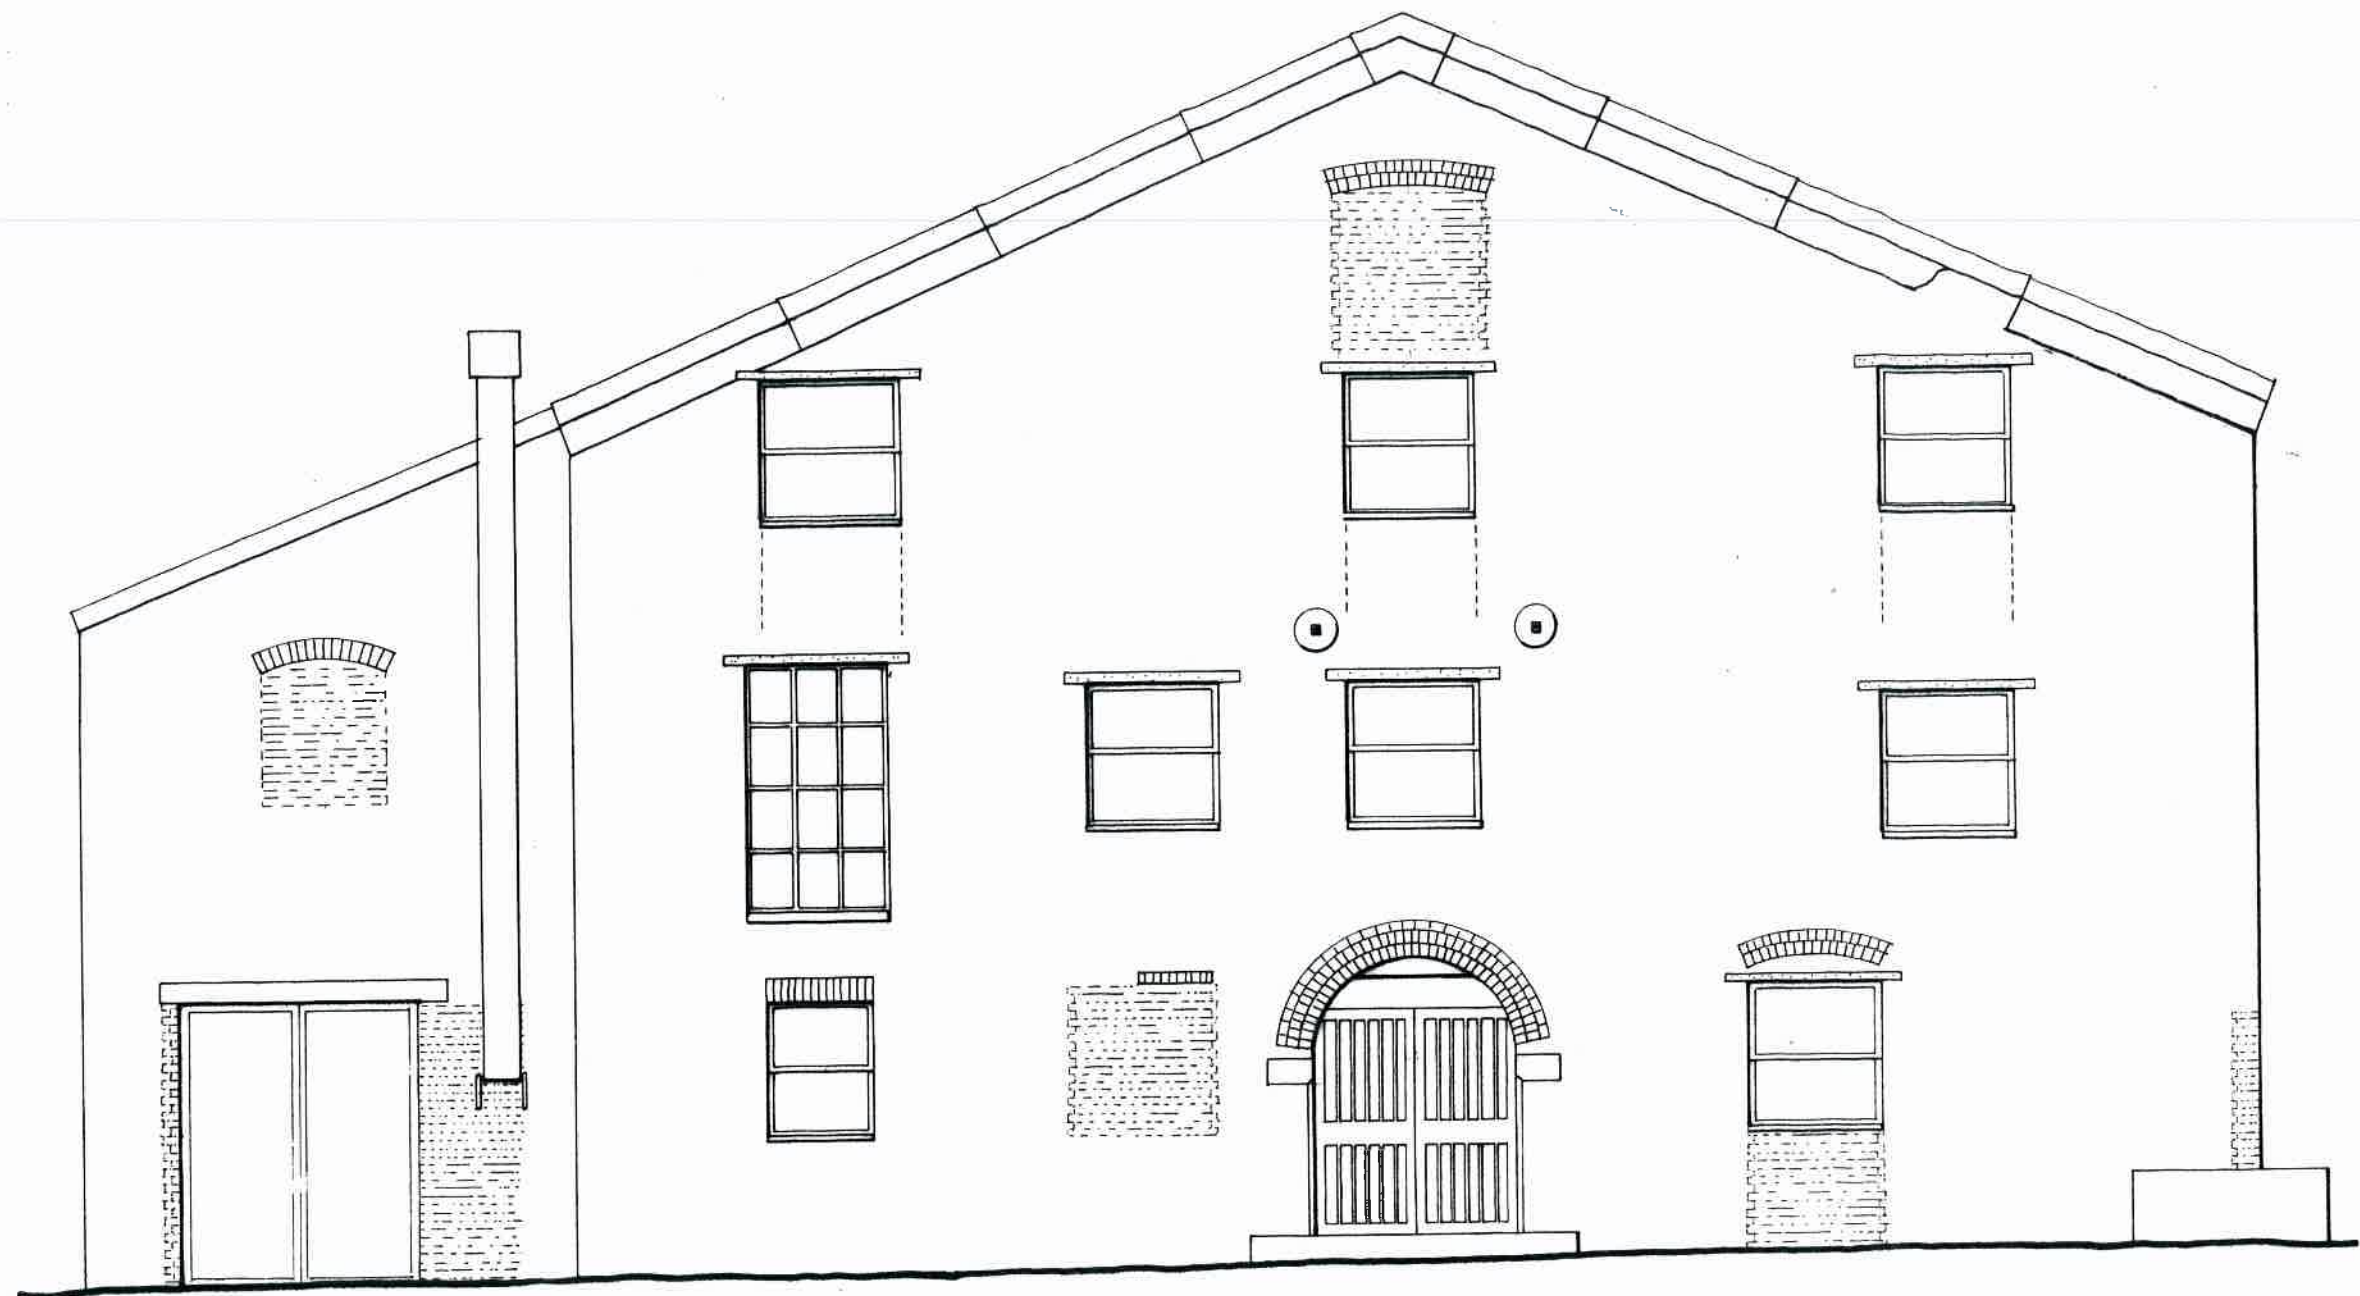
Oxford Archaeological Unit
Platt's Brewery, Hungerford, Berks
FIG 8: Block B west elevation
Survey: May 1998 Scale 1:50 at A2

ashlar padstones beneath brick segmental arch. The double doorway was a twentieth century replacement. The west elevation of the northern extension (Plate 12) contained a bricked up first floor window beneath segmental brick arch and large ground floor doorway beneath concrete lintel.

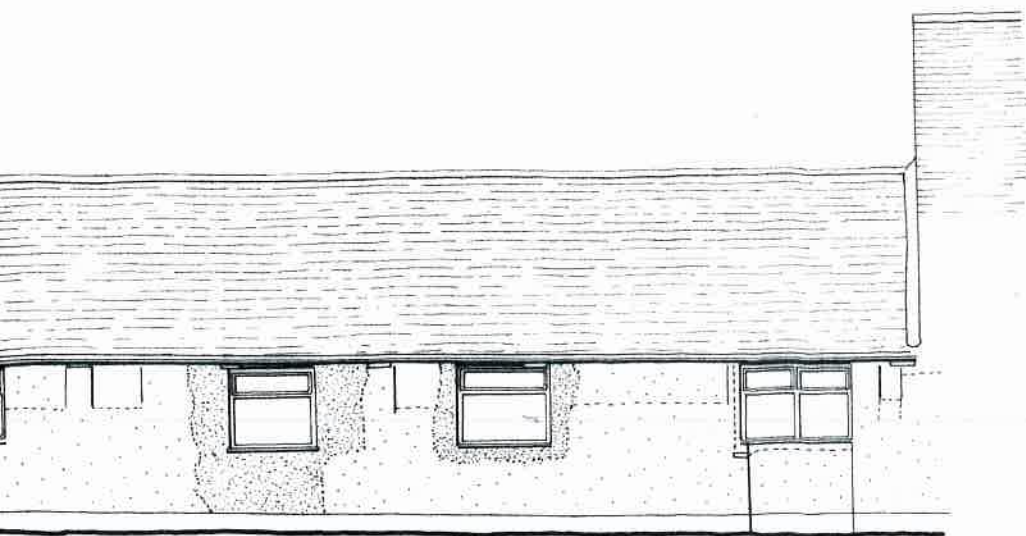
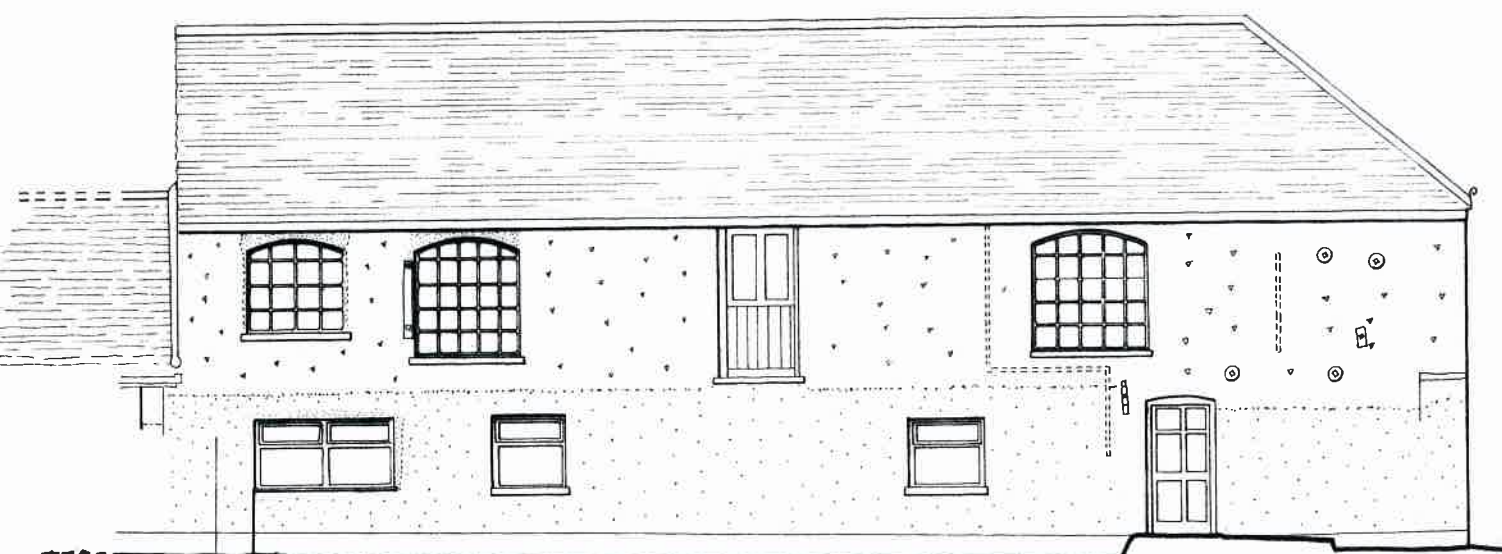
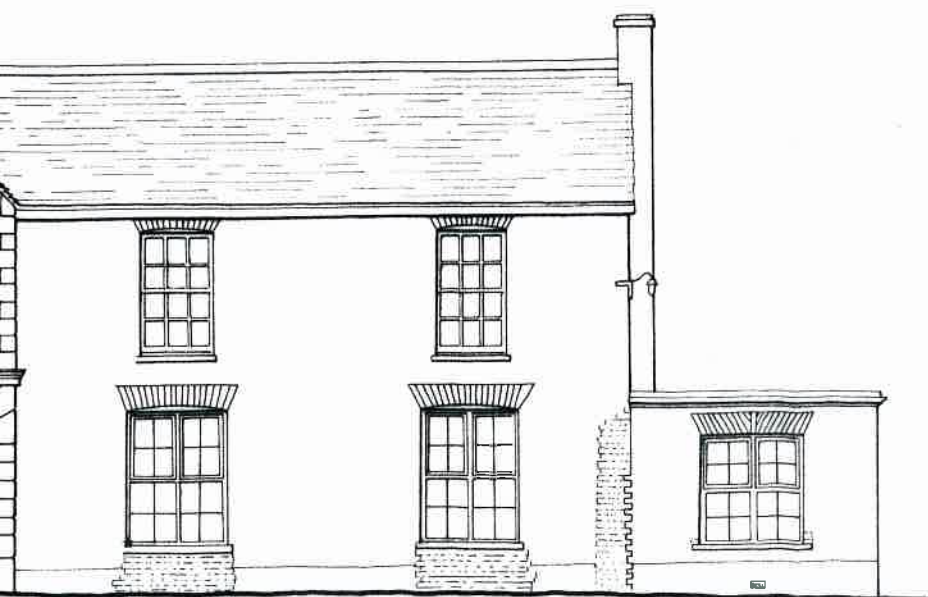
Oxford Archaeological Unit
 Platt's Brewery, Hungerford, Berks
**FIGURE 12: Blocks A, C, E
 south elevation. Block E east
 elevation**
 Survey: May 1998 Scale 1:50 at A1

5.2.2 The south elevation (Figure 12) had a sloped shoulder 5 cm deep at 1.4 m above floor level, extending along its full length (and along Block C) punctuated by several projecting piers or pilasters flush with the lower wall (Plates 2 and 3). The structure of the elevation was obscured by a course render, with several patches of fine render suggesting later work. There were two patches of fine render surrounding inserted windows and the other main patch of this later render hid the junction with Block E (further detail below). Despite the render the sites of three blocked doors (two with pilasters) were visible in the south facade. The ends of the irregularly-spaced roof trusses were visible in the south elevation which suggested that it was originally 12 bays long. The sagging between each truss contrasted with the straighter roof line of the adjacent Block C.

- 5.3.2 Block C was c 17 m long x c 6 m wide with a roof of deep redish-brown tiles, hipped at the east and gabled to the west. The southern façade (Figure 12) was covered with a white render of differing textures, coarse at ground floor level and very course at first floor. The east façade was entirely of homogenous painted brick apparently contemporary with the upper storey (Figure 12). There were three first floor windows in the south façade and one to the east, each cast iron-framed matching the windows in Block B (Plate 4). There was a similar window in the ground floor of the east façade and three secondary UPVC windows in the south façade, similar to the windows to the adjacent façade of Block A. There was a door to each floor of the south façade. There was no staircase to the upper door, which was clearly a taking-in door.

- 5.4.3 The east façade (Figure 12) contained a slightly projecting (c 10 cm) ornate door surround (Plate 6) and gable, set off-centre. The door surround consists of a semi-elliptical arch to ground floor, projecting quoins to first floor and moulded cornice between floors.

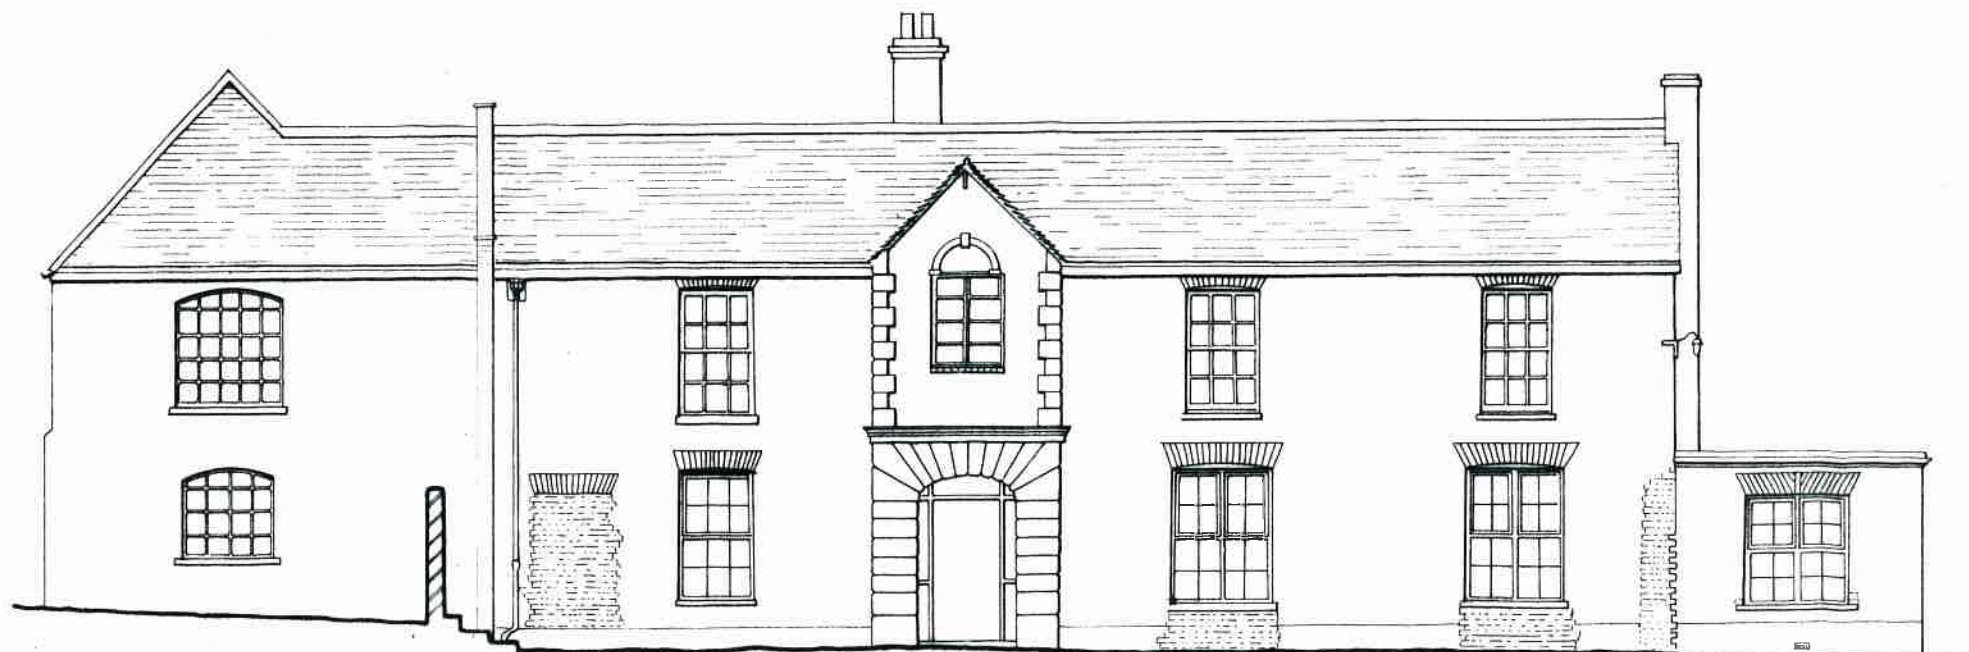
Oxford Archaeological Unit
 Platt's Brewery, Hungerford, Berks
FIGURE 12: Blocks A, C, E
 south elevation. Block E east
 elevation
 Survey: May 1998 Scale 1:50 at A1

South elevation

East elevation

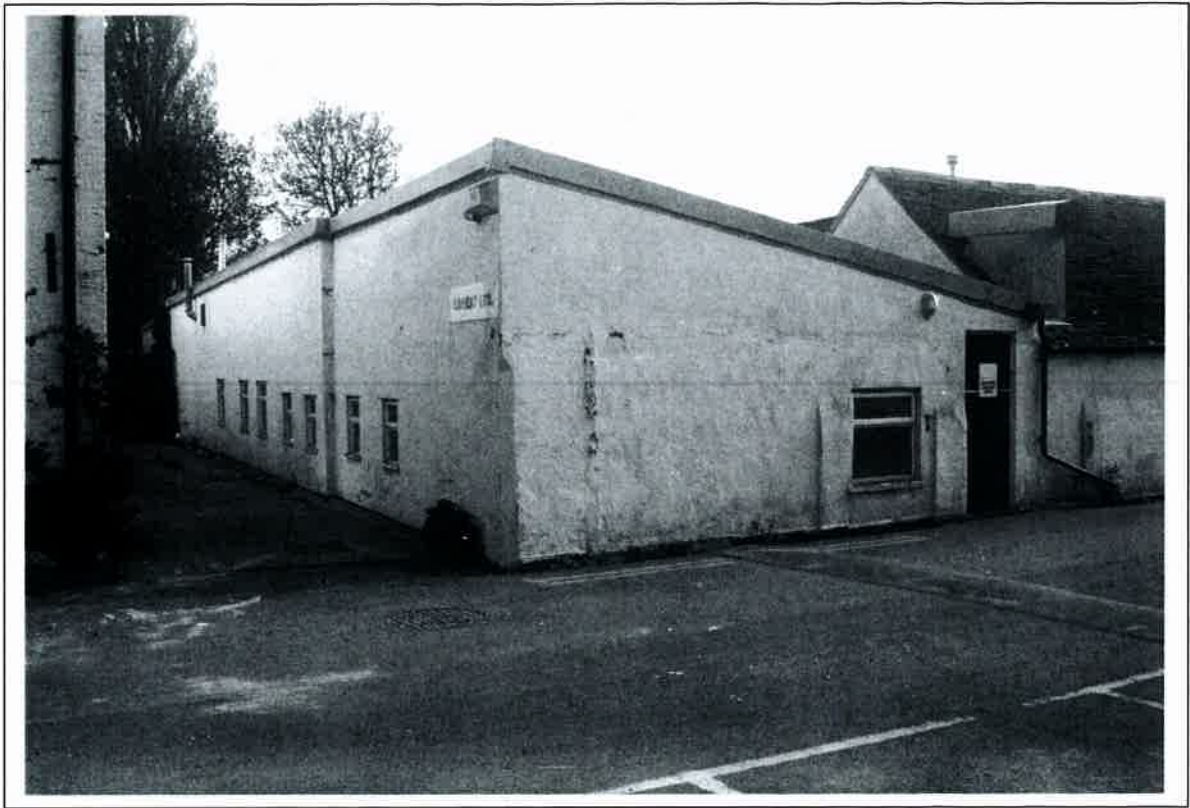
Plate 7. Block E: general view from north-west

- 5.5.1 Block E was a single storey structure (41.5 m x 2.8 m) with a modern roof, extending north from the west end of Block A to form the western side of the yard (Plate 7). Each Ordnance Survey map from 1878 to 1961 shows a structure of about its width at this location, although that shown was about two thirds the length of Block E. The northern third would appear to have been added soon after this last map, probably at the same time as the new roof.

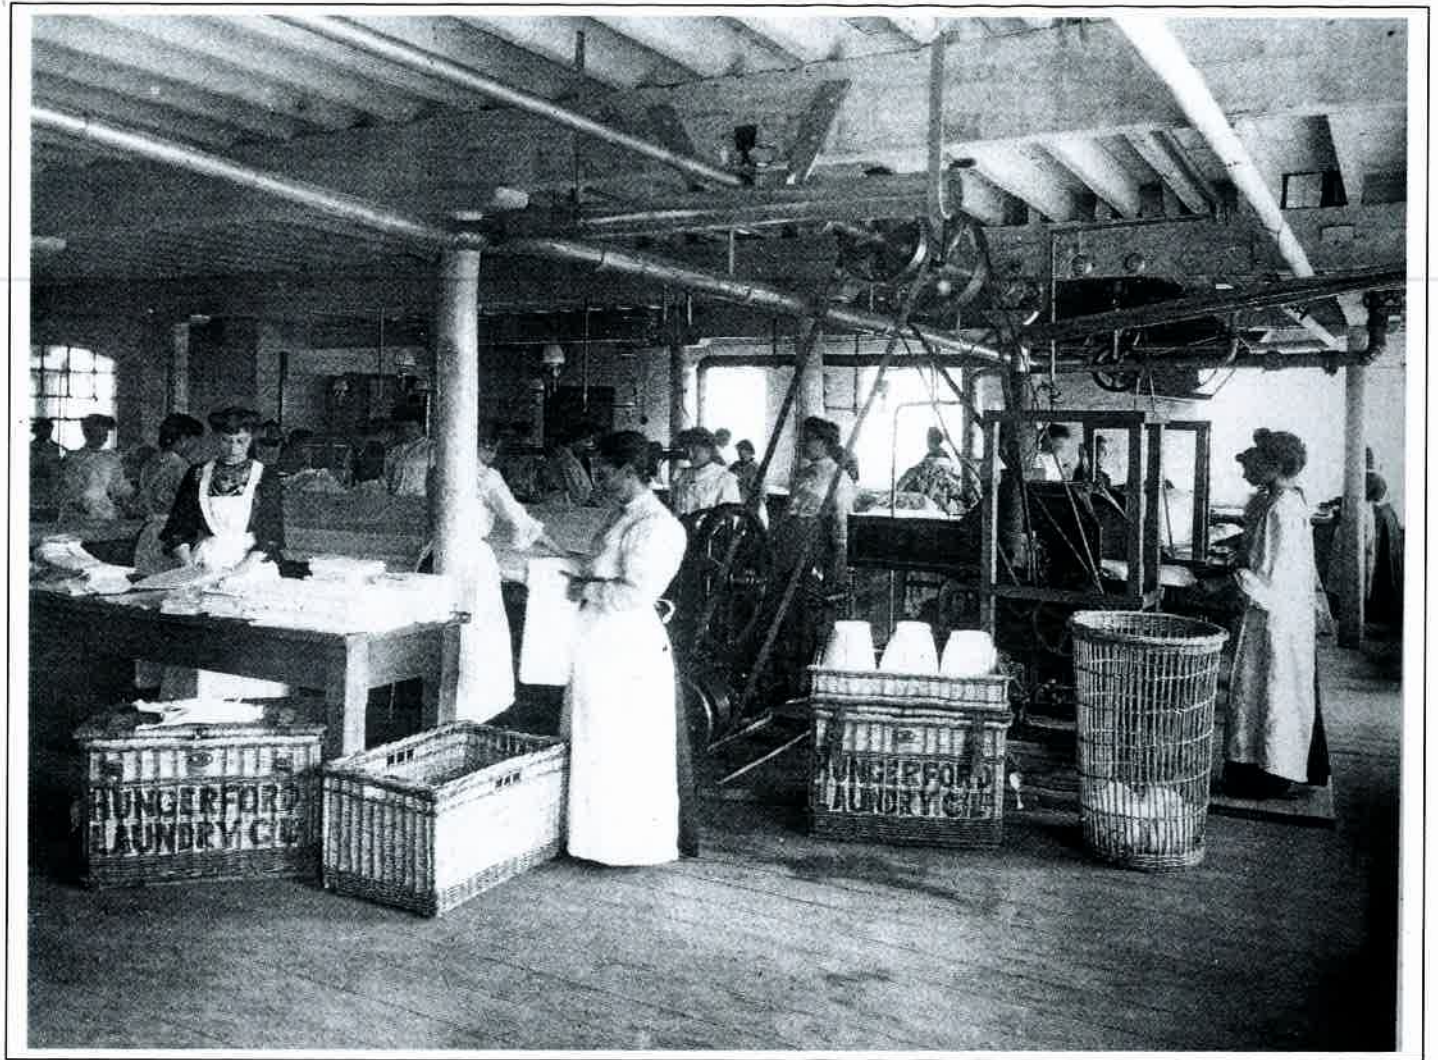
Plate 22 Ironing room of the Hungerford Sanitary Laundry Co taken c 1910.
Possibly first floor of Block B looking west.
