St Mary's Church, Little Coxwell, Oxfordshire

ARCHAEOLOGICAL WATCHING BRIEF REPORT

Oxford Archaeological Unit

October 1999

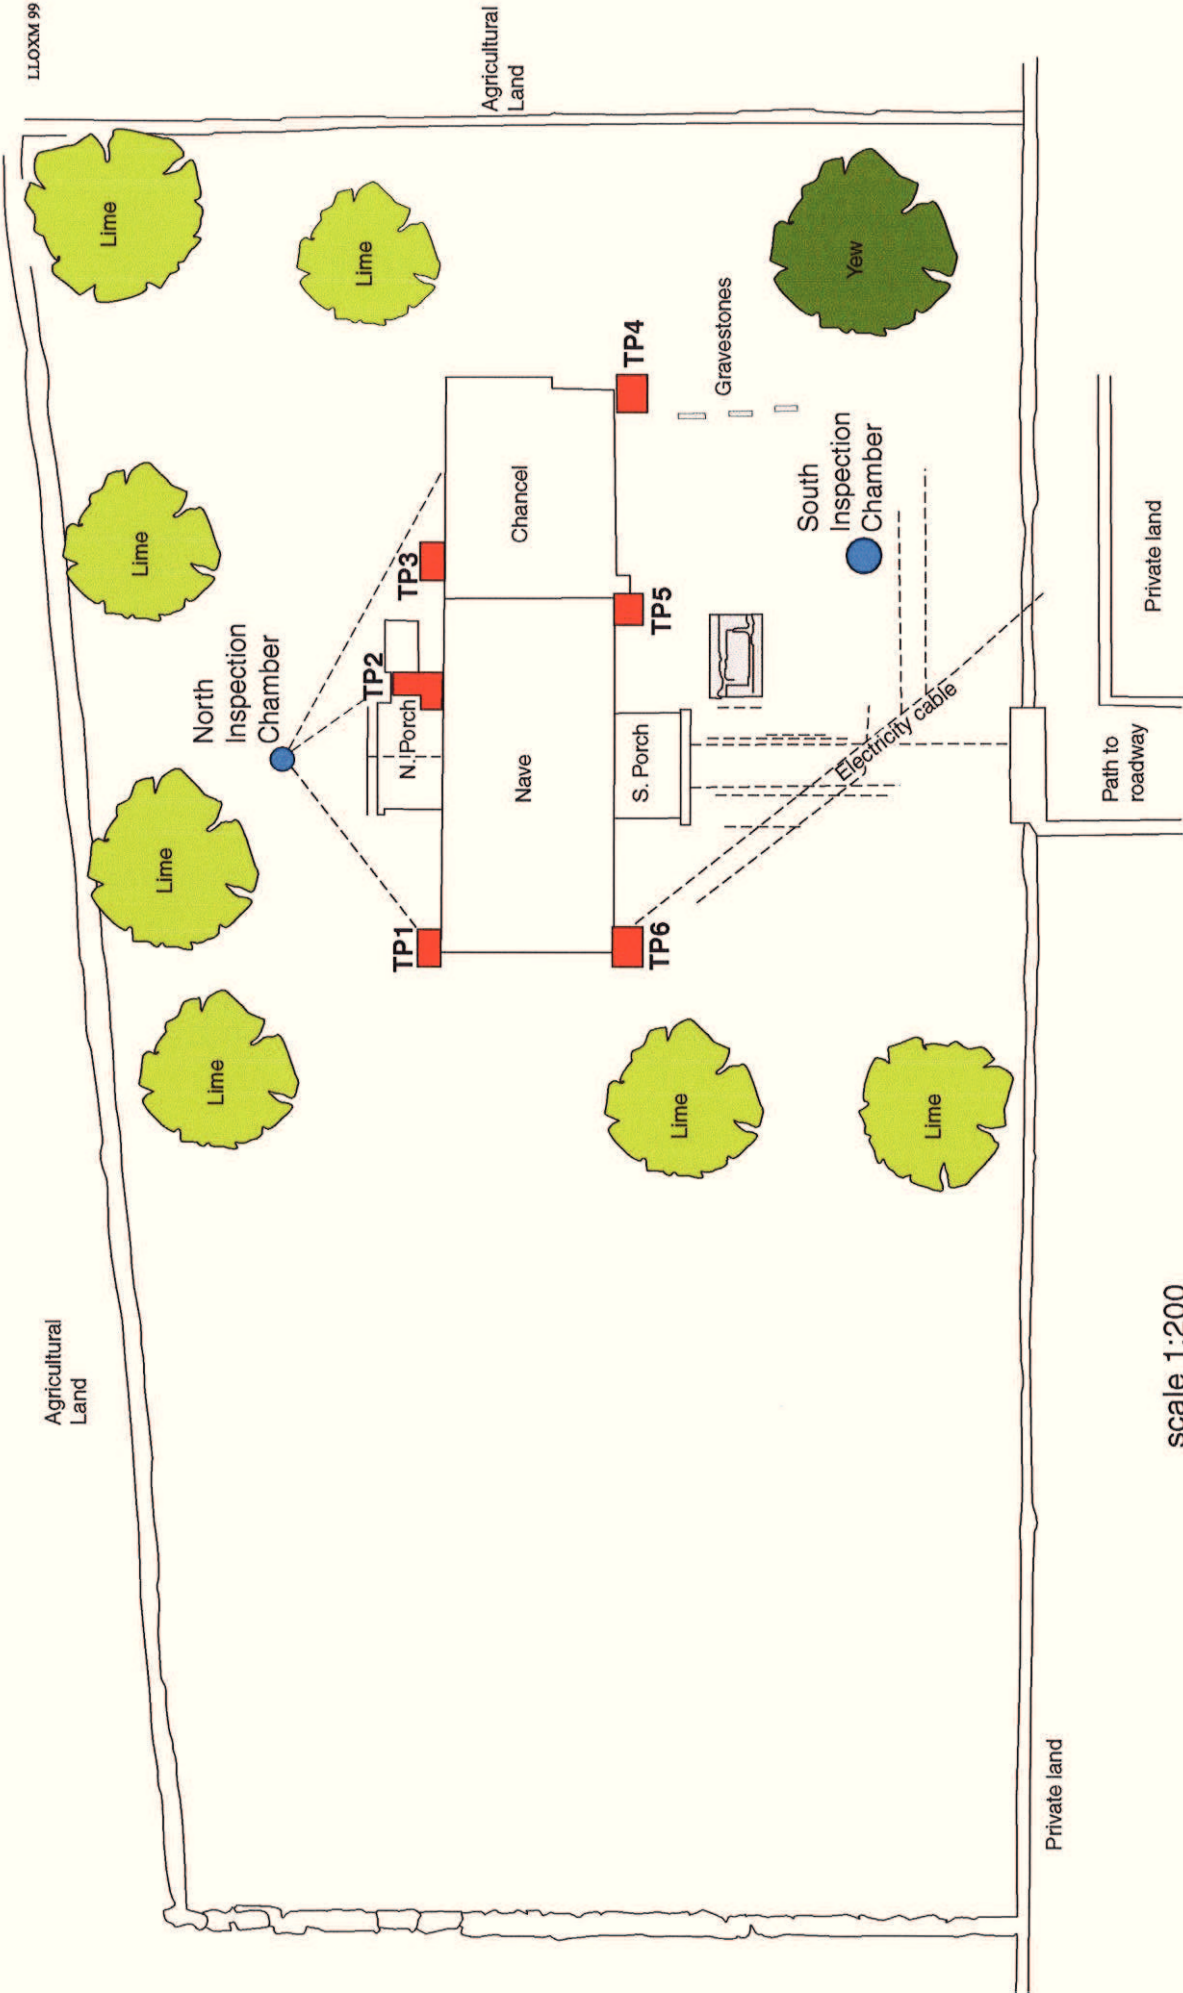
figure 1: plan showing location of test pits

The development proposal comprised the excavation of six trial holes to reveal the foundations of the church prior to the provision of new drainage works. An archaeological watching brief was required due to the potential for disturbance to archaeological deposits and/or human remains.

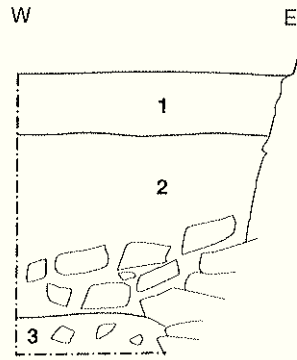
Test Pit 1 measured 0.97 m east-west by 0.80 m north-south and was 0.93 m deep. The church foundations were exposed to the full depth of the pit, and comprised regular coursed blocks of limestone, with a slight batter projecting 0.25 m out from perpendicular, to a depth of 0.55 m below the present ground surface. Below this point and to the base of the pit the foundation became quite ragged and consisted of large irregular blocks and much loose rubble, a large quantity of which was removed; this material projected toward the wall face by some 0.50 m. The sequence of deposits identified ran as follows:

- (1) – topsoil; 0.20 m of mid gray silty clay loam.
- (2) – subsoil/graveyard soil; 0.60 m dark gray silty clay loam with much loose limestone rubble.
- (3) – natural; 0.13 m mid brown/orange clay.

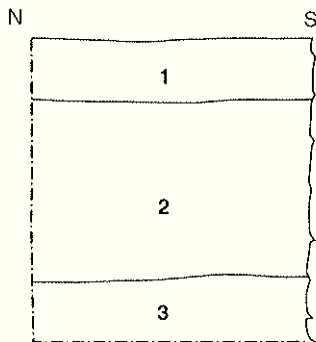
Test Pit 3 measured 0.91 m east-west by 0.95 m north-south by 1 m in depth, and exposed the footings for a buttress possibly marking the original gable end of the building. The footings went down to a depth of 1 m and were vertical and smooth. By contrast, the footings for the north wall were much rougher, incorporating unworked limestone pieces, and terminated at a depth of 0.60 m. The sequence of deposits identified ran as follows:

- (1) – topsoil; 0.20 m of mid gray silty clay loam.
- (2) – subsoil/graveyard soil; 0.60 m dark gray silty clay loam.
- (3) – natural; 0.20 m mid brown/orange clay.

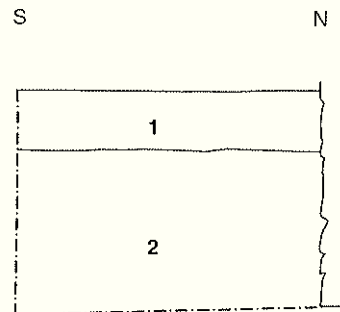
Test Pit 6

Test pit 6 measured 0.98 m east-west by 0.79 m north-south by 0.75 m depth. The foundations were exposed to the full depth of the pit and were regular, and presented a vertical face. The sequence of deposits identified ran as follows:

- (1) – topsoil; 0.20 m mid gray silty clay loam.
- (2) – subsoil/graveyard soil; 0.55 m dark gray silty clay loam, quite heavily rooted.
