# St John's College Chapel Oxford

## Archaeological Watching Brief Report

### St. John's College Chapel St. Giles, Oxford

#### ARCHAEOLOGICAL WATCHING BRIEF REPORT

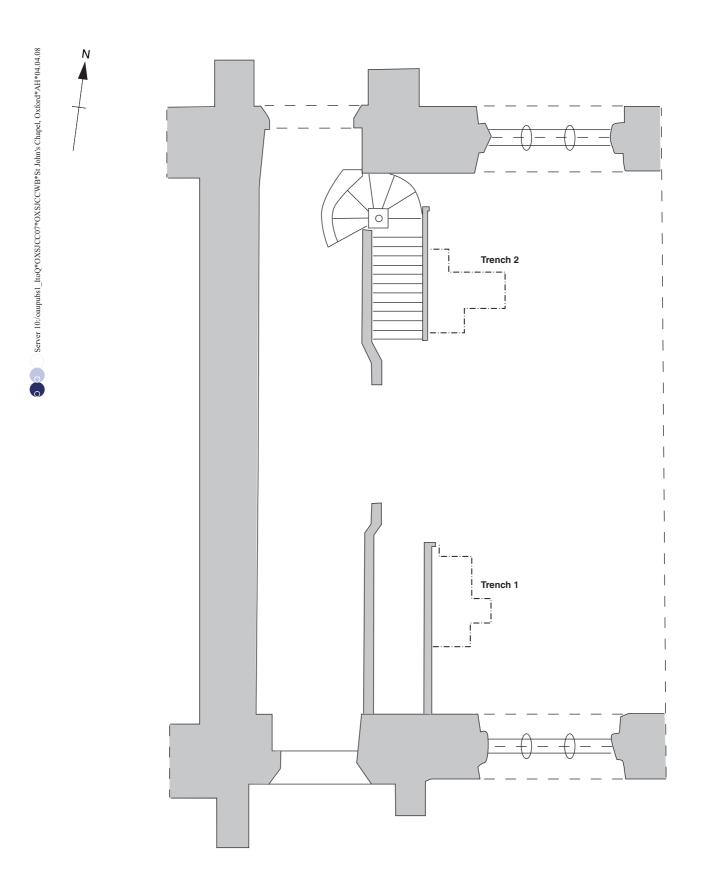
- 3.1.1 Two foundation pits (Trenches 1 and 2) were excavated within the Chapel (Figs 2 and 3). These were located to the south and north side respectively of the central axis of the Chapel. Trench 1 was excavated to a depth of 2.3 m and Trench 2 was excavated to a depth of 1.8 m. Two representative sections were drawn in Trench 2 prior to reaching its maximum depth as safety precautions precluded the detailed recording of sections at the final depth. These sections are held in the archive.
- 3.1.2 Within both trenches natural yellow sand (119) overlain by natural gravel (118) was recorded from a depth of c 1.5 m below the floor level reflecting the average depth that the graves had been dug to. These had effectively removed the upper horizons of sand and gravel although some of the grave structures did penetrate the remaining

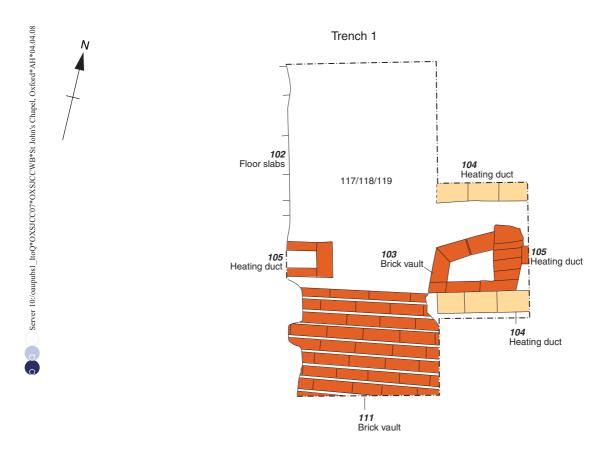
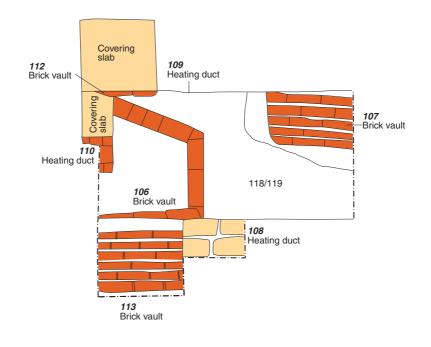
- 3.1.5 Six burial vaults of brick-build were encountered within the trenches. Two (103 and 111) in Trench 1 and four (106, 107, 112 and 113), in Trench 2. Vaults 107, 111 and 113 each had vaulted roofs remaining intact and undisturbed. However, vaults 103, 106 and 112 had suffered varying degrees of disturbance and modification resulting from the insertion of the stone heating ducts. This was relatively minor to 103 where only a small portion of the roof construction had been removed by the heating duct trench. Vaults 106 and 112 were constructed at a shallower depth than 103 which had resulted in the complete removal of the roof to these grave structures. To accommodate the heating duct these graves had been sealed with large limestone slabs which formed the base to the duct trench minimising the disturbance of the primary burials.

- 3.1.6 All of the vaults were aligned east-west and constructed of orange-red brick laid in a single skin stretcher bond. Vault 106 contained a large amount of disarticulated human remains (115) below the removed covering slab. The interior of this vault was not excavated further to establish the presence or condition of the primary burial. Vaults 103, 107, 111, 112 and 113 were left undisturbed.

- 4.1.1 The watching brief indicated that the new foundation pads would impact upon *in situ* burial vaults. As a result, a new scheme was designed to construct the foundations, thus protecting the vaults from unnecessary damage. This allowed the primary burials to remain undisturbed within the associated vaults. The heating duct walls were partially removed and recorded to allow the necessary depth for the foundations.
