4 St James's Square
(including 7-9 Babmaes St.)
Westminster
London

**Building Investigation and
Watching Brief**

Oxford Archaeology

December 2006

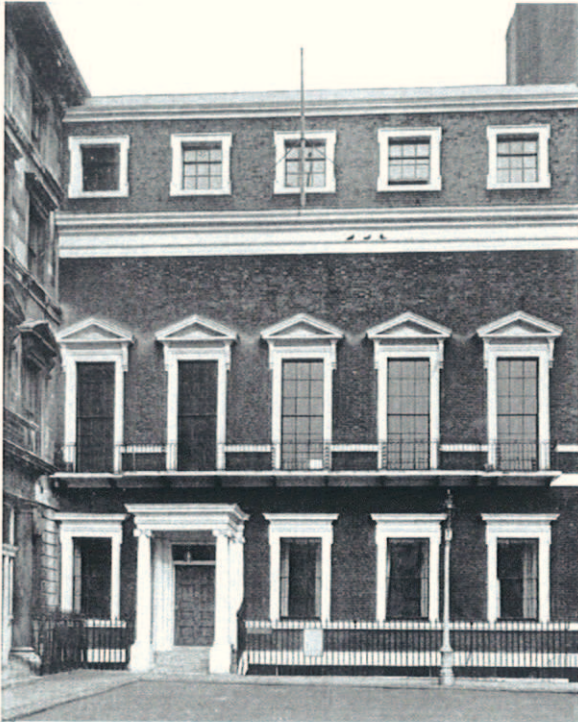
Plate 1: 4 St James's Square (Taken from the Arts Council note, 1951)

The street frontage of the building dates to the 1725-28 rebuild of the property. It is five windows wide with three storeys and basements (Plate 1). The walling is of yellow brick with painted stone dressings and a slate covered hipped roof. The entrance doorway is off-centre and is framed by a projecting porch with Ionic columns. The windows of the ground floor (level 2) have eared architraves with friezes and cornices. A sill band runs along the wall at the bottom of the ground floor windows. The division between ground and basement floors is marked by a thicker sill band. The basement drop is guarded from street level with railings having spear head and urn finials.

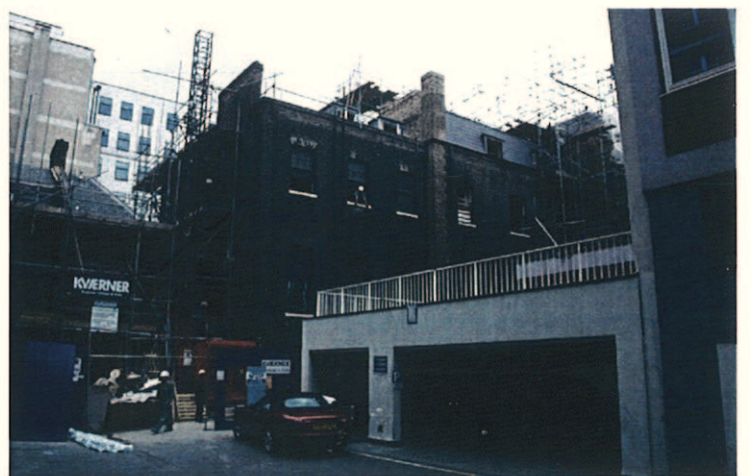
Plate 5: Earl de Grey 1830's rebuild and projecting 1790's Byfield Stair

The north elevation of the house is very plain, facing over the previously open mews courtyard (Plate 5). The projecting back stair added in 1790 by George Byfield for Marchioness de Grey is visible with its original circular windows.

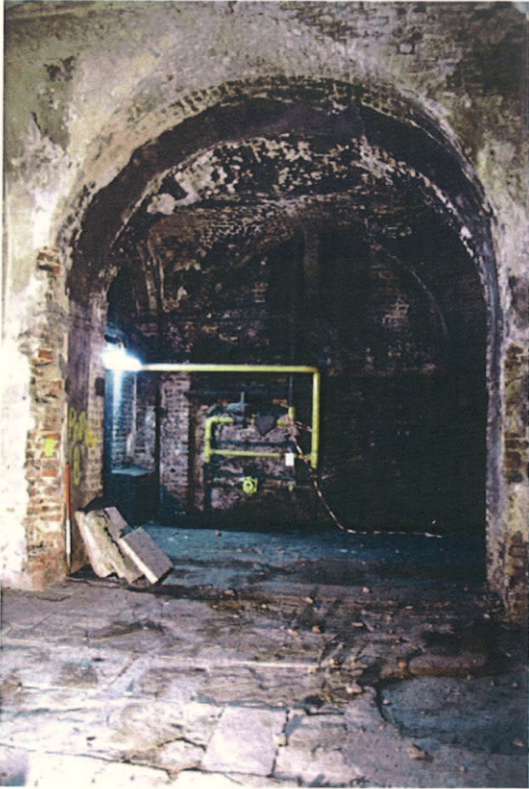
Plate 10: Basement of the Babmaes Building, E132&3, view north

3.3.6 *Babmaes Building - (Plates 10 - 13)*

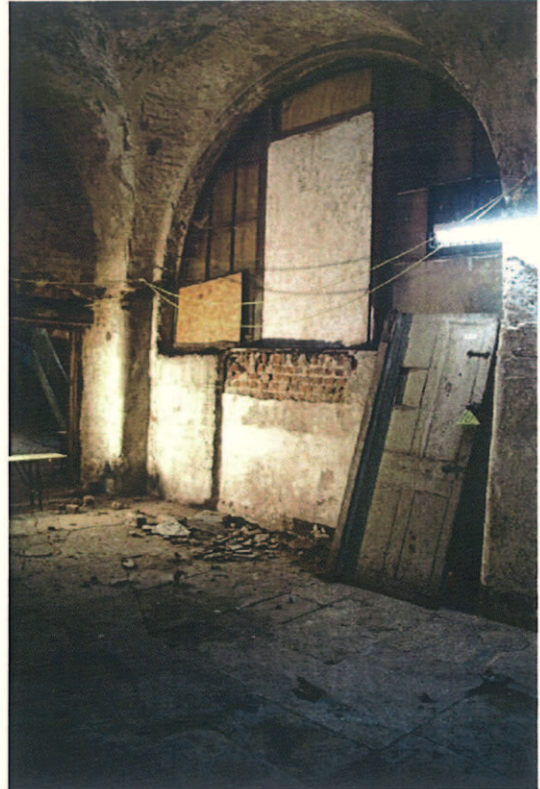
Plate 11: Lunnette window in west wall of E133 replacement window

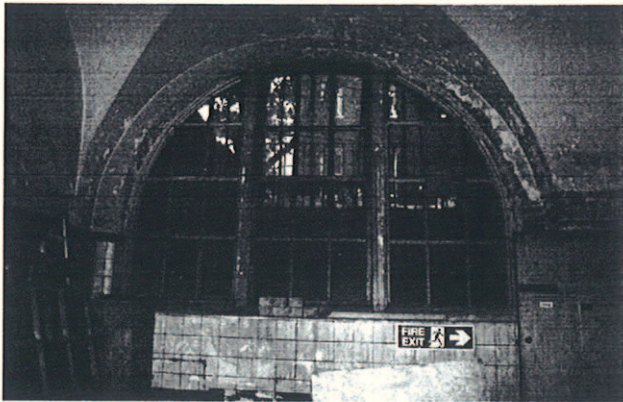
Plate 12: Original lunnette window in E138, west wall

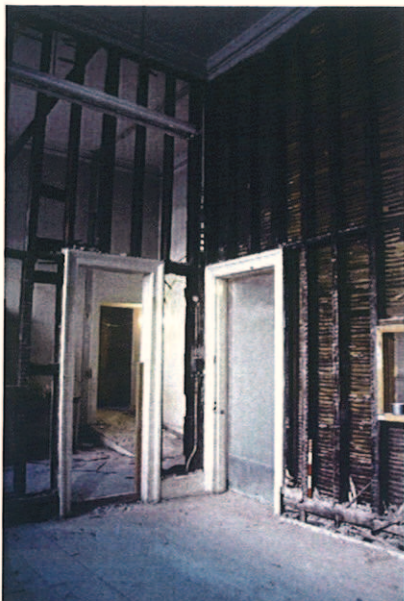
43	E416		The internal divisions separating E414, E415 & E418 were photographed prior to the stripping of lath and plaster. The exposed timber stud framework was again photographically recorded. The former location of a door central to the south wall was observed during the process, as were C20th insertions. The character of the partitions suggests that they were original 19 th century work.
44	E417	<i>Ceiling removed</i> Stripped before arrival – plasterboard? Photographic record. <i>B&W-Film 21:14-19</i> <i>Colour Slide-Film 18:10-19</i>	Not observed The majority of timbers visible in the stripped ceiling appear to be 20 th -century replacement softwood timbers. The main beams however appear to be original and show signs of smoke blackening and charring suggesting that the need to replace timbers followed a fire. The yellow stock brick vault holding up the hearth of E624 was also visible.

Plate 14: Typical internal partition wall construction, E414

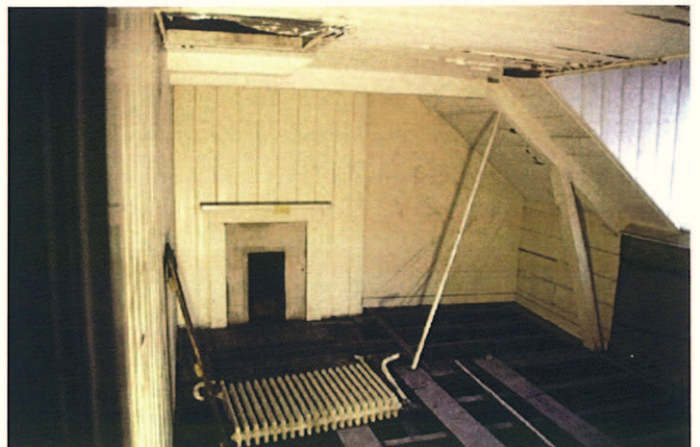
Plate 15: Servant accomodation, E709, view west

Level 7 (Plate 15) – It appears that originally only the front range of the 1725-8 building was used as servant accommodation (E701/706). It is unclear if this space was subdivided although this is unlikely due to the provision of only one fireplace at the north end of the range, currently blocked with breeze blocks. The tongue-and-groove panelling of the suite of rooms within the roof pitch of the return wing suggest a later Victorian date for their insertion.

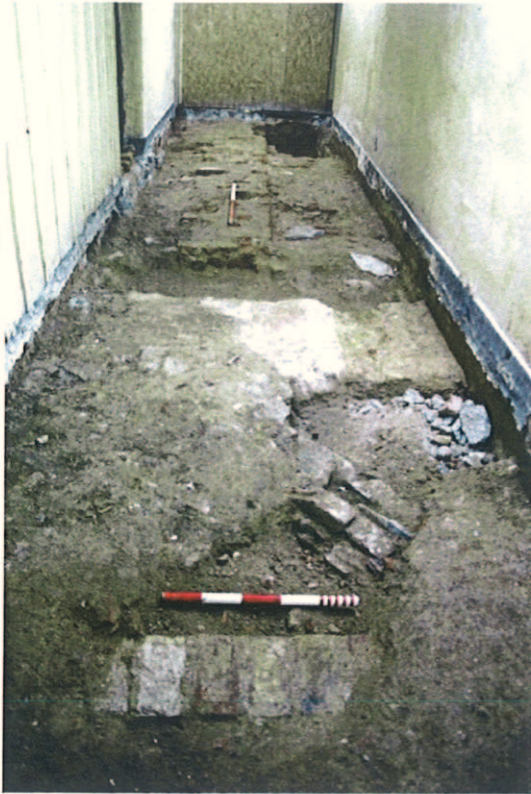
4.2.1 A brief description of the features observed along corridor E108 within the 1725-28 rebuild phase of the building follows with OAU context numbers (10) referring to the plan (Figure 26. See also Plates 16-18). During the investigation the most important feature observed along the corridor was the remains of a red brick wall thought to relate to the pre-1725 fire building. Construction trenches for the current building and the pre-1725 building were observed, as were small areas of brick flooring and several drainage channels.

Plate 16: Corridor E108, exposed archaeology including possible remains of the 1670's Barbon building – red brick wall (1), white mortar area (24) and later service conduit in foreground (27) (see Figure 26)

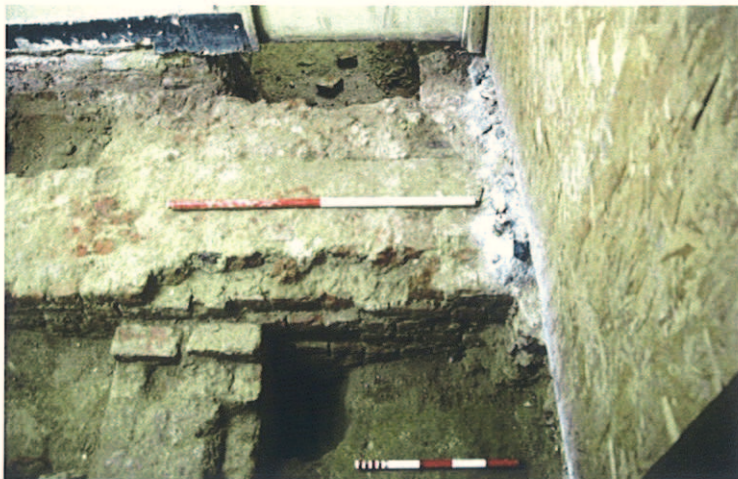
4.2.2 ***Remains of north-south running brick wall (1)*** To the south end of corridor E108 a c5m length of brick wall (1) was uncovered, lying centrally within the passage and measuring 0.58m wide. The bricks were of dark orange-red material with rare inclusions and no frog. The sides of the bricks were creased sides and arrisses were irregular. The size of the bricks was also irregular with average dimensions of 0.22 x 0.1 x 0.6m. The bonding mortar of the remains of the brick wall was mid yellow-brown in colour with a cemented texture and occasional inclusions of charcoal, red brick clay and white lime fragments. To the west of the southern end a test pit had been dug by the contractors which allowed a view of the elevation of the brick wall. The wall survived to between 7 and 8 courses, 0.56m in total, and appeared to be laid to an approximate English bond, although the irregularity of the bricks made this fairly variable, the majority of bricks being of header dimensions. Along the east side of the wall indications of a foundation plinth or offset was seen (4) & (7). The 0.11m wide offset was one course down from the upper surviving course of the wall and the general clearance level. A conduit chase (14)

Plate 17: Remains of walls (1) and (9), possibly from the 1670's Barbon building, at south end of corridor E108

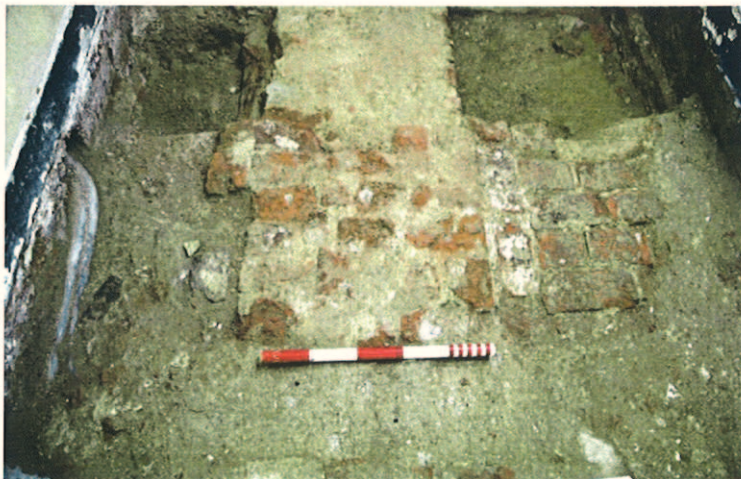
Plate 18: Remains of wall (1) and floor surface (18), possibly from the 1670's Barbon building, E108
