WESTMINSTER  
4 ST. JAMES SQUARE  
SJQ 97

Line 1: [OASouth] County:[Greater London] Parish:[Westminster] Site:[4 St James Square]

**IN AND OUT LTD.**  
**THE NAVAL AND MILITARY CLUB**  
Relocation to Number 4, St. James Square.  
Architect: John Warren RIBA, FRPI, FSA.  
Quantity Surveyor: David Connolly FRICS.  
Franklin and Andrews

Oxford Archaeological Unit  
Architectural Survey

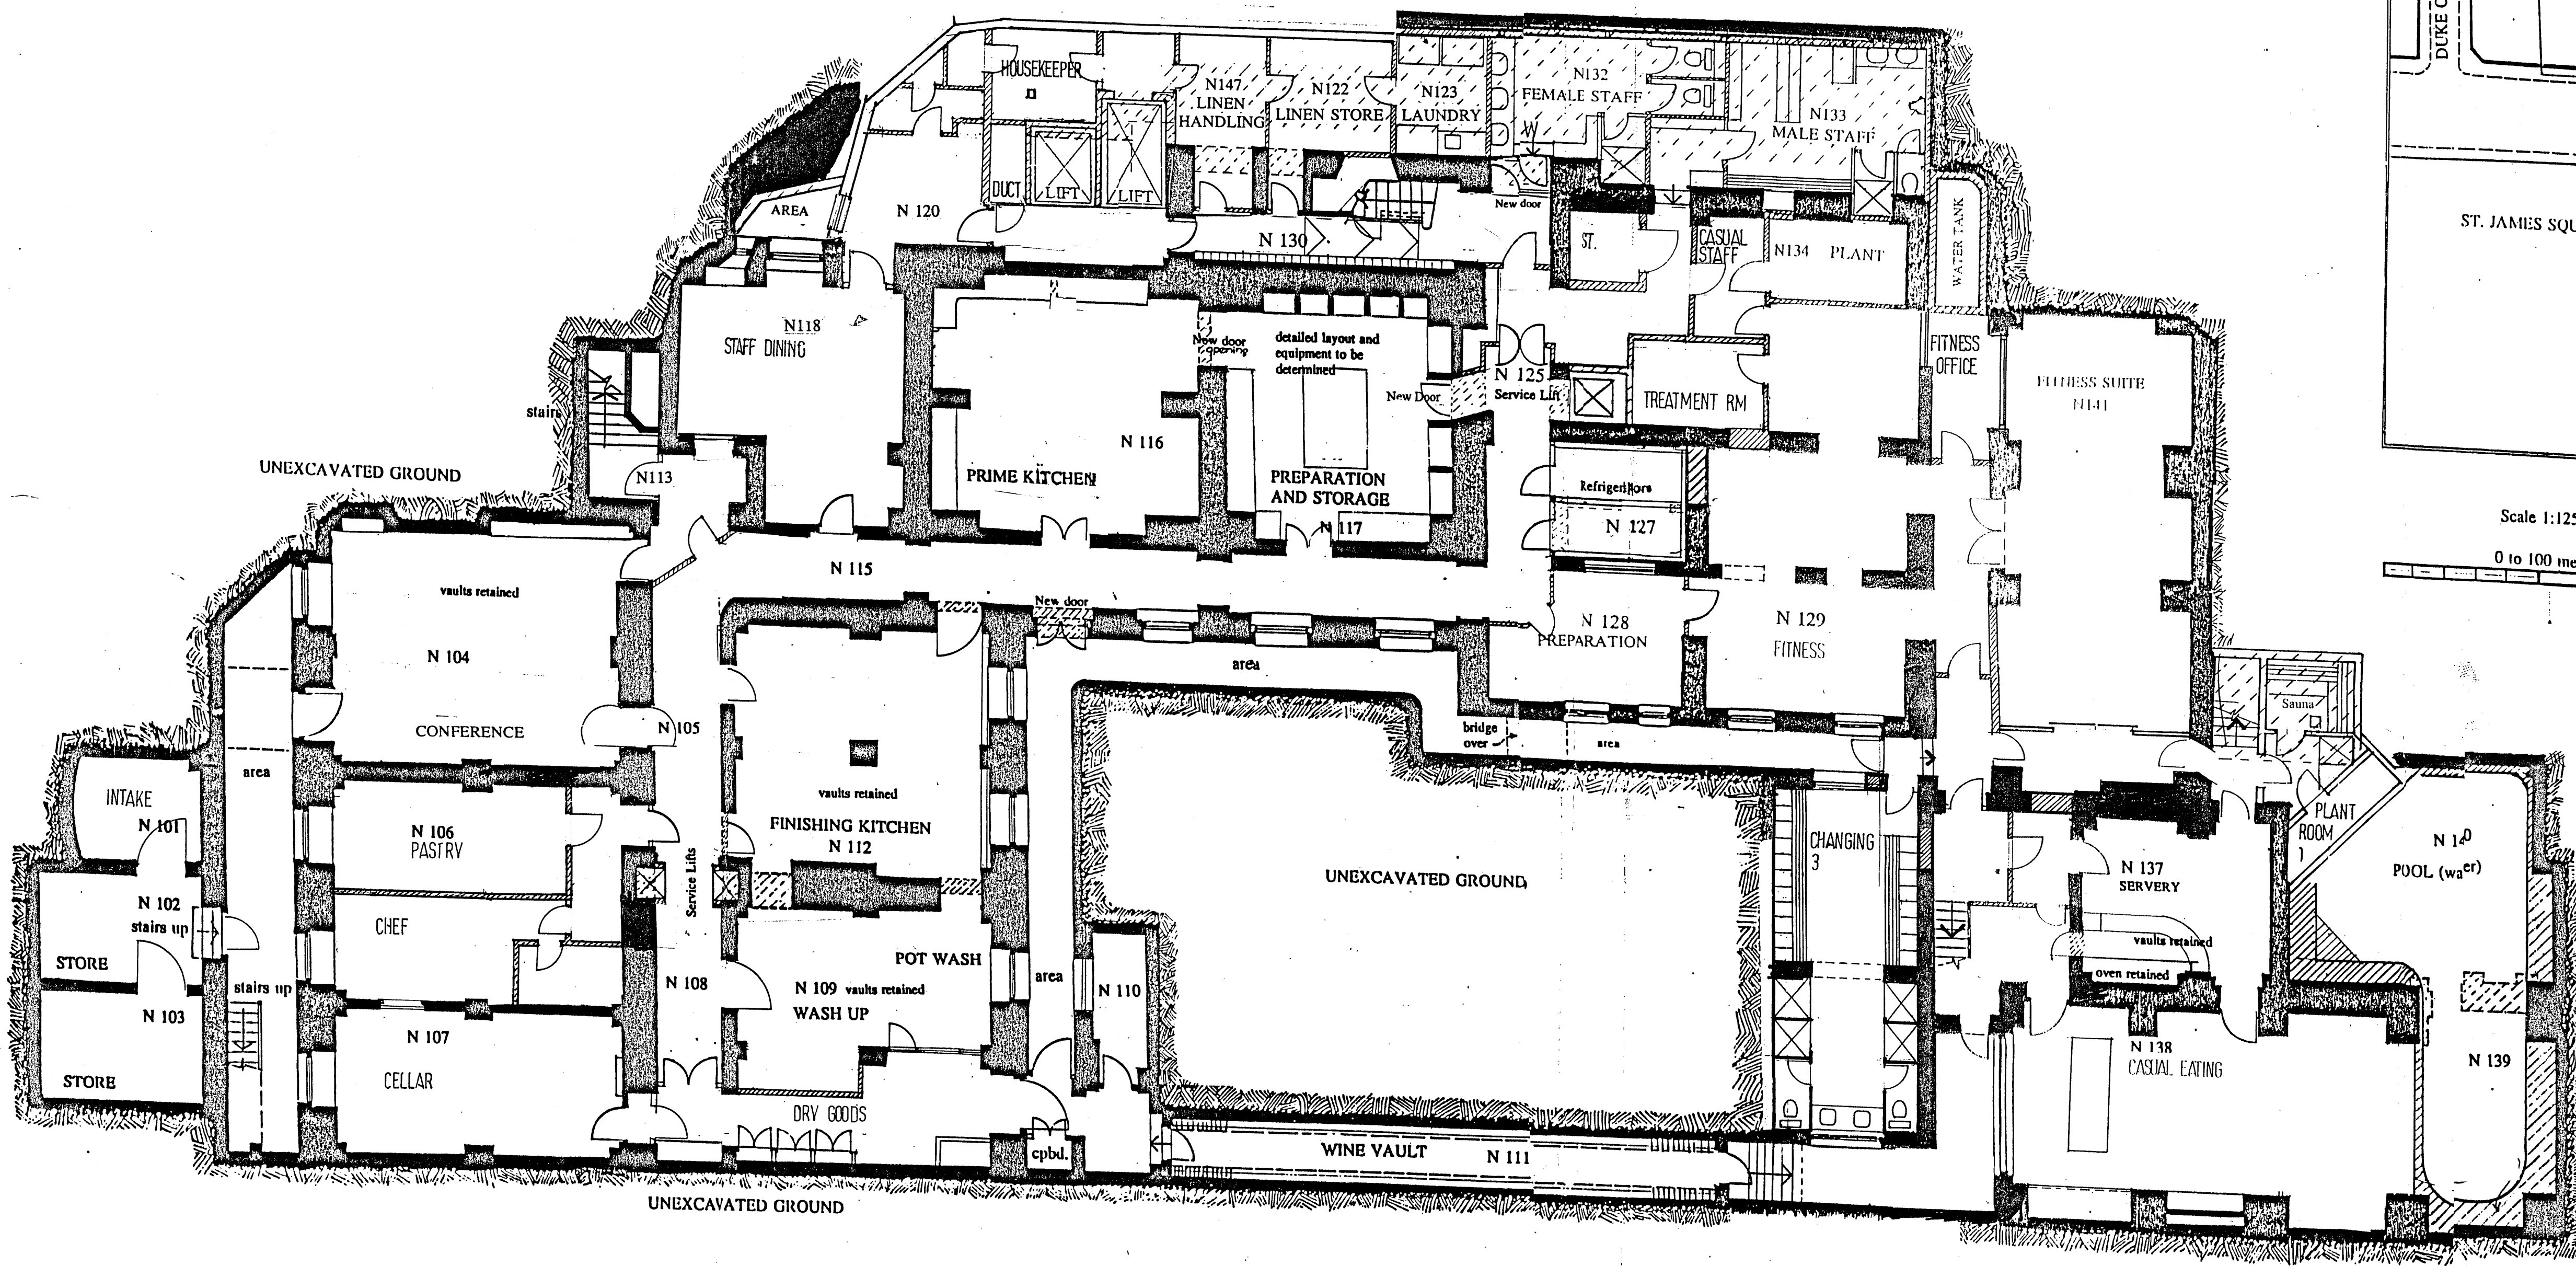
drawing no. **SJ/D 001/ amendment F6**

on stairs all arrows indicate UP  
all areas diagonally hatched indicate new construction  
all areas diagonally broken hatched indicate removal of existing work

**BASEMENT PLAN**

Principal Amendments between Series E and Series F2.  
Excavation in 'North Yard' (N120 - N133) and in fitness area (N143 - N145) has been revised.  
The following areas are redesigned;

- N 109 Wash up
- N 110 Air intake
- N 118 Pastry and W.C.
- N 120 Chef and Electrical Dist.
- N 127 Refrigerators
- N 128 Preparation
- N 129 Staff Dining
- N 134 Plant
- N 142 Dry Stores
- N 138 Billiards Stair
- N 141 Fitness Suite

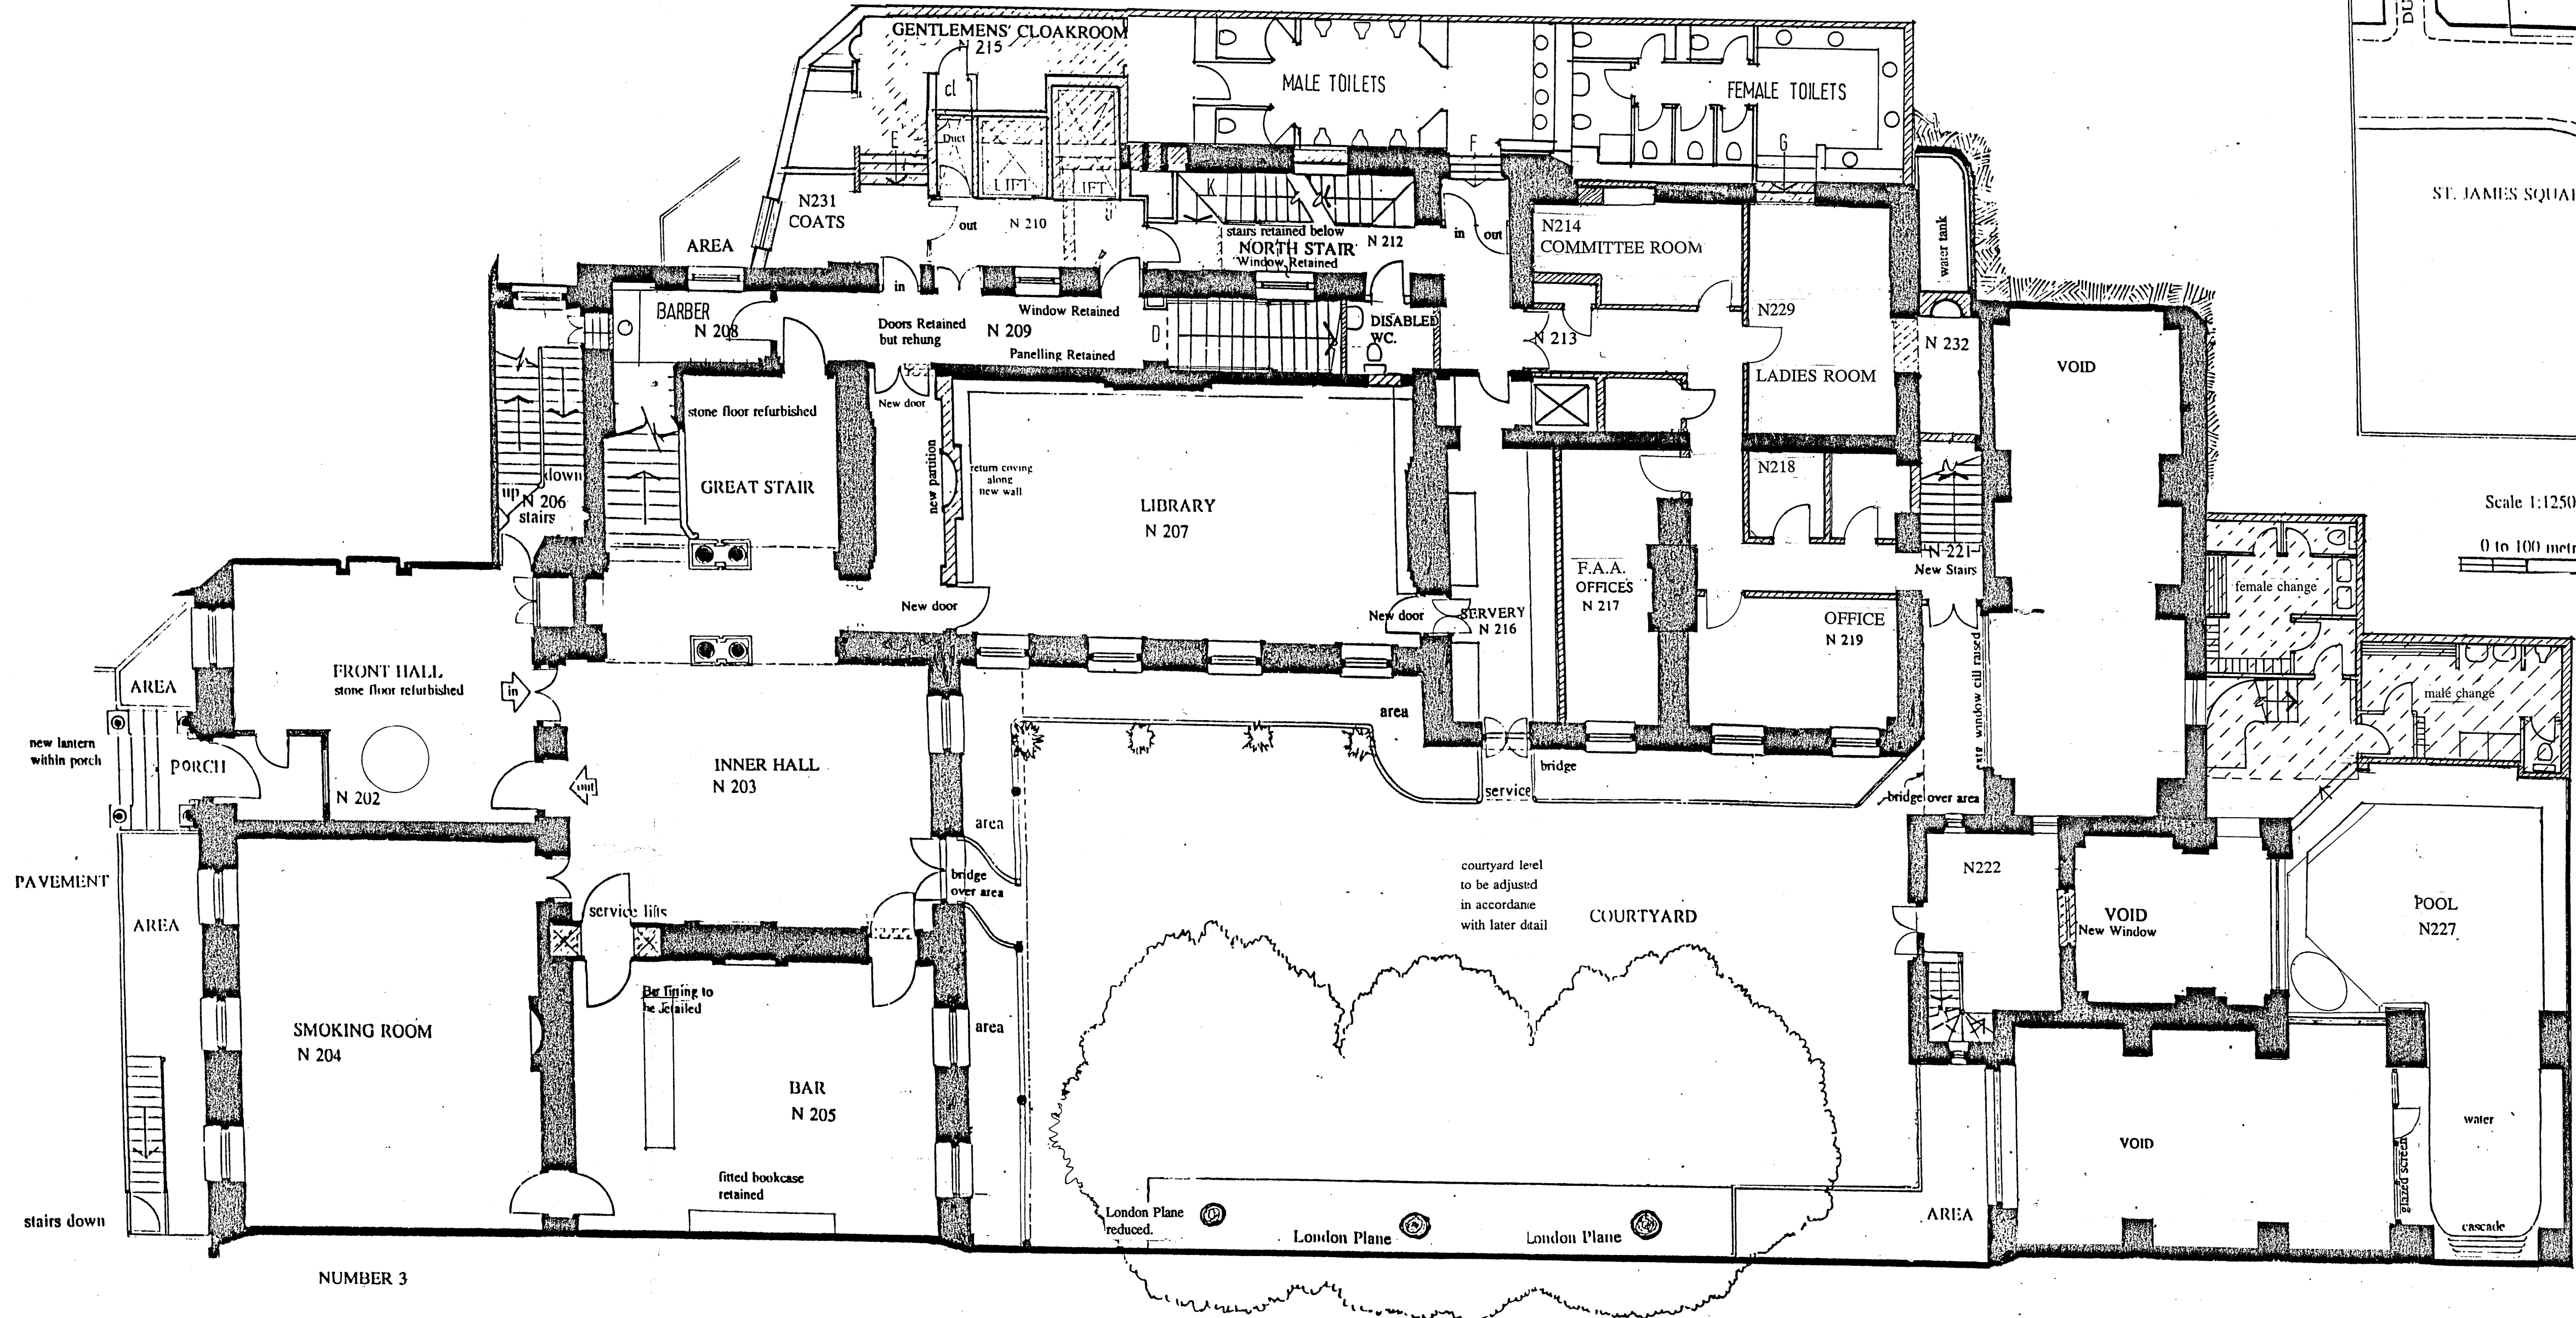
drawing no. **SJ/D 002/ amendment F6**

GROUND FLOOR PLAN  
LEVEL TWO (ST. JAMES SQUARE)  
scale 1:100

Principal Amendments between Series E and Series F2.  
Excavation in "North Yard" (N215 - N230) and in fitness Area (N224 - N226 lower mezz, N233 - N234 upper mezz has been revised).

- N 201 Lobby
- N 209 Stair/W.C
- N 217 Office
- N 220 Archives
- N 229 Ladies Coats
- N 223 Balcony - Mezz removed
- N 222 Stair

Courtyard: reduced area enlarged stair modified

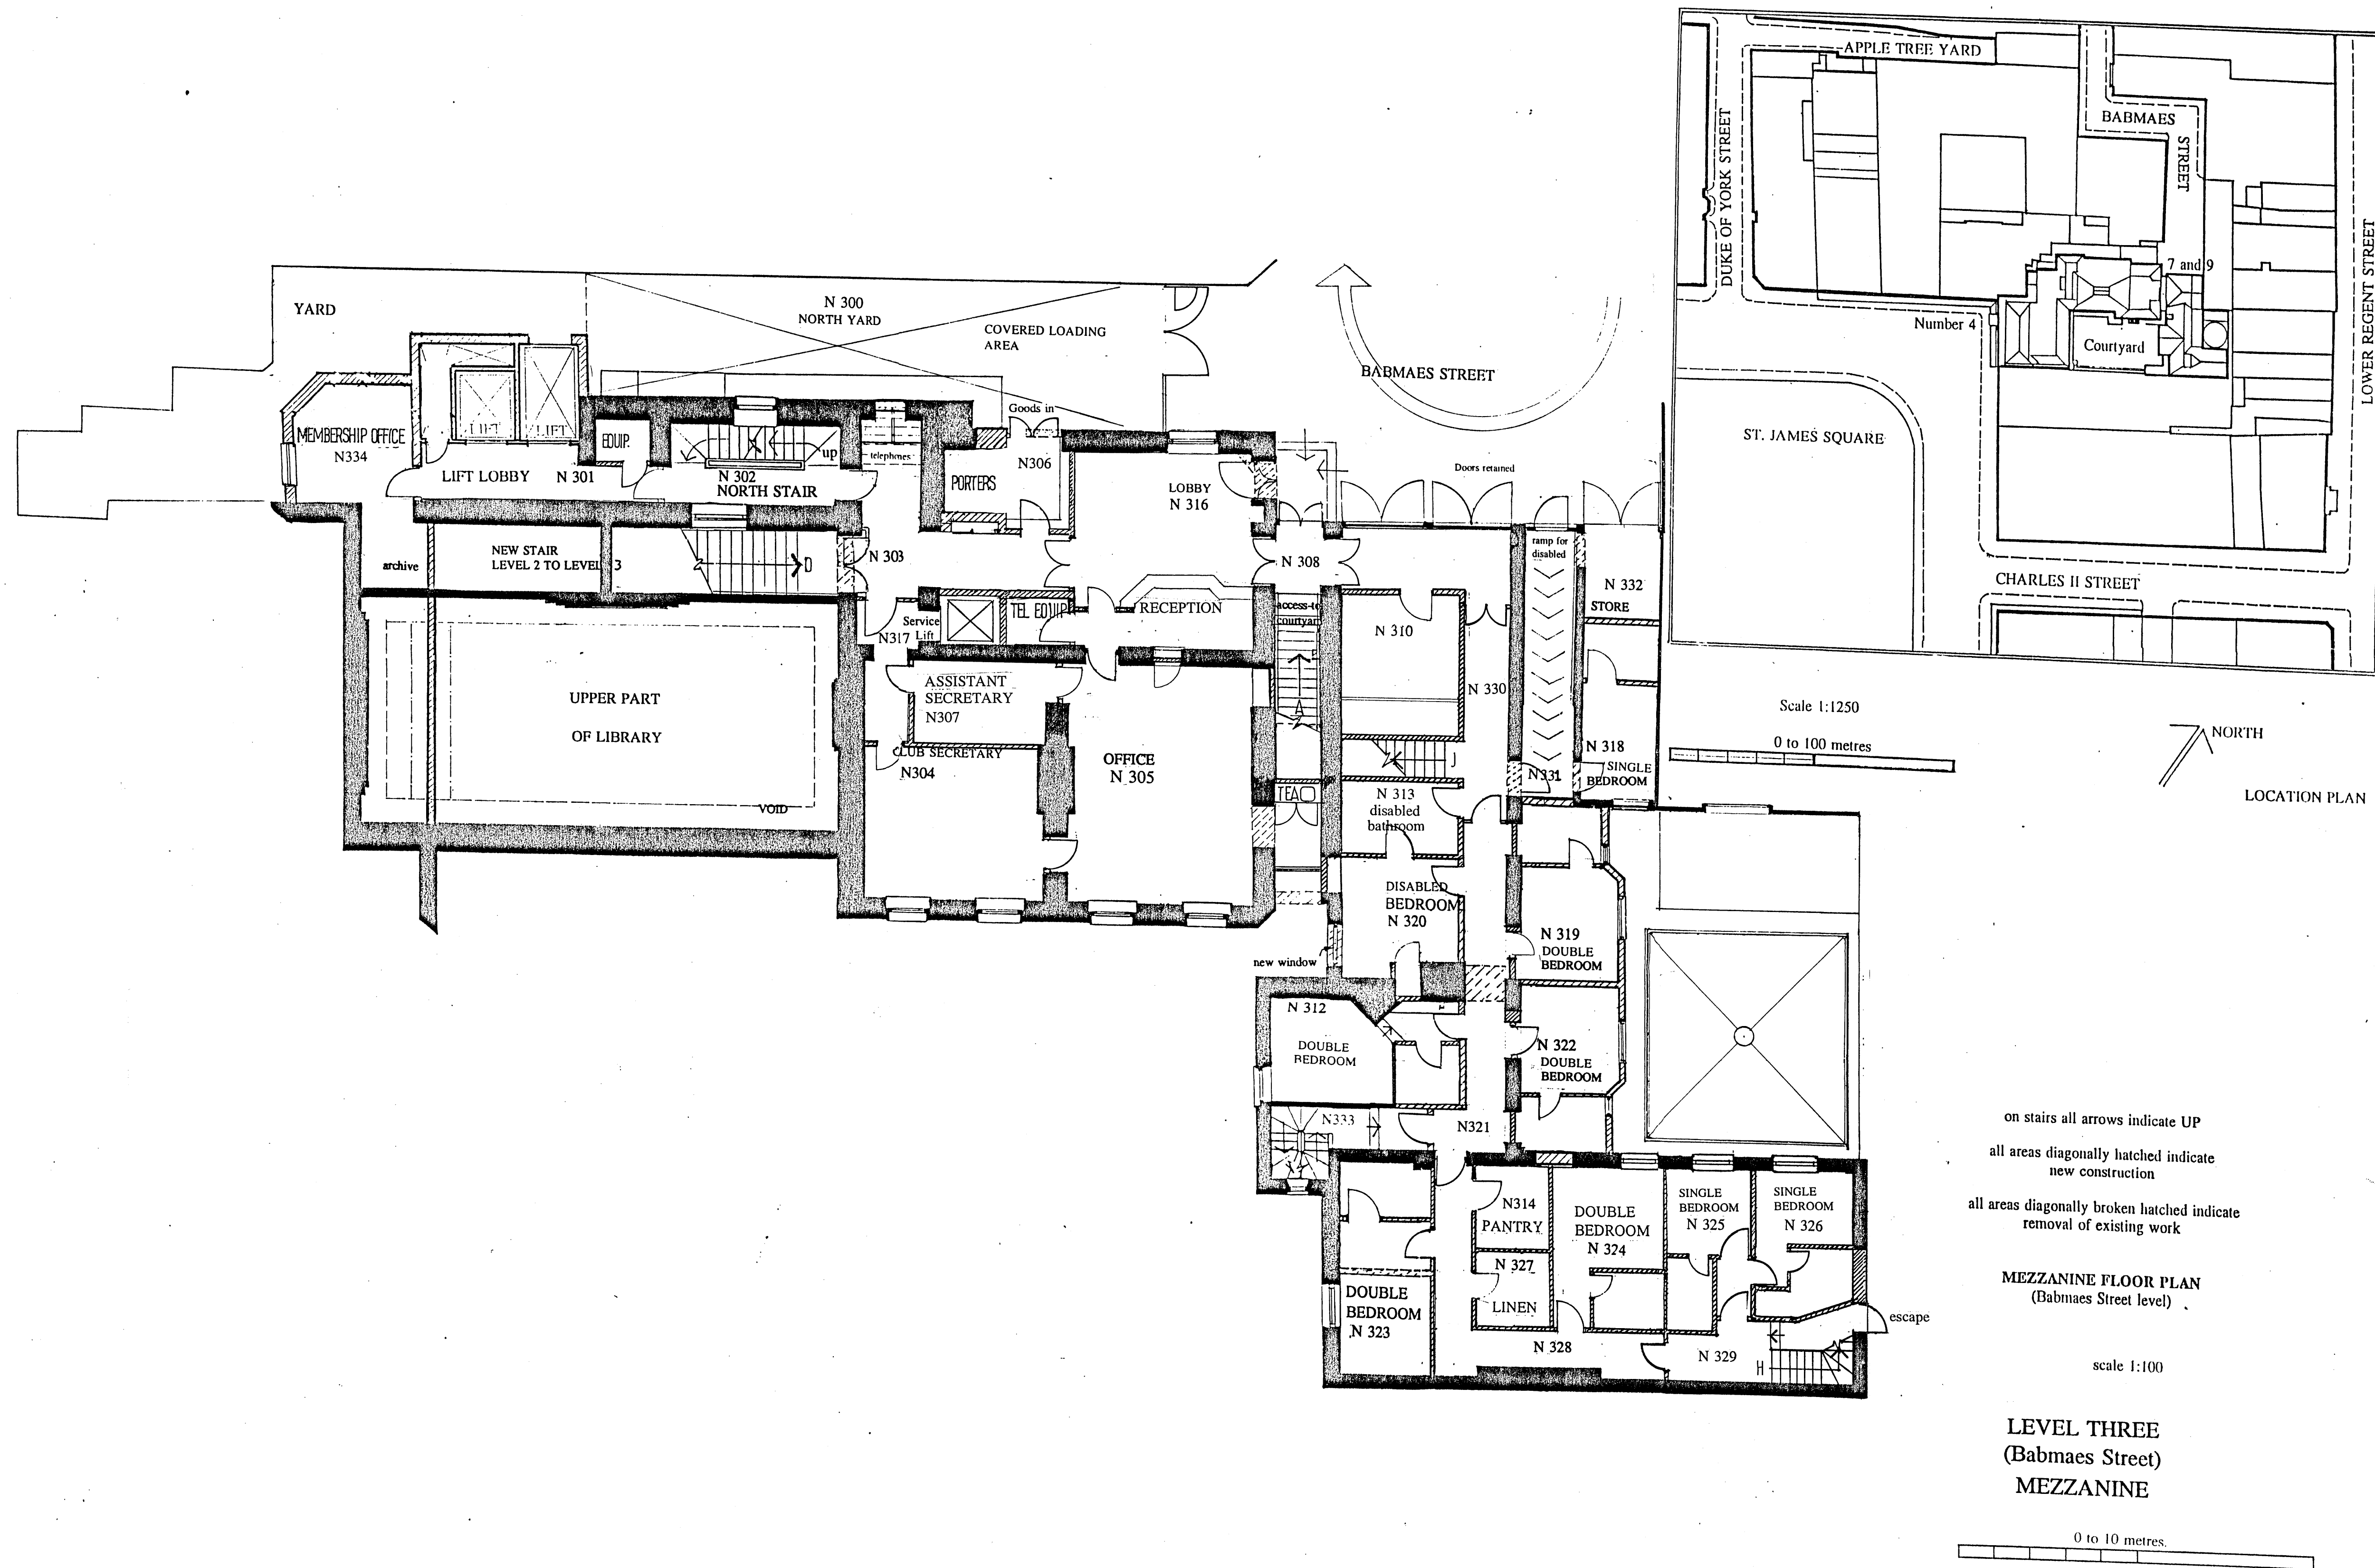
drawing no. **SJ/D 003/amendment F6**

MEZZANINE FLOOR PLAN  
 (Babmaes Street level)

Principal Amendments between Series E and Series F2.  
 The following areas have been modified:

- N 300 North Yard loading area
- N 334 Canning club
- N 304/305 Office
- N 311 Reception
- N 316 Lobby
- N 309 Hall
- N 310 Agency
- N 313 Disabled Bath
- N 312 Bedroom
- N 314/327 Linen
- N 329 Stair
- N 332 Store

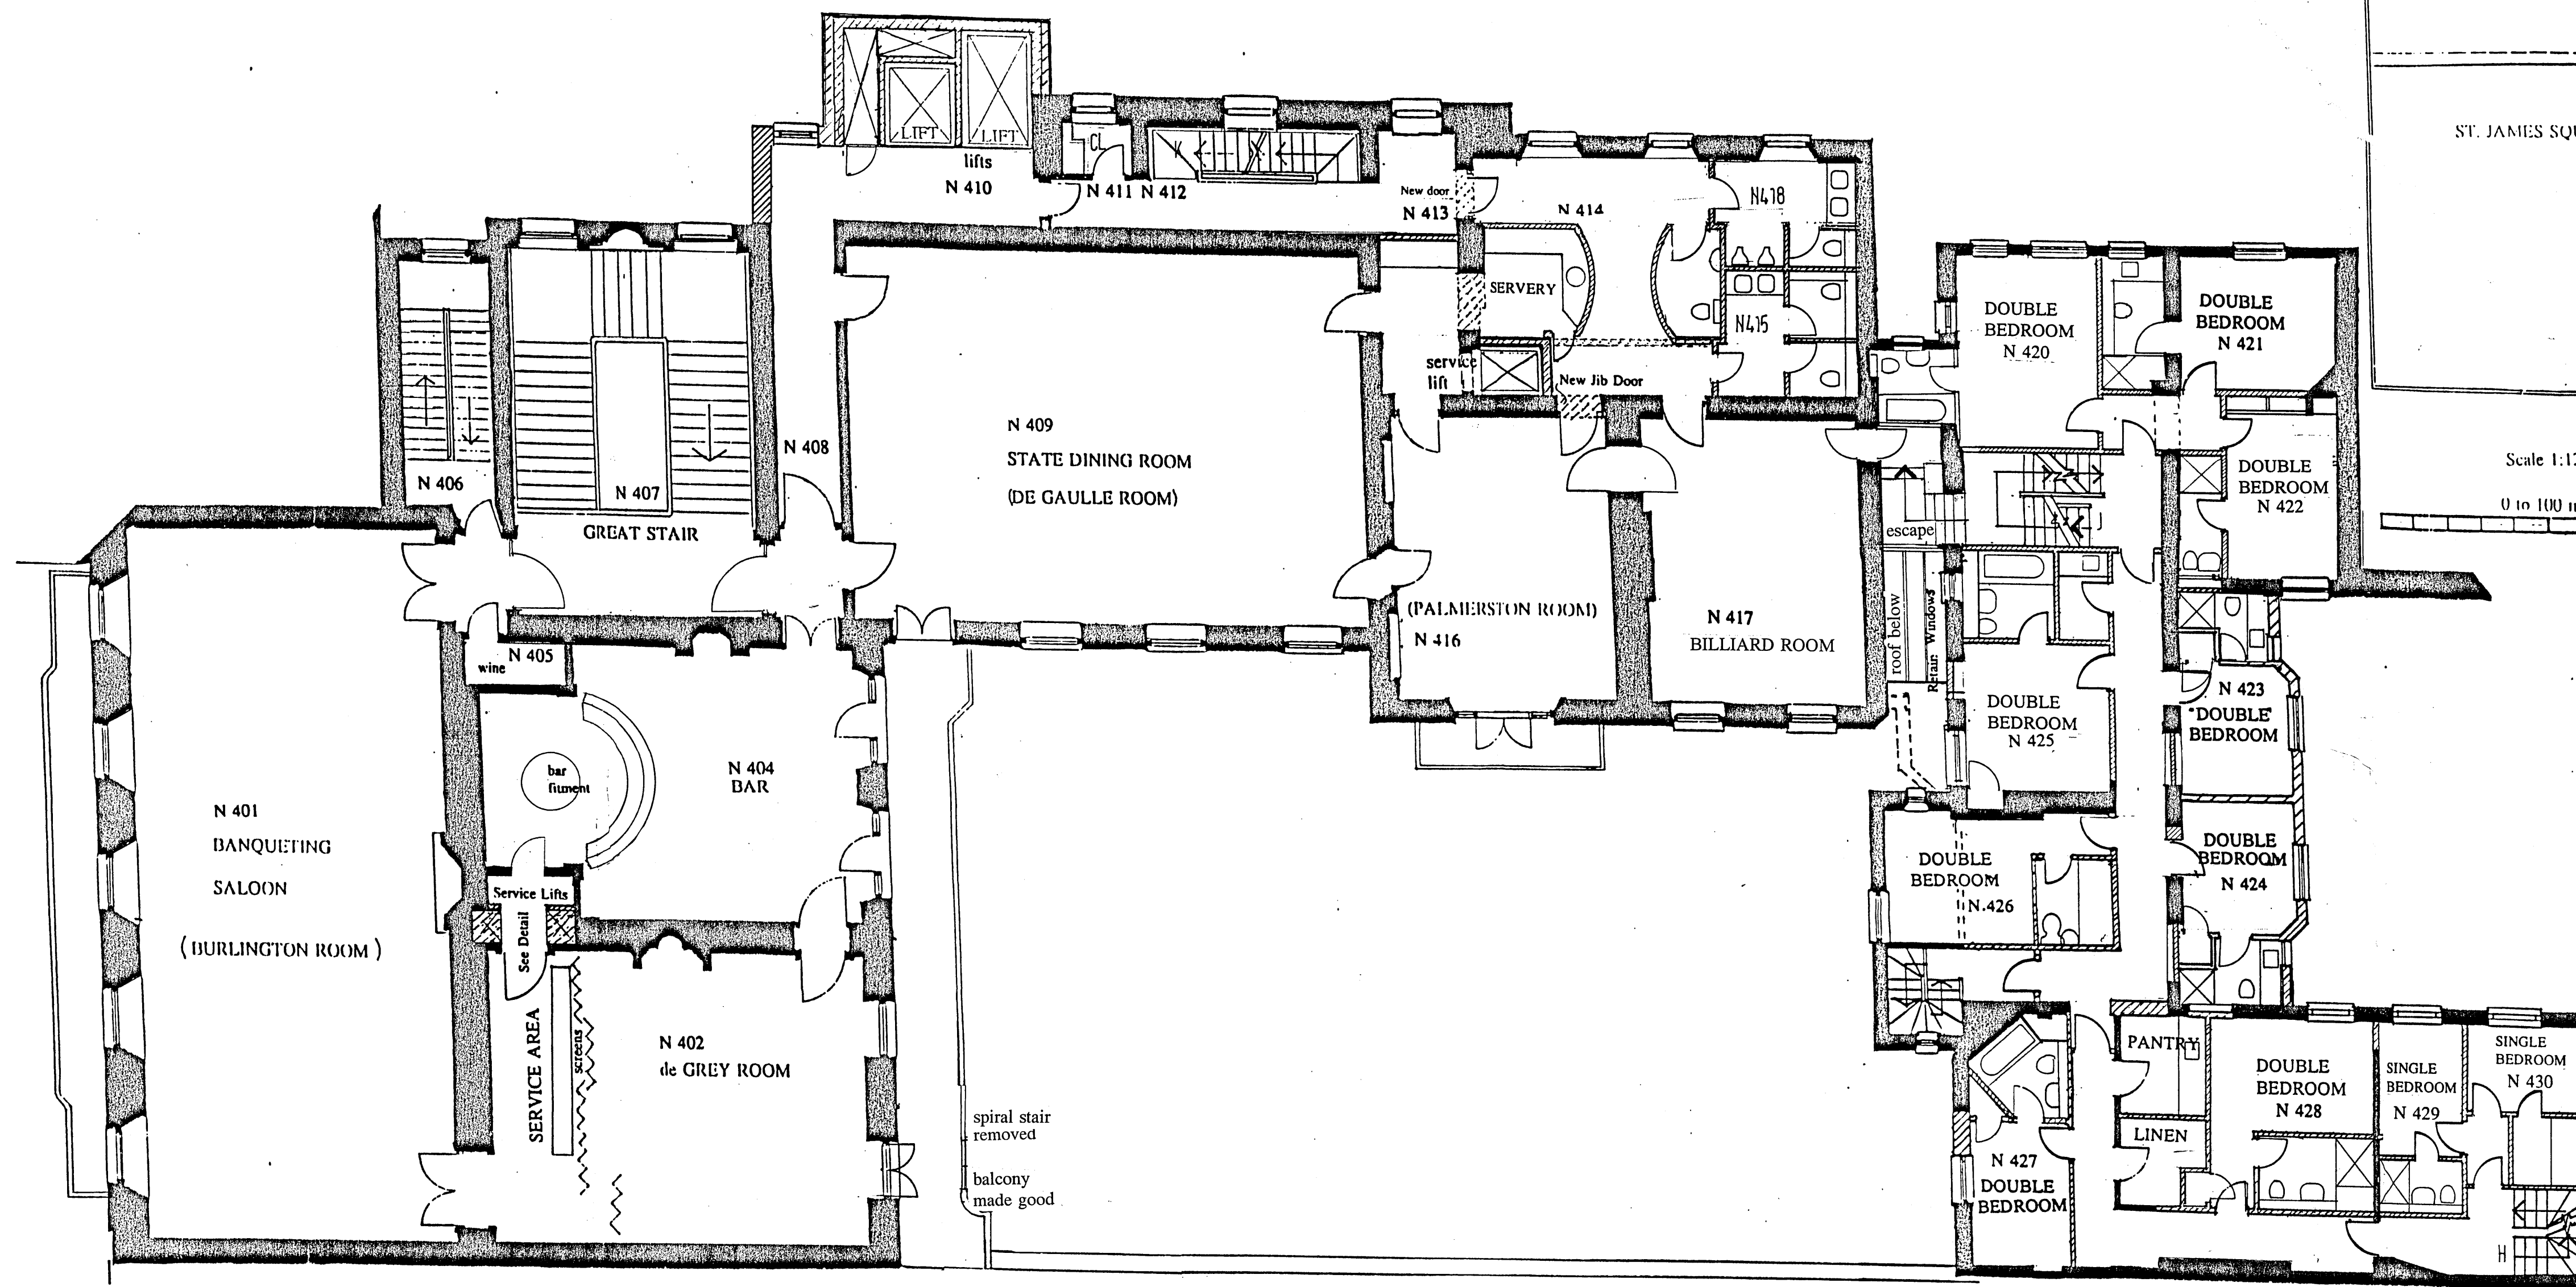
drawing no. **SJ/D 004/amendment F6**

**LEVEL FOUR  
FIRST FLOOR  
PLAN**  
scale 1:100

Principal Amendments between Series E and Series F2.  
The following areas have been modified;

- N 407 Fire screens to Great Stair
- N 403 Jib door re-opened
- N 415/418 Disabled W.C.
- N 414 Hall
- N 428-430 Linen/pantry
- Bedrooms
- Stair
- Courtyard; stair modified

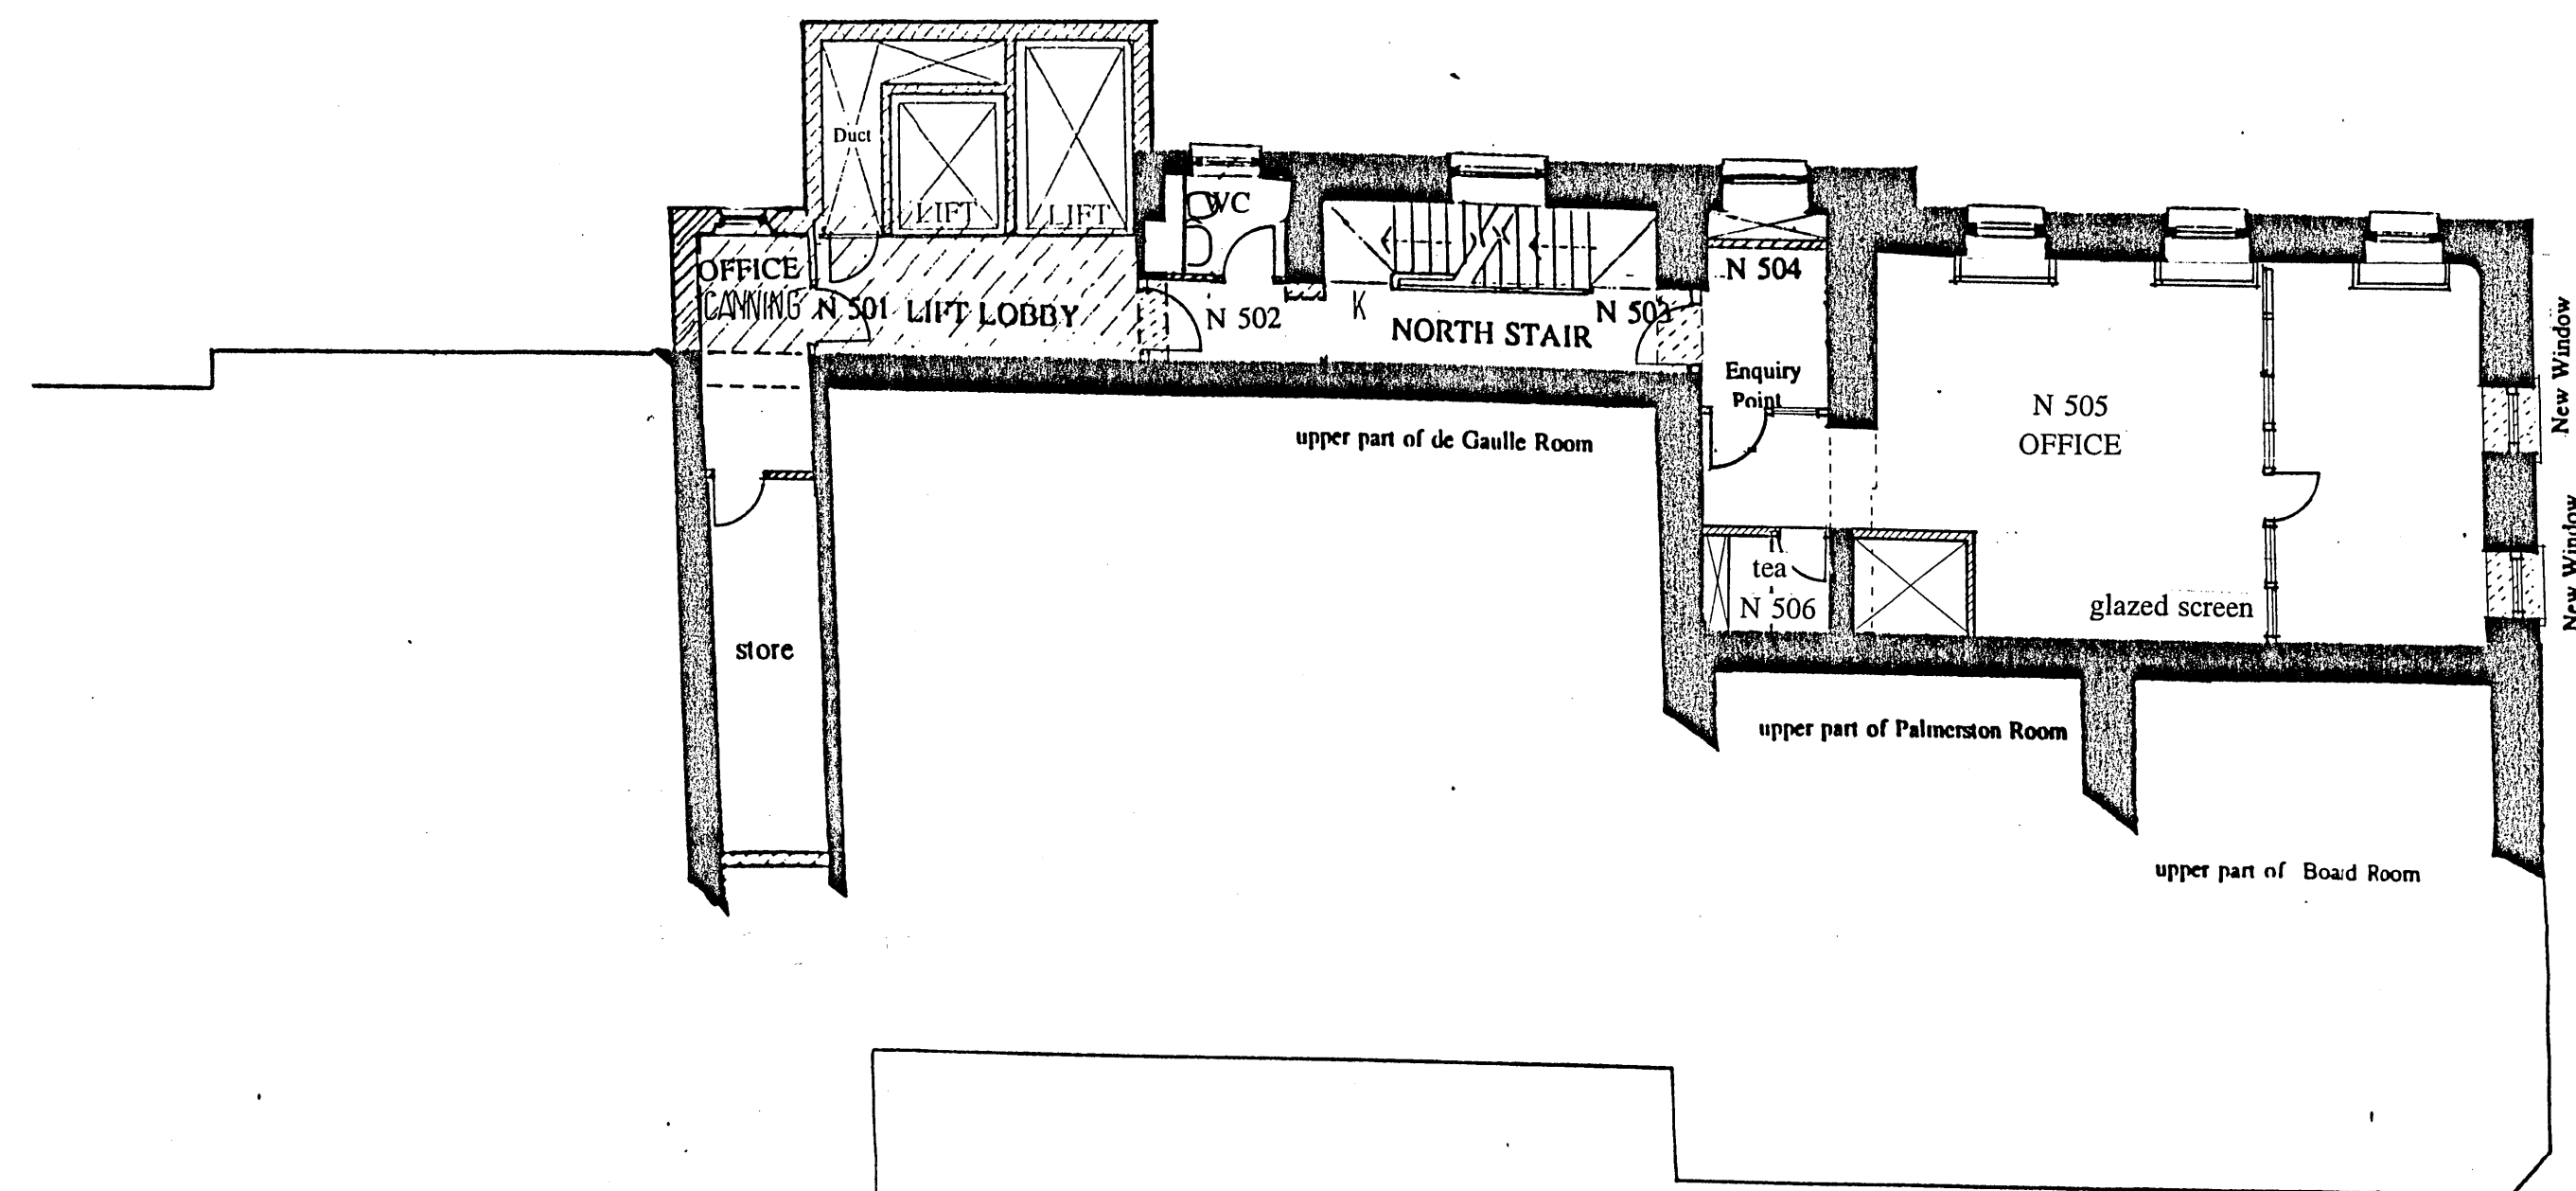
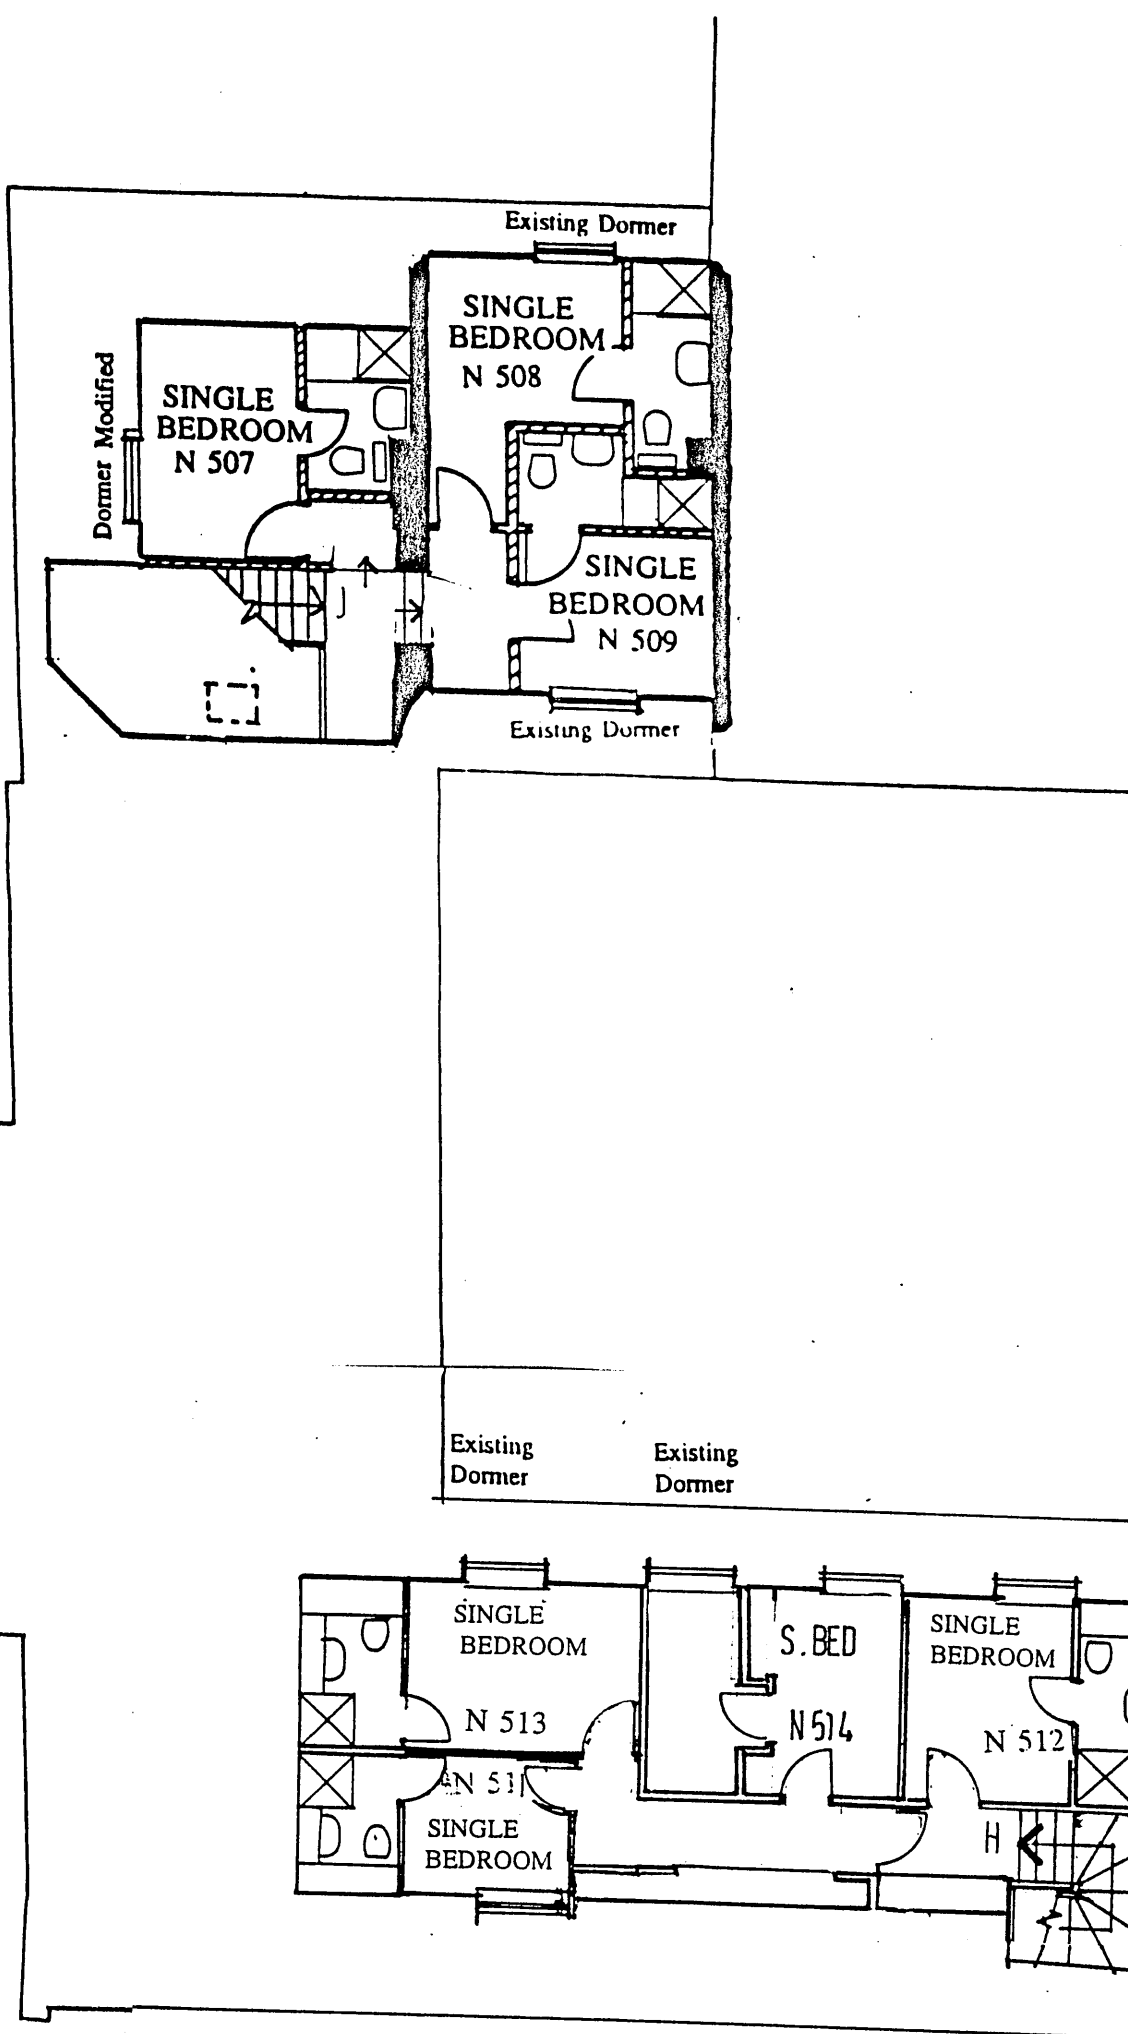
drawing no. SJ/D 005/amendment F6

**LEVEL FIVE  
UPPER MEZZANINE**

Principal Amendments between Series E and Series F2.  
The following areas have been modified;

- N 502 Stair
- N 505 Accounts Office
- N 510 Stair
- N 511-513 Bedrooms

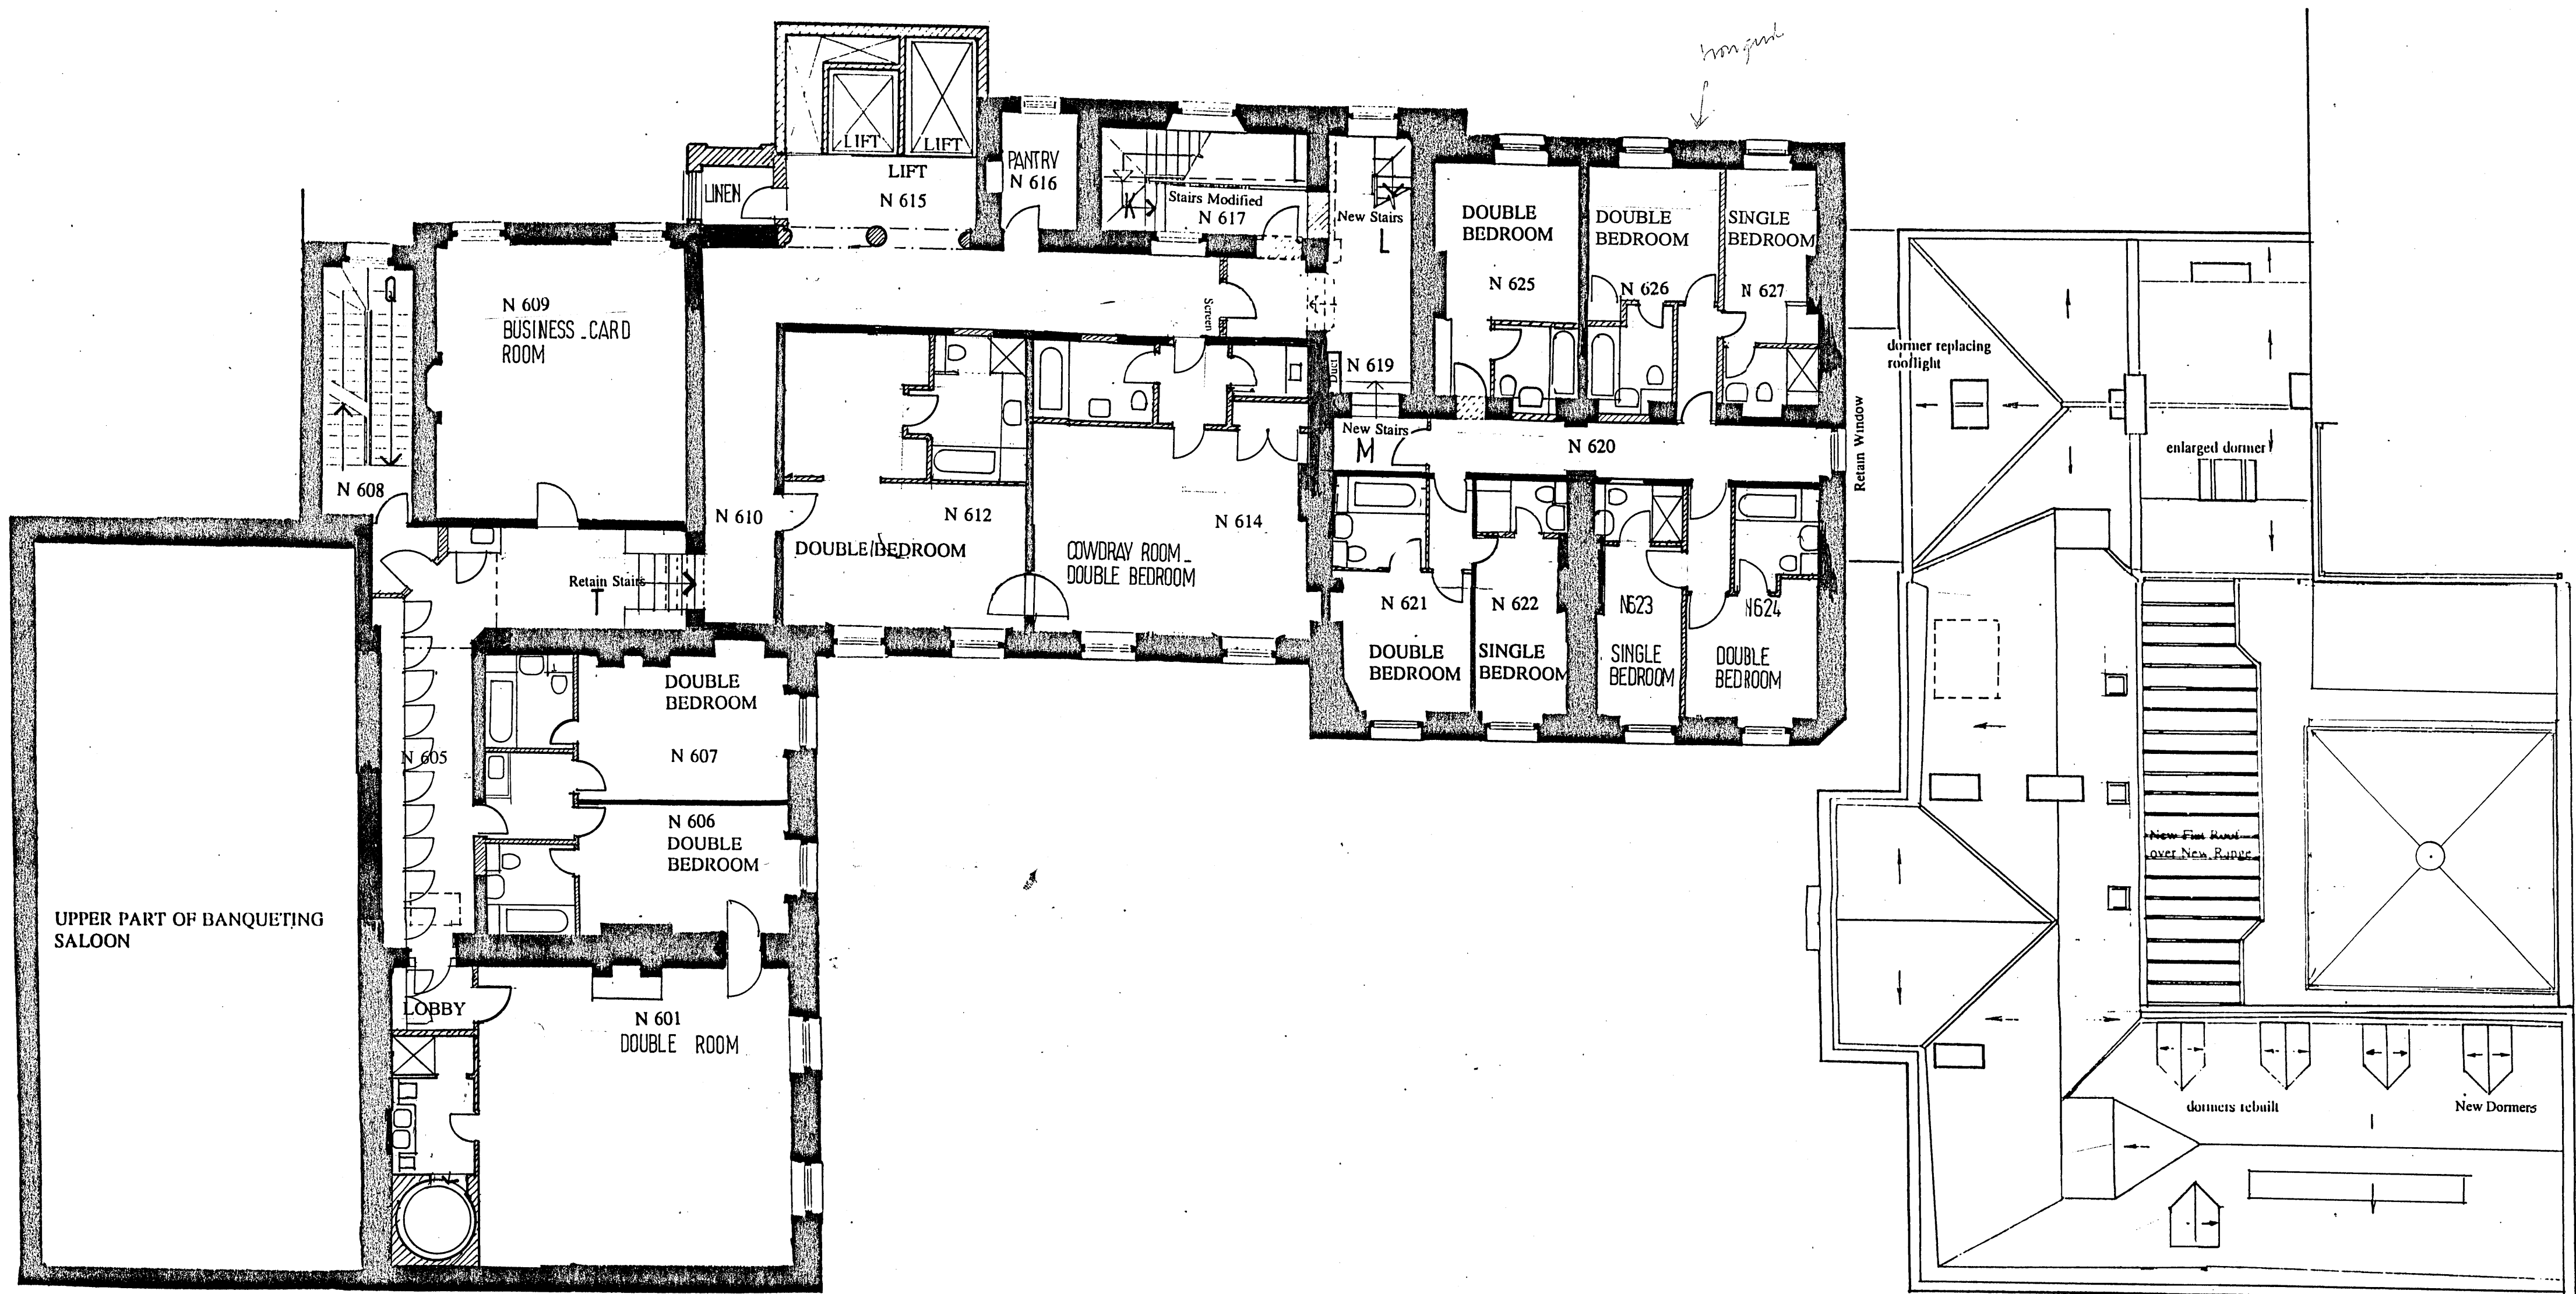
drawing no. **SJ/D 005.1/amendment F6**

parallel coupled lines indicate diagrammatically the rolls of sheet metal 'flat' roofs; roof of lift motor room similar  
chimneys are shown in heavy outline  
falls of roofs are indicated by arrows  
on stairs all arrows indicate UP  
all areas diagonally hatched indicate new construction  
all areas diagonally broken-hatched indicate removal of existing work

**LEVEL SIX  
BEDROOM FLOOR**  
scale 1:100

Principal Amendments between Series E and Series F2.  
The following areas have been modified:

- N 602 Changing
- N 606/607 Bathrooms
- N 611 Bedroom
- N 615/618 Lift lobby
- N 617 Stair
- N 619 Floor raised
- N 621-627 Bathrooms
