WESTMINSTER  
4 ST. JAMES SQUARE  
SJQ 97

Line 1: [OASouth] County:[Greater London] Parish:[Westminster] Site:[4 St James Square]

**IN AND OUT LTD.**  
**THE NAVAL AND MILITARY CLUB**  
Relocation to Number 4, St. James Square.  
Architect: John Warren RIBA, FRPI, FSA.  
Quantity Surveyor: David Connolly FRICS.  
Franklin and Andrews

Oxford Archaeological Unit  
Architectural Survey

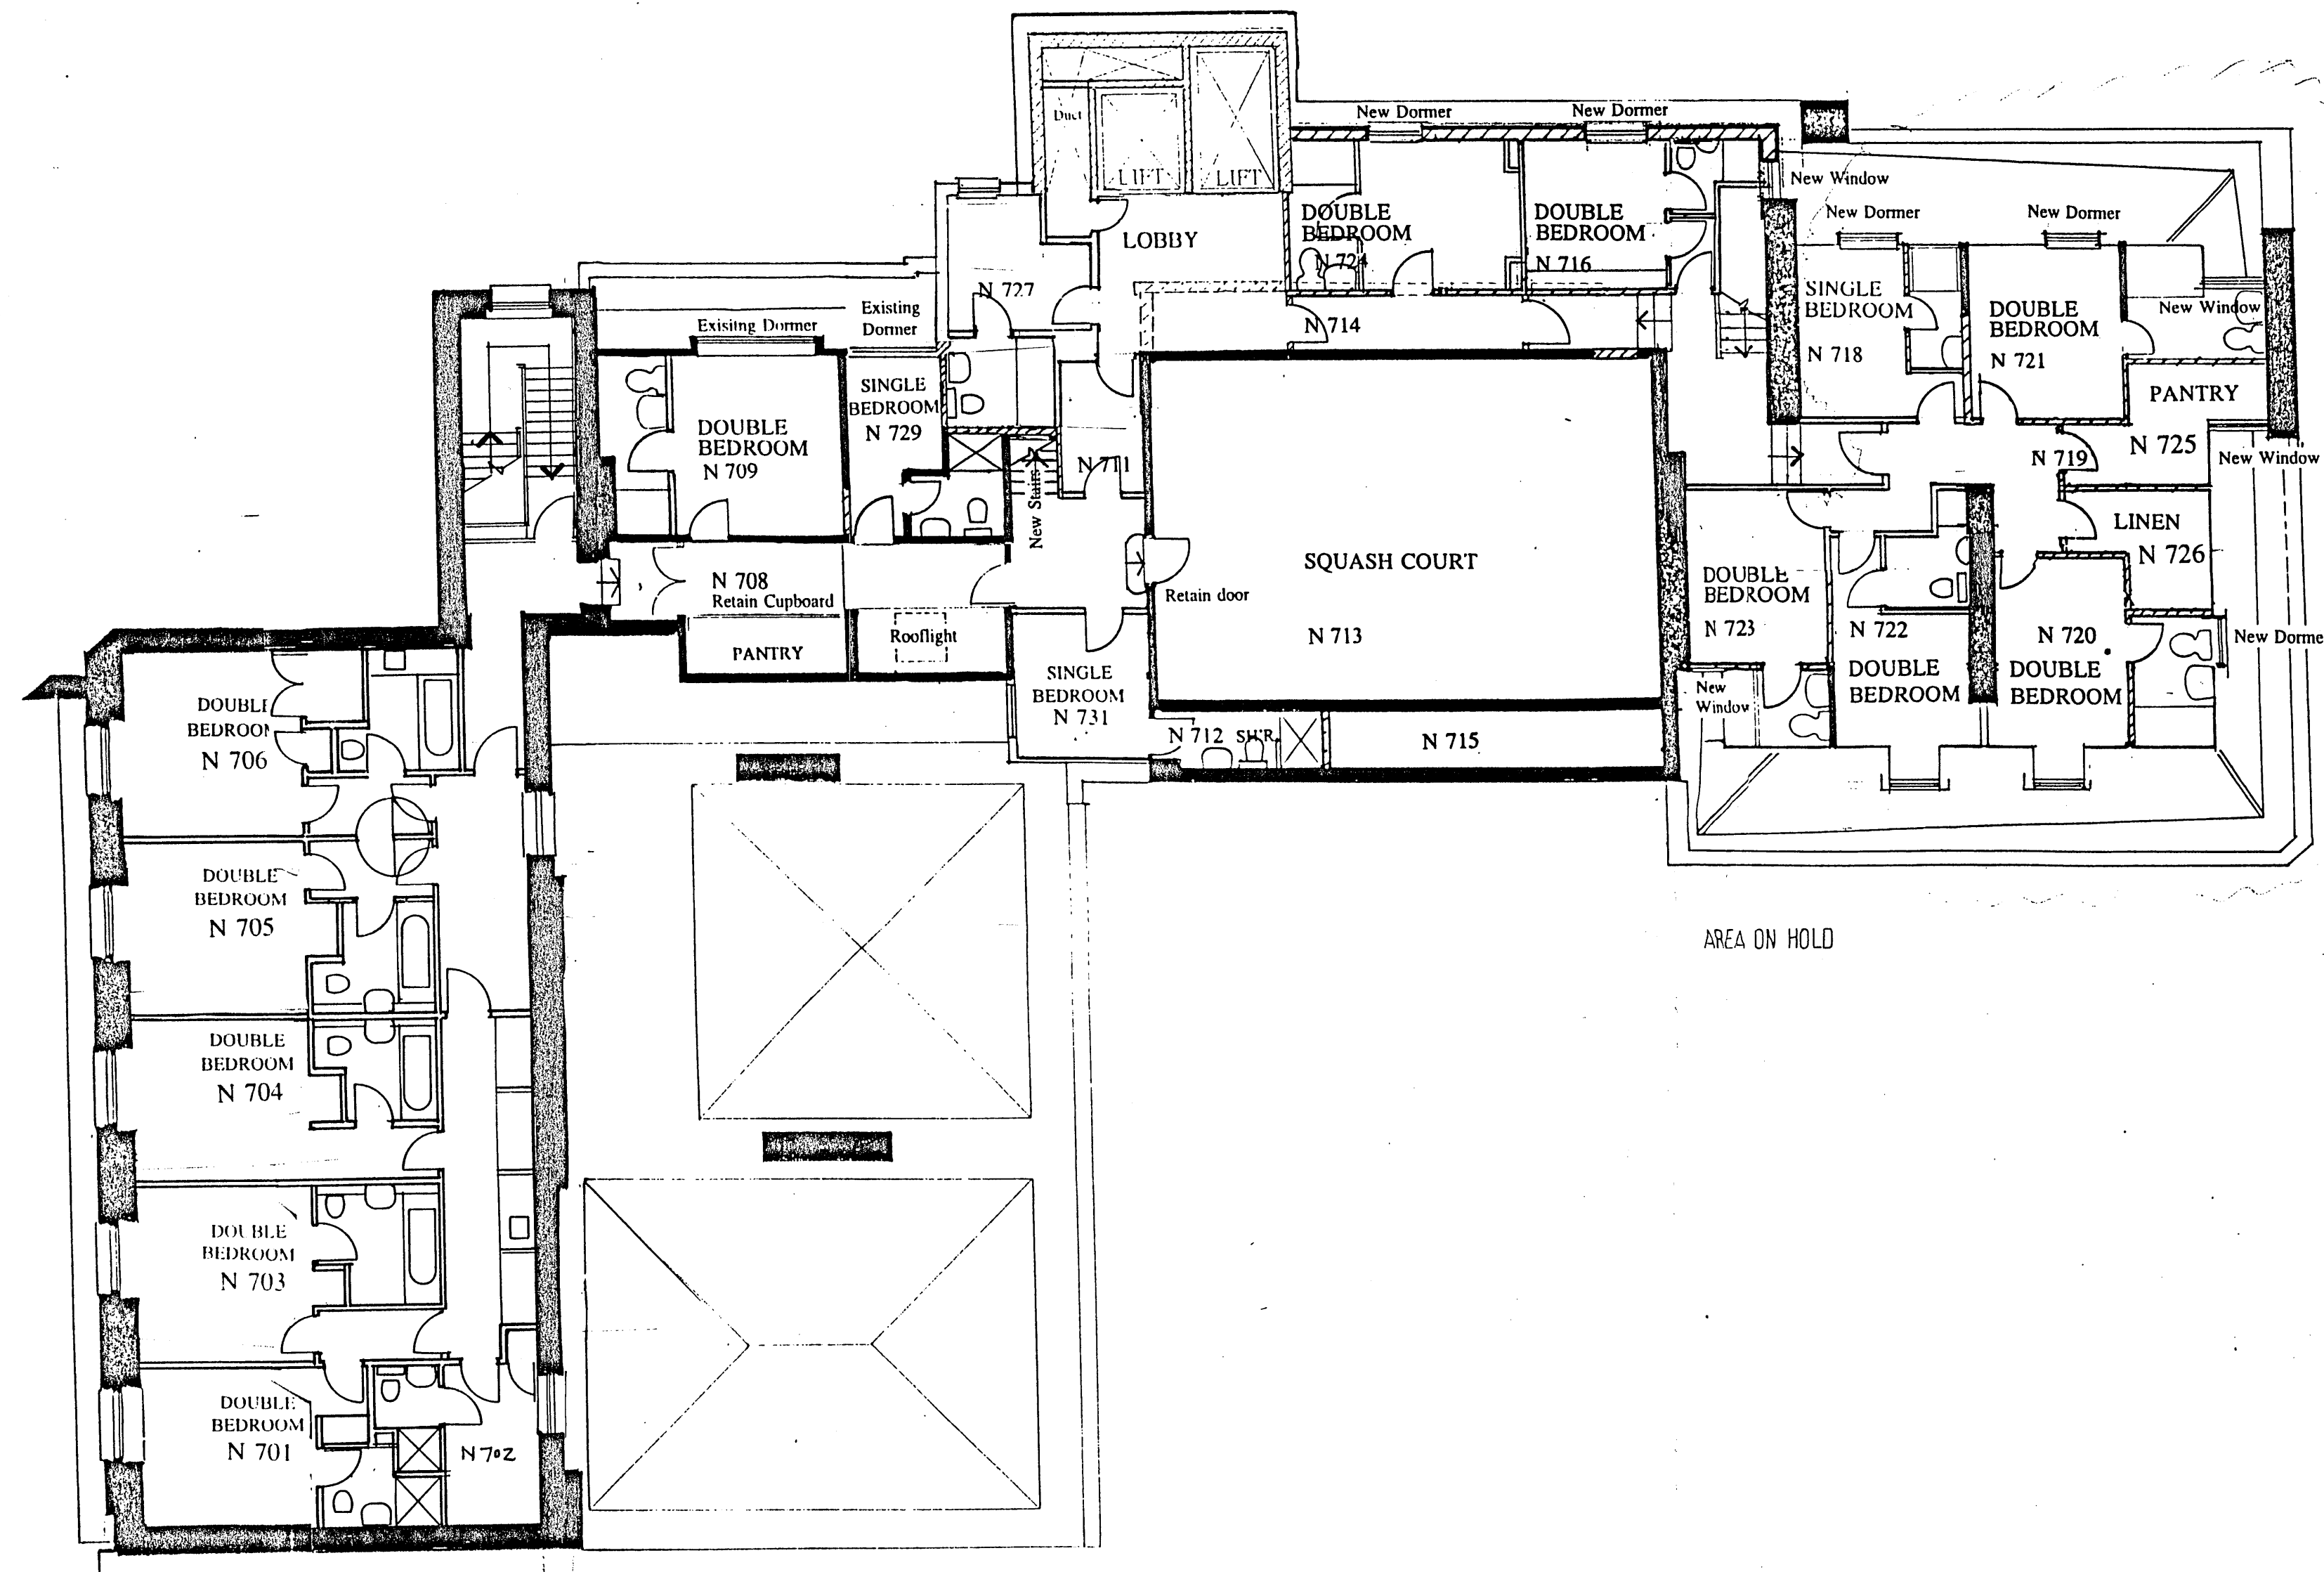
drawing no. **SJ/D 006/amendment F6**

**LEVEL SEVEN  
TOP FLOOR**

Principal Amendments between Series E and Series F.

- N 701-N 706 Bedroom layout modified.
- N 730 New window modified.
- Escape amended
- N 710 Male changing relocated
- Double bedroom added
- N 711 Stair to viewing gallery modified
- Lift tower modified
- Enclosure extended - single bedroom added.
- N 712 Female change relocated
- Single bedroom added
- N 717 stair modified
- N 724 Bedroom modified
- N 725 Pantry enlarged
- N 726 Linen added
- N 722/720 Rooflights added
- Bathroom layout modified.

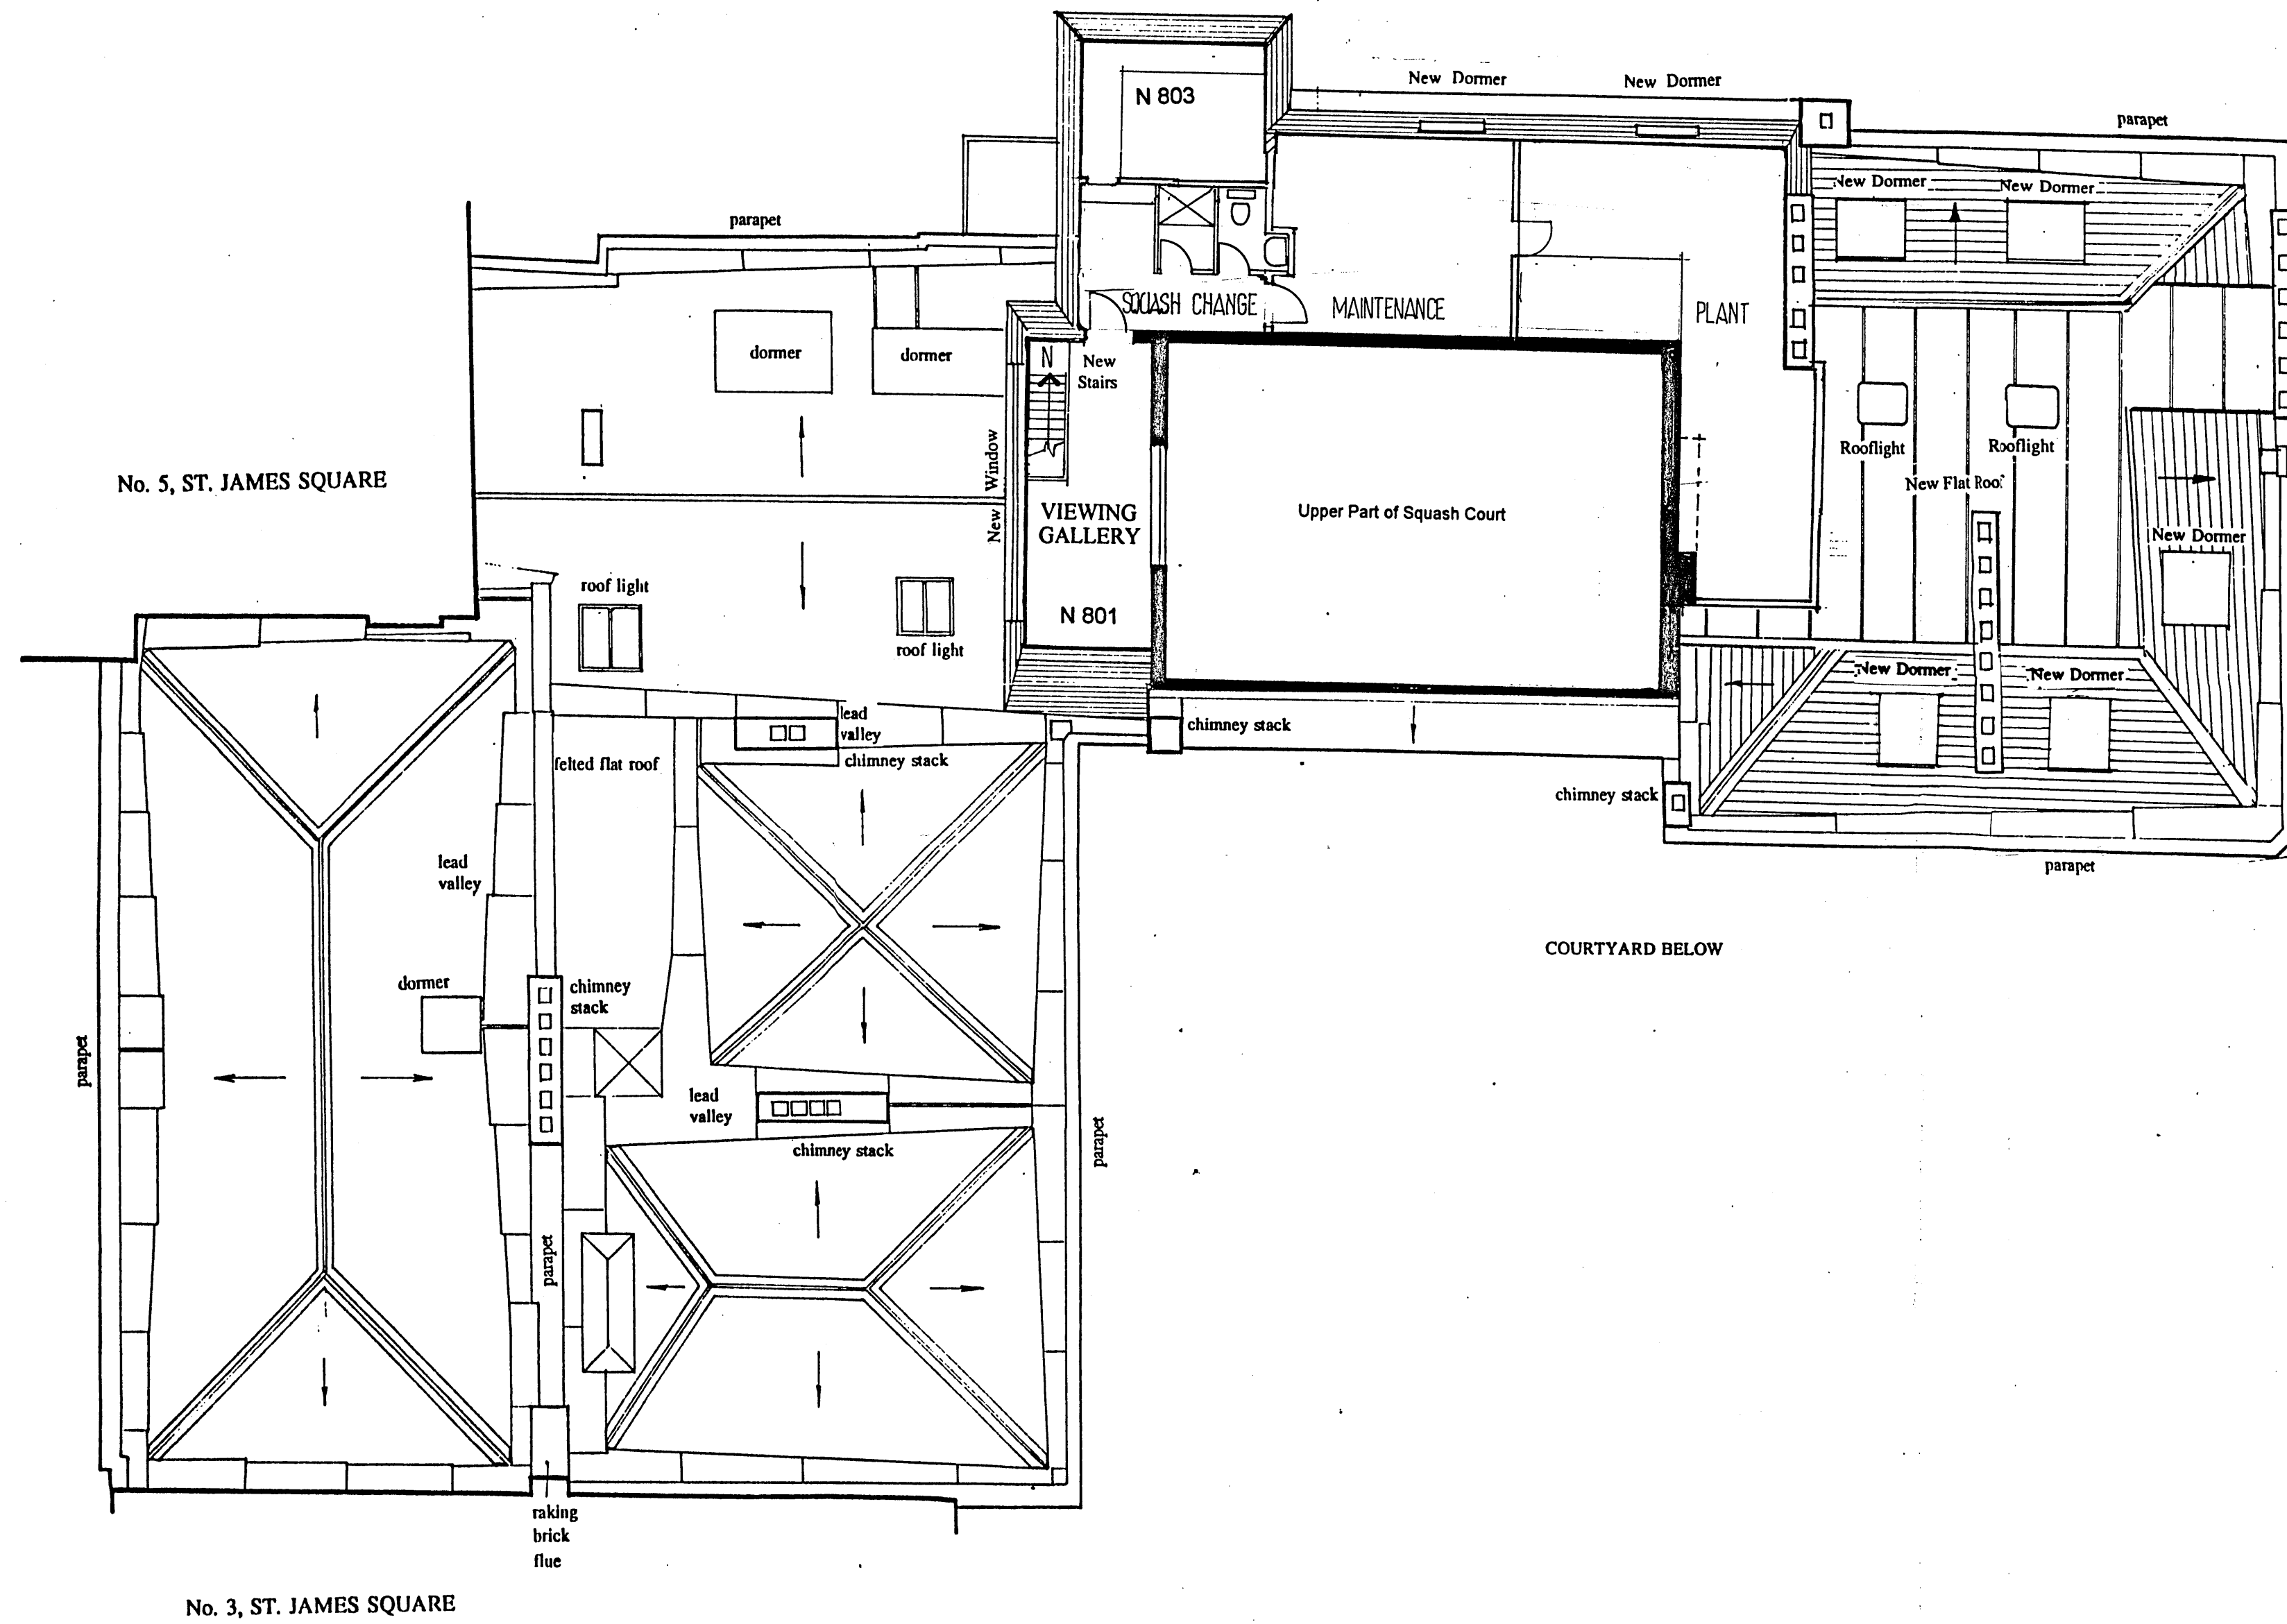
drawing no. **SJ/D 007/F6** FOURTH FLOOR/ROOF PLAN

- close hatching indicates new steeply-pitched slate
- wider hatching indicates new low-pitched slate
- parallel coupled lines indicate diagrammatically the rolls of sheet metal "flat" roofs:
- chimneys are shown in heavy outline
- falls of roofs are indicated by arrows
- on stairs all arrows indicate UP
- all areas diagonally hatched indicate new construction
- all areas diagonally broken-hatched indicate removal of existing work

**ROOF PLAN**

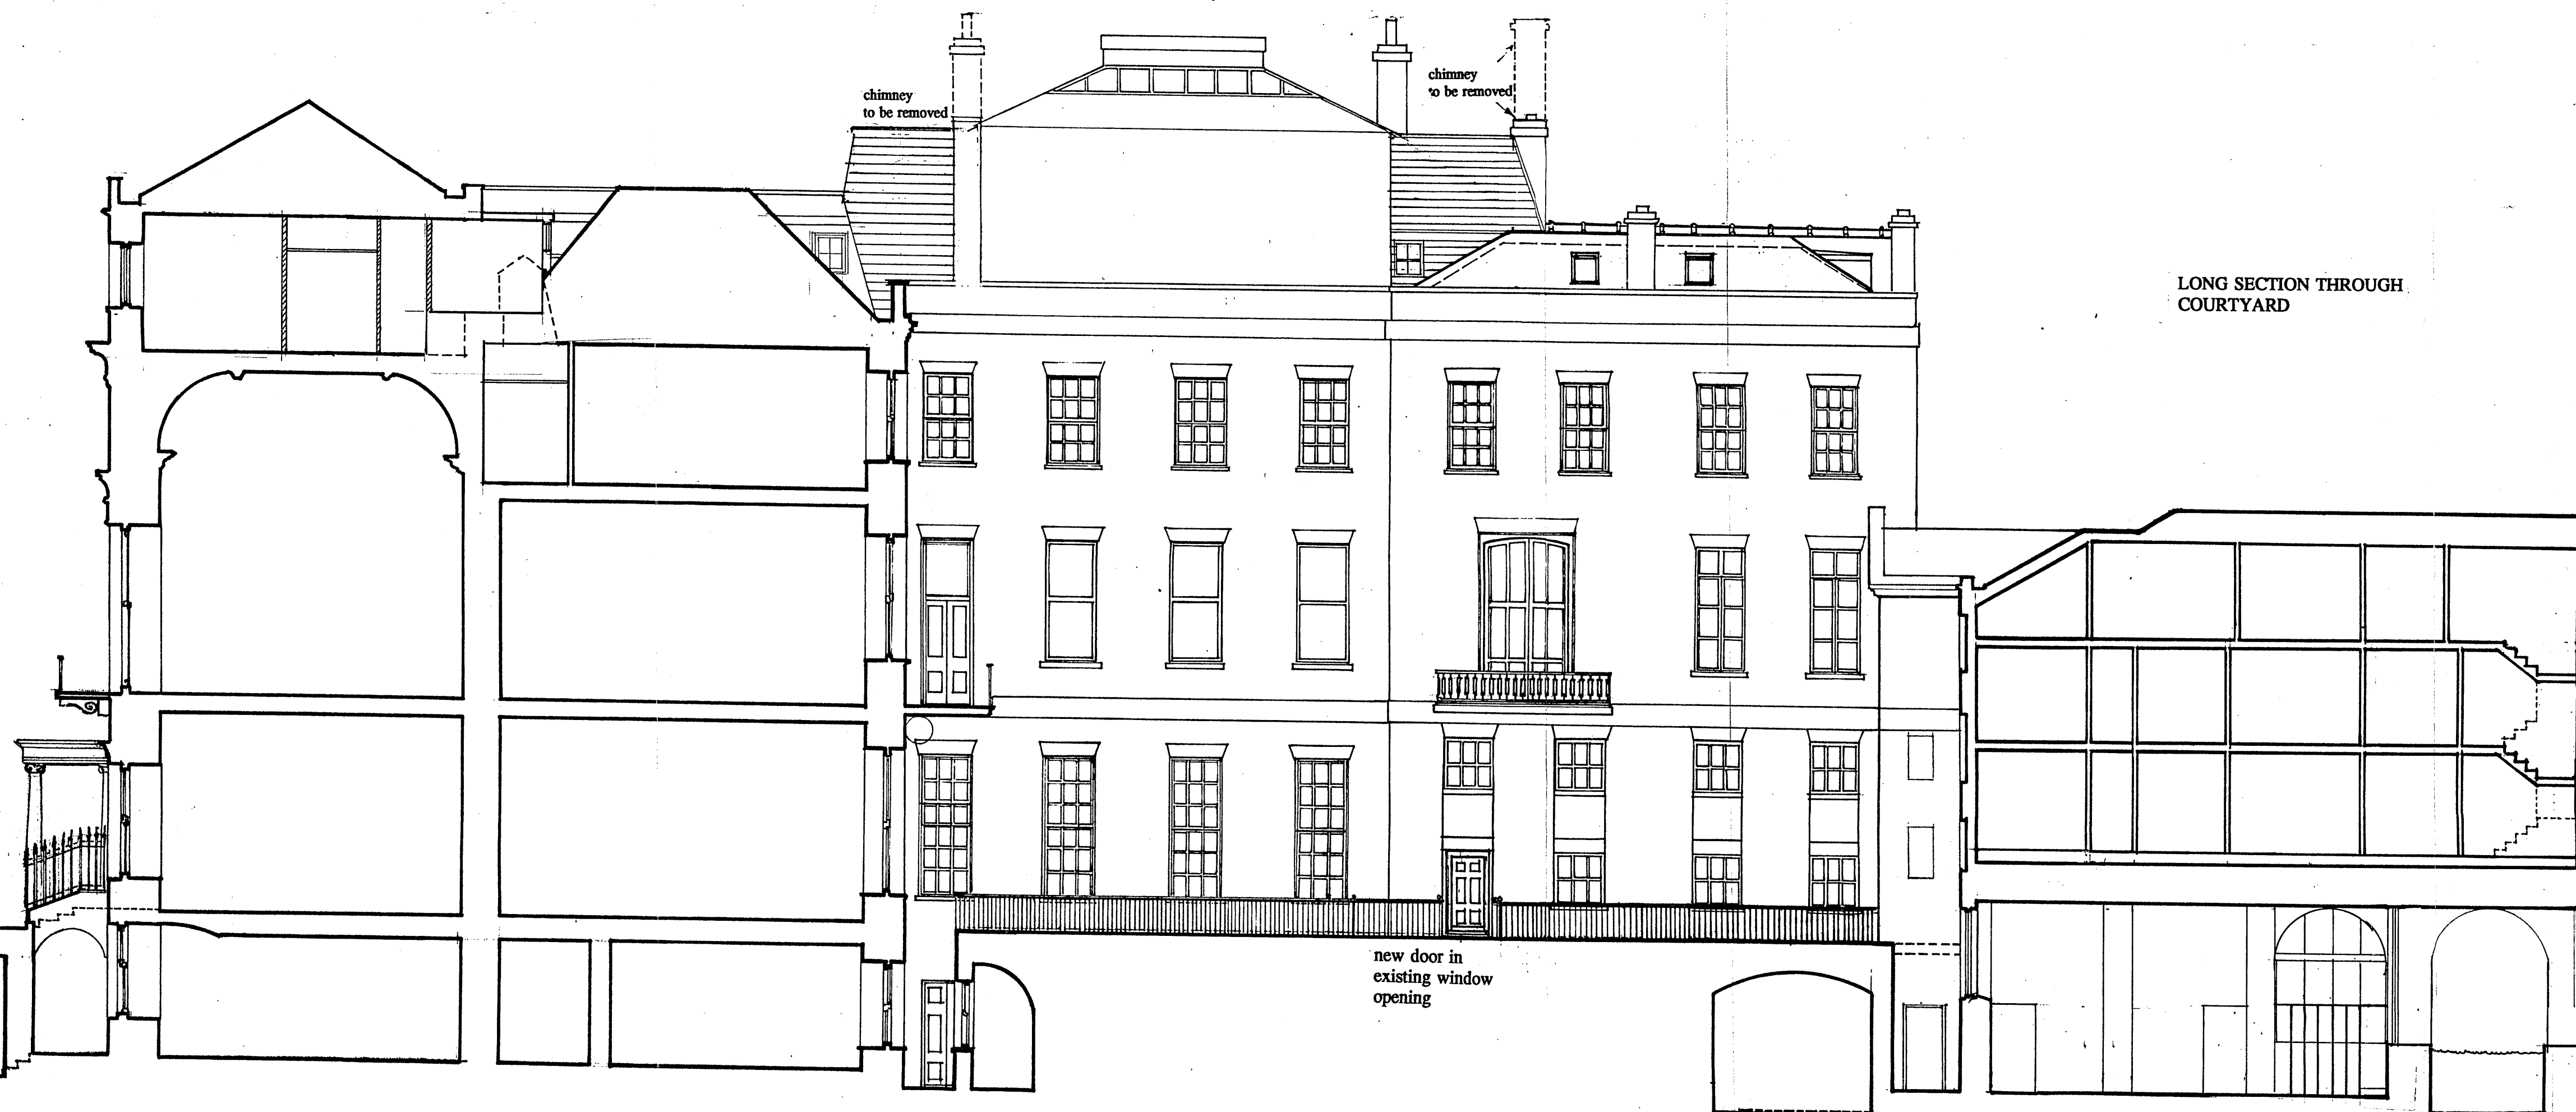
drawing no. SJ/D 009/ amendment F1

LONG SECTION THROUGH  
COURTYARD

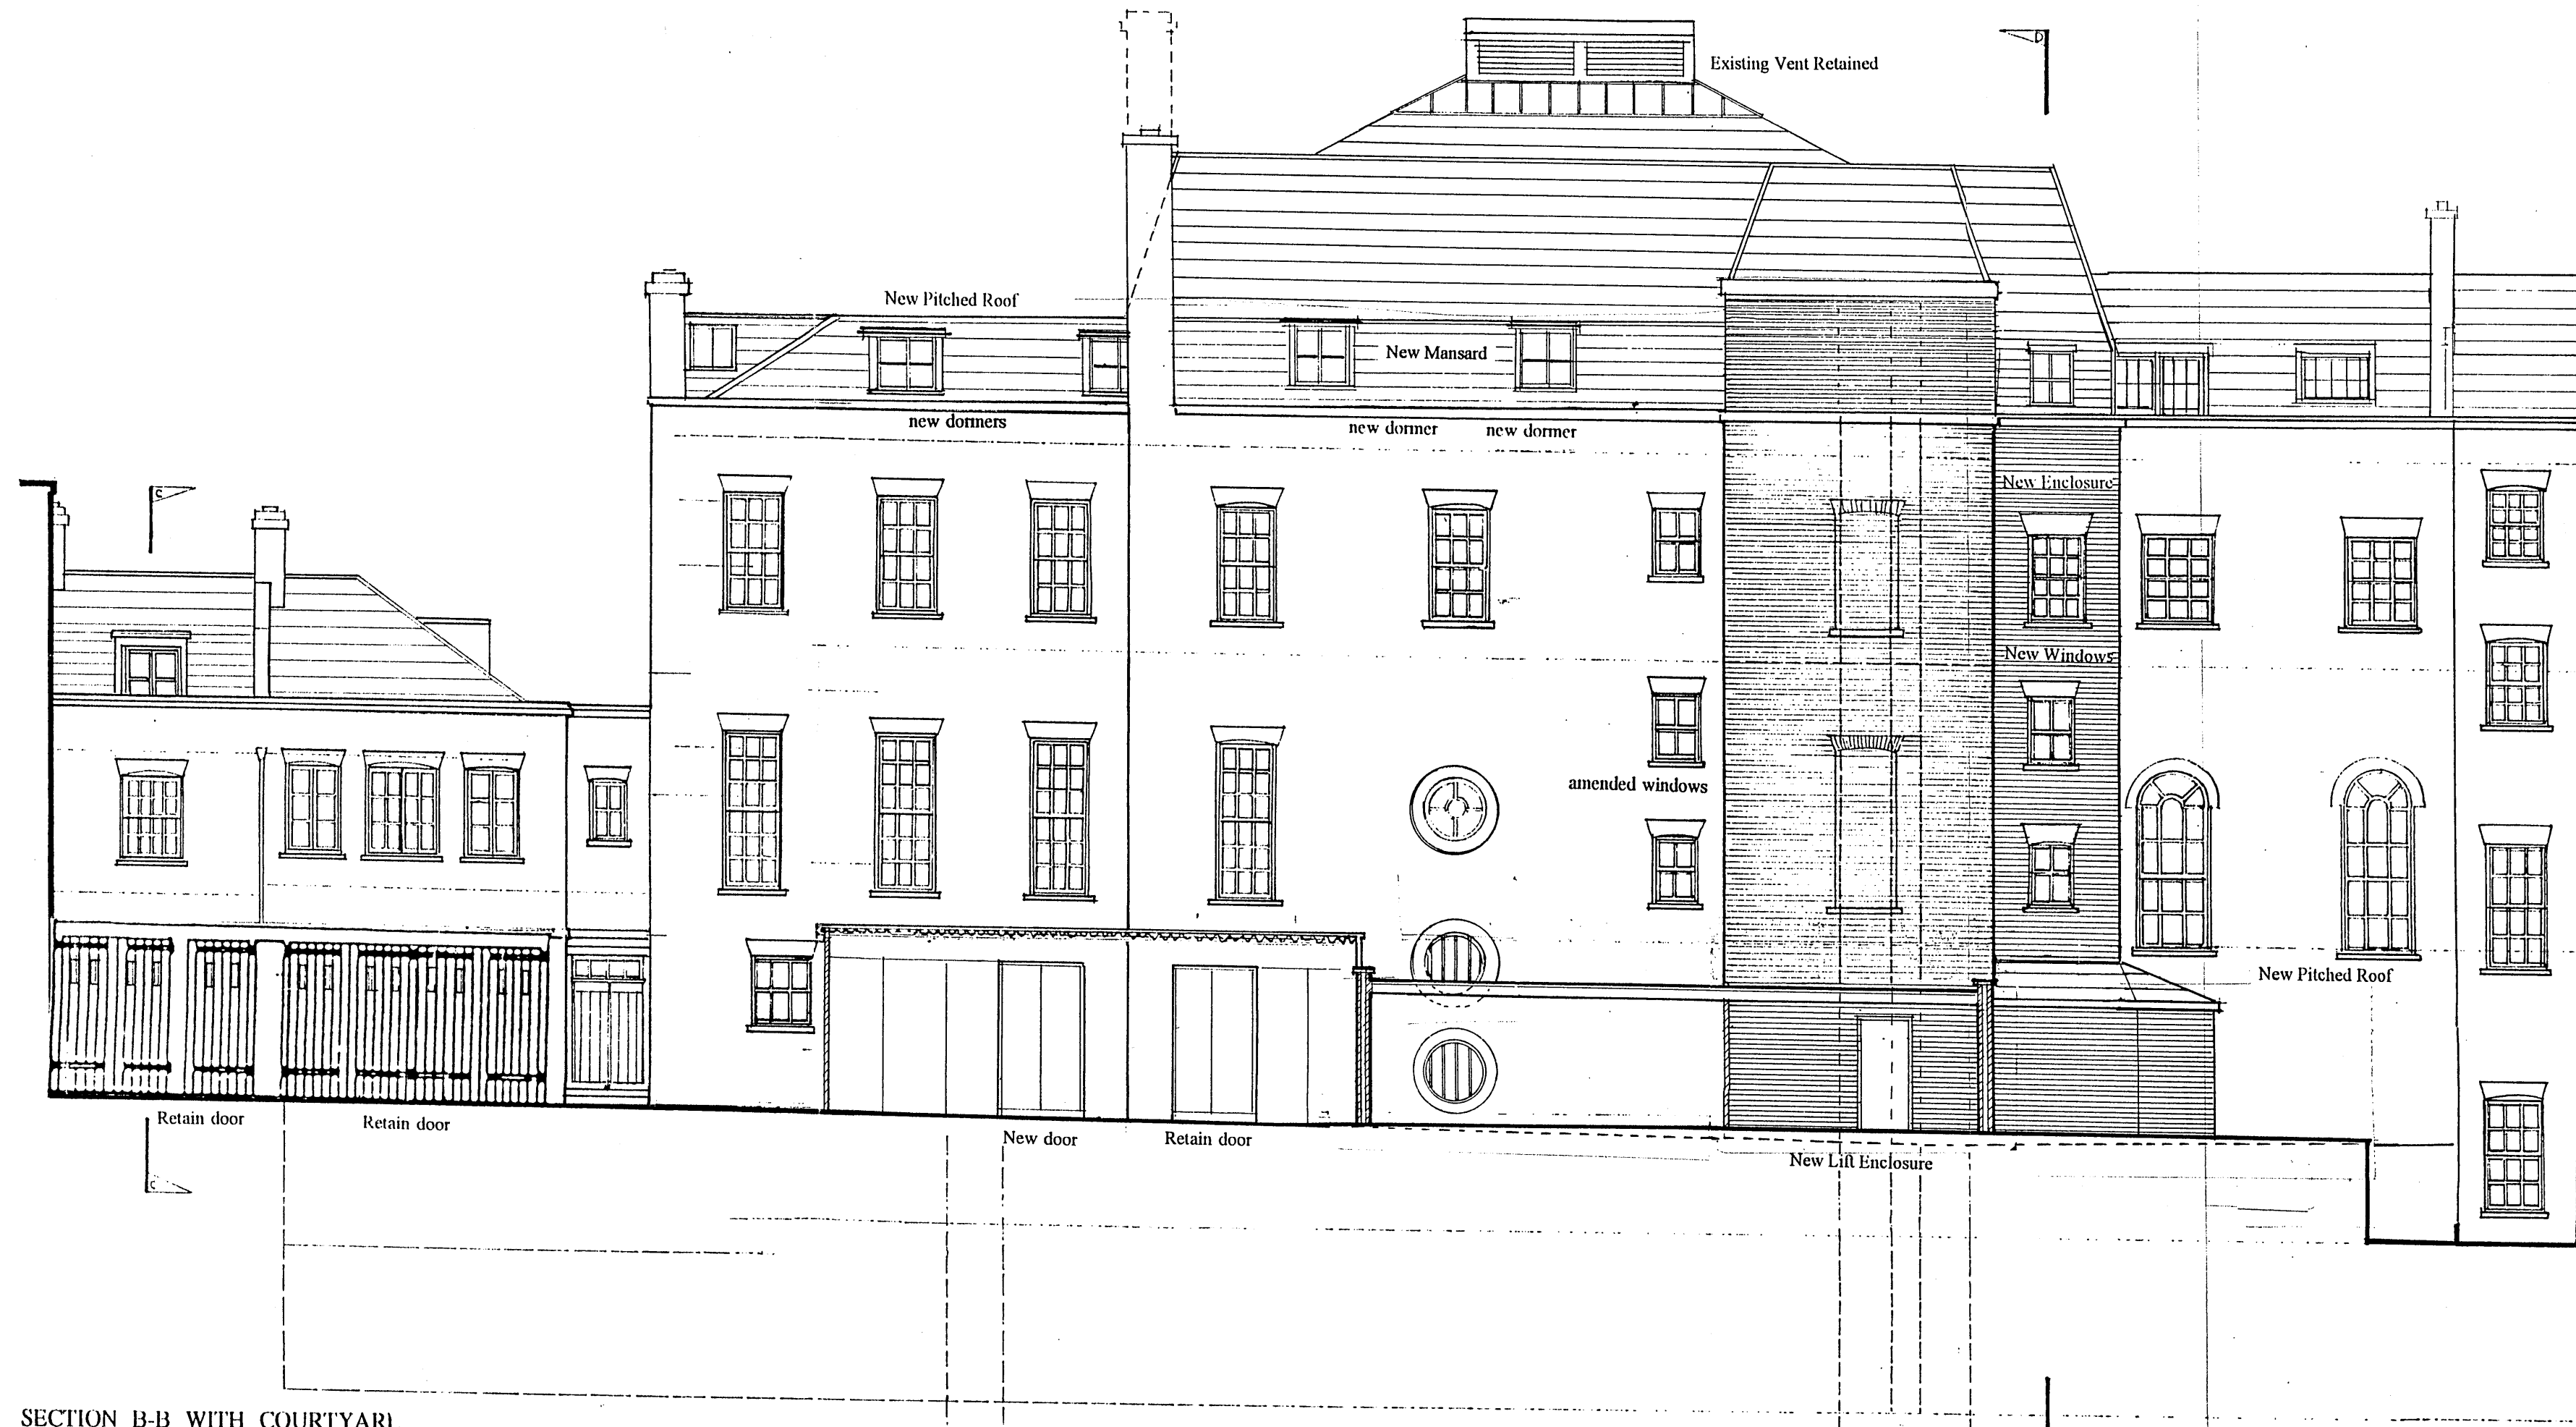
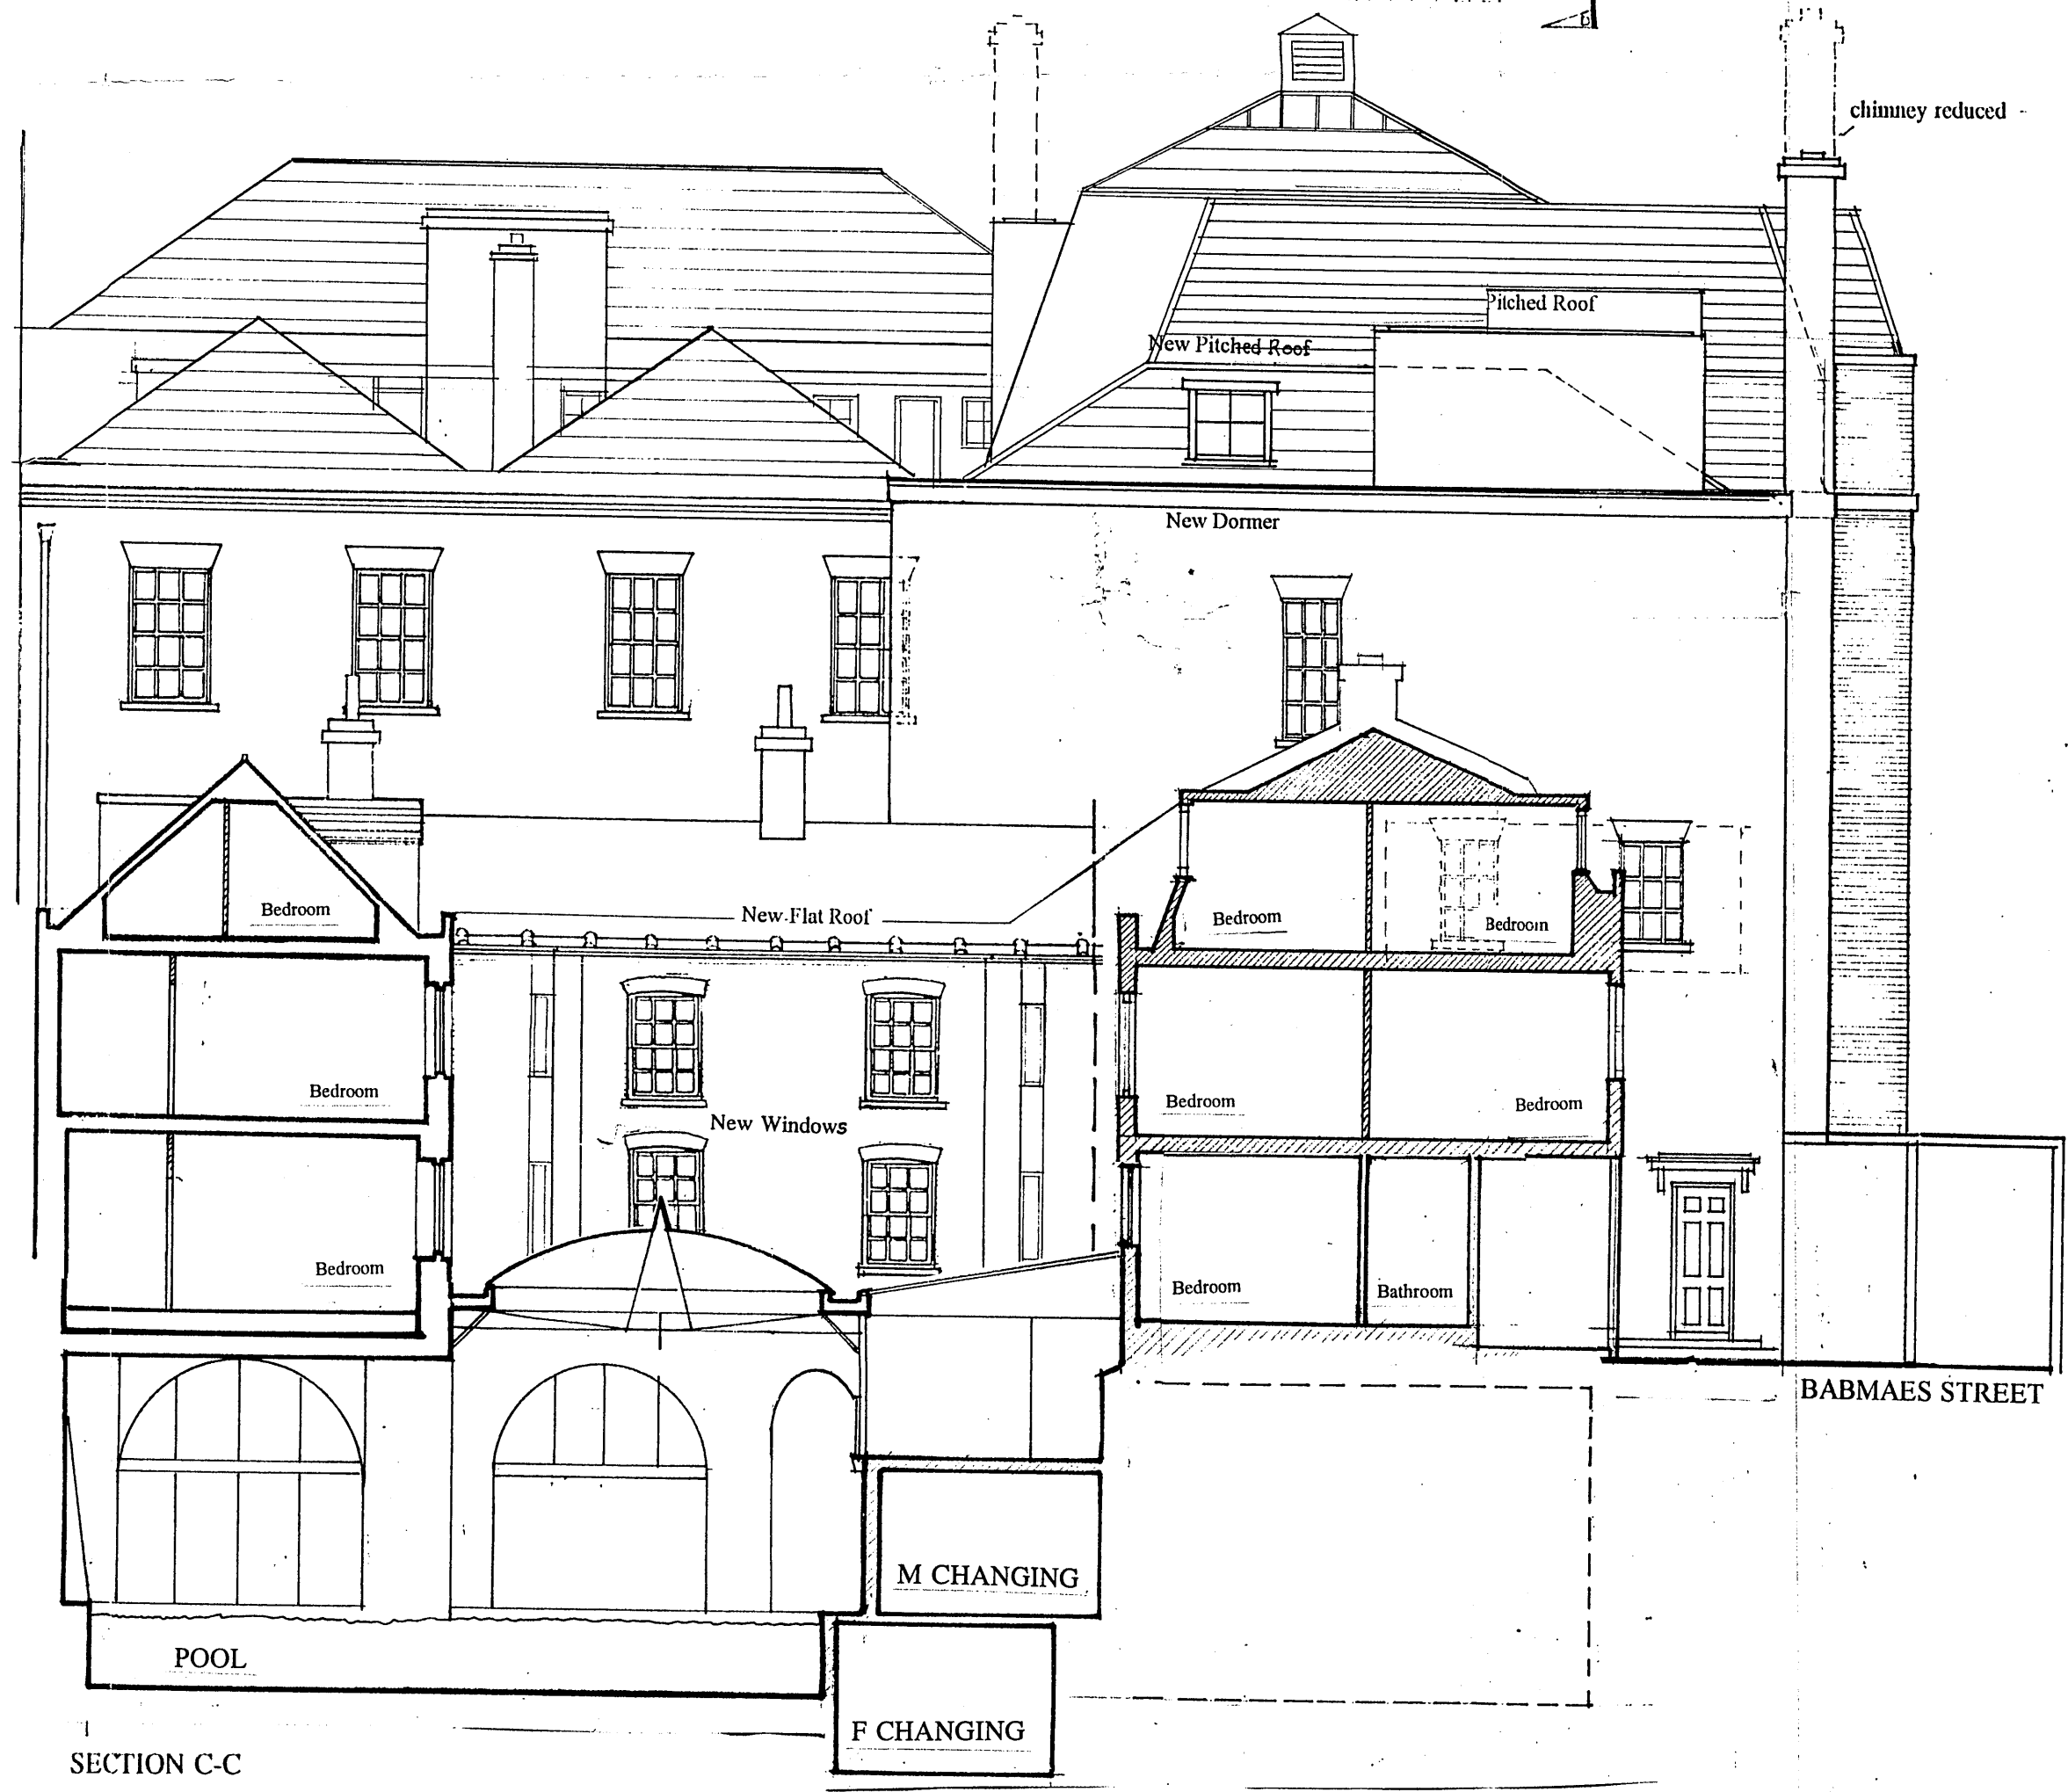
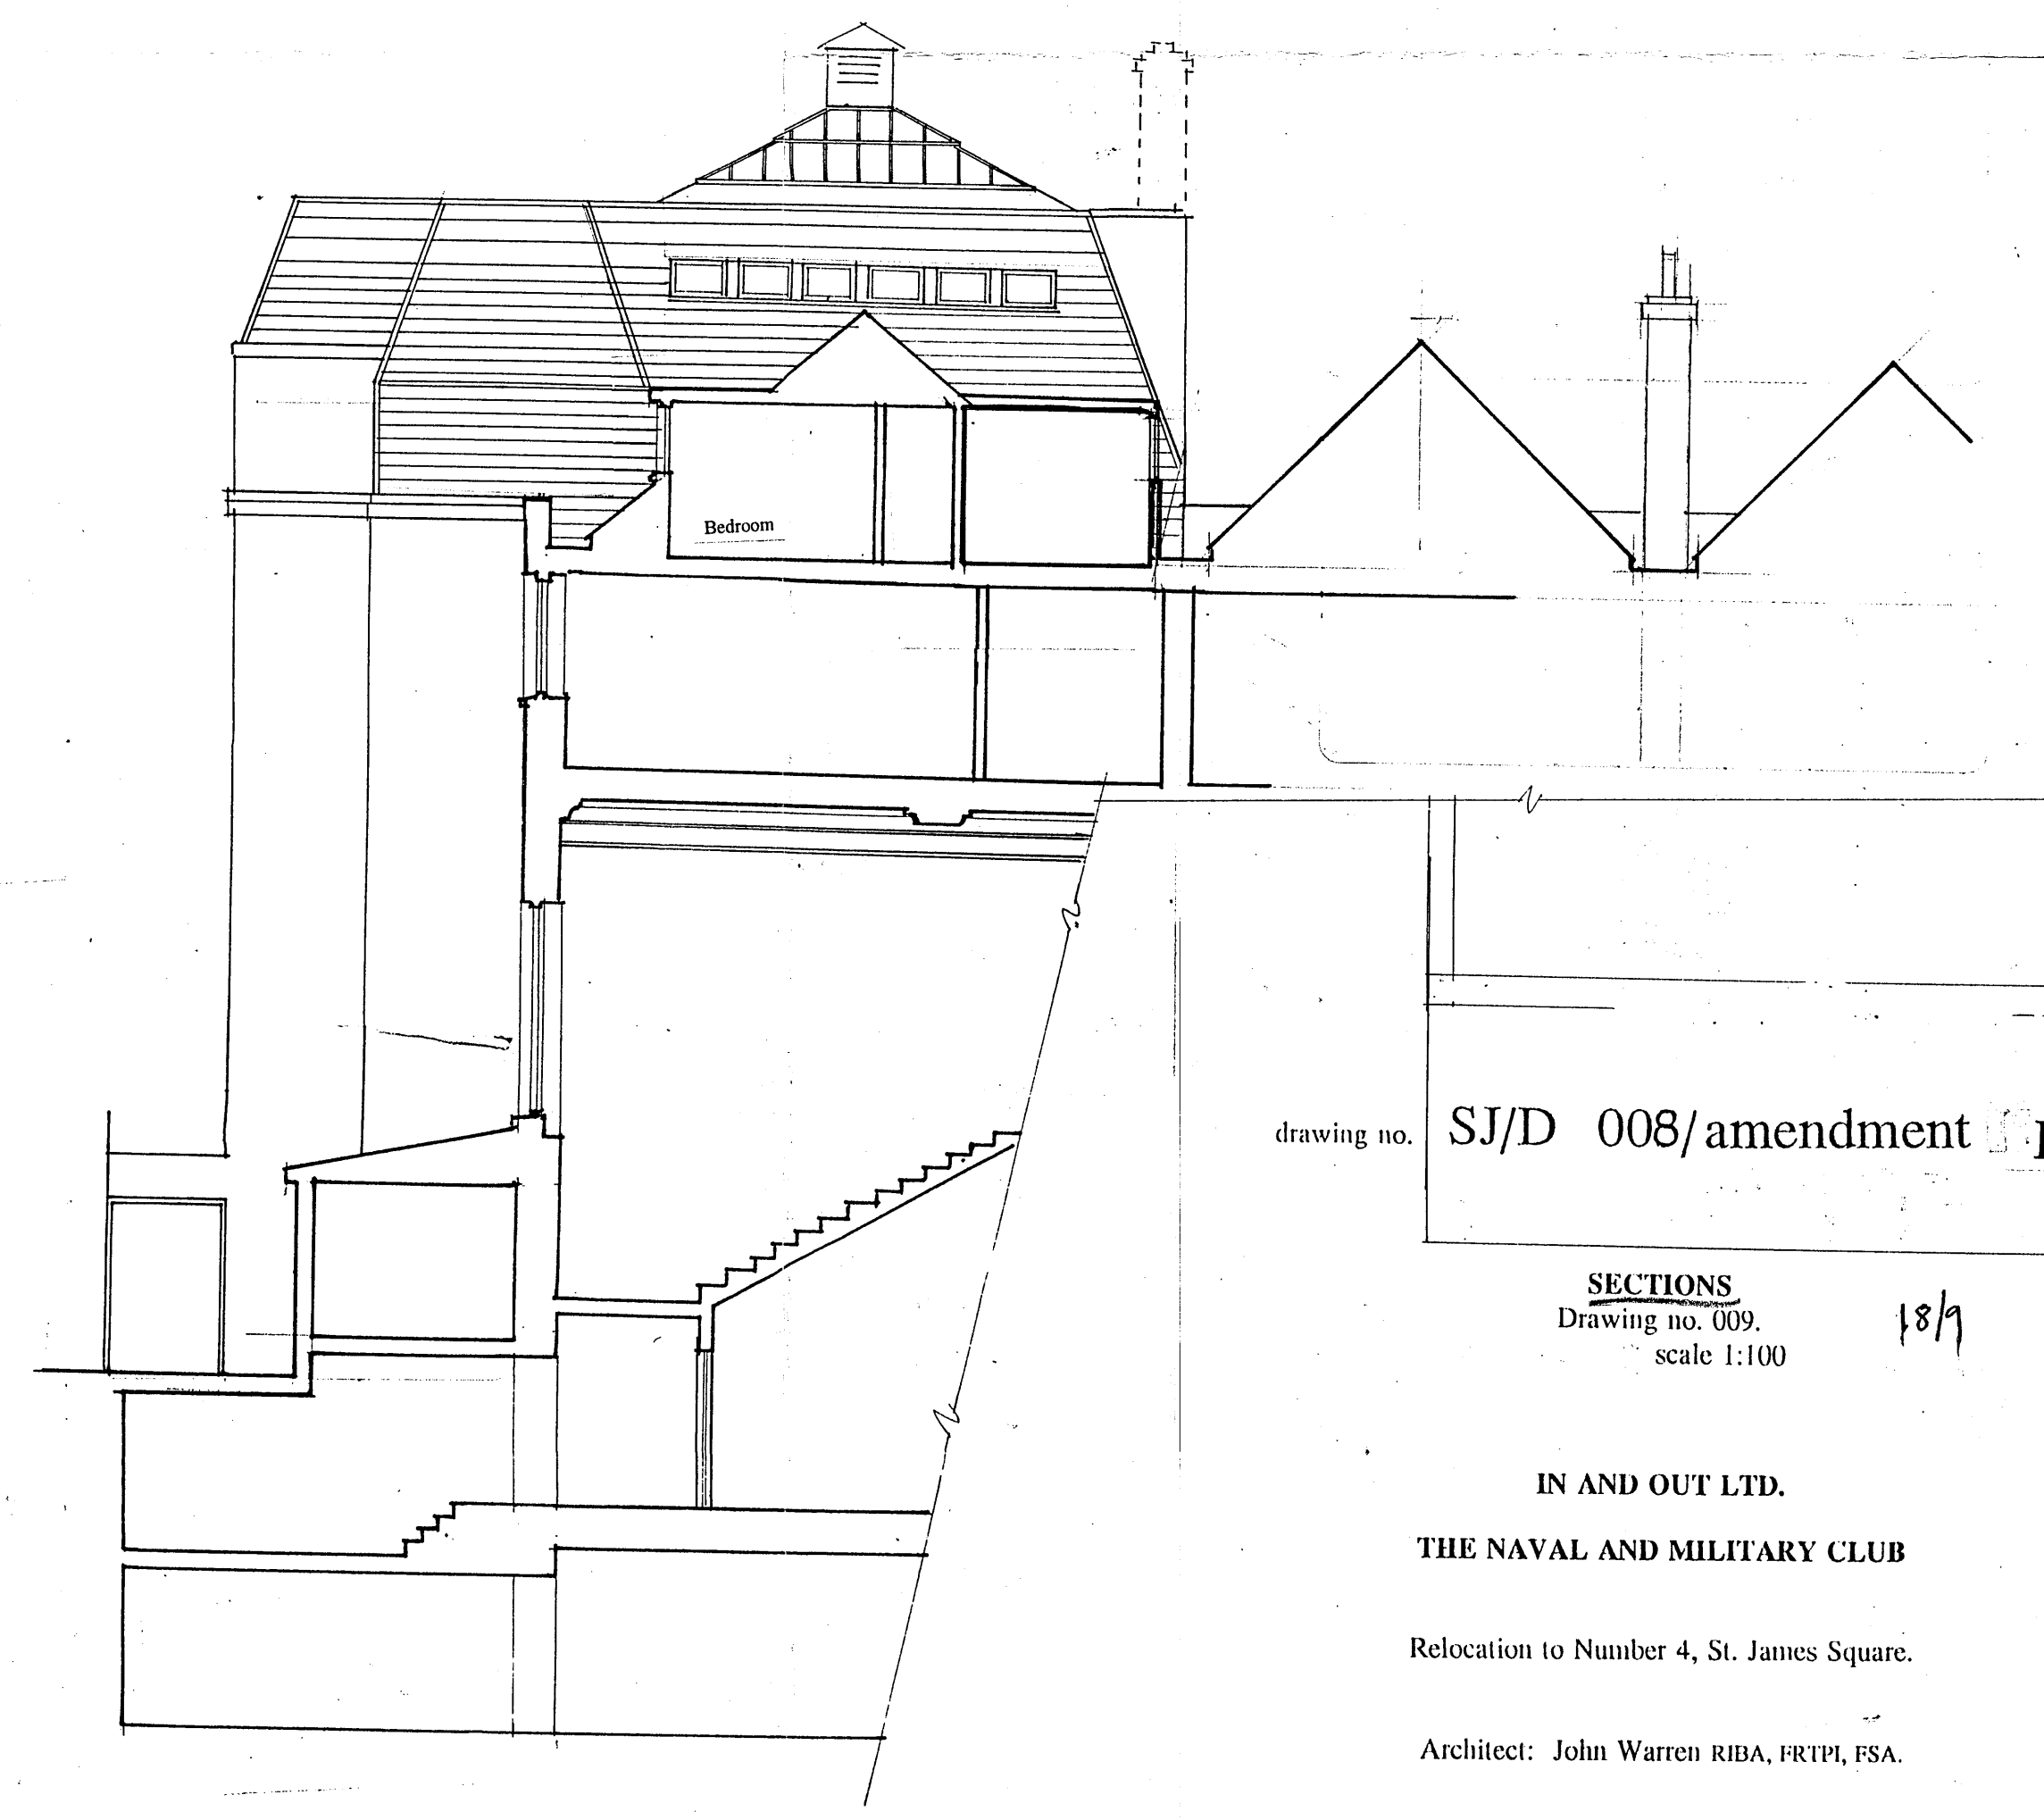
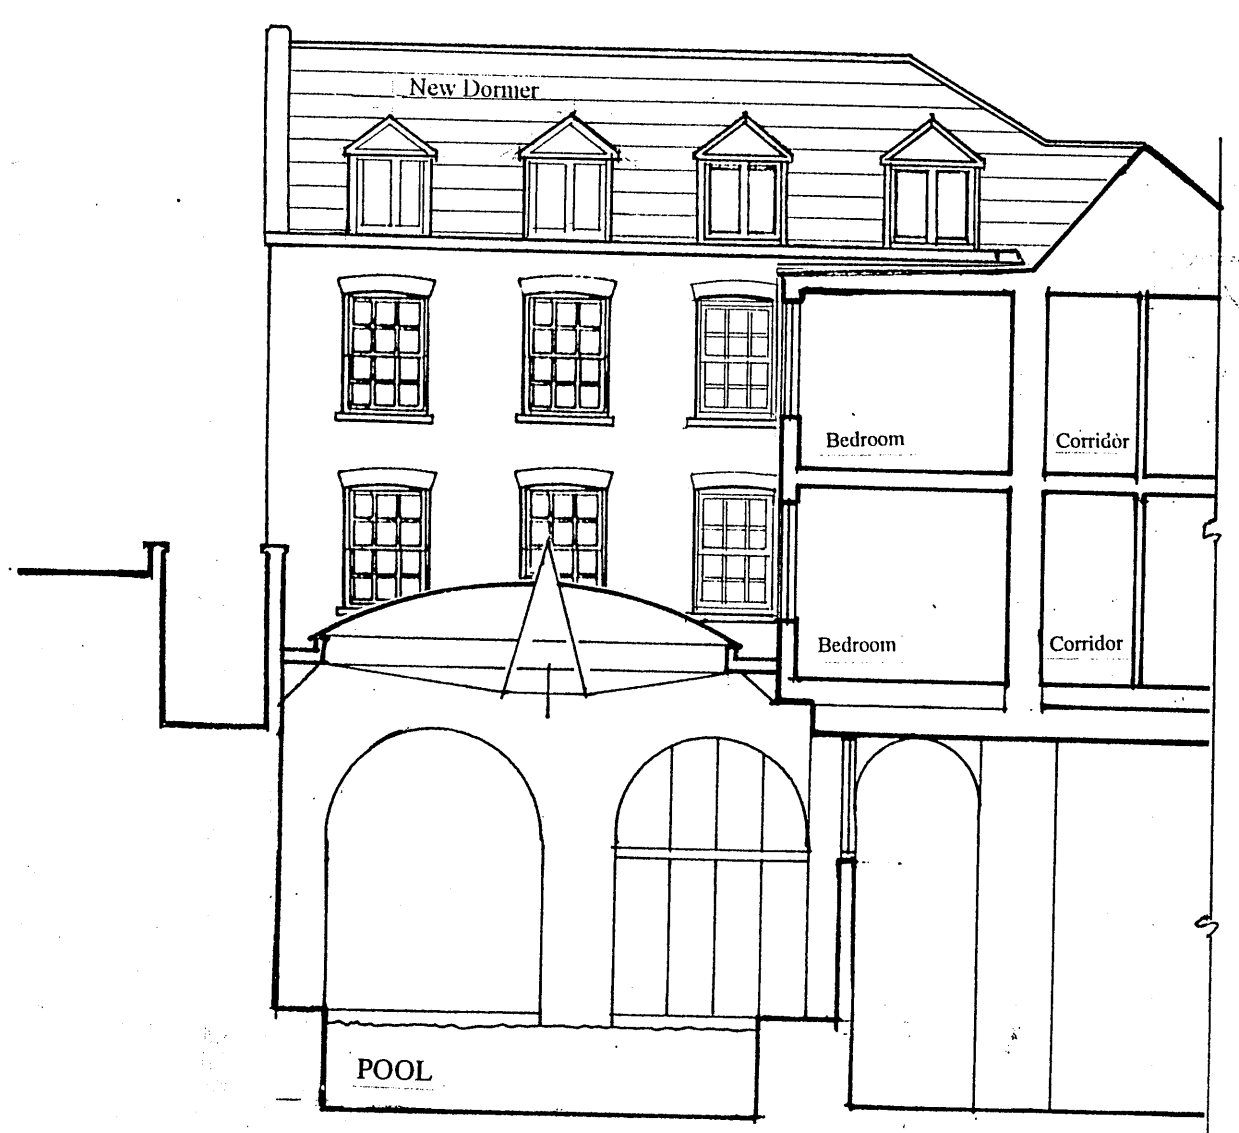
drawing no. SJ/D 008/amendment F1

SECTION B-B WITH COURTYARD ELEVATION

SECTION C-C

SECTION D-D

SECTION A-A
