WESTMINSTER  
4 ST. JAMES SQUARE  
SJQ 97

Line 1: [OASouth] County:[Greater London] Parish:[Westminster] Site:[4 St James Square]

**IN AND OUT LTD.**  
**THE NAVAL AND MILITARY CLUB**  
Relocation to Number 4, St. James Square.  
Architect: John Warren RIBA, FRPI, FSA.  
Quantity Surveyor: David Connolly FRICS.  
Franklin and Andrews

Oxford Archaeological Unit  
Architectural Survey

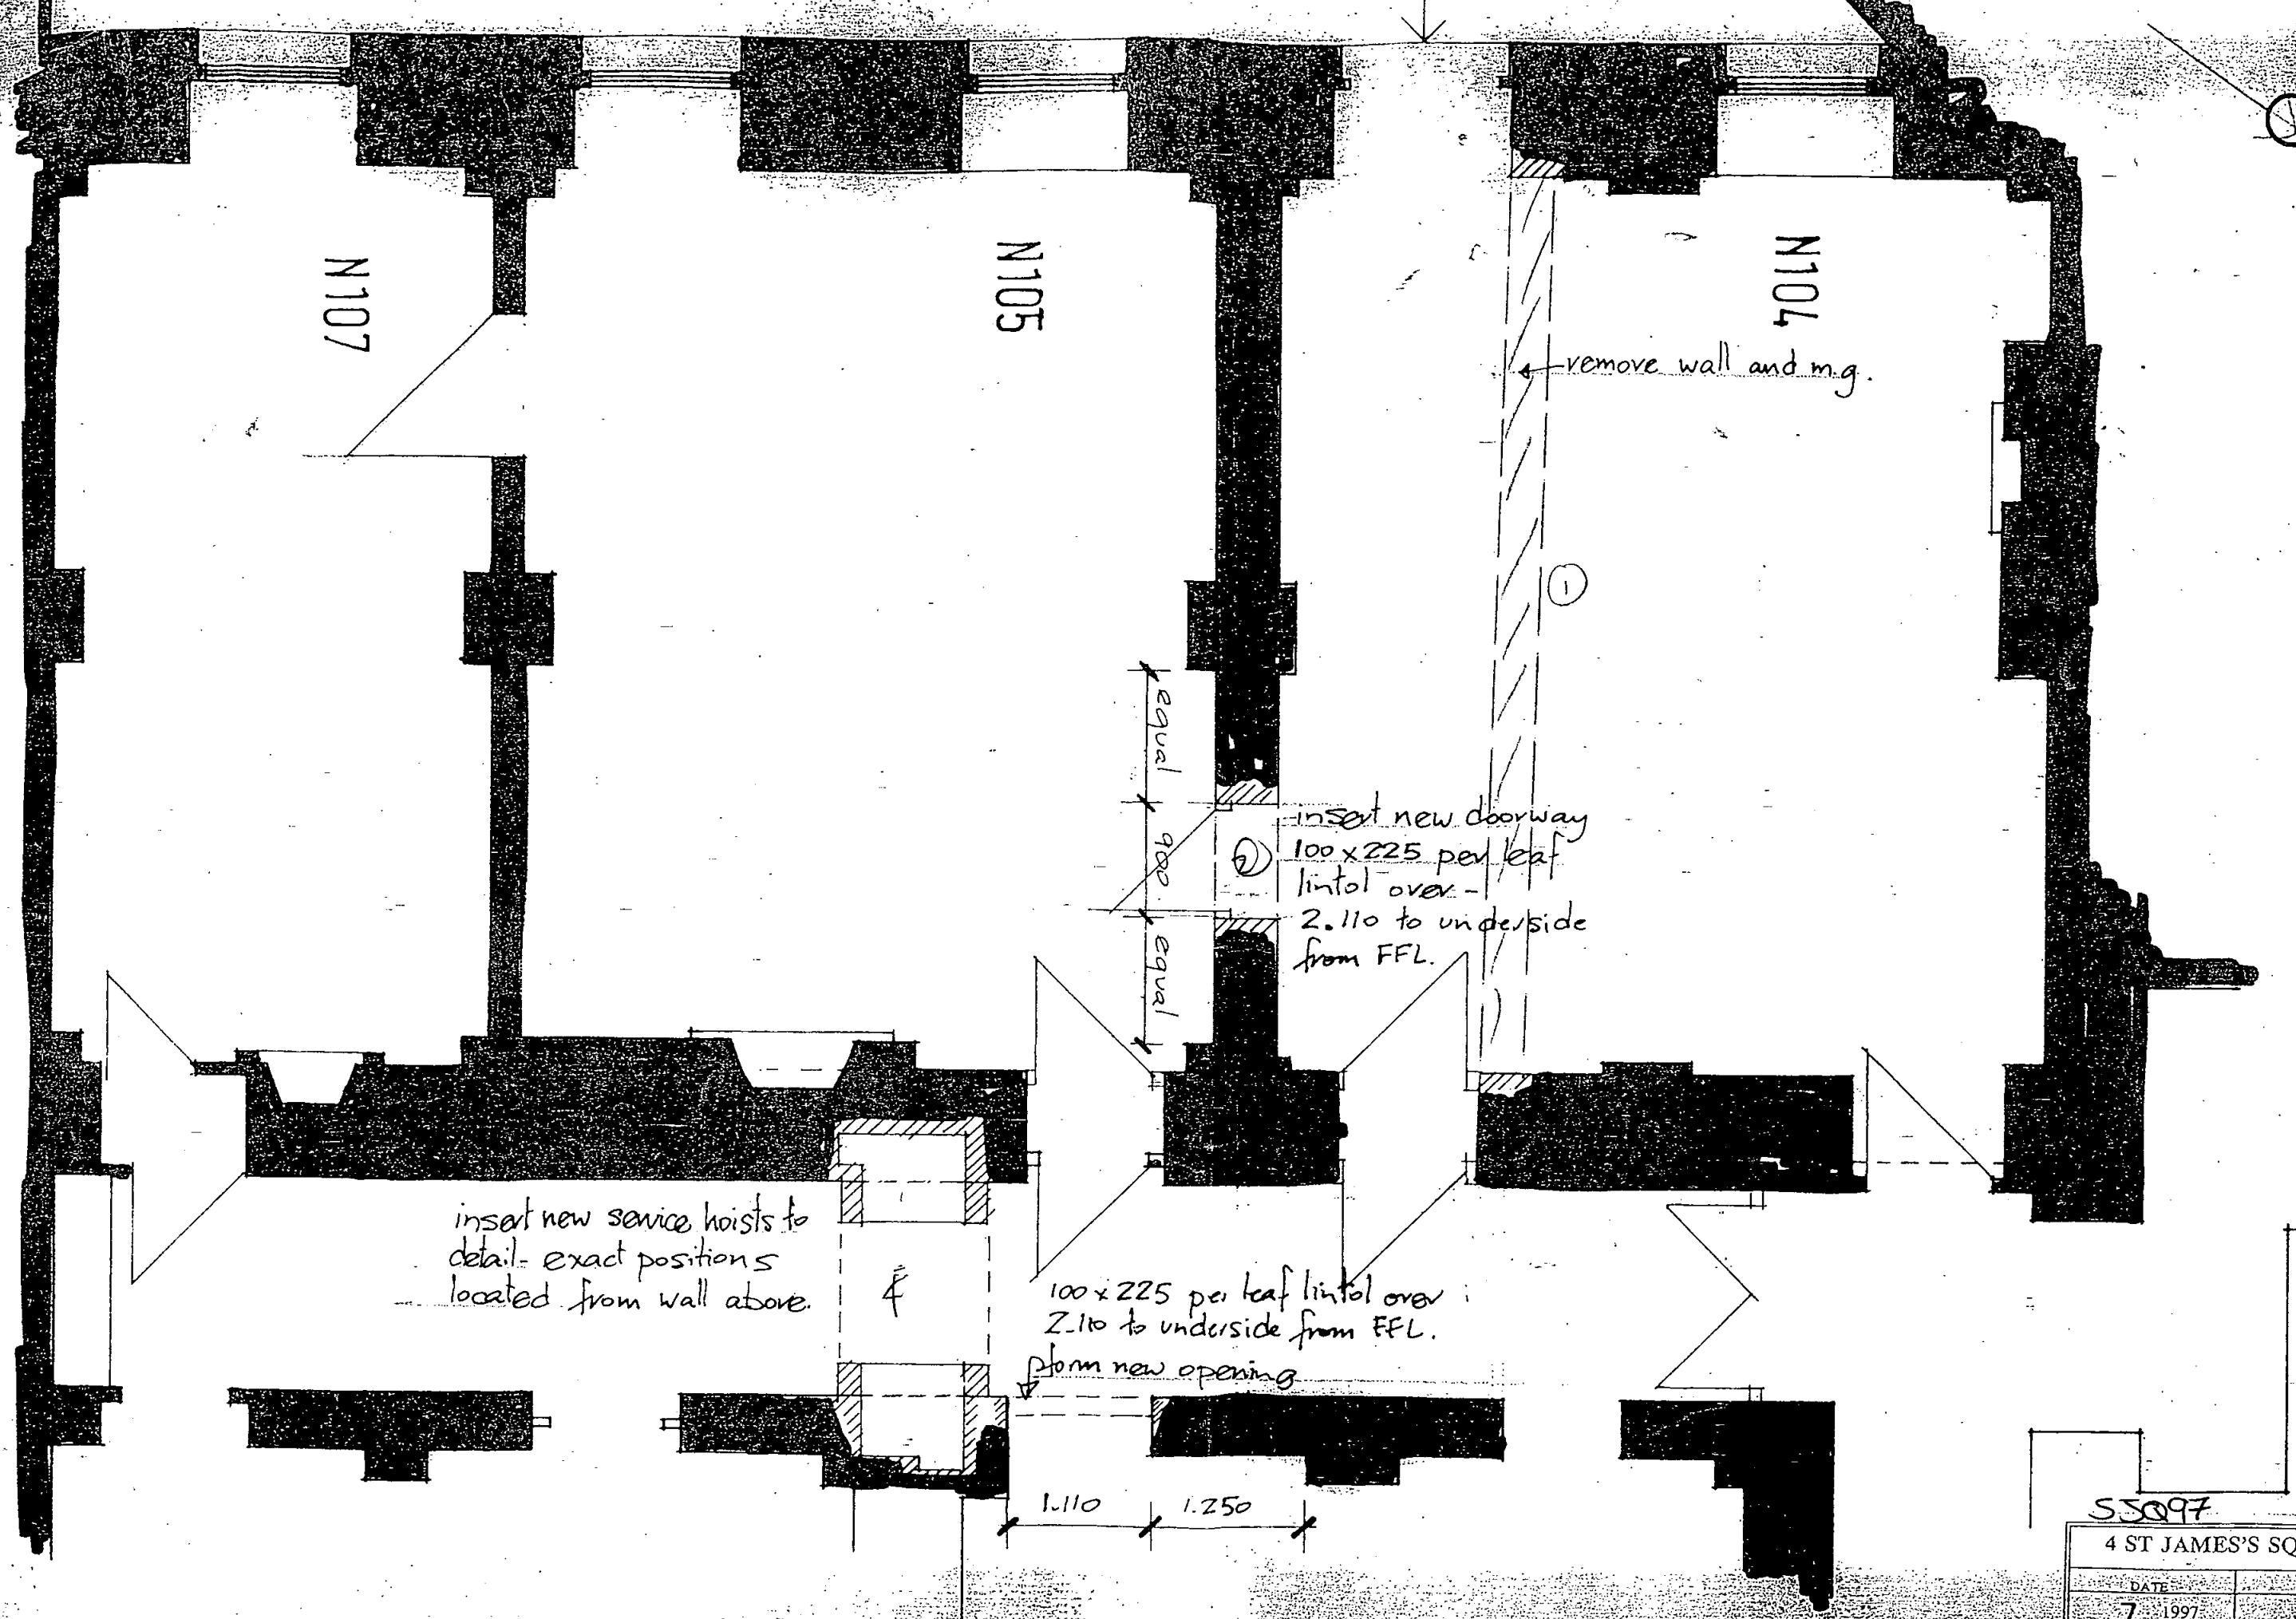
4 ST JAMES'S SQUARE	
DATE	SCALE
7 1997	1:50
LEVEL	DRG NO.
1	818 B

①  
 insert new doorway  
 100 x 225 per leaf  
 lintol over -  
 2.110 to underside  
 from FFL.

insert new service hoists to  
 detail - exact positions  
 located from wall above.

100 x 225 per leaf lintol over  
 2.110 to underside from FFL.  
 Form new opening

form new opening  
2.110 to v/s lintol  
100x225 lintols per  
leaf

service duct in floor - see detail

form new opening  
follow line of duct  
over

remove window and insert  
new door

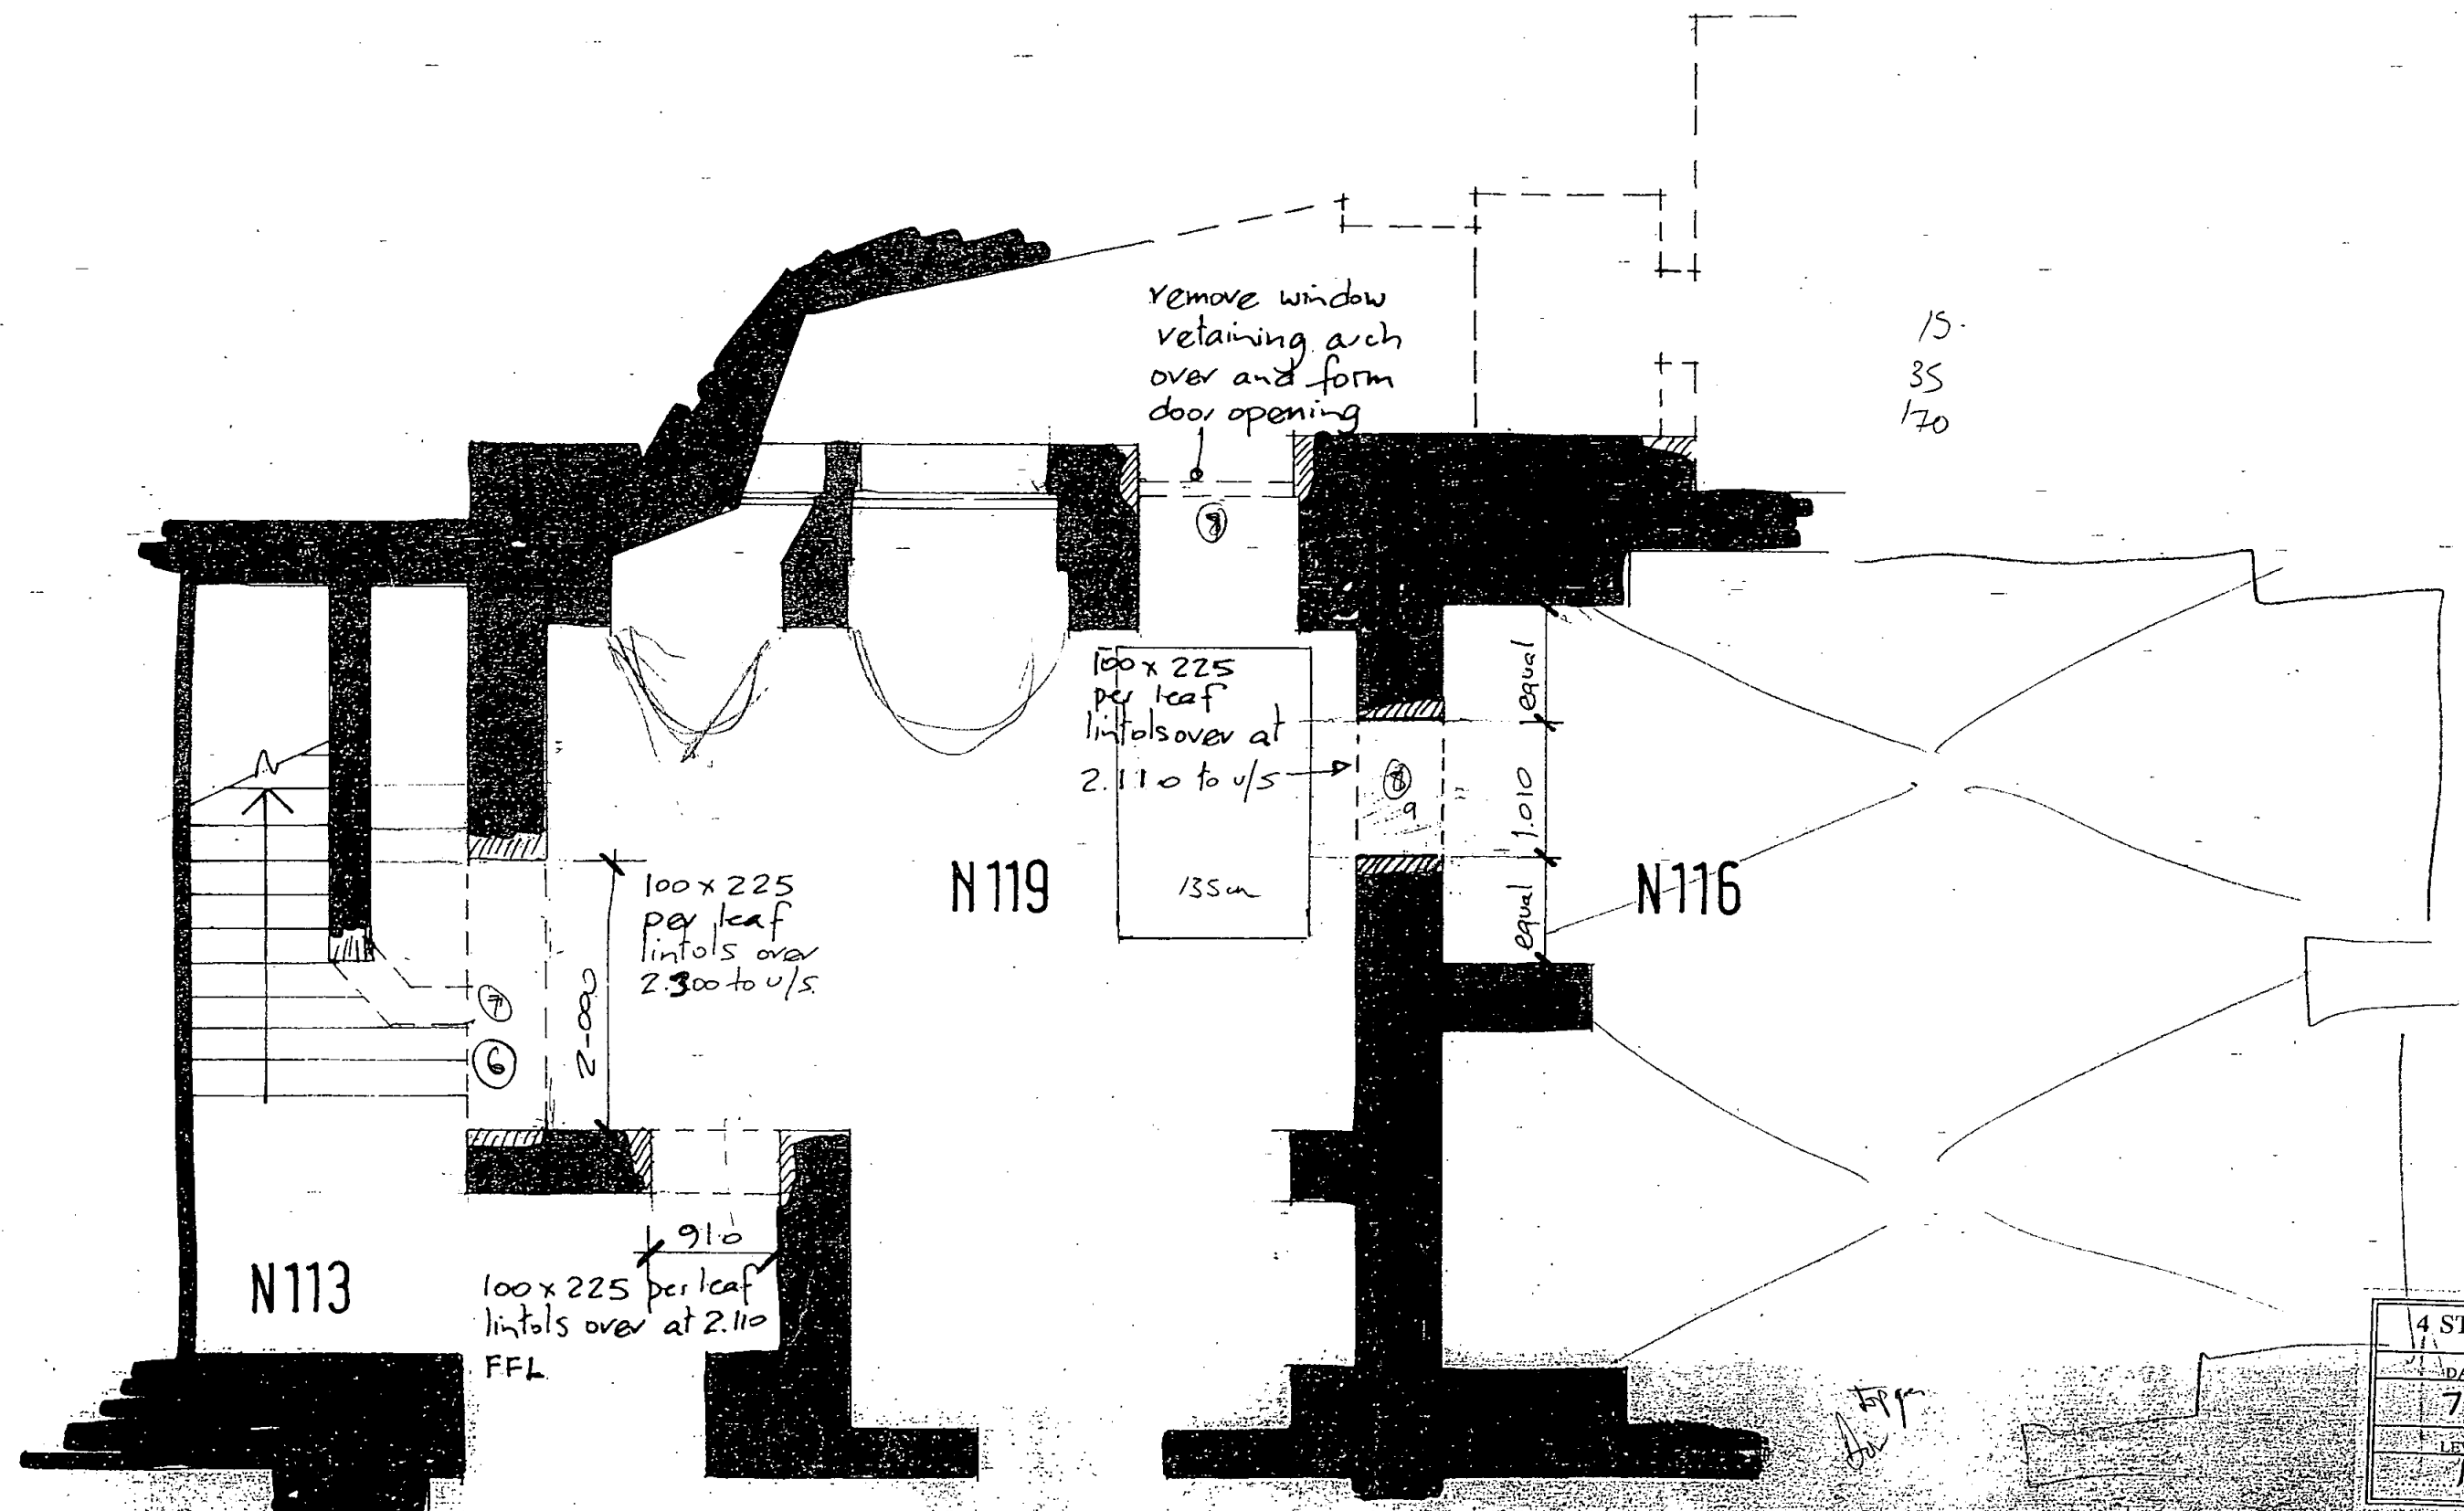
4 ST JAMES'S SQUARE	
DATE	SCALE
7-1997	1:50
FLOOR	DWG. NO.
1	B21B

100x225  
per leaf  
lintols over  
-2.110 from  
FFL

form new openings  
insert lintols over  
2.110 to v/s.

remove  
window  
and  
form  
doorway

100x225 per leaf  
lintol over - arch  
to be formed under  
to run through  
following line of  
existing arch

form new opening  
follow v/s of existing  
arch over

remove  
slab only  
as  
indicated

form new  
openings  
2.110 to v/s of  
openings  
100x225  
per leaf  
lintols over

178x102  
RSJ  
lintols  
with 102x51  
RSJ jambs  
& sill picture  
frame.

area hacked  
floor  
from  
40  
32  
back  
37  
46 from top of existing

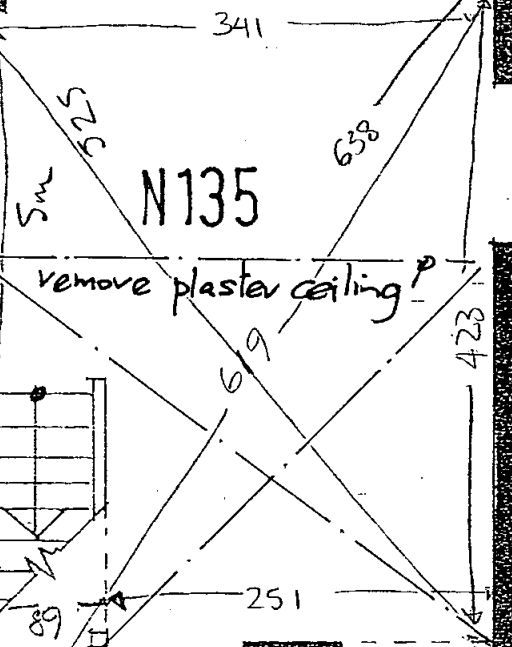
DATE	SCALE
7 1997	1:50
LEVEL	DWG NO
1	B24A

remove to v/s of window cill over

remove wall

cut back to a height of 1.800 above existing floor

retain oven + cupboard

carefully remove oven for re-installing

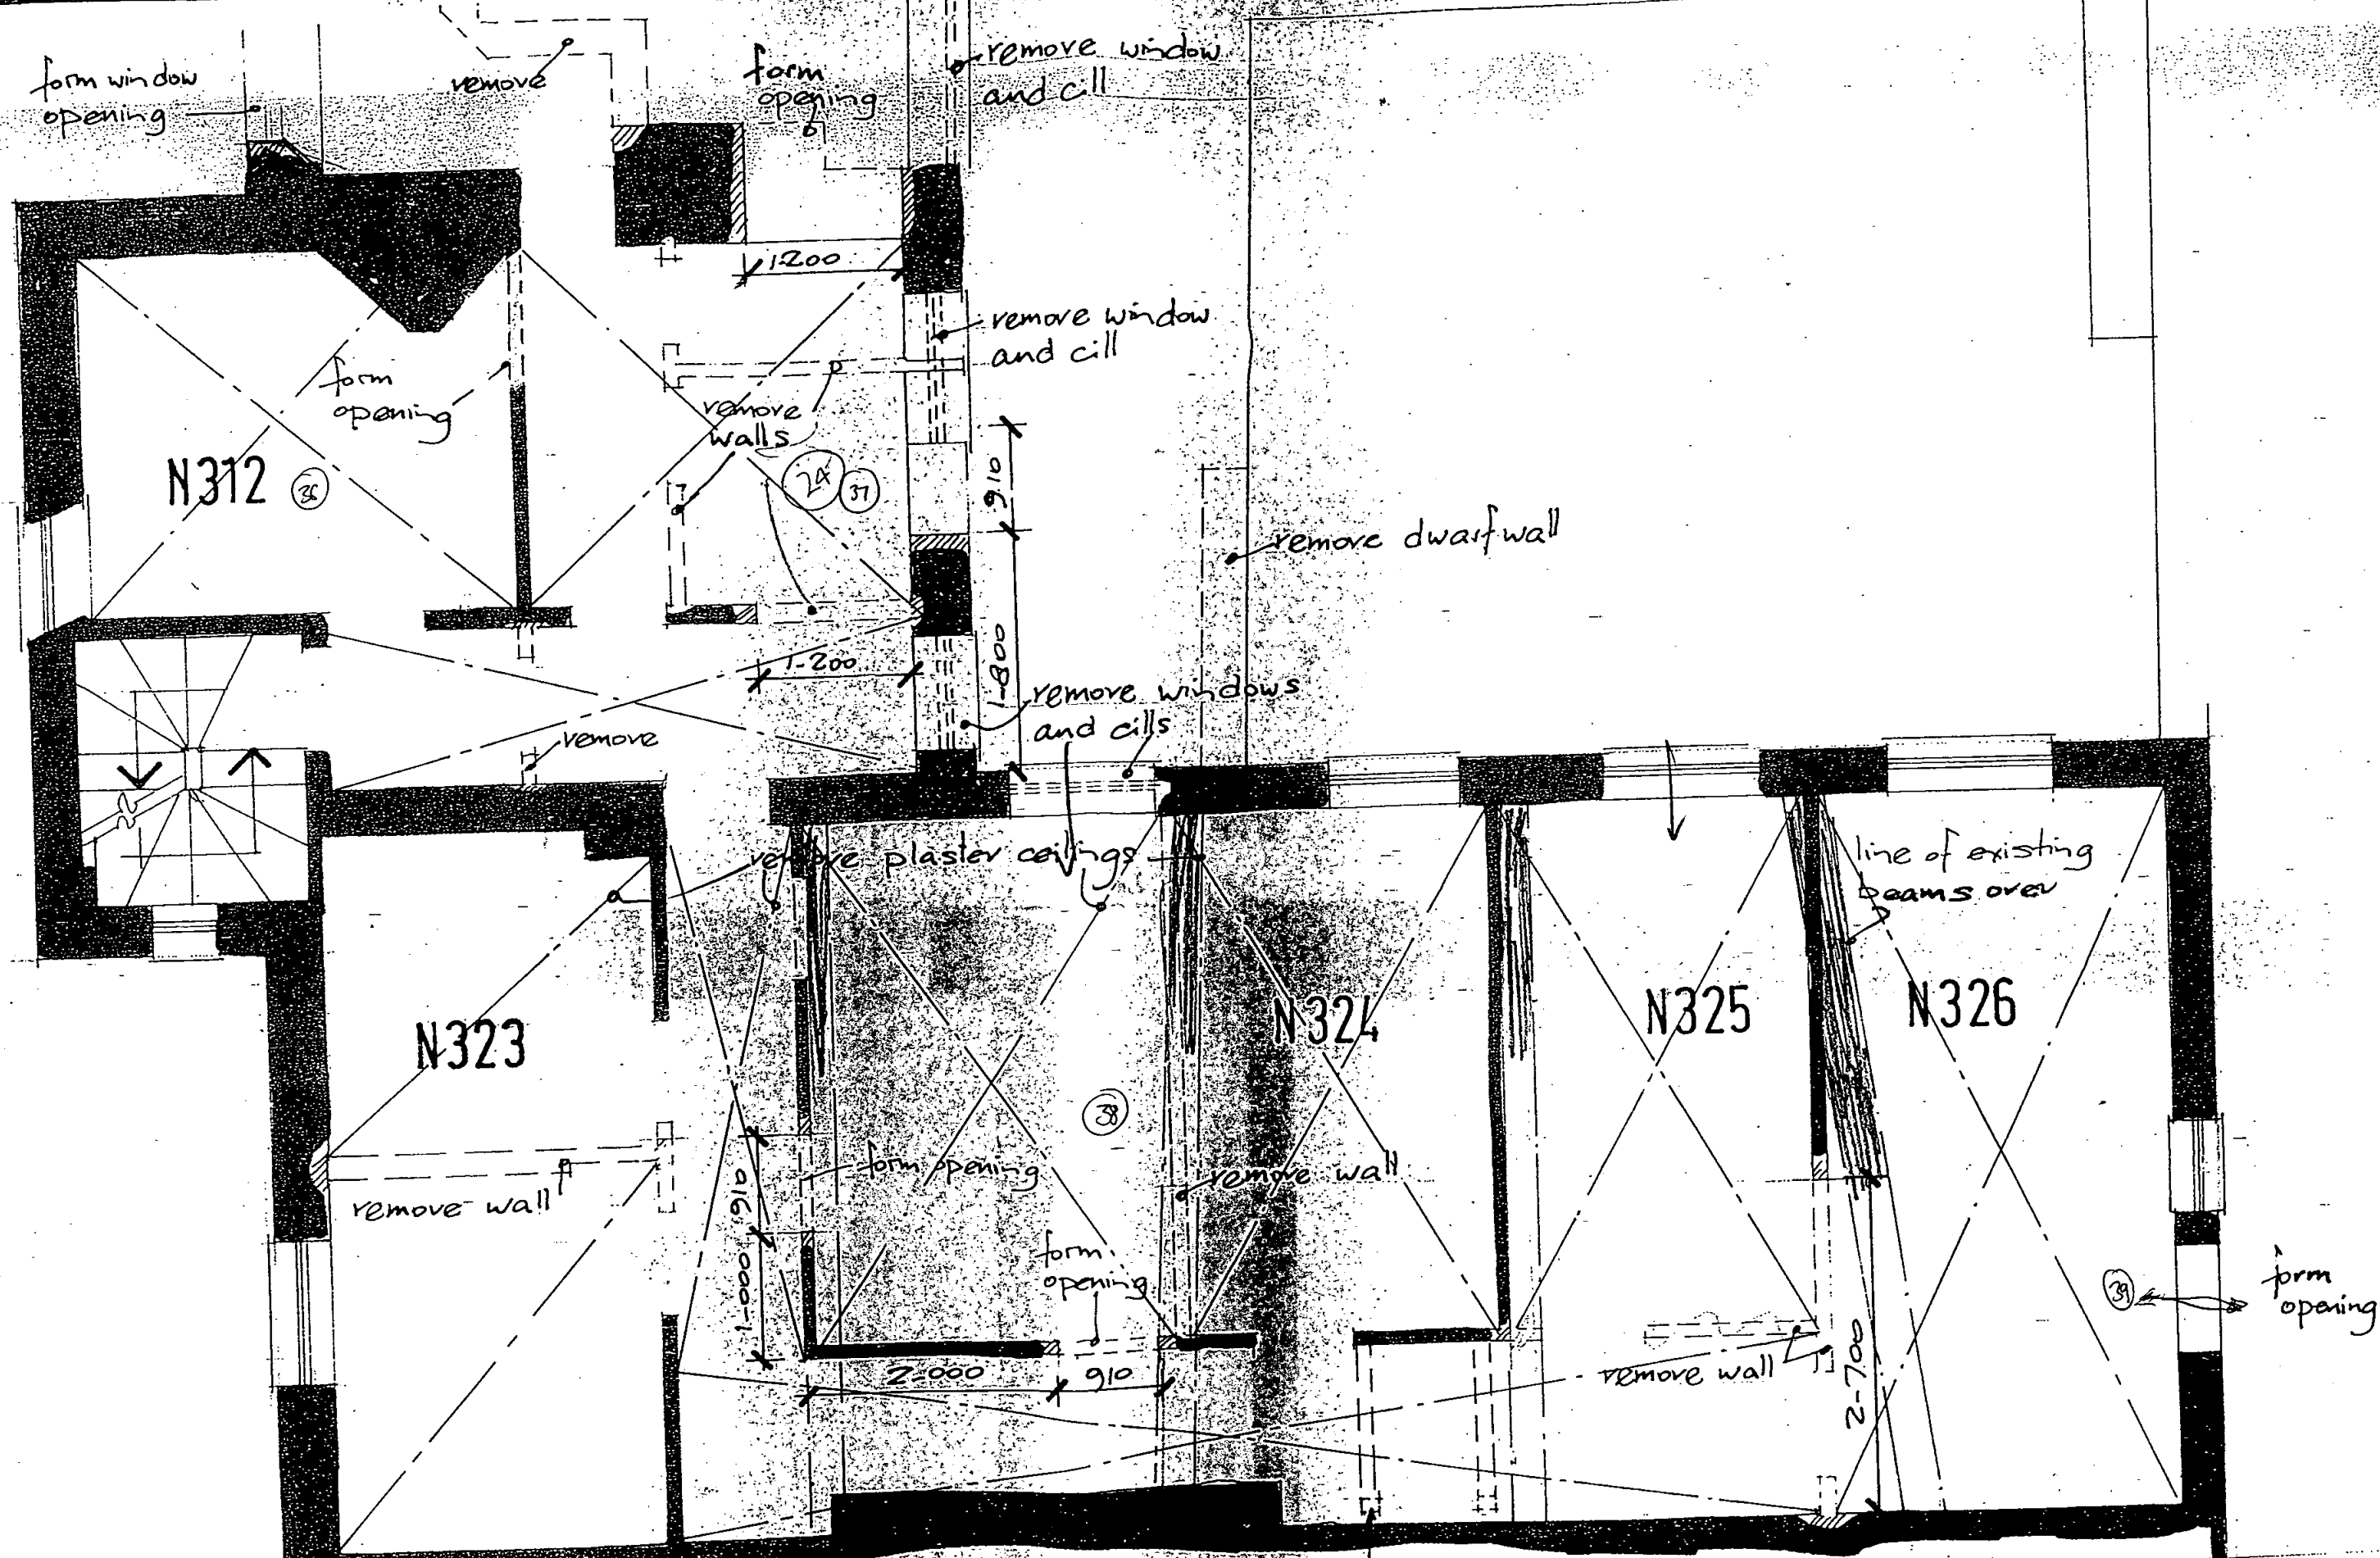
4 ST JAMES'S SQUARE	
DATE	SCALE
8. 1997	1:50
LEVEL	DWG NO.
3	910 A

remove steel structure supporting safe over - first remove safe

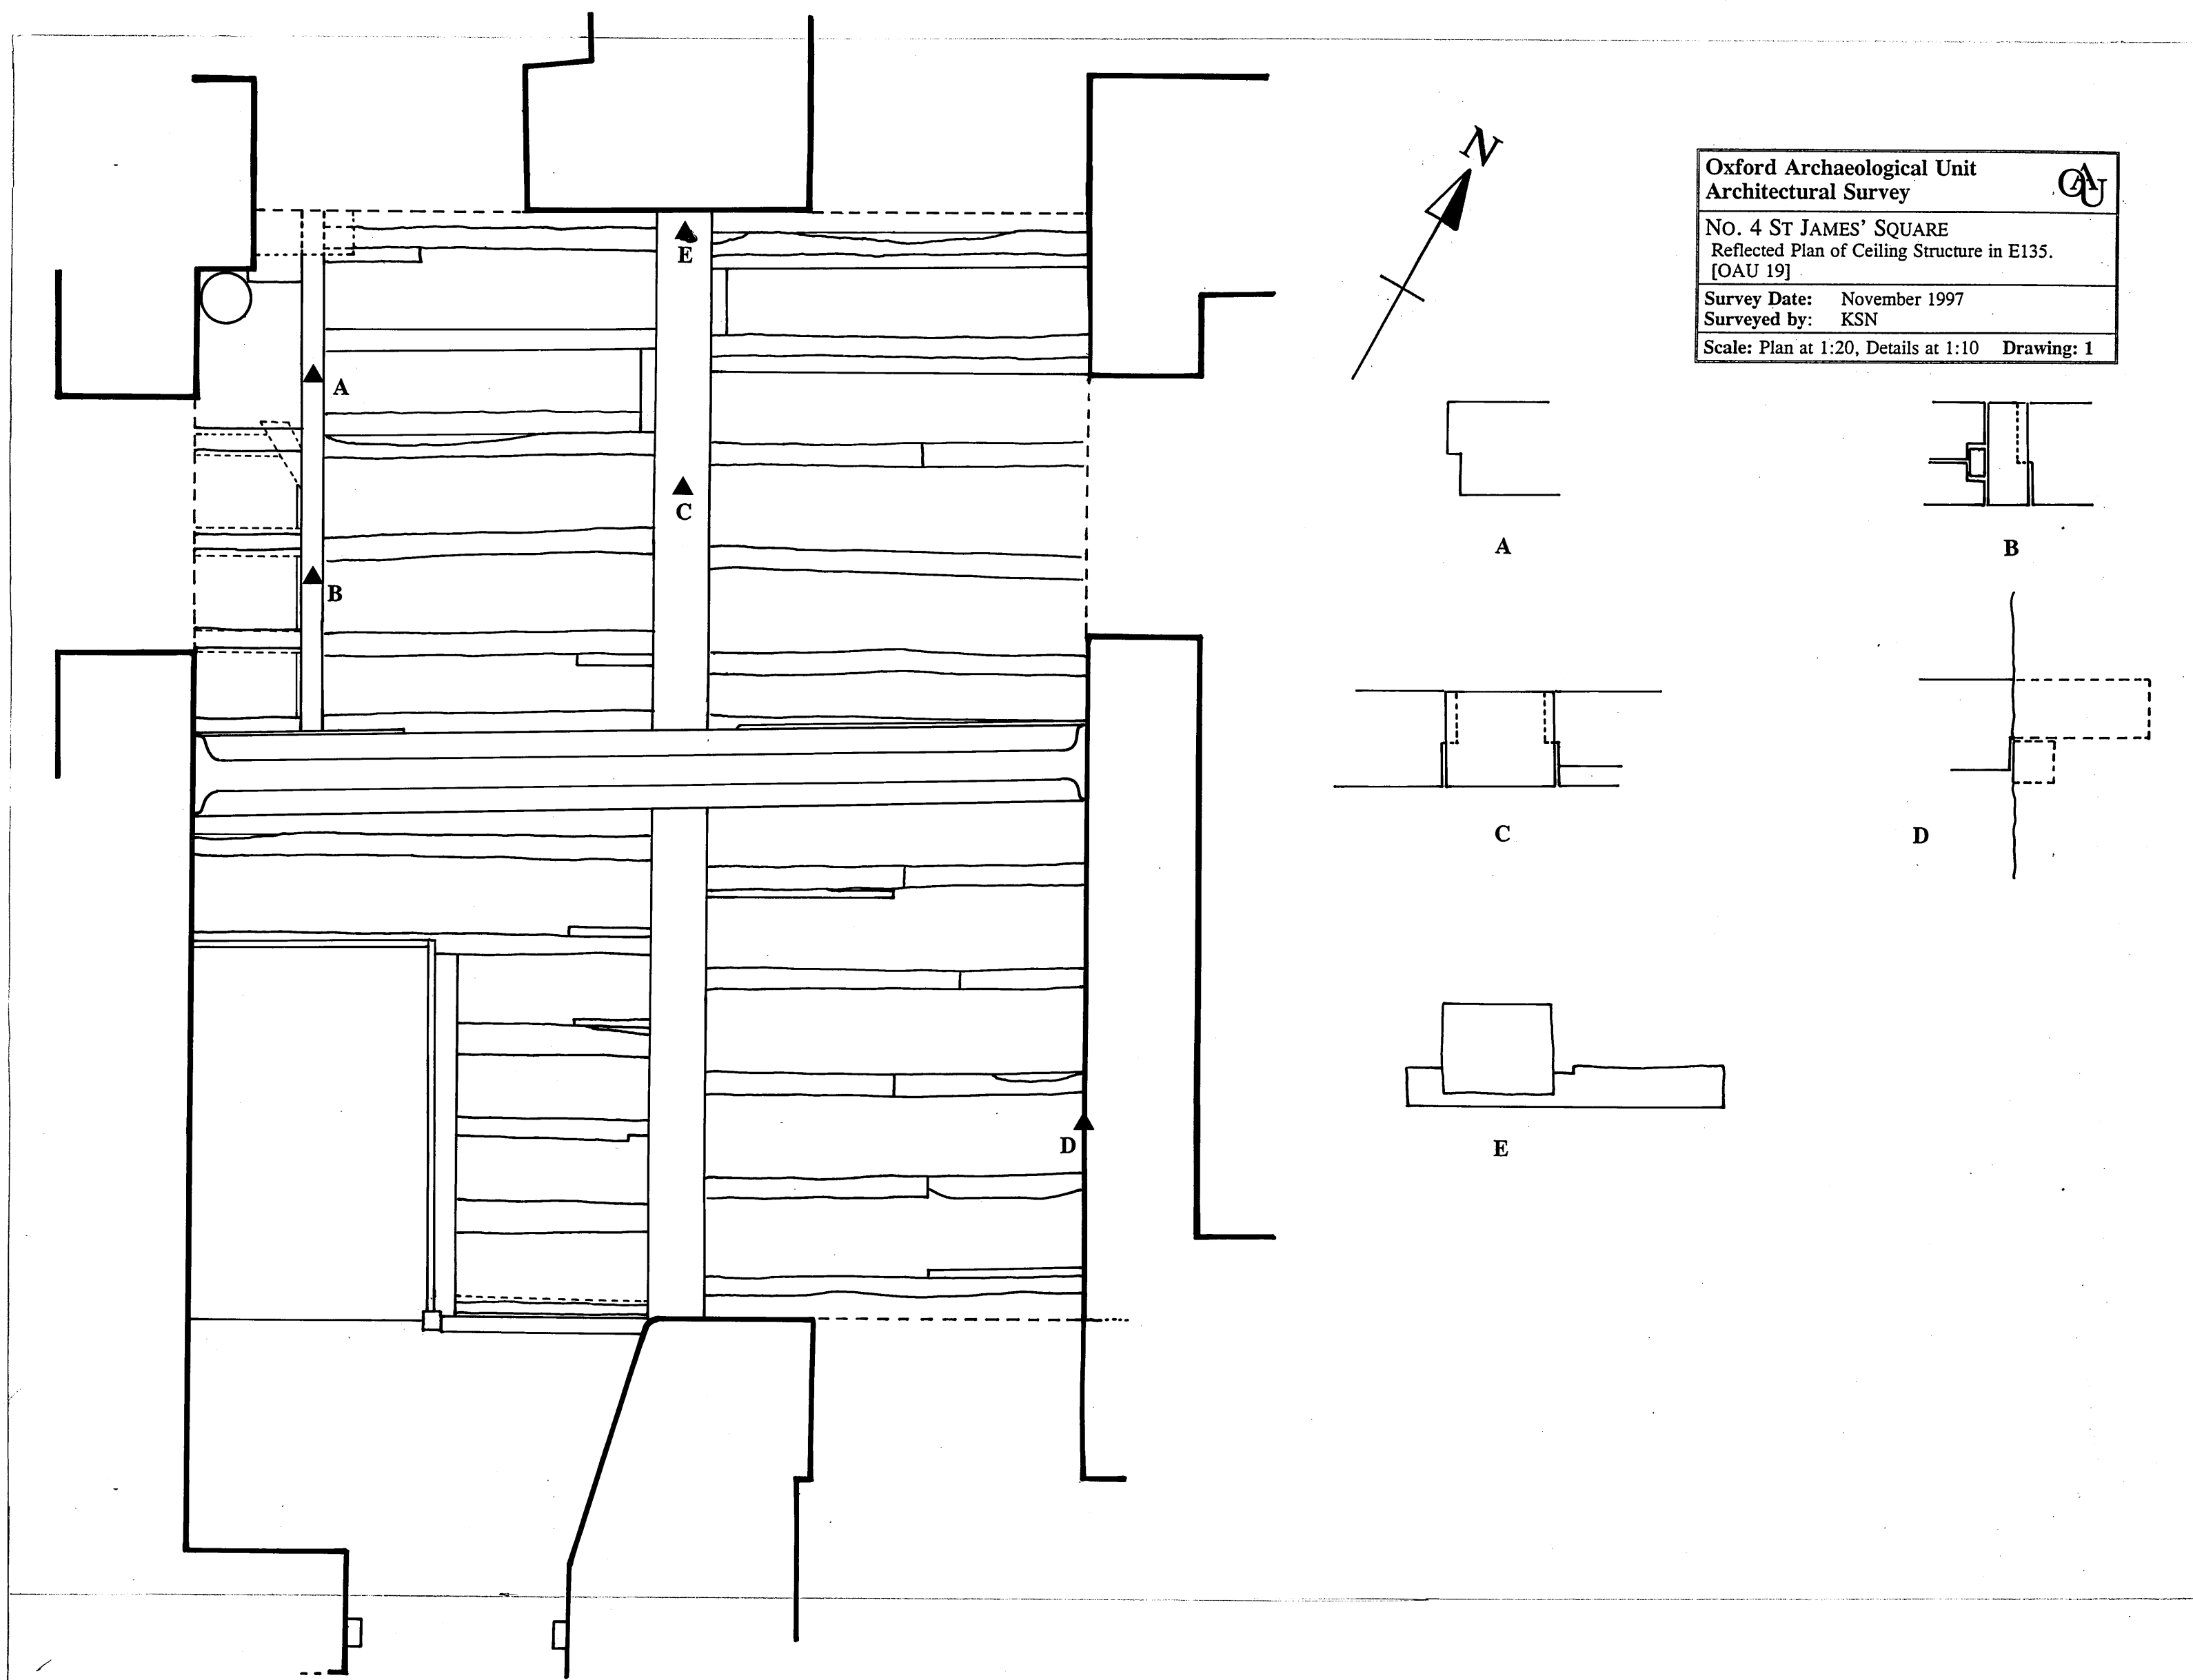
NO. 4 ST JAMES' SQUARE  
Reflected Plan of Ceiling Structure in E135.  
[OAU 19]

Scale: Plan at 1:20, Details at 1:10 Drawing: 1

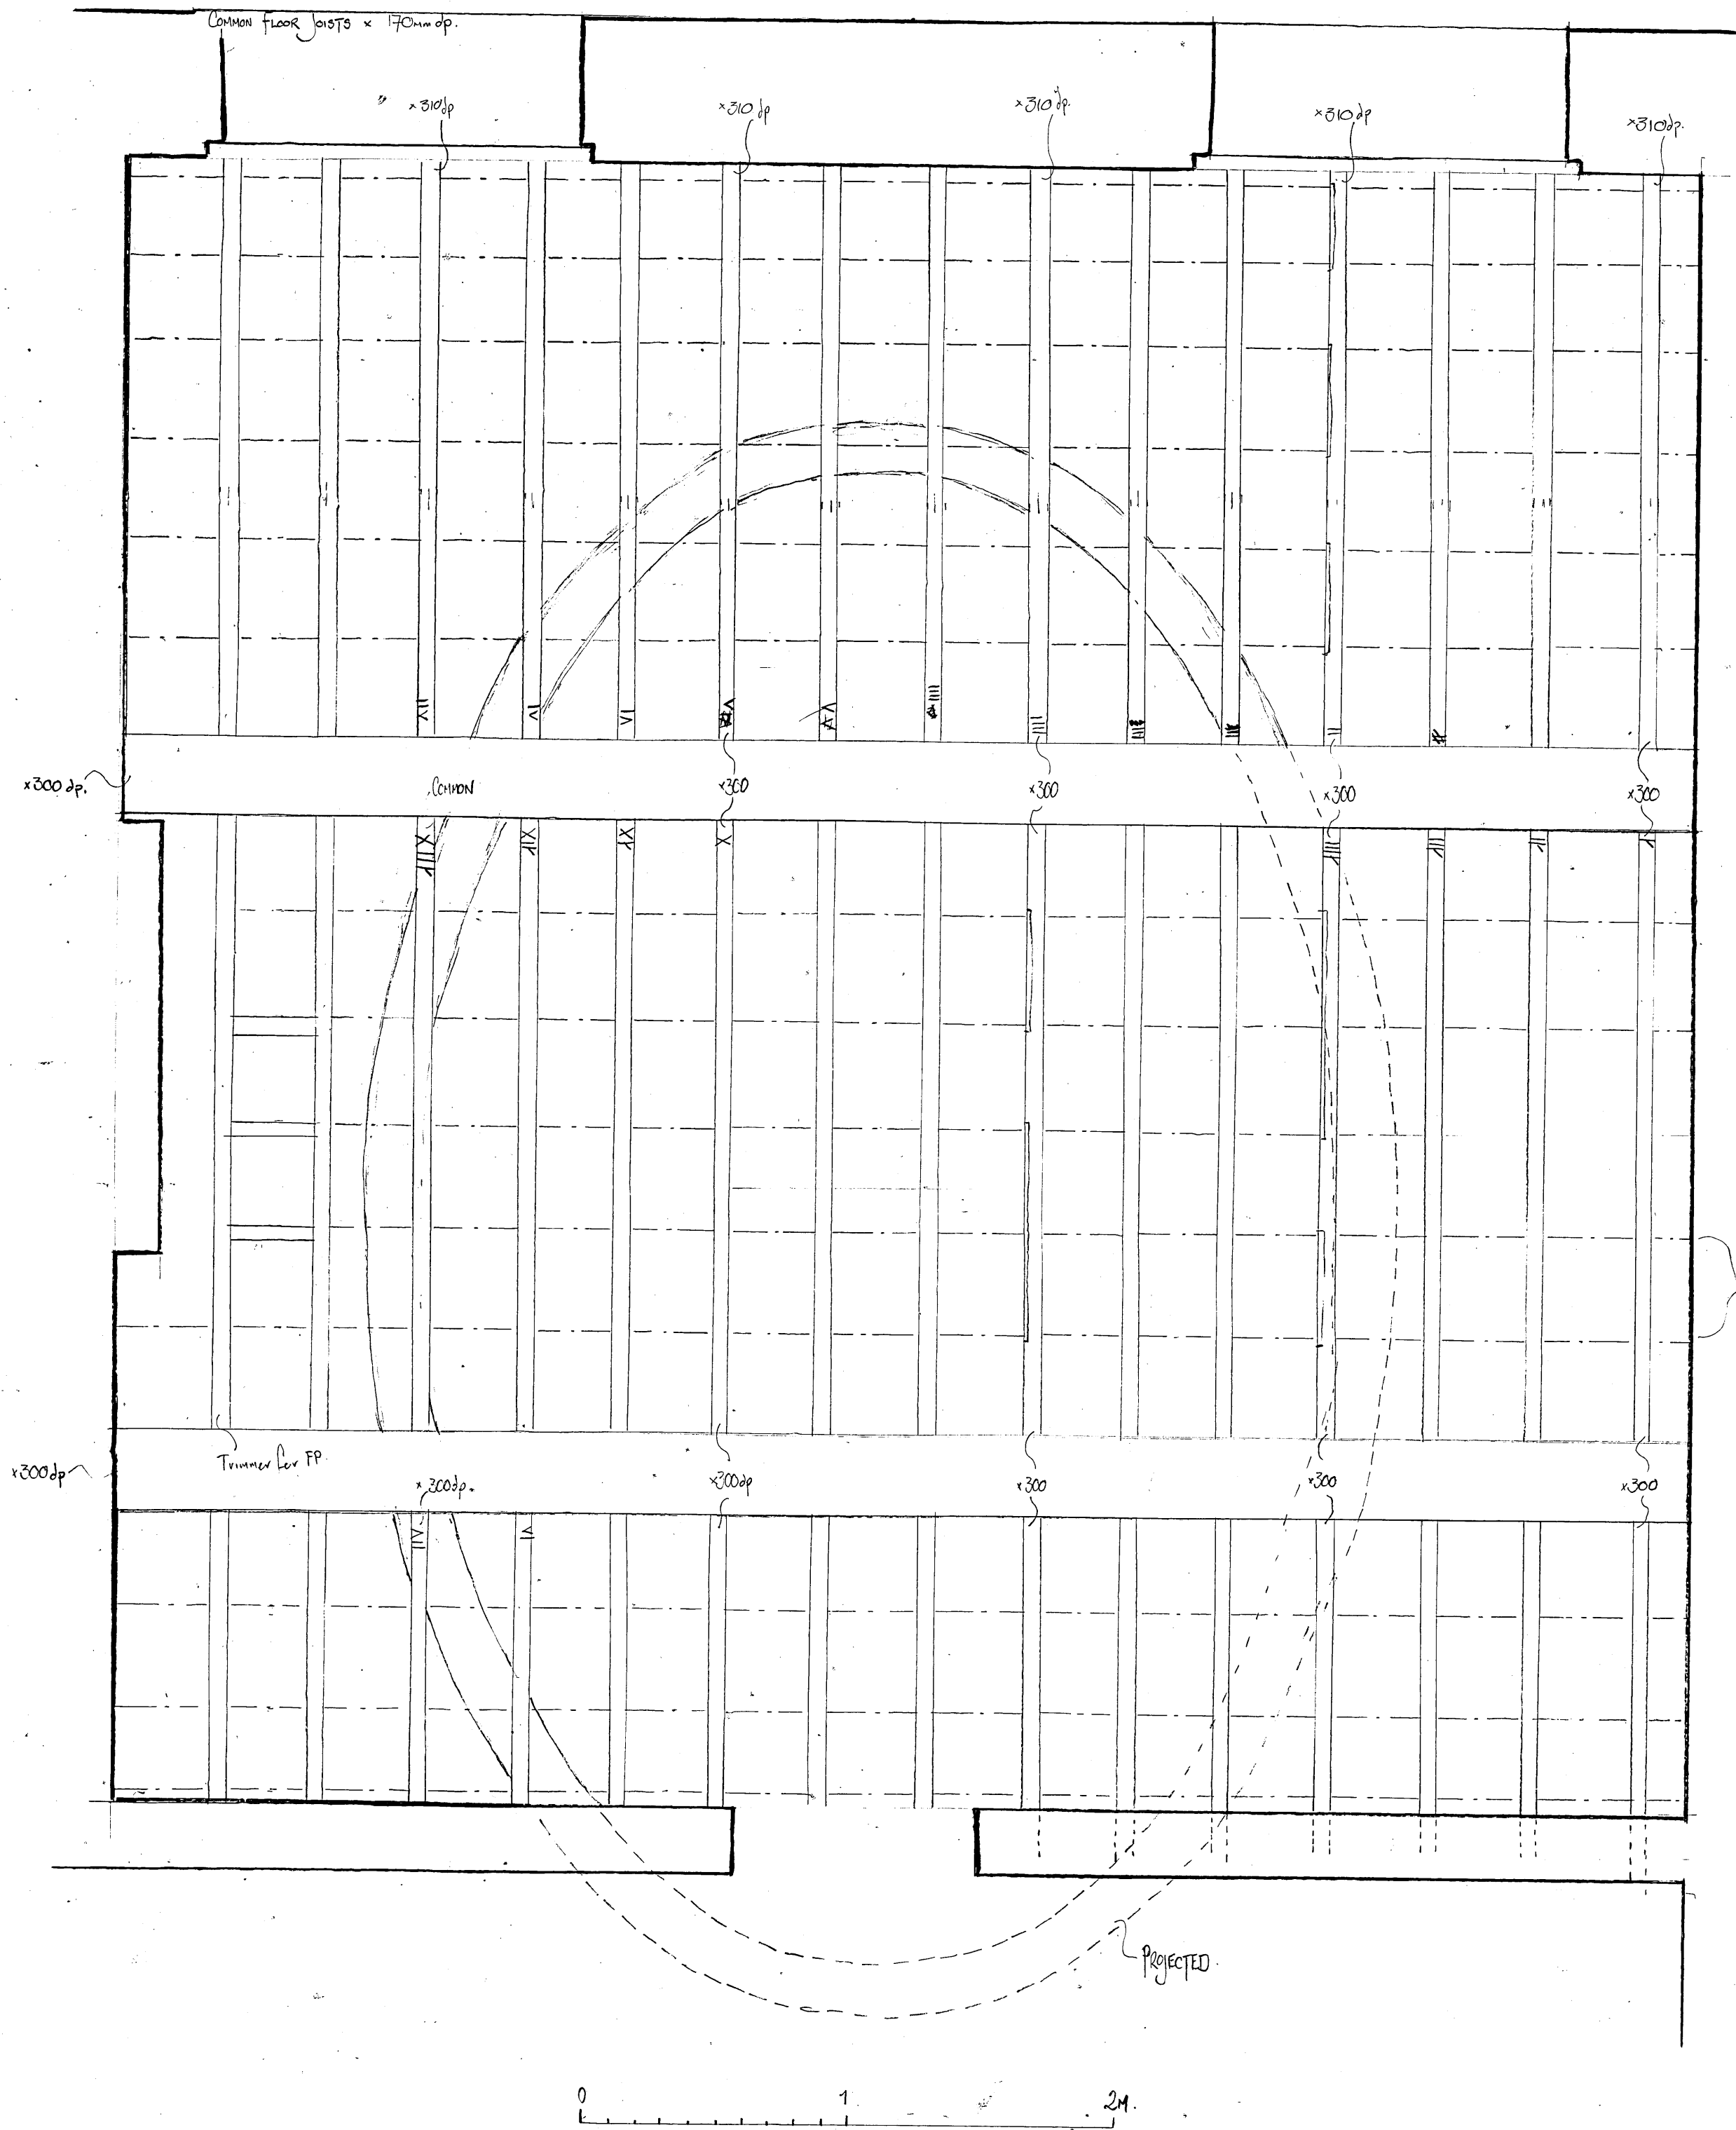
60mm x 70mm Ceiling joists @ c. 400mm c/s

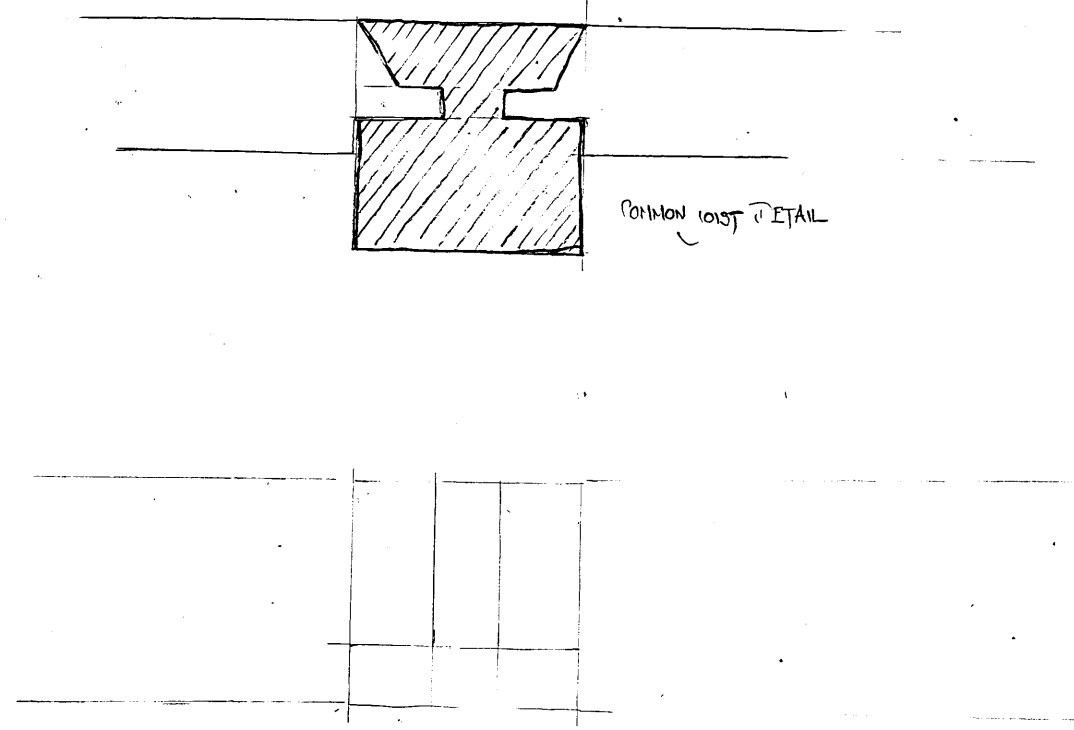
Ceiling joint housed in simple mortice to W, chased mortice (pairs) to E or S.
