WESTMINSTER  
4 ST. JAMES SQUARE  
SJQ 97

Line 1: [OASouth] County:[Greater London] Parish:[Westminster] Site:[4 St James Square]

**IN AND OUT LTD.**  
**THE NAVAL AND MILITARY CLUB**  
Relocation to Number 4, St. James Square.  
Architect: John Warren RIBA, FRPI, FSA.  
Quantity Surveyor: David Connolly FRICS.  
Franklin and Andrews

Oxford Archaeological Unit  
Architectural Survey

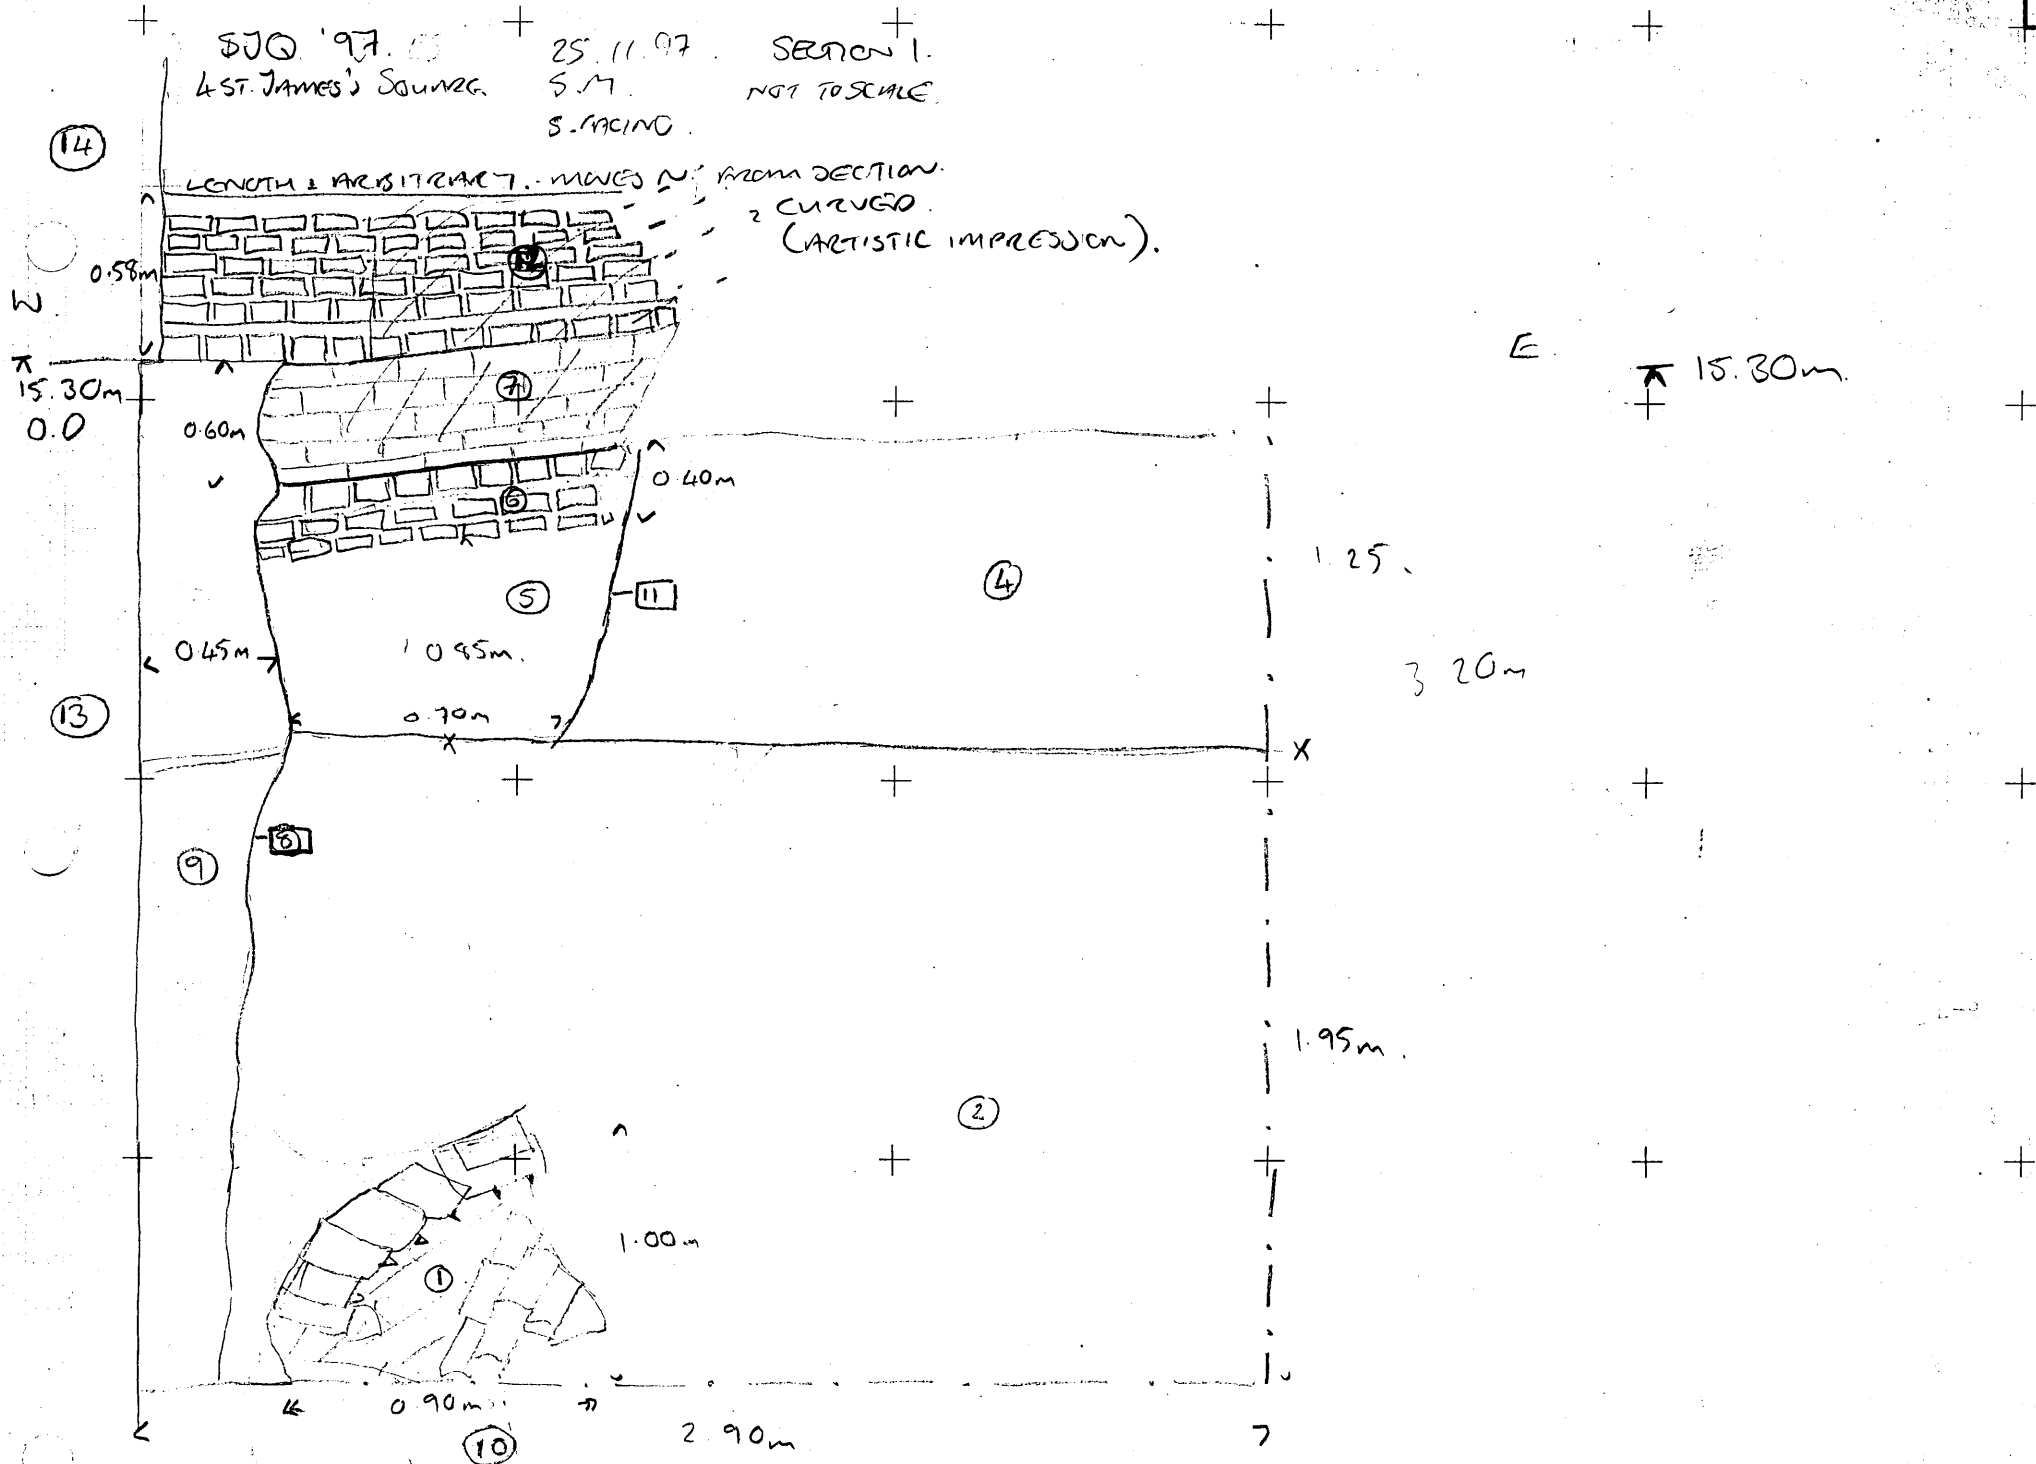
DRAWN/SECTION NO. 1			NOTES  Section 1  SW CO-ORD.
DRAWN BY S.M.			
CHECKED BY			
DATE 25.11.97			
SCALE NOT TO SCALE		SITE SJQ 97	
<b>OXFORD ARCHAEOLOGICAL UNIT</b>

SKETCH SECTION - NOT TO SCALE  
 S-FACING

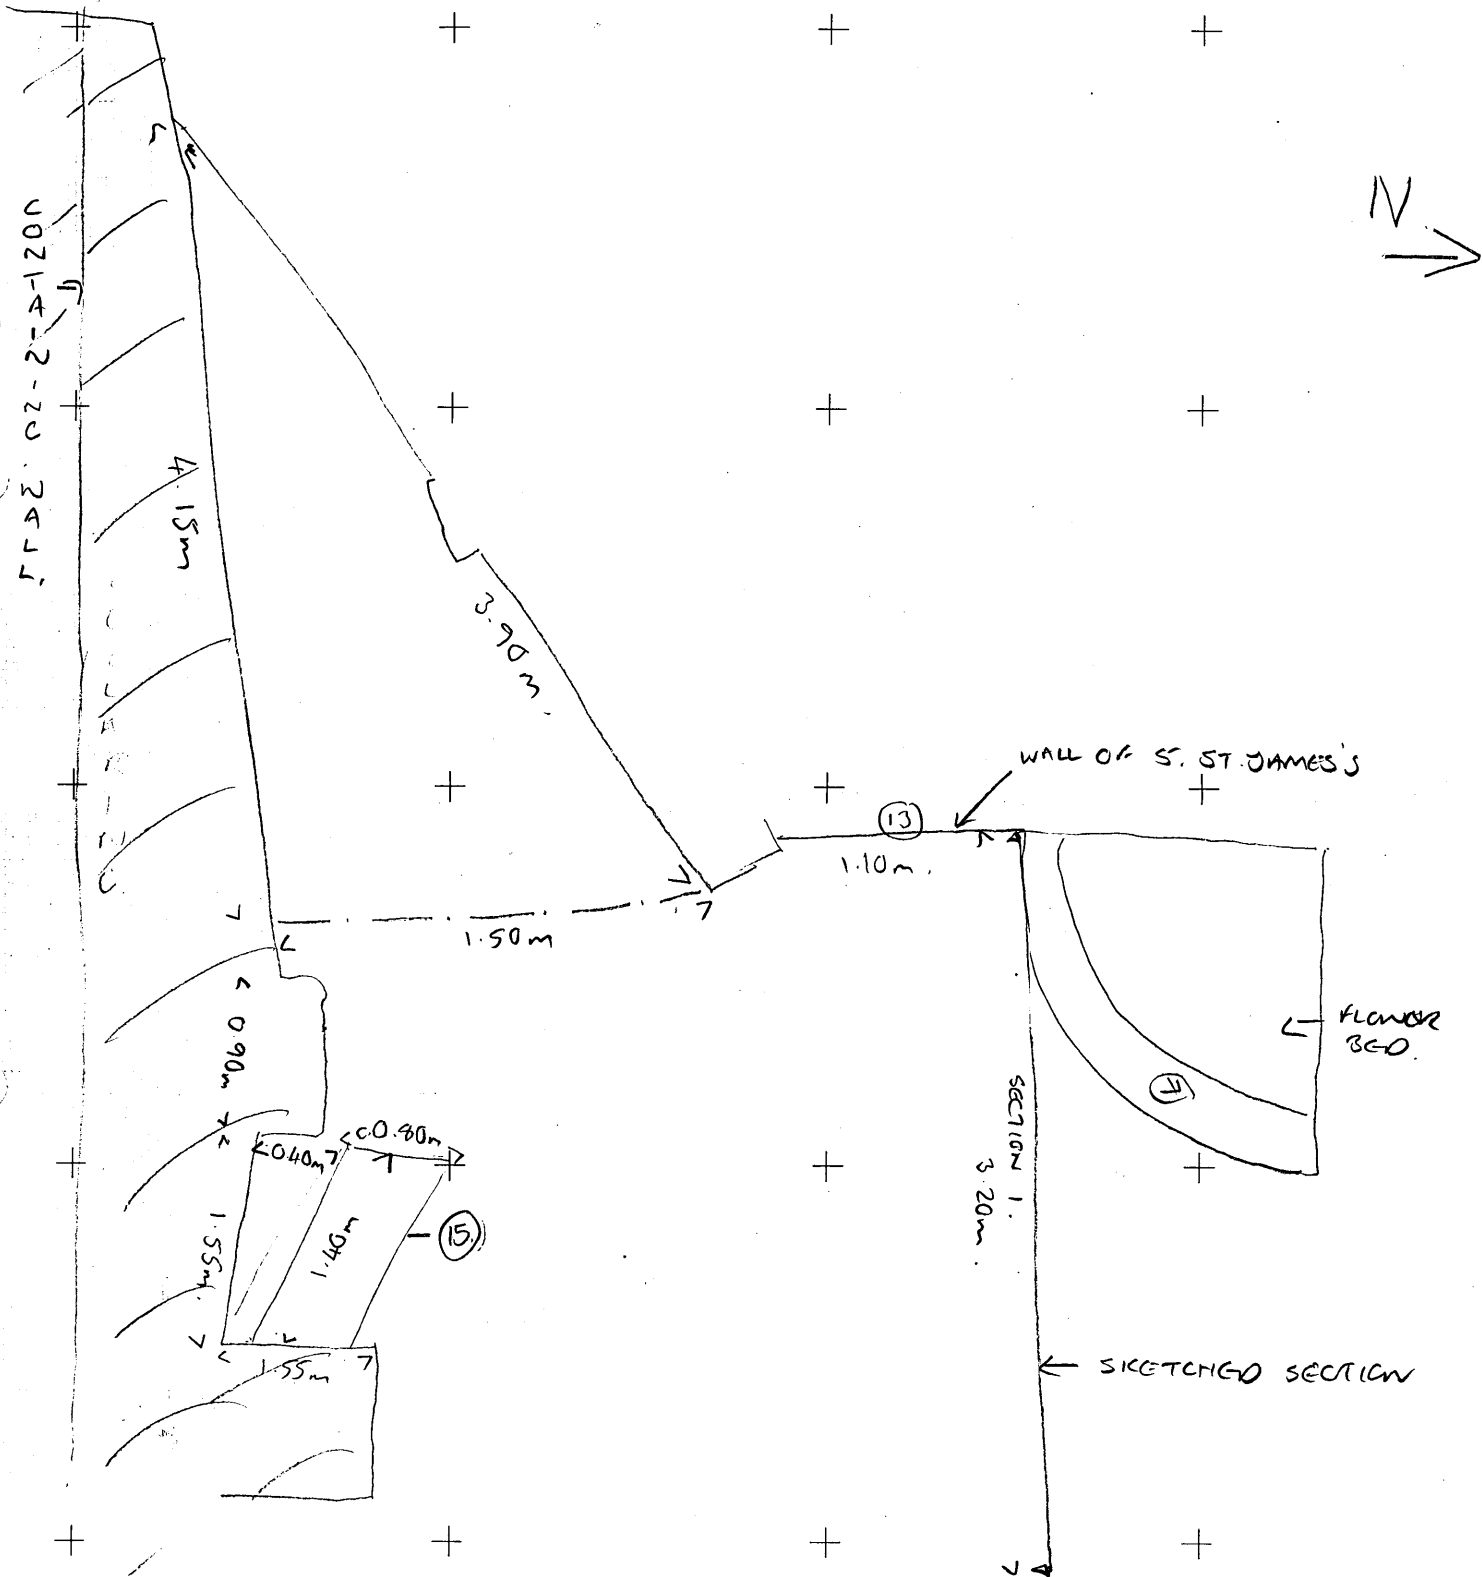
SKETCH PLAN - NOT TO SCALE SHOWING CELLARING & LOCATION OF  
SEWER / DRAIN (16)
