A14 Huntingdon
Viaduct improvement
scheme, Monitoring of
associated Groundworks

Monitoring and Recording

May 2013

OA East Report No: 1467

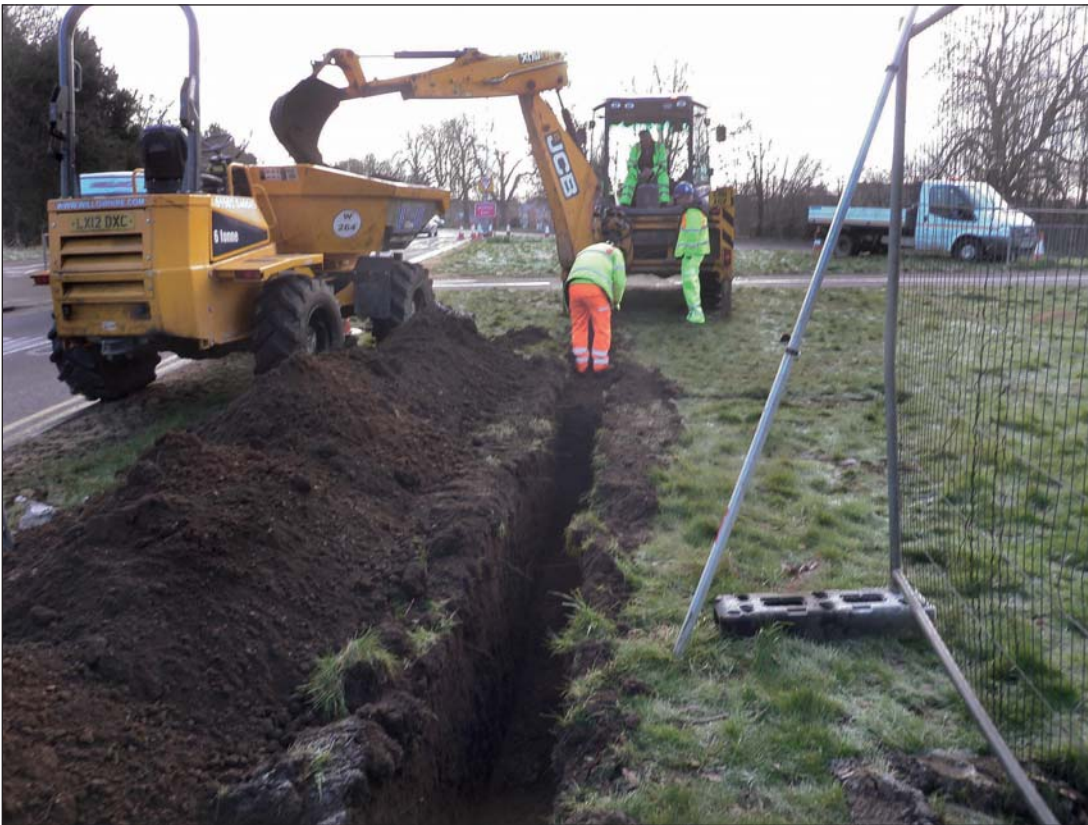
- 4.1.1 The groundworks within this area consisted of a narrow deep trench, for the purpose of additional drainage, and an open area strip, for the construction of a new roadway.

- 4.1.2 The drainage ditch was excavated to a depth of 1.5m and 0.5m in width, the top soil measured 0.15m and the subsoil measured 0.78m, the remaining depth cut into the natural gravels (Sections 1 and 2. Fig. 1). The subsoil contained fragments of modern brick, as well as small amounts of black tarpaulin, and plastic items, although access was limited, preventing accurate locating of modern finds within the deposit these materials appeared to be mixed into the deposit, rather than stratified within the deposit.

Plate 1: Drain trench at Brampton Road Interchange, taken from the west

- 5.1.1 The work at the Brampton interchange showed the subsoil overlying the natural gravels to be a considerable depth. The presence of modern finds within the deposit suggests, the soils had been redeposited, or at least disturbed. The lack of evidence for a former buried topsoil or stratified layers within the deposit would suggest a widespread stripping of the previous soils, probably during the modern construction of the junction, the soils then being replaced to the required level. It is unclear to what extent the natural gravels may have been truncated during the process. No archaeological finds were recovered from the excavated soils, however if the soils had been removed and replaced, the provenance of the soil would be unknown, and therefore unrepresentative of a potential finds assemblage in the locality. Archaeological features may survive below the modern soils if little or no truncation had taken place on the natural gravels, although no features were encountered within the deeper drainage trench.

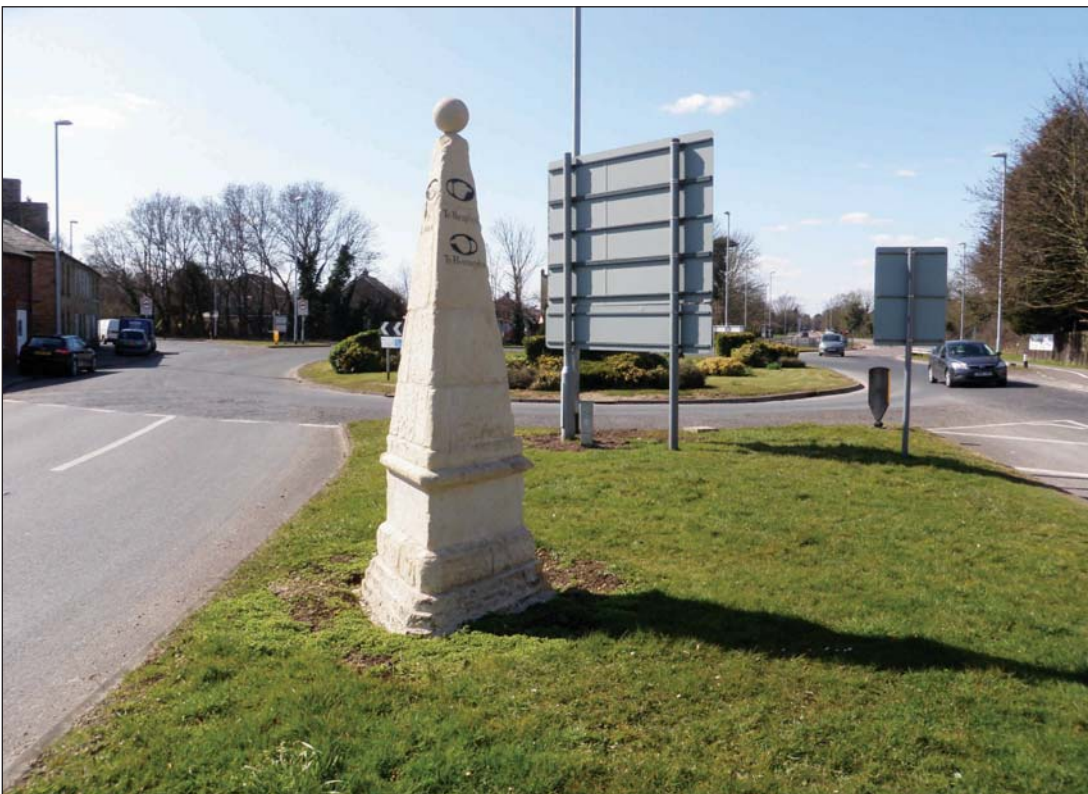
- 4.1.7 A new sign post was installed in close proximity to the Milepost at the junction of Thrapston Road, Huntingdon Road, and Church Road, Grade II listing, entry number 1130186.
- 4.1.8 Observations and guidance was rendered to ensure the milepost remained unaffected by the necessary groundworks, and sign construction.

Plate 2: Milepost at the junction of Thrapston Road, Huntingdon Road, and Church Road, taken from east
