# Whispers Cottage, Church Lane, Tydd St Mary, Lincolnshire

## Historic Building Survey and Archaeological Monitoring

OA East Report No: 1097

*By Taleyna Fletcher (BA, AIFA)*

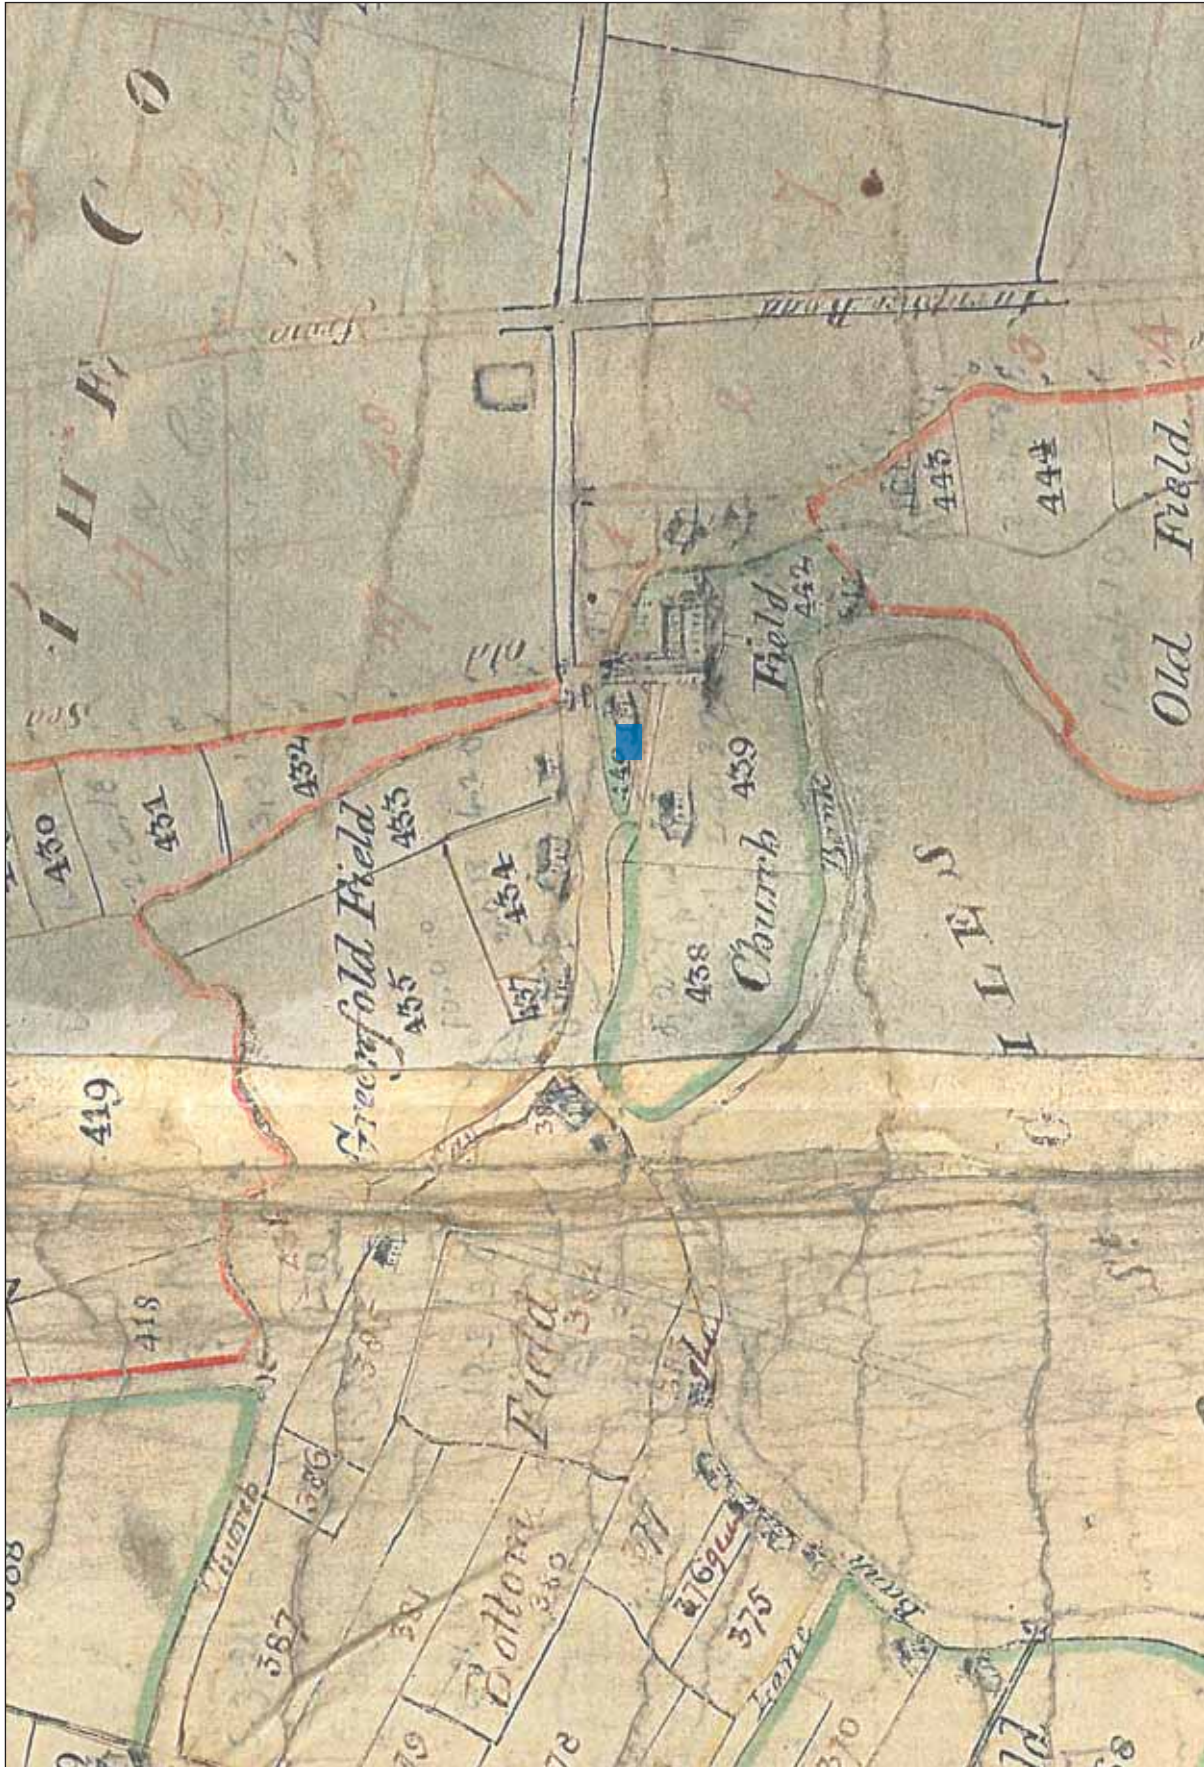
Figure 3: Survey and Map of the Parish of Tidd St Mary", 1779, showing the approximate location of Whispers Cottage, in blue

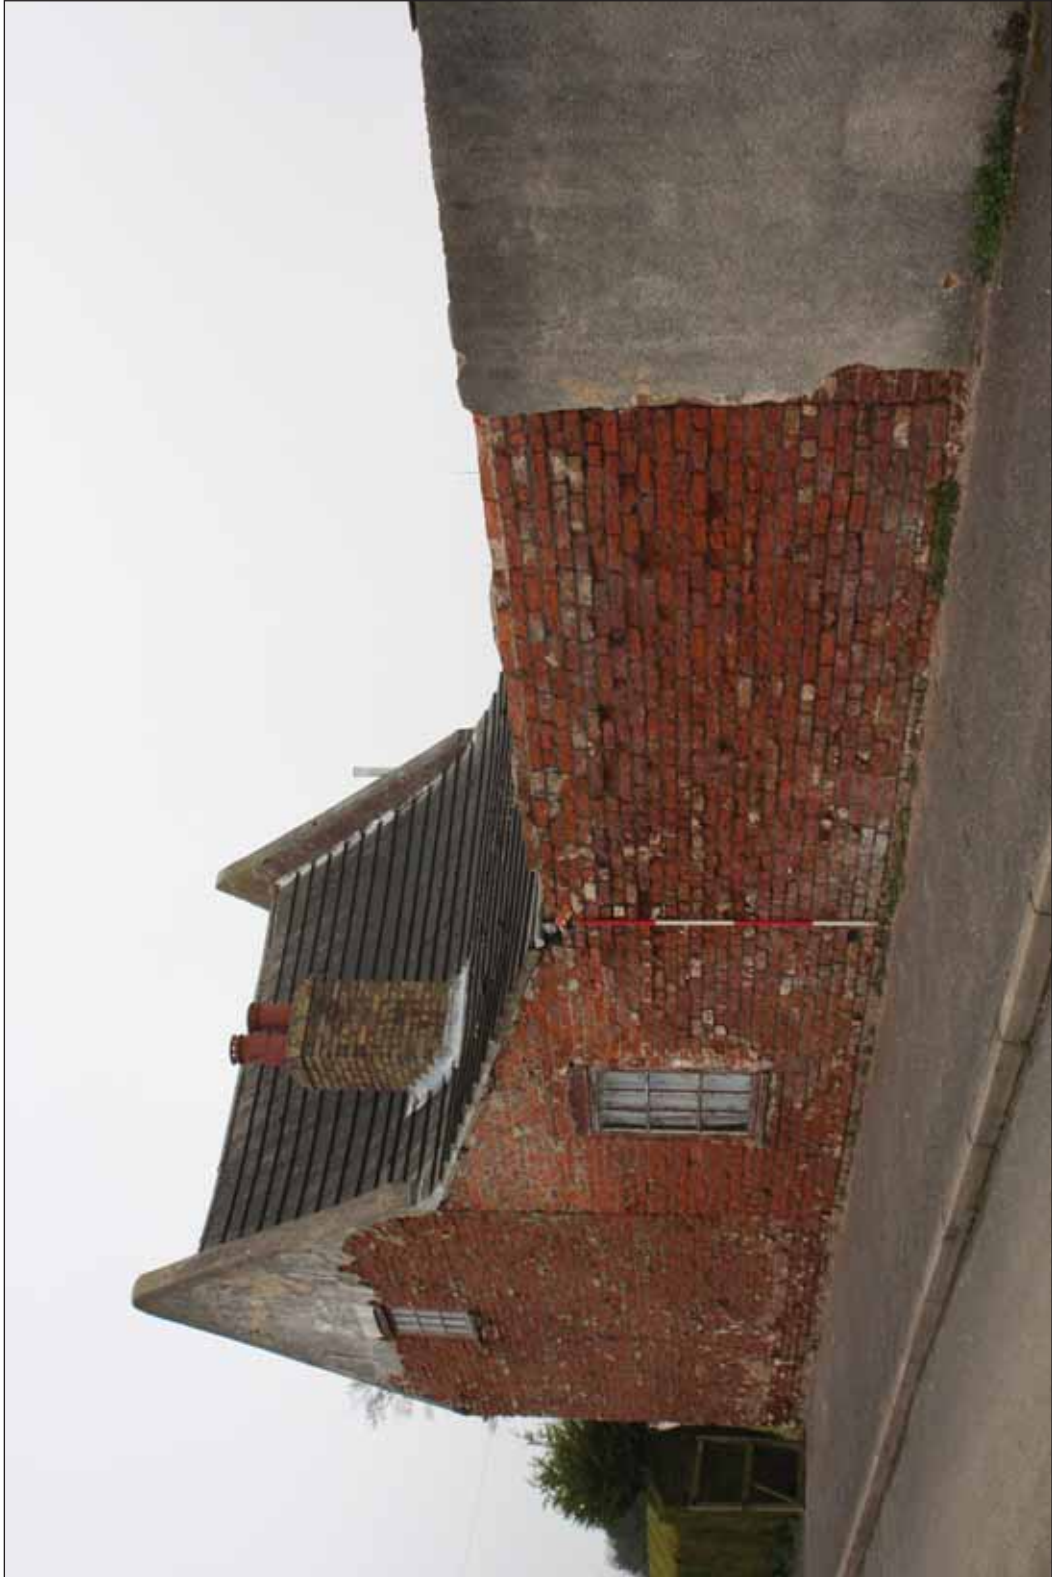
*Plate 1. South-facing elevation (from southeast)*

- 4.1.1 This elevation clearly had a number of phases as demonstrated in plate 1 which shows the differences in brickwork. From this elevation, the building can be divided into three main elements (from left to right, plate 1); two storey building, single story extension and wall of earlier demolished buildings.

- 4.1.5 The final element of this elevation was recorded at the eastern end (far right in plates 1 and 4). Although it was almost entirely covered with concrete render, the lower courses of brick were visible where it meets the previously mentioned wall. All that can be seen from this elevation is that they are not contemporary and not joined/keyed together. The remains of a wooden framed window was recorded in this element of the wall – all glass had been removed.

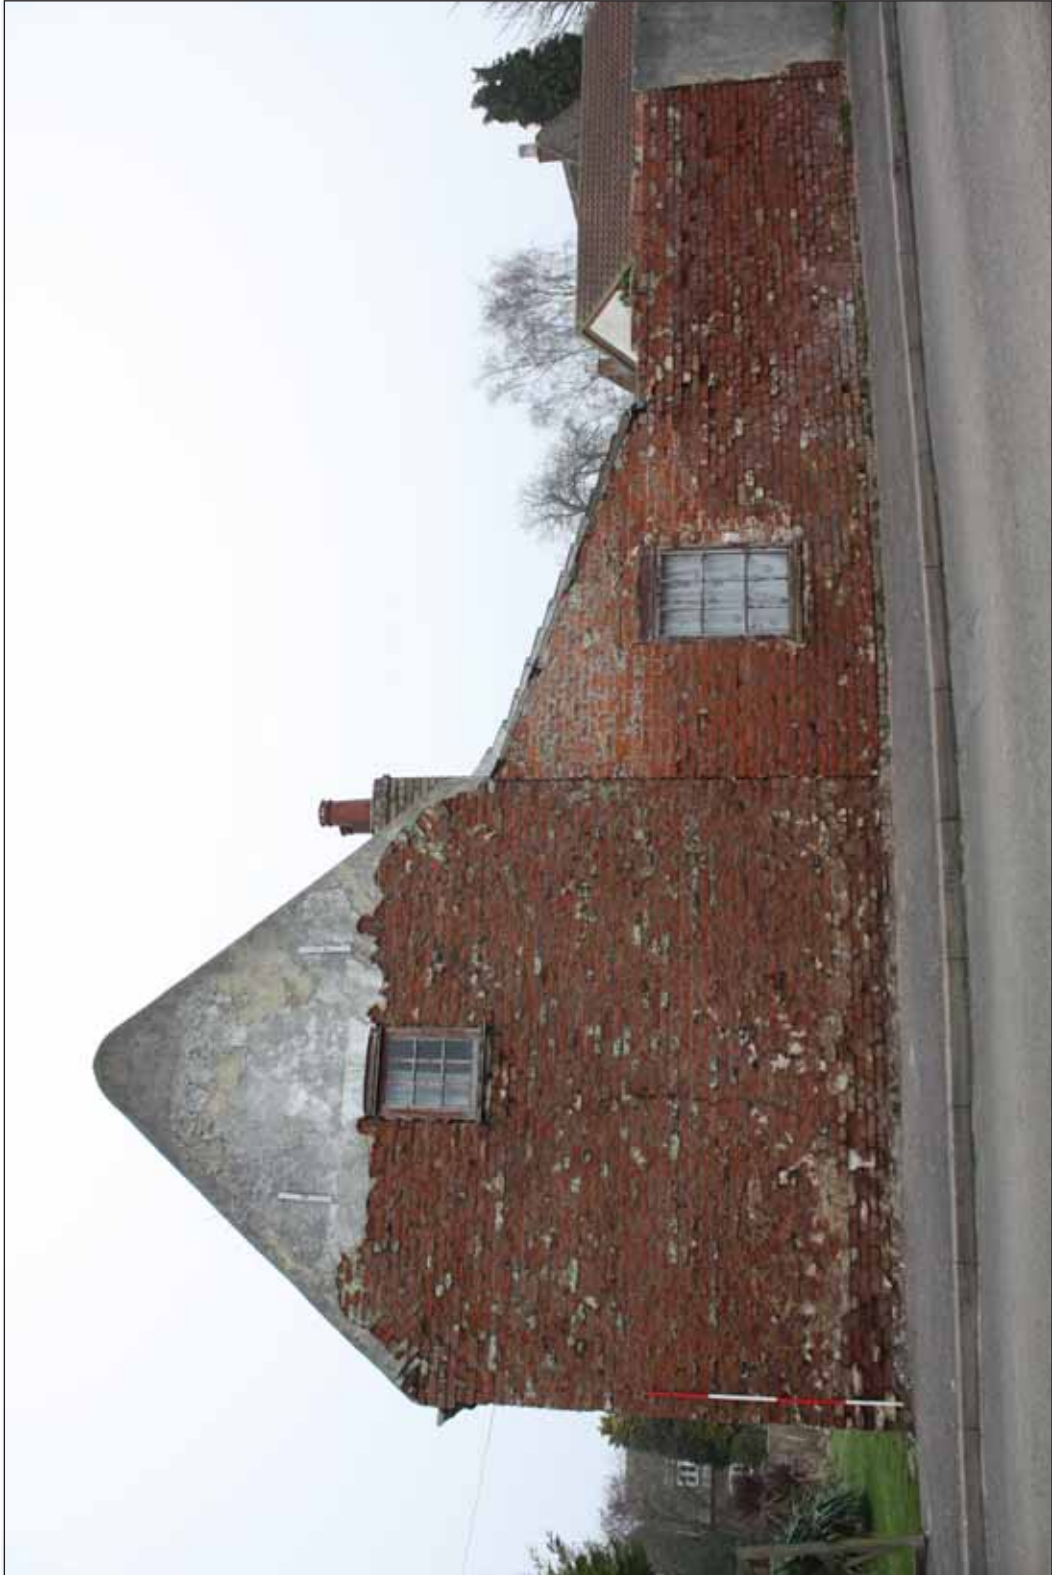
*Plate 2. South-facing elevation (from east)*

- 4.1.2 The two storey building (plate 2) is constructed of a dark red brick in a English/random bond. The average brick dimension is 24 x 6.5cm (  $9^{3/4} \times 2^{1/2}$  ") and many had diagonal pressure marks. The bricks had been set in a soft, crumbly ash mortar with small crushed flint inclusions. This elevation demonstrates the pitch of the roof which is approximately 60° with brick tumbling . A nine-pane, wooden-framed casement window with thin wooden glazing bars and wooden lintel was located at first floor level. This window is likely to date to the early-mid 20th century. Above this window was a cement lintel with three incised lines to give the impression of a keystone. There was a substantial crack in the brickwork from ground level to just beneath the window. Two iron tie plates were recorded above the window on either side which may be for reinforcement/structural support and from the level of the window upwards, cement render was still in place. This element of the building measured 5.06m wide.

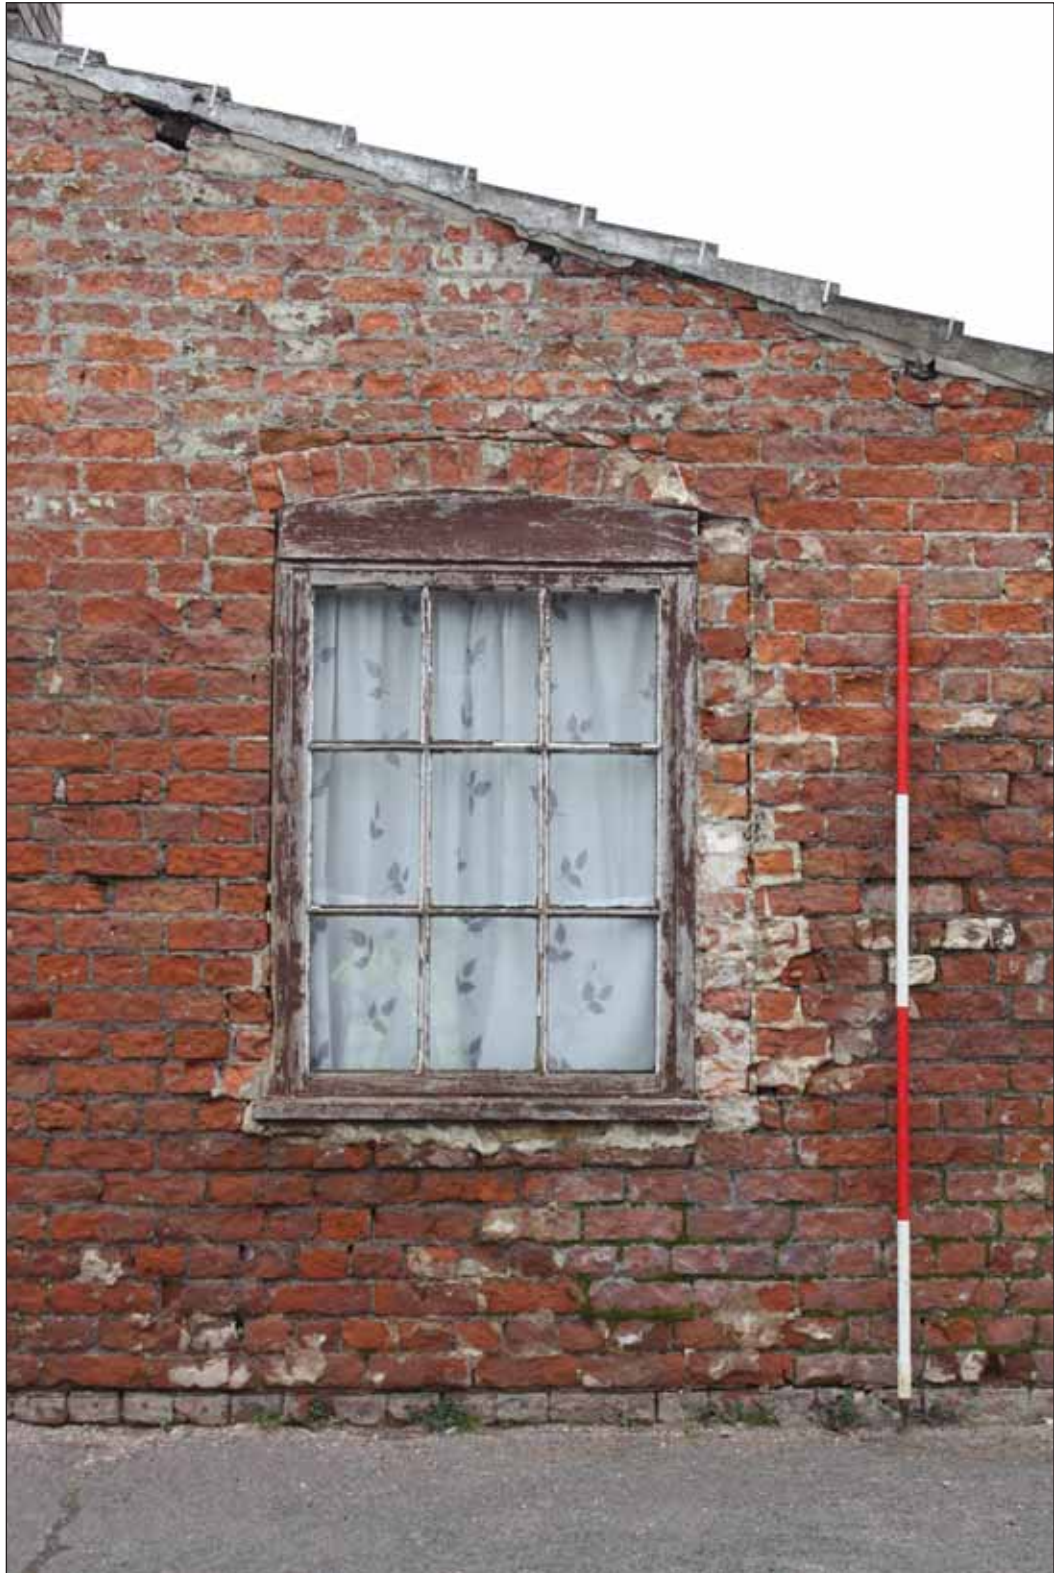
*Plate 3. Detail of window on south-facing elevation*

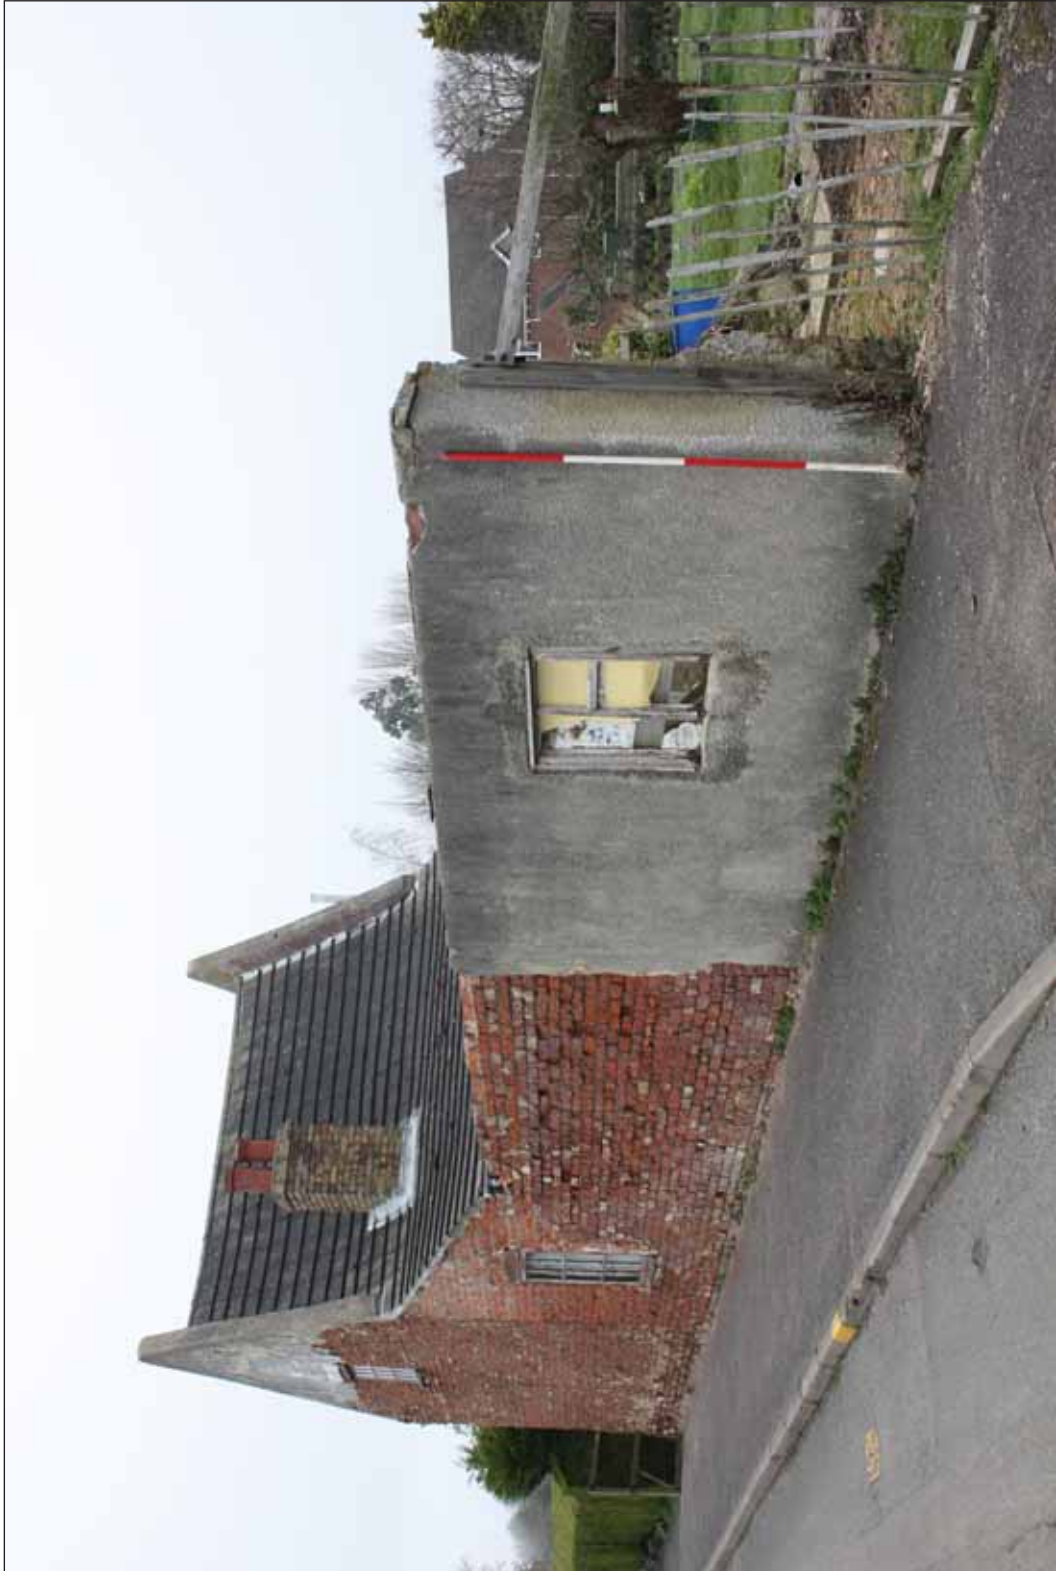
Plate 4. South-facing elevation (from southeast)

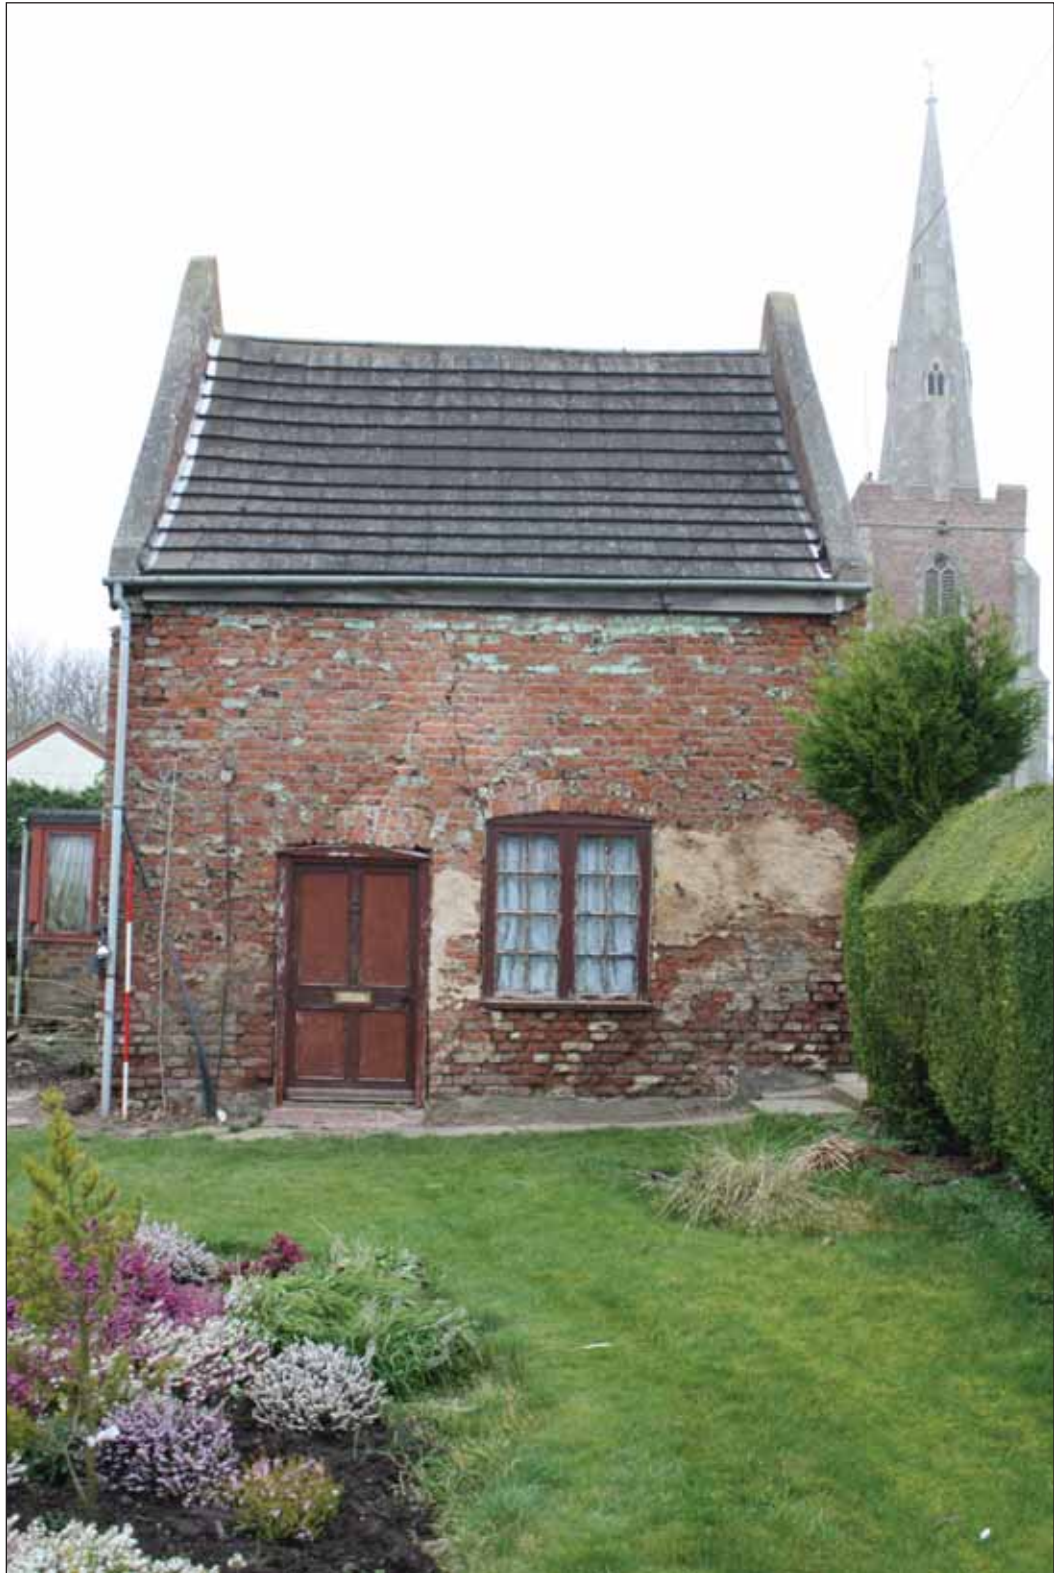
*Plate 5. West-facing elevation*

- 4.1.8 The fenestration in this elevation appears contemporary with that on the southern side, however this was a two-part casement window measuring 1.43m (H) by 1.22m (W) with eight panes per side in a two-two-two-two arrangement (plate 5). The window is set beneath a brick arch comprising two courses of headers. The brickwork on the left of the window respects the opening, however, the brick on the other side appears to have been cut to allow the window to be inserted. A substantial crack was recorded running from the corner of the window towards the roofline.

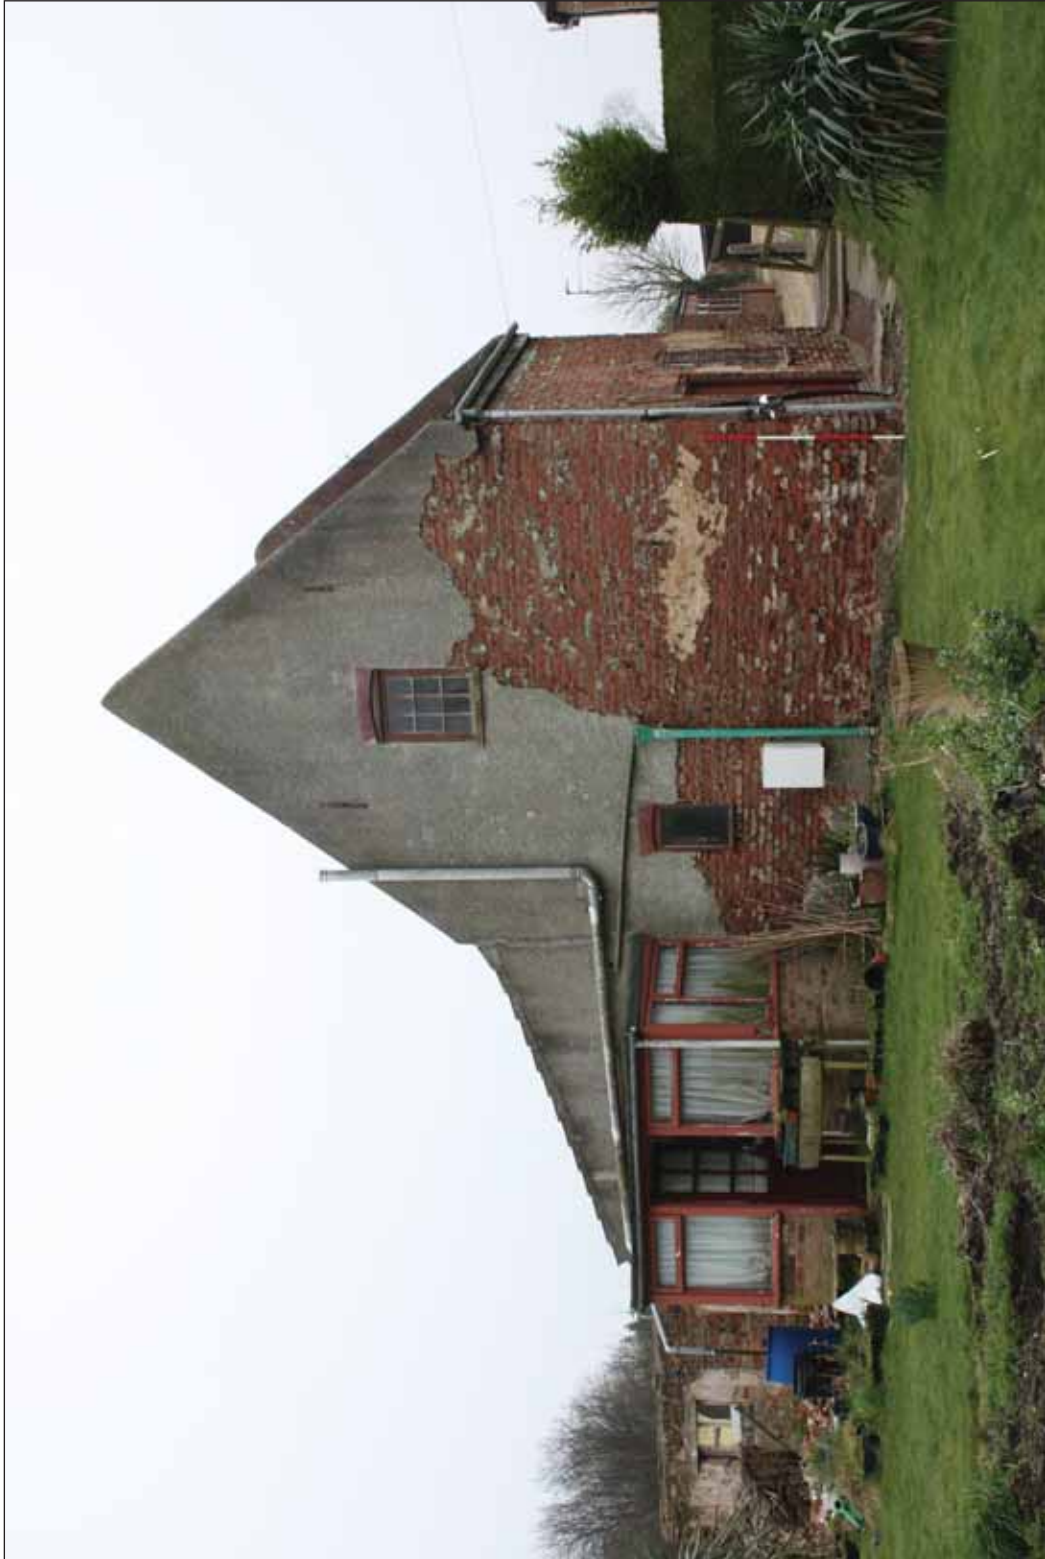
*Plate 6. North-facing elevation*

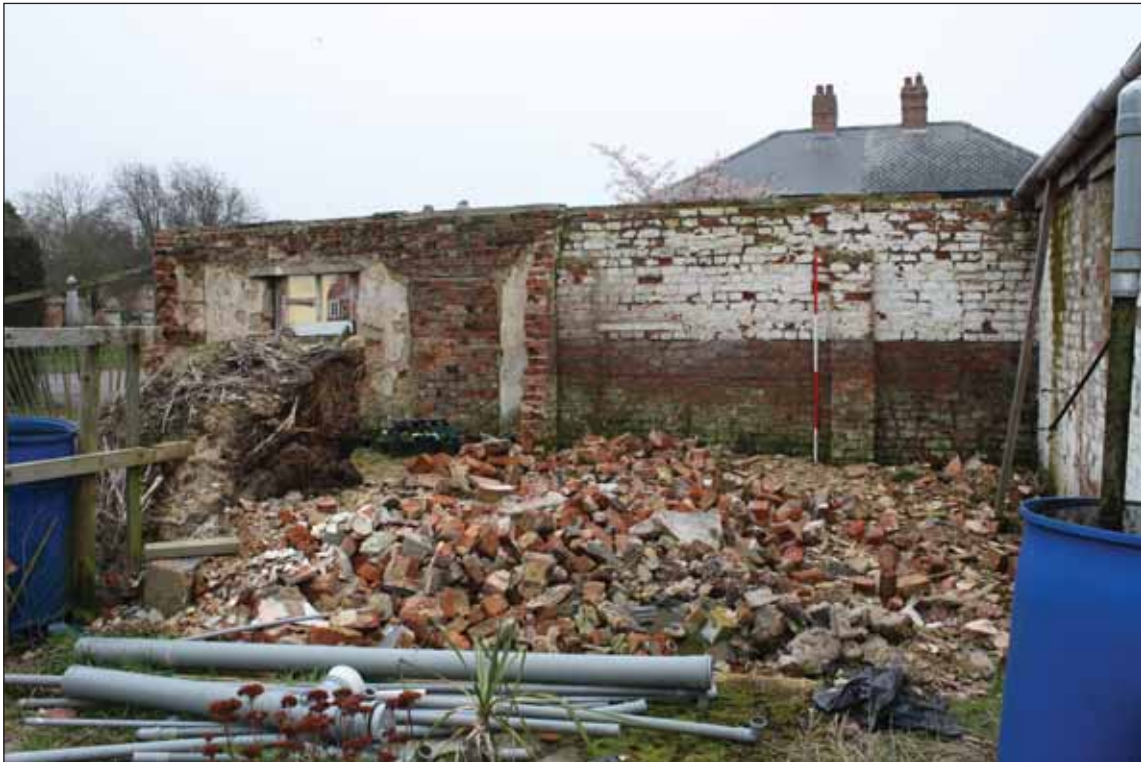
*Plate 7. North-facing wall*

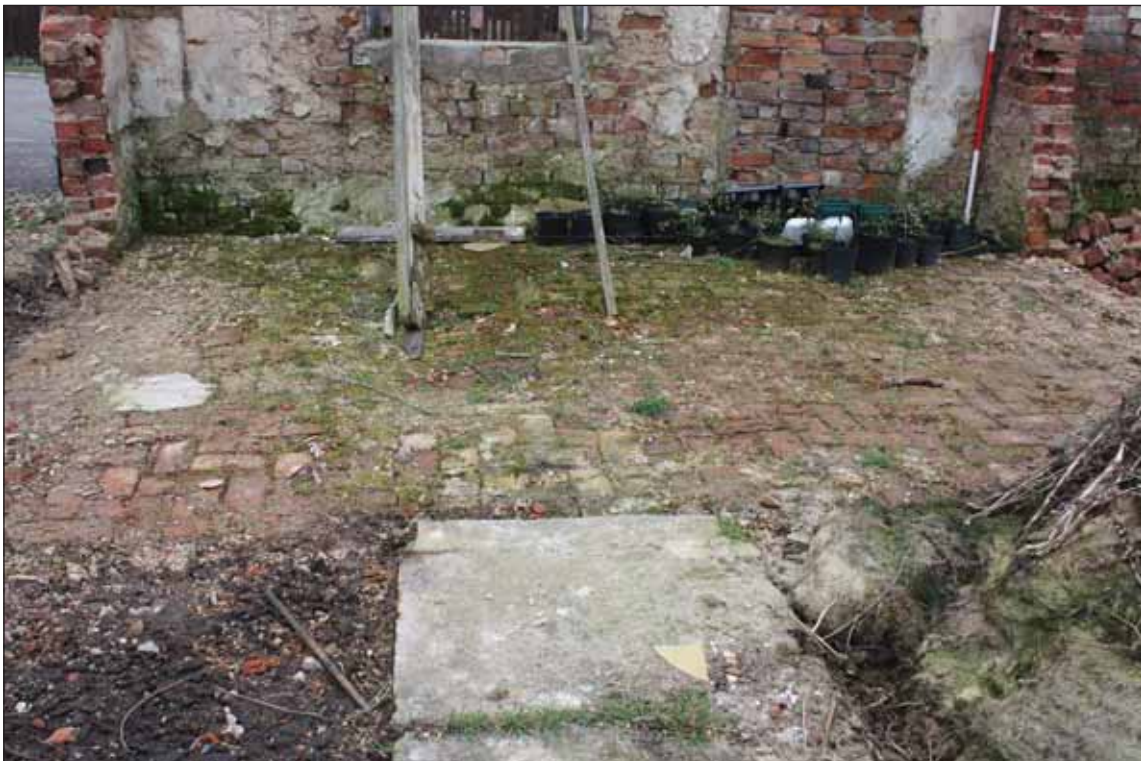
*Plate 8. Detail of brick floor*

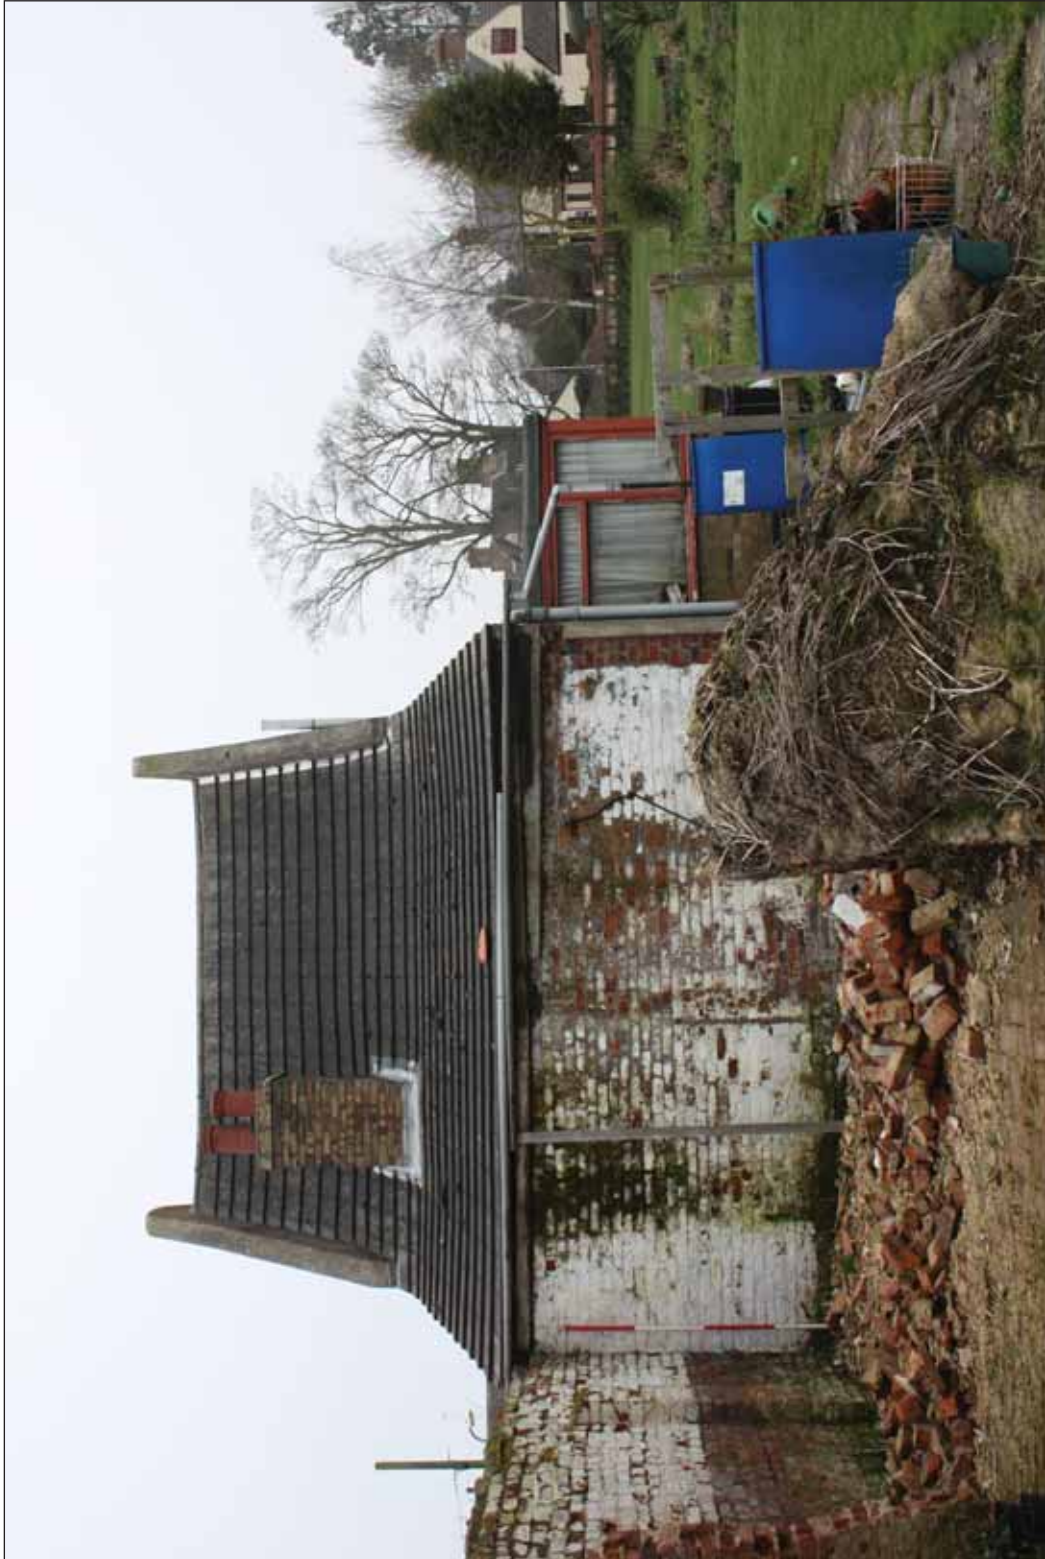
Plate 9. East-facing elevation

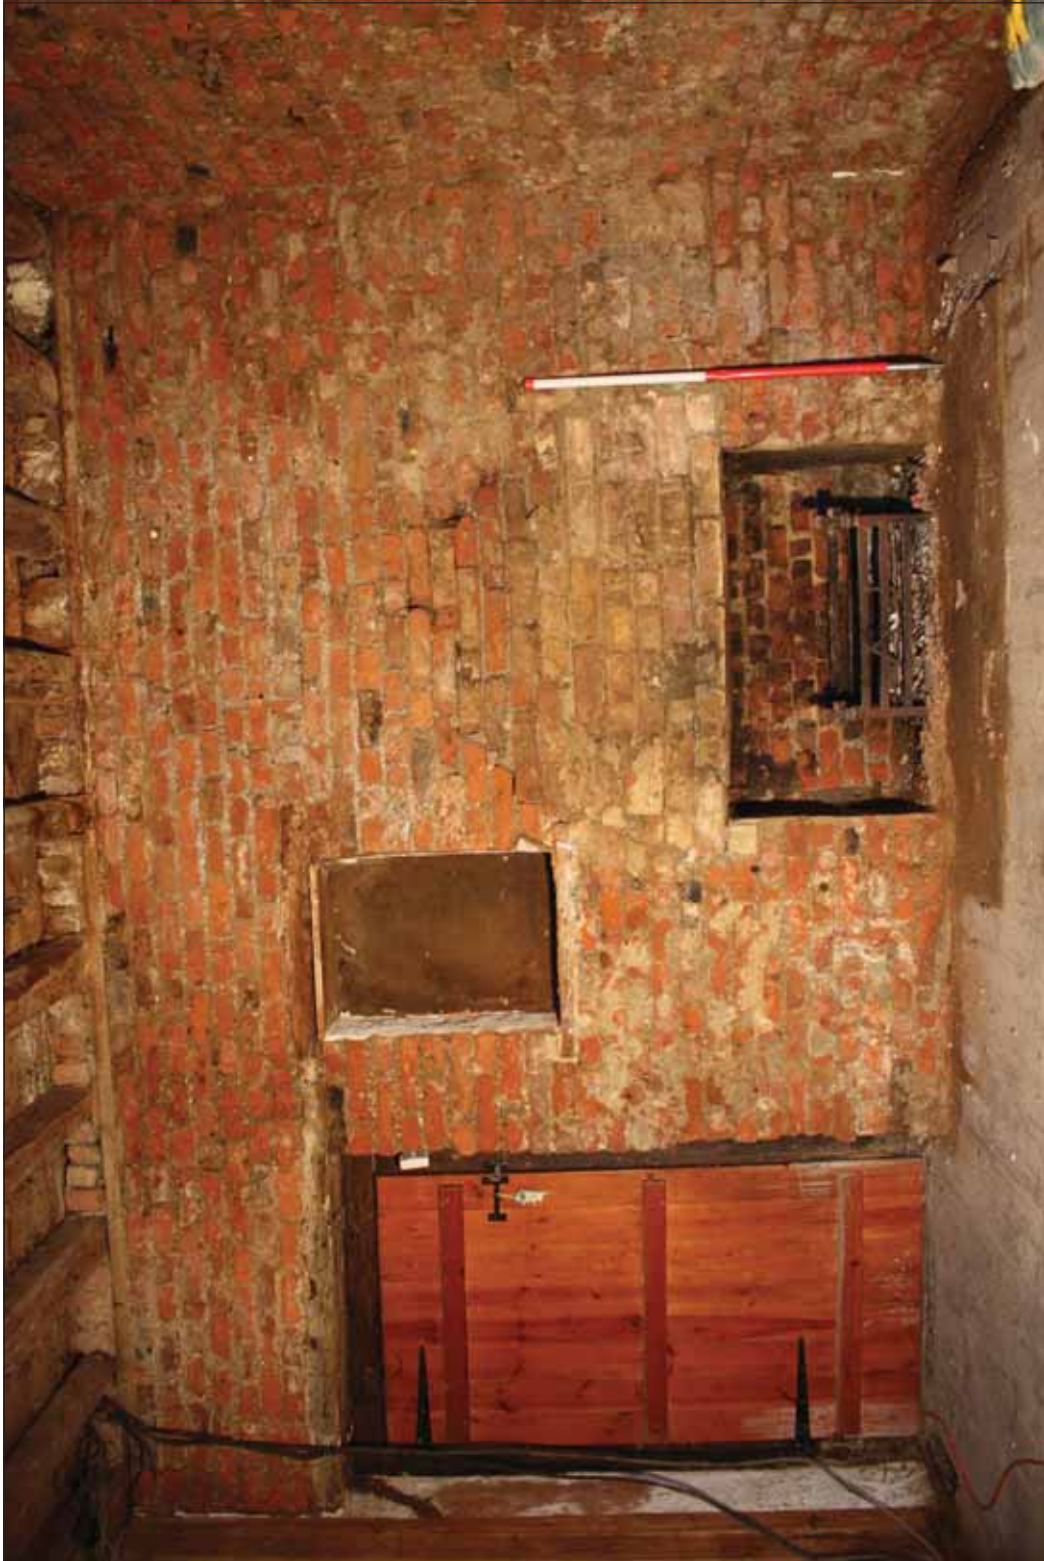
Plate 10. Interior wall, G1

- 4.2.2 The floor was covered with wooden floorboards measuring approximately 17cm wide, aligned east-to west (from door to door).
- 4.2.3 The wall which separated G1 and G2 (and west-facing) had a number of features to be recorded which included the doorway, a small window and a fireplace (plate 10). The doorway measured 1.16m in width and although the door itself was a 20th century replacement, the opening itself appeared to be original, respected by the brickwork on either side of the opening. Above the door was a timber lintel which was set within the brickwork on either side. A timber door frame was also recorded and although clearly not modern, it may be an early replacement. The door opening allowed the thickness of the walls to be measured here which were 0.43m.

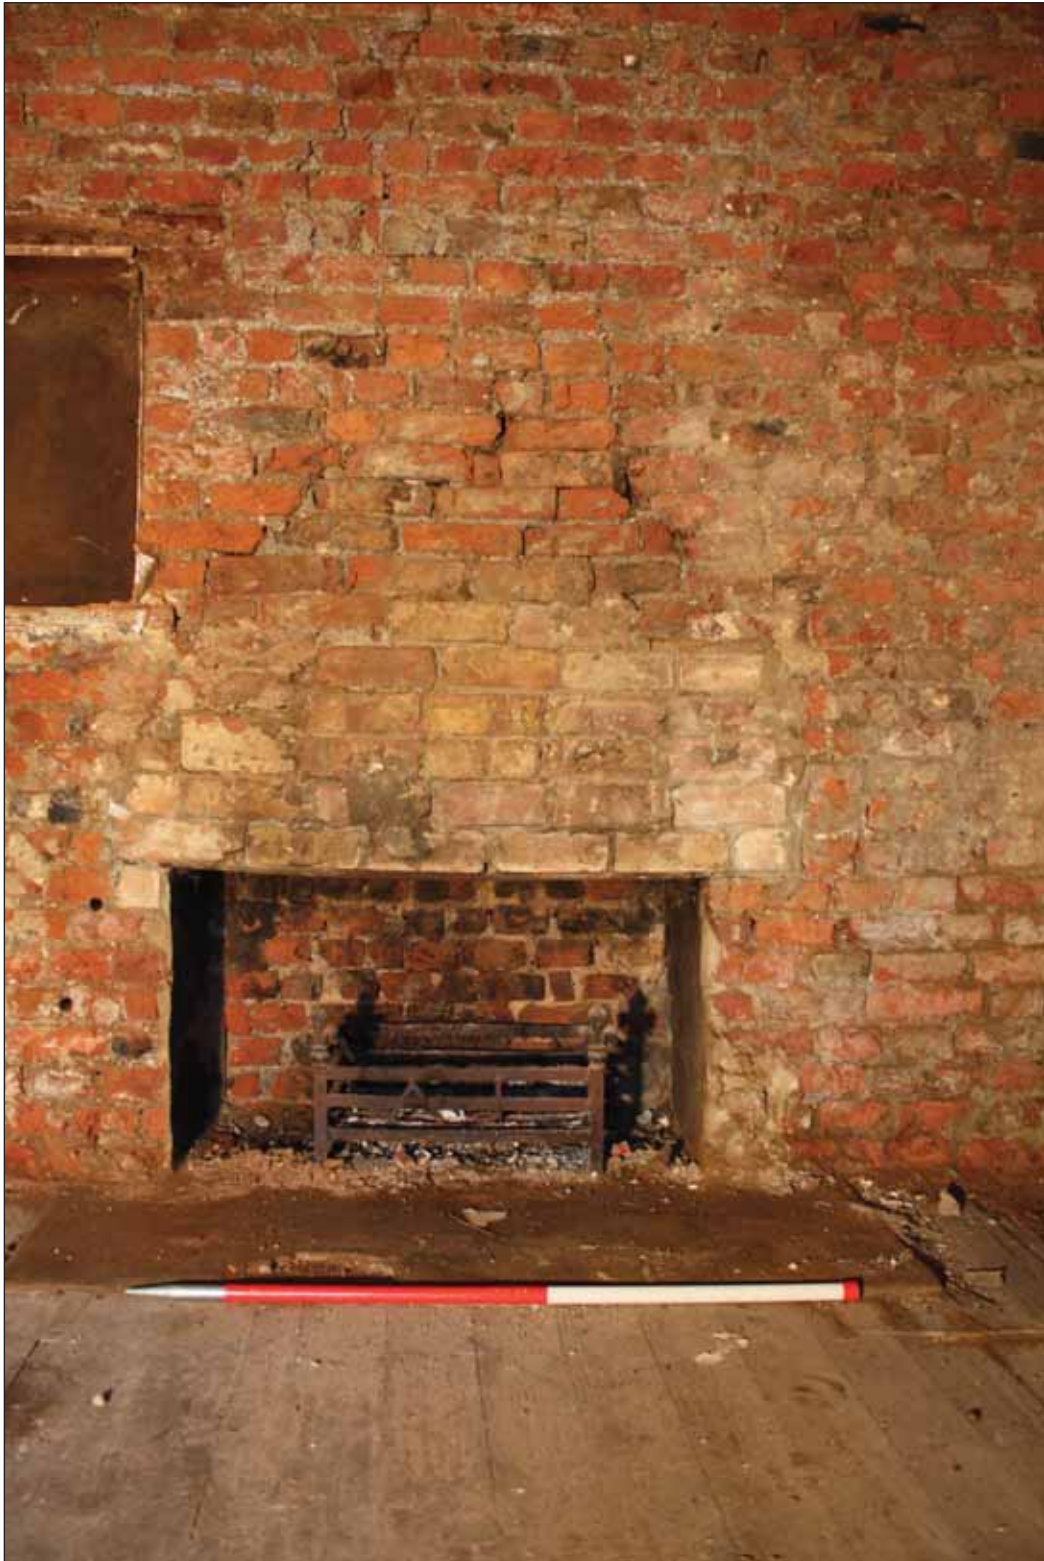
*Plate 11. Detail of fireplace, G1*

- 4.2.5 Right of the window was an opening for a small, modest fireplace. A stone hearth extended forward into the room. There was no evidence of there having ever been a surround and a change in the brickwork immediately above the opening indicates that the opening has been repaired, altered or possibly created. The brick used here is contemporary/same as that used to build the stack – c.19th century. Located within, but not built in is a wide metal grate bearing the initials “A.J.” (plate 11).

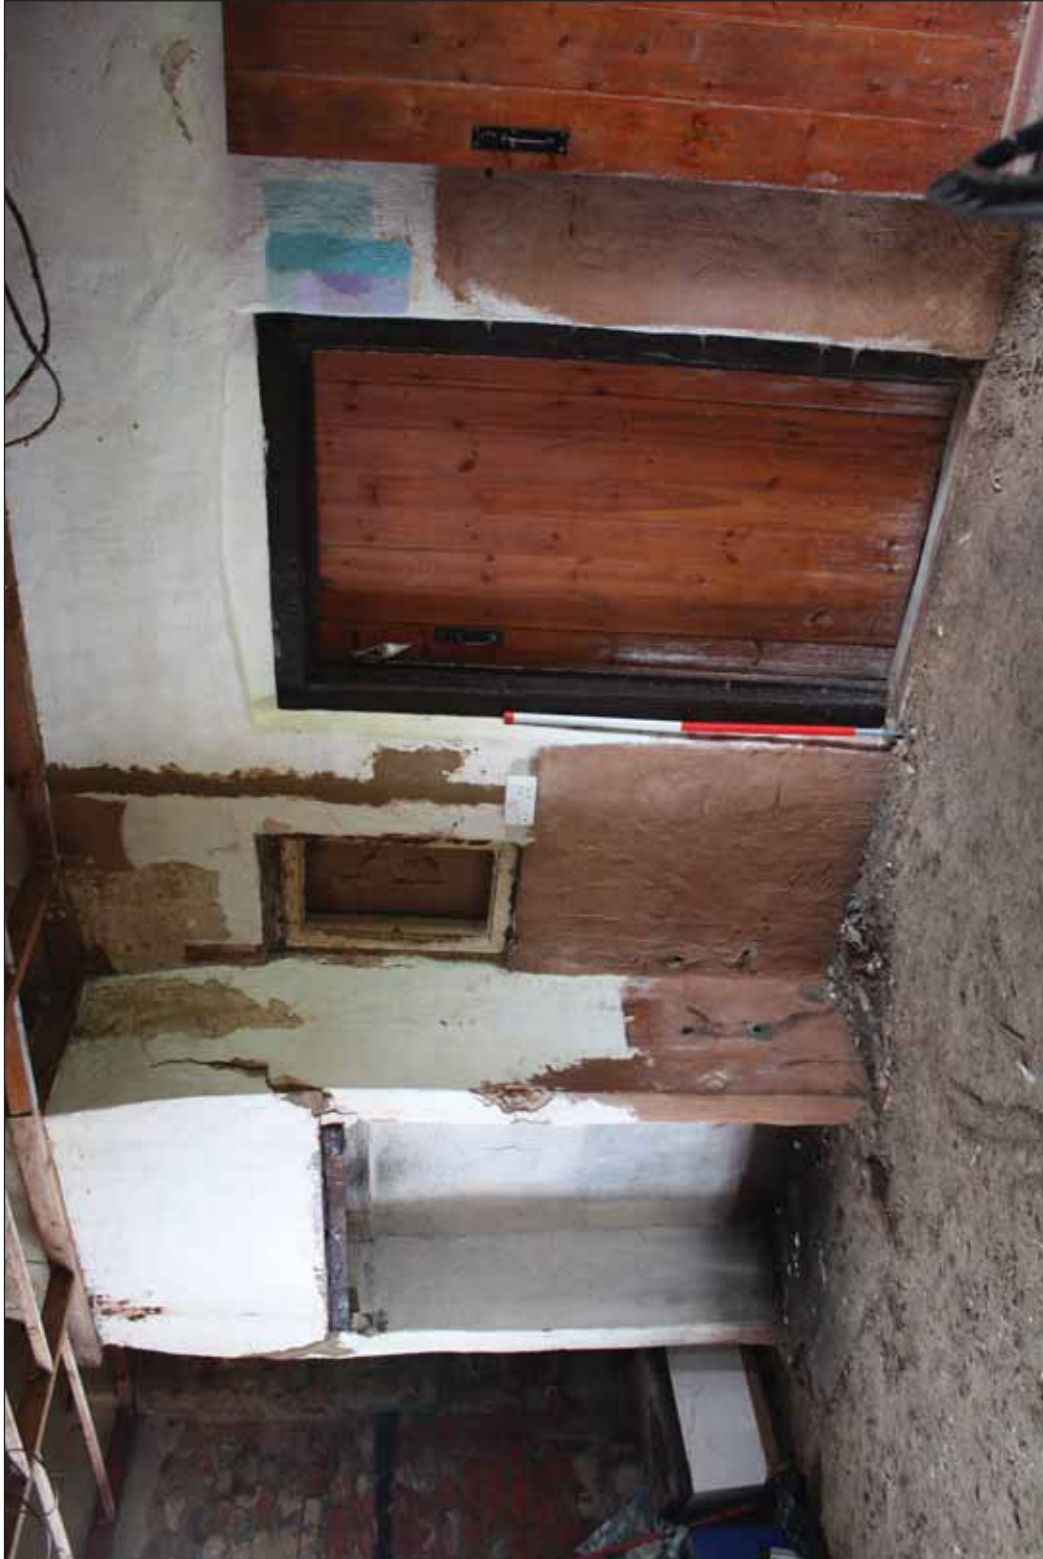
Plate 13. Interior wall, G2

- 4.2.11 The wall between G1 and G2 (east-facing) had the back of the three features recorded in G1; an opening which backed onto the fireplace, the blocked window and the doorway (plate 13). The fireplace and chimney breast were brick-built, plastered and painted white. There was no evidence of a fire surround and inside the opening had been sealed with an iron sheet into which was a round hole where a flue had recently been for an Aga (recently removed).
