# Whispers Cottage, Church Lane, Tydd St Mary, Lincolnshire

## Historic Building Survey and Archaeological Monitoring

OA East Report No: 1097

*By Taleyna Fletcher (BA, AIFA)*

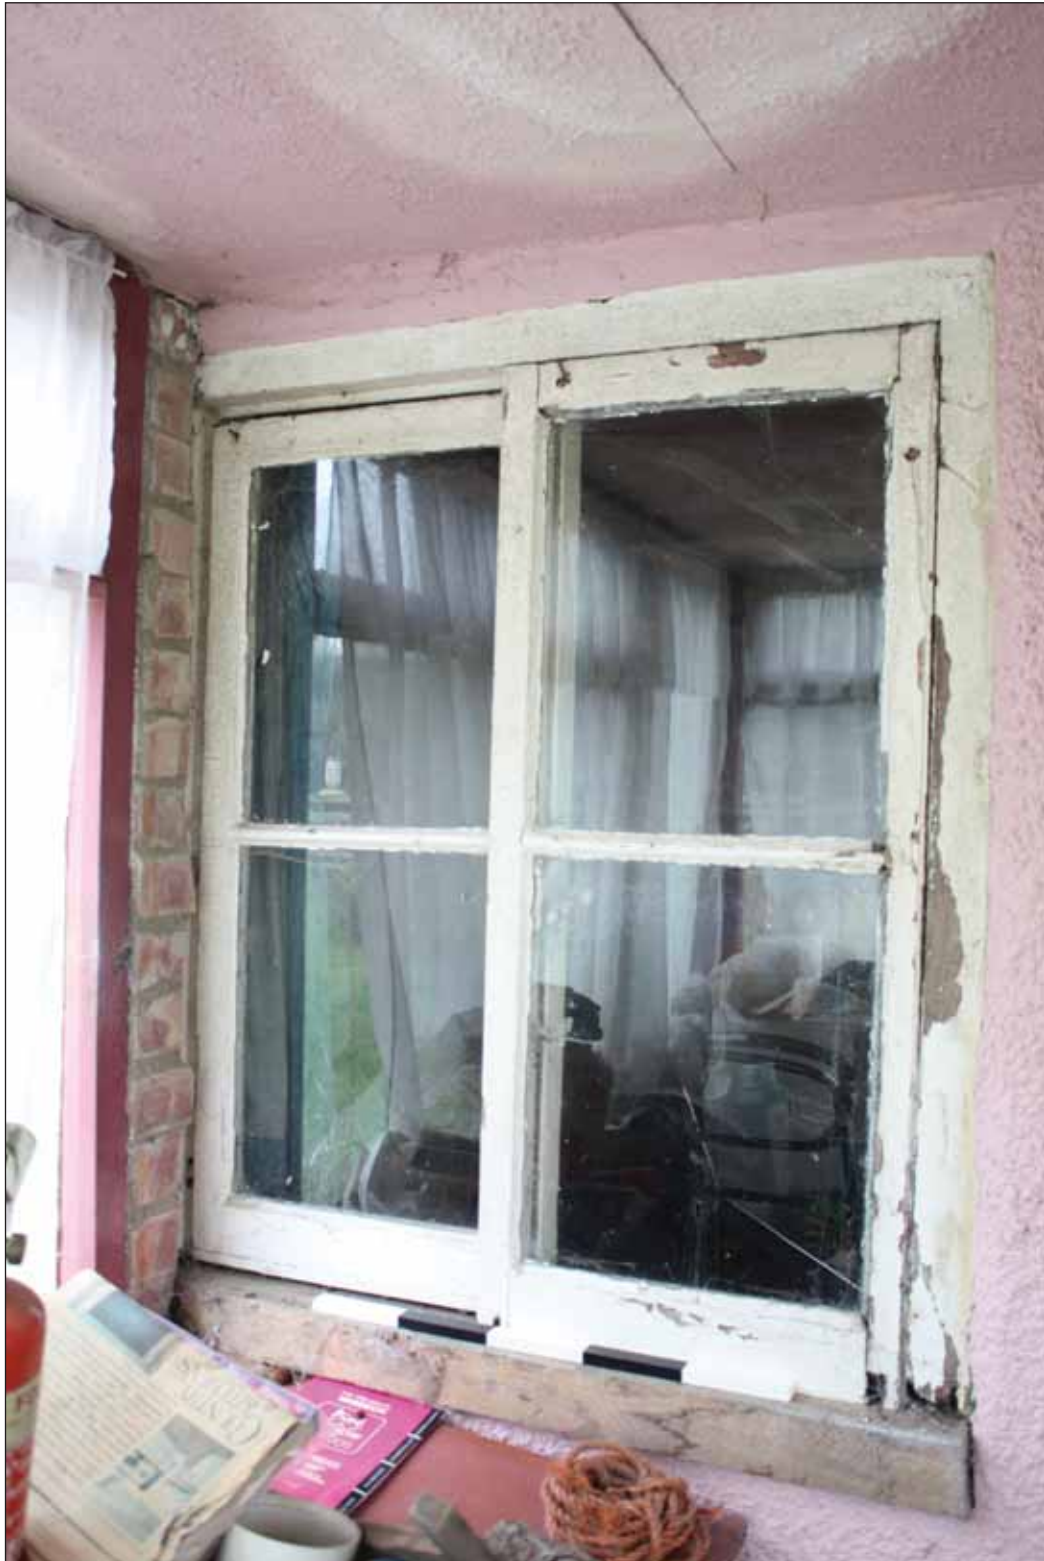
*Plate 14. Detail of window (from G3)*

- 4.2.16 This room was rectangular in plan, measuring approximately 2.90m x 1.90 (Figure 9) and was accessed via an internal door from G2 and an external door on the north-facing elevation. At the time of the survey this room was being used to store various pieces of gardening equipment.
- 4.2.17 The floor was covered with a modern linoleum.
- 4.2.18 The window on the wall between G2 and G3 was visible from this room, clearly once an external window (plate 14). There were no other architectural features in this room.

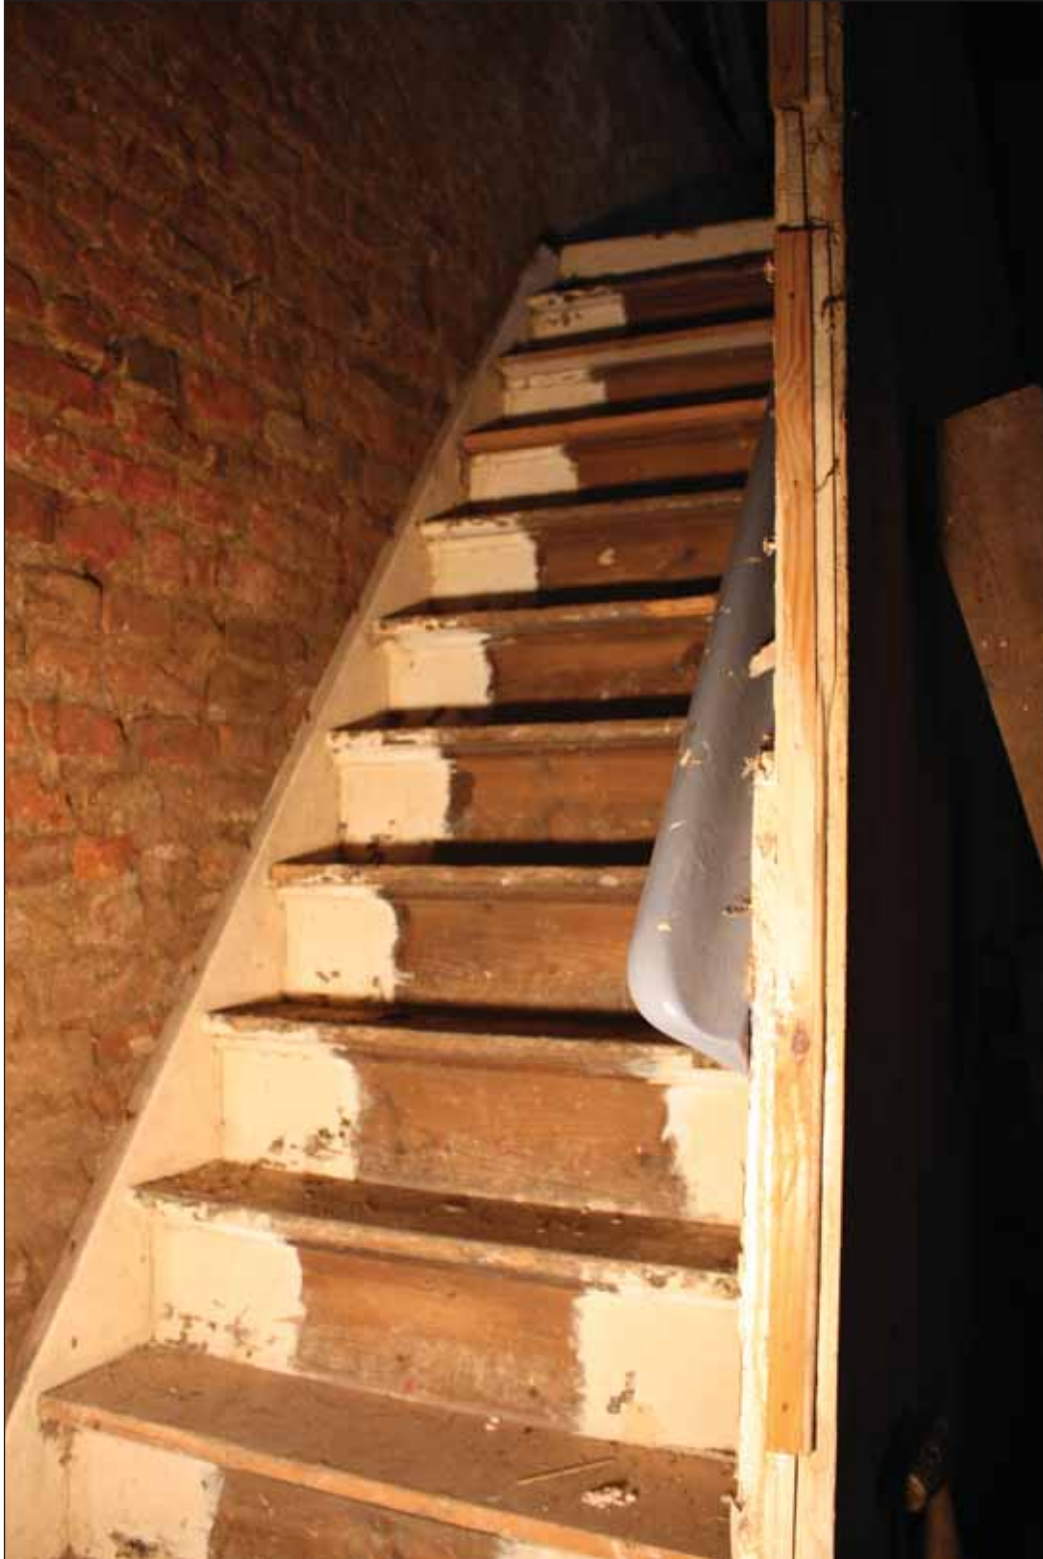
*Plate 15. Stairs*

- 4.2.19 Access to the first floor was gained via a set of stairs in G1 (plate 15). The stairs were very narrow with each tread and riser measuring approximately 0.16m. White paint was noted on either side indicating a carpet runner had been in the middle. A narrow wooden handrail ran on one side with a wooden newel at the top of the stairs. The top of the stairs entered directly into F1 (plate 16).

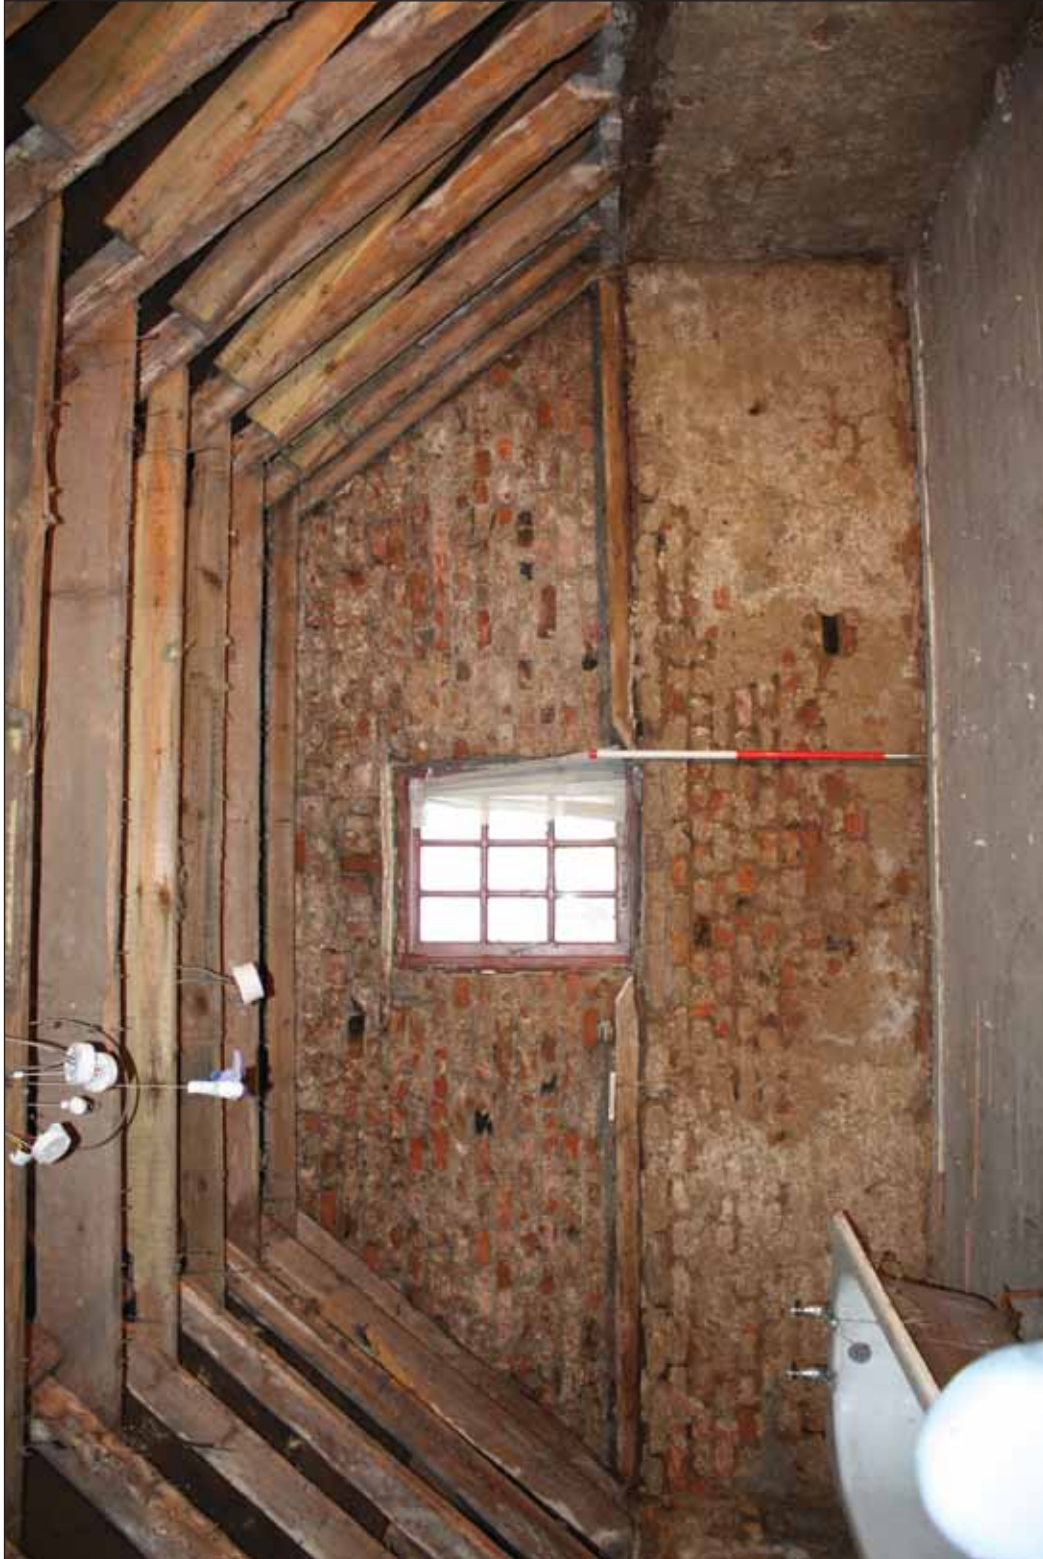
Plate 17. Internal shot of southern gable end (F1)

- 4.2.23 There were two windows, one on either gable end which were described previously from the external elevations (Section 4.1). The window in the south-facing gable end is clearly not original, however, evidence from this internal elevation shows that there was an opening in this location previously (plate 17). This opening was much narrower as indicated by the brick arch of headers. There is no indication of length as this has been lost with the insertion of the later window. A wooden lintel has been inserted when the window was replaced for additional support and to prevent the collapse of the arch. The wall plate has also been sawn to accommodate the later window. There is no indication of an earlier window on the opposite gable end from the brickwork (plate 16), although this may have been lost when the replacement window was inserted.

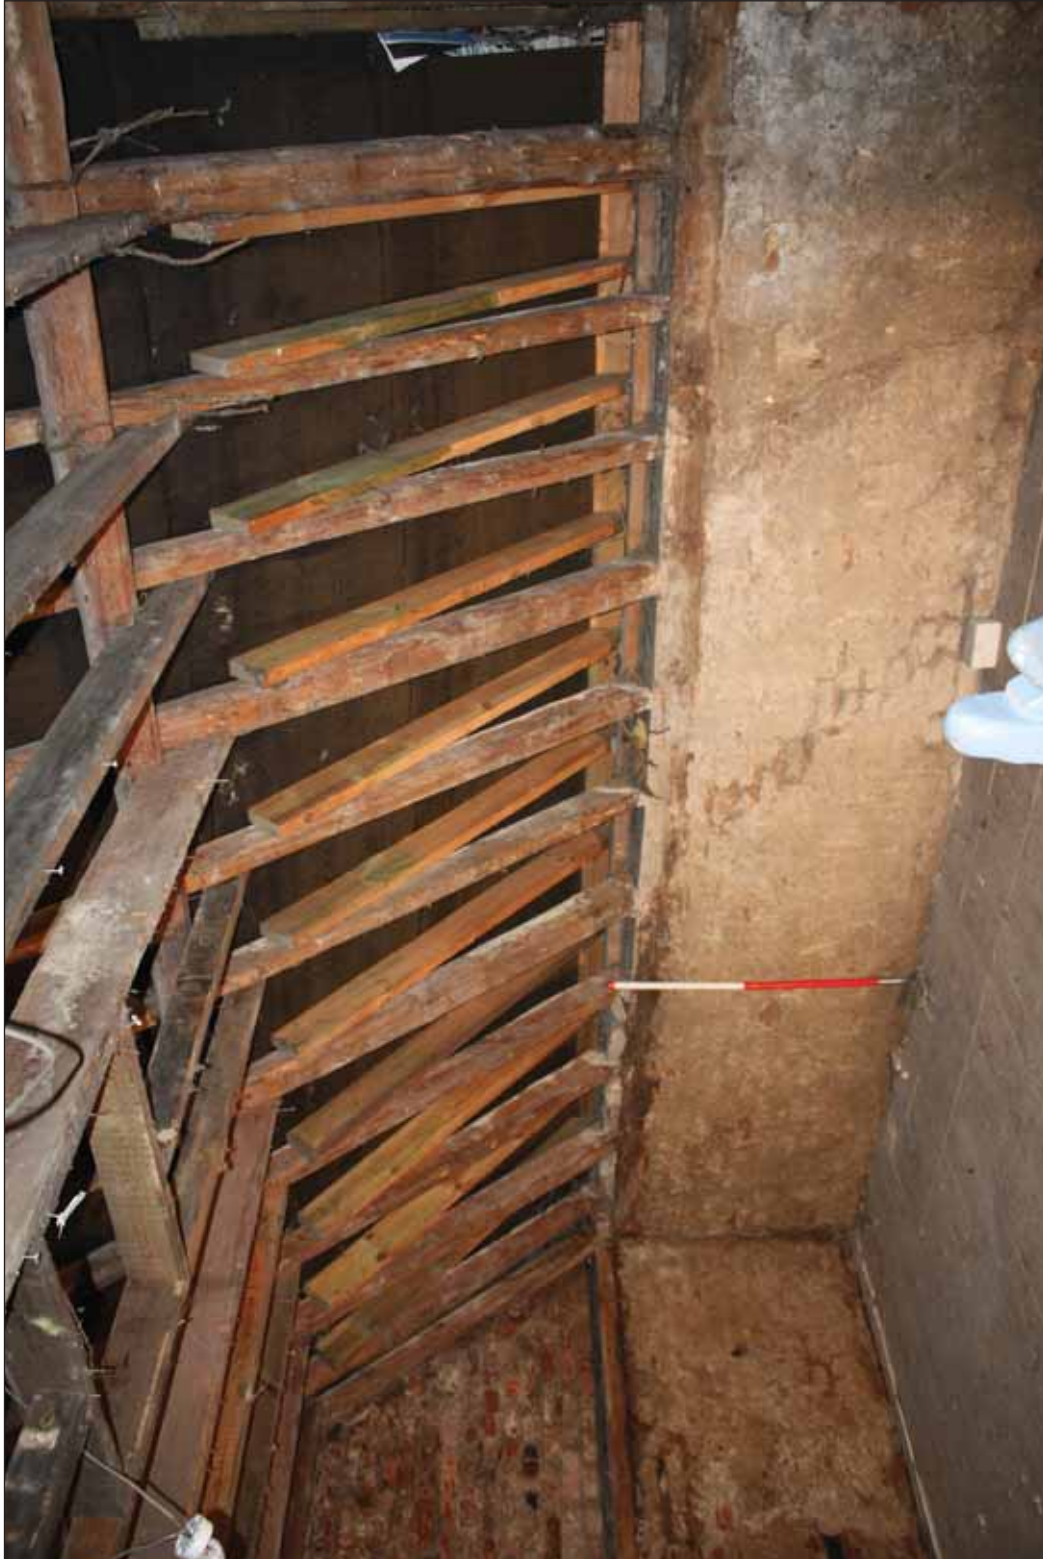
Plate 18. Room shot showing rafters, wall plates and collars, F1

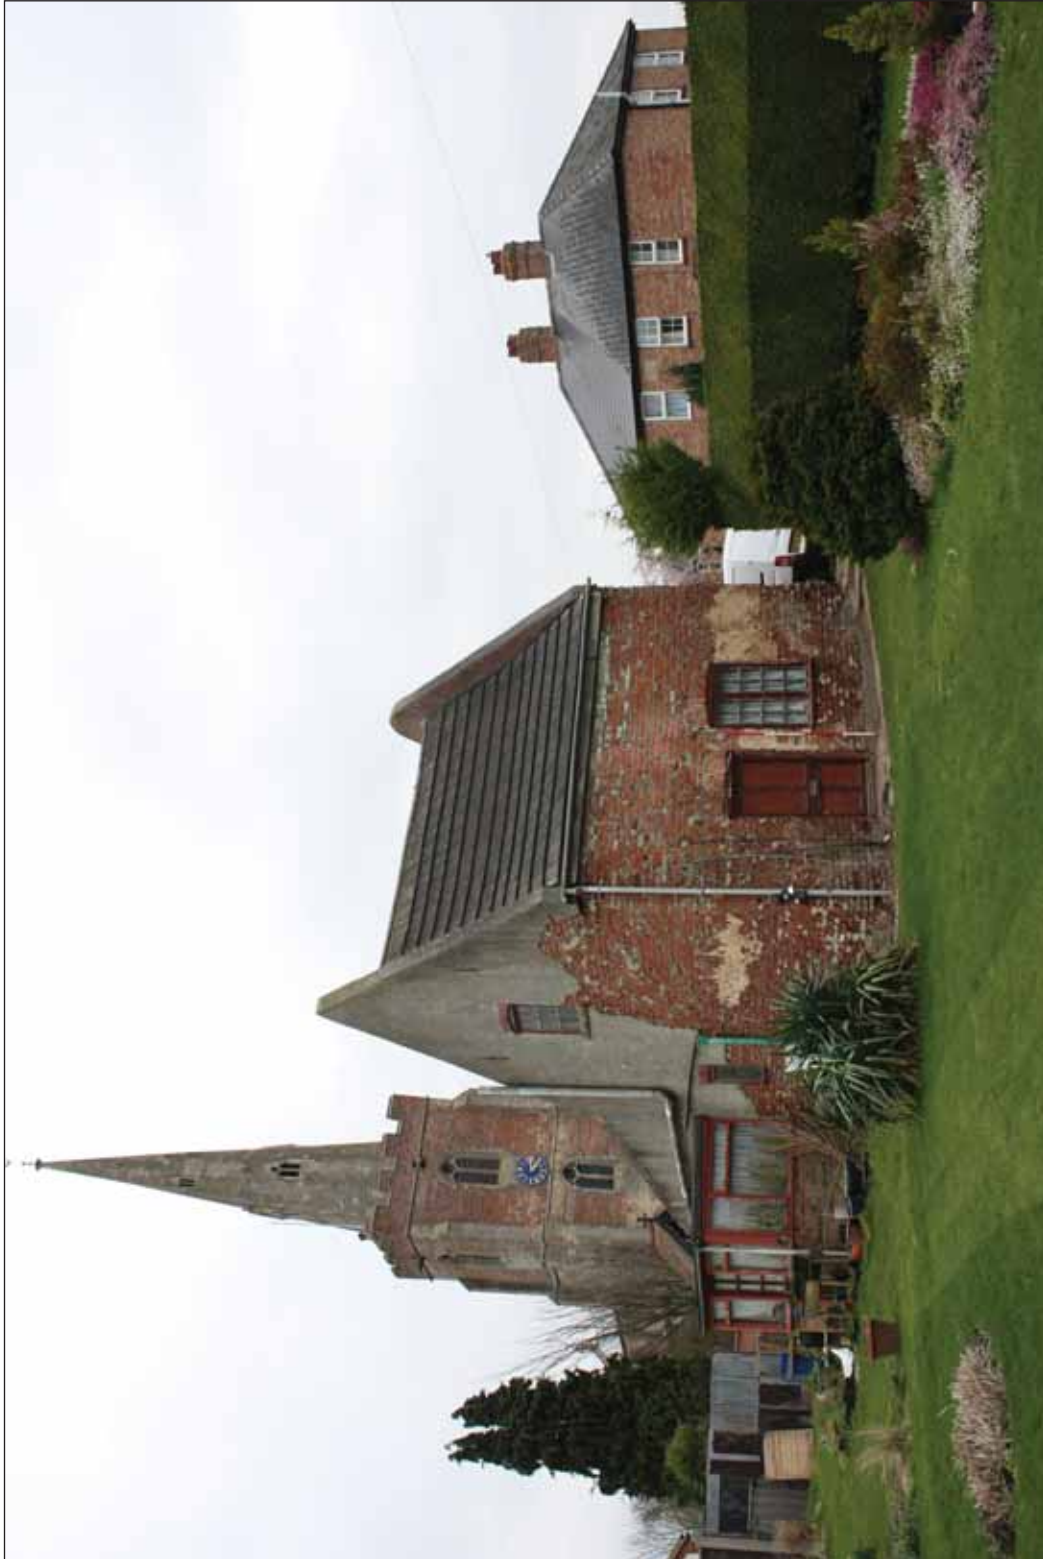
Plate 20. Whisper Cottage (from northwest) showing proximity to St Marys Church
