**Land adjacent to 88 Union Street, Dunstable**

***ARCHAEOLOGICAL EVALUATION REPORT***

**Planning Ref: SB/TP/98/0710**

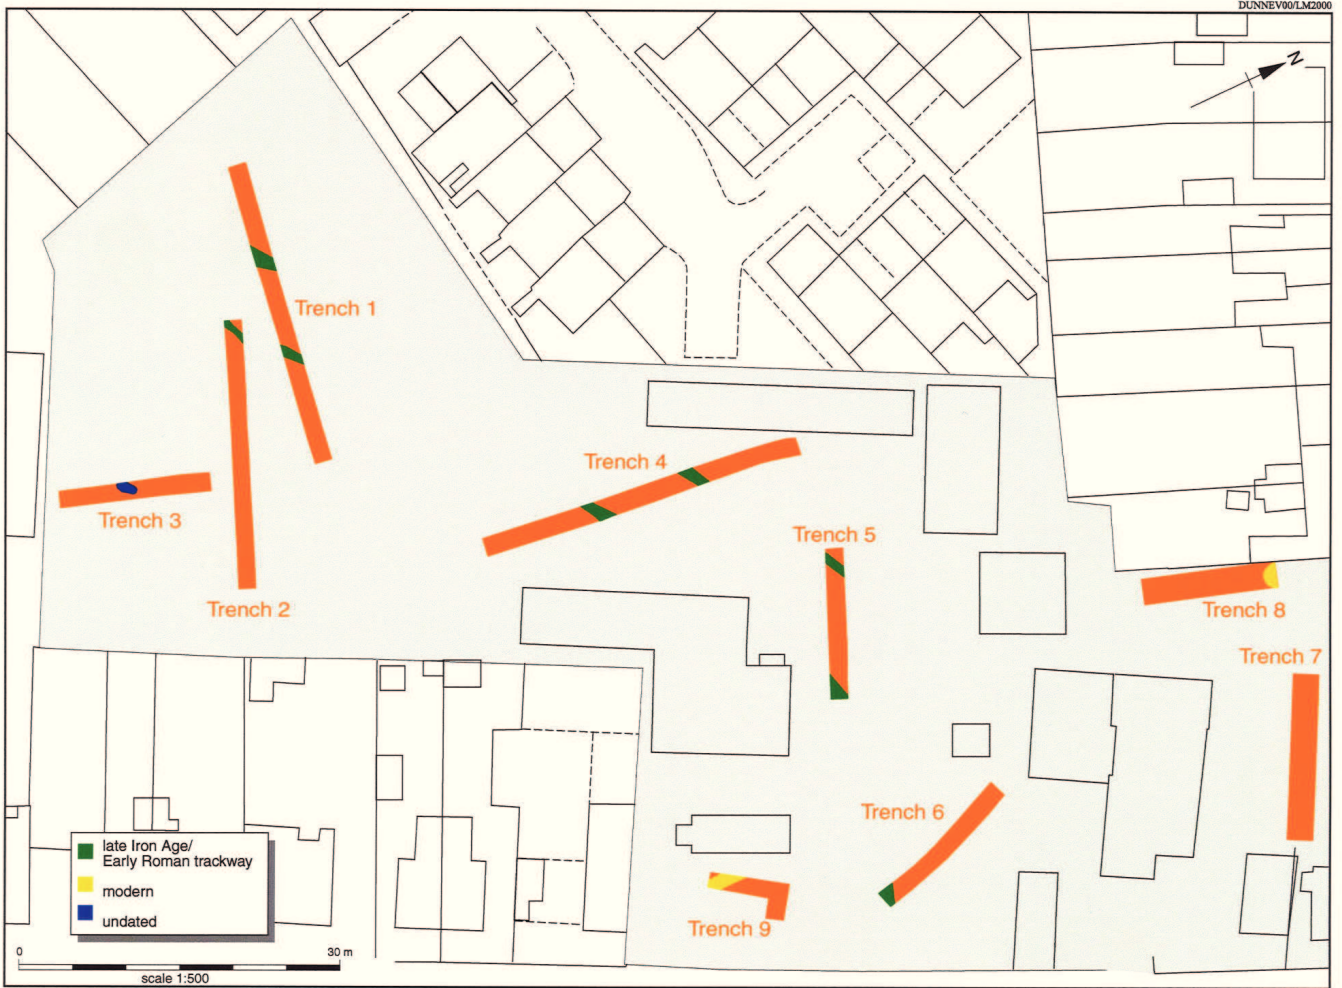
Figure 2: Trench Plan

- 3.1.1 The evaluation consisted of nine trenches; three measured c.30 m x 1.60 m, five measured c. 15 m x 1.60 m and one L shaped trench measured 3.5 m (north south) x 7.5 m (east west) and 1.6 m wide (Fig 2). The overburden was removed under close archaeological supervision by a 360° mechanical excavator fitted with a toothless bucket.
- 3.1.2 A provision for a contingency of 150 square metres had been allowed for, so that further investigation of any significant features or deposits encountered may be undertaken.

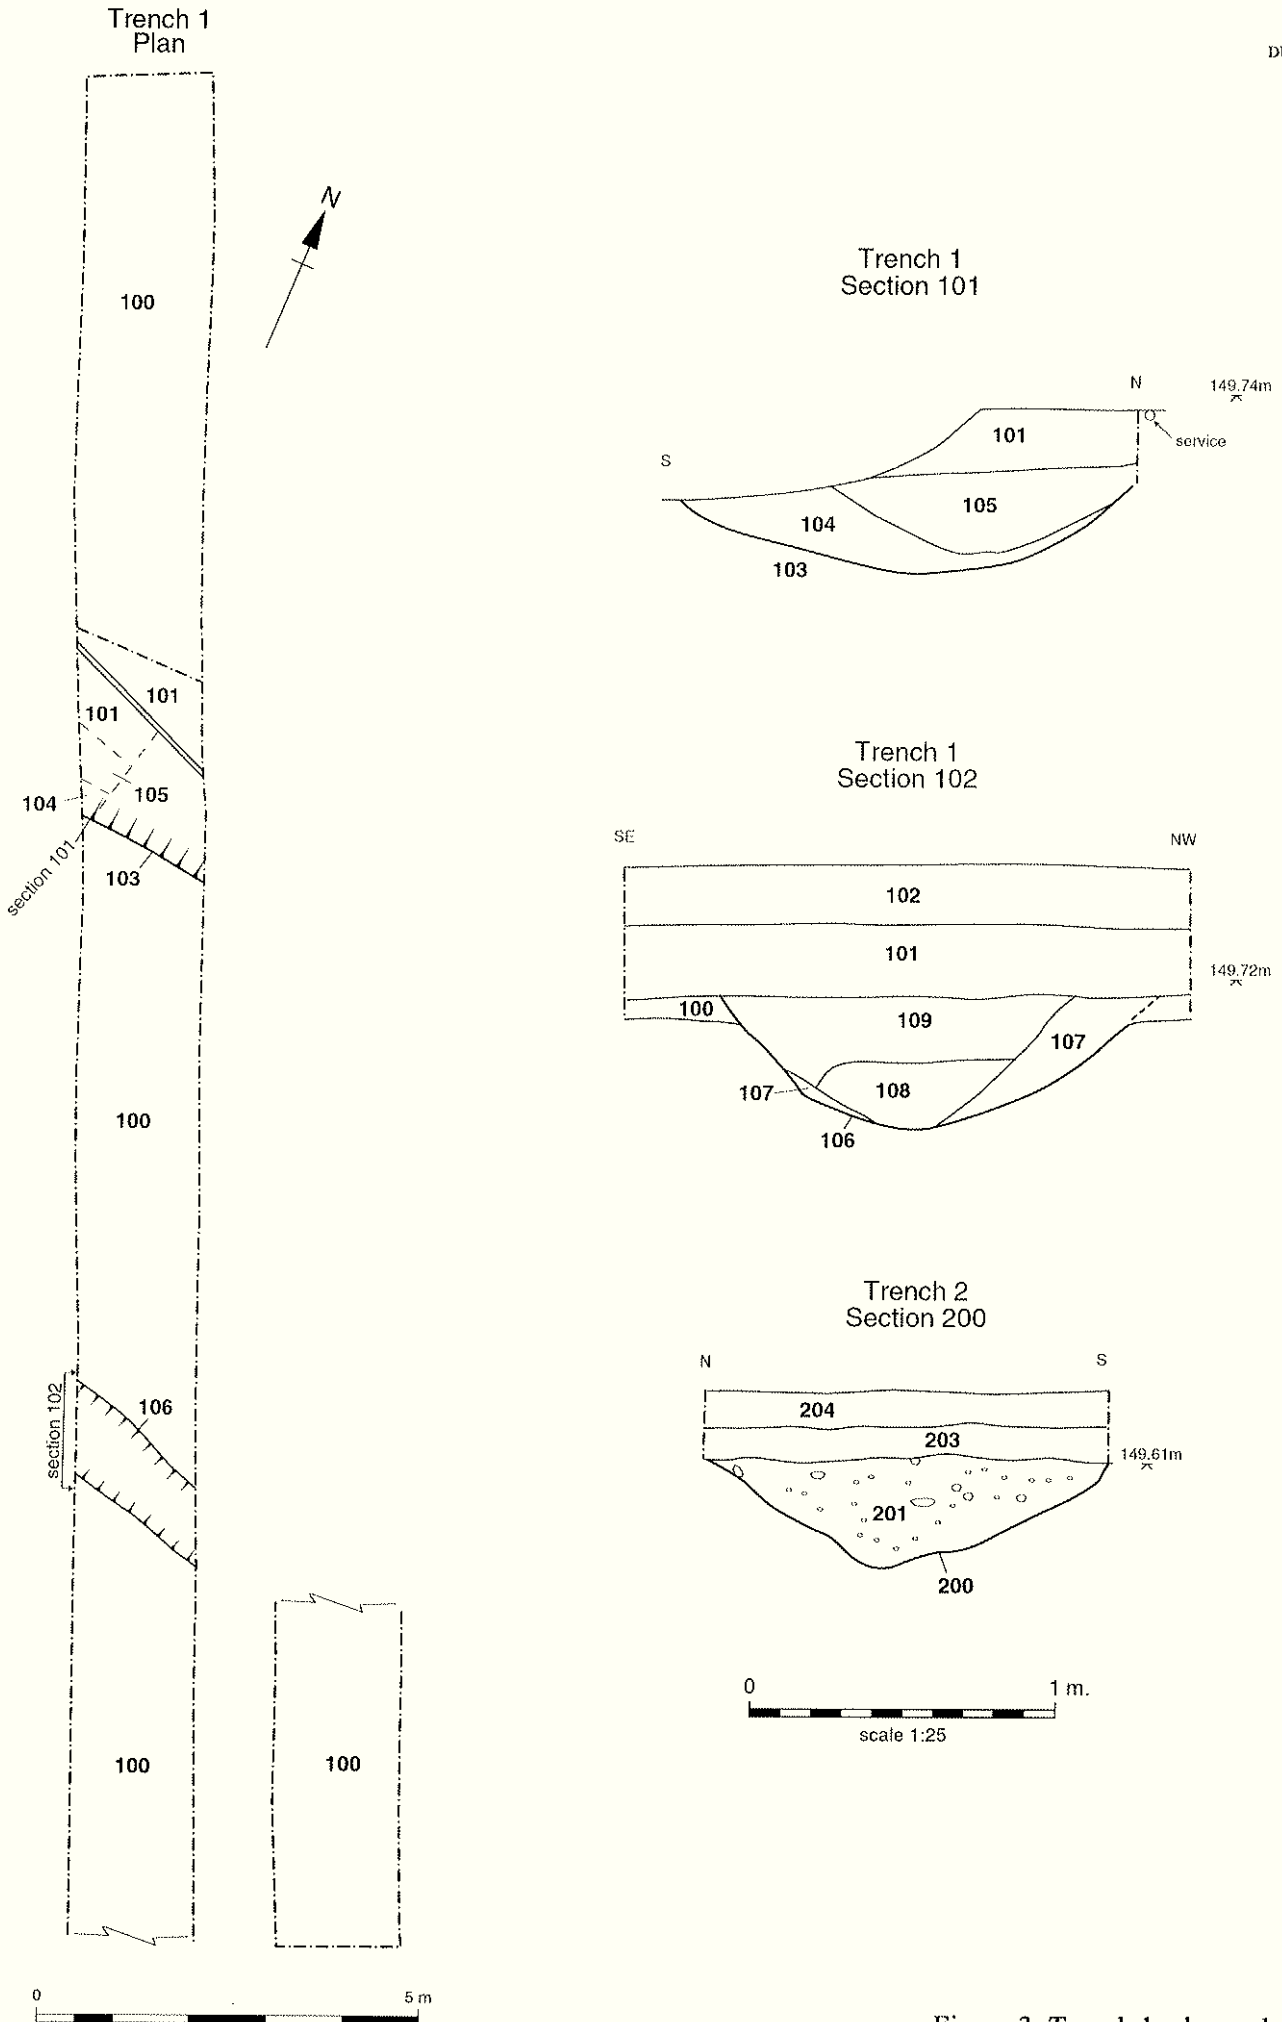
Figure 3: Trench 1, plan and sections.

The natural chalk (100) was revealed at a depth of 0.54 m below ground level (bgl) in the northwest end of the trench (149.36 m OD). In the trench two eastwest aligned ditches were seen 7.5 m apart. To the north-east of the trench was ditch 103, 0.43 m deep and over 1.60 m wide with a flat base. In the south-west of the trench was ditch 106, 0.43 m deep and 1.85 m wide with a concave base; both ditches were filled with a redeposited natural layer (104 and 107 respectively) beneath a silty clay (105 and

108/109 respectively) containing late Iron Age/early Roman pottery. A flint flake was also retrieved from fill 109. Overlying the fills of these ditches was a subsoil (101) and a topsoil (102).

In Trench 2 natural chalk (202) was encountered at a depth of 149.61 m OD (0.32 m bgl). At the north end of the trench a ditch was seen (200) which was aligned eastwest, 0.35 m deep, 1.30 m wide and with a fairly flat base. It was filled with a silty clay (201). Above the fill 201 was a subsoil (203) and a topsoil (204).

The archaeology encountered consisted of sections of two roughly parallel ditches running eastwest across the site. They appeared to turn south-eastnorth-west in Trenches 5 and 6, where they were spaced further apart. The argument for the two parallel ditches is based on the premise that ditches 103, 407 and 504 are part of the northern ditch and ditches 106, 200, 404, 502 and 604 form the southern ditch. The dating evidence, from the pottery retrieved, would suggest that these are late Iron Age or early Roman ditches, and given the even spacing, they may define the edges of a trackway. Ditch 407 in Trench 4 had a line of flint nodules over the primary weathered natural slippage possibly as an aid to drainage. The trackway could be associated with the Roman town of Dunstable which lies on the edge of Union Street.

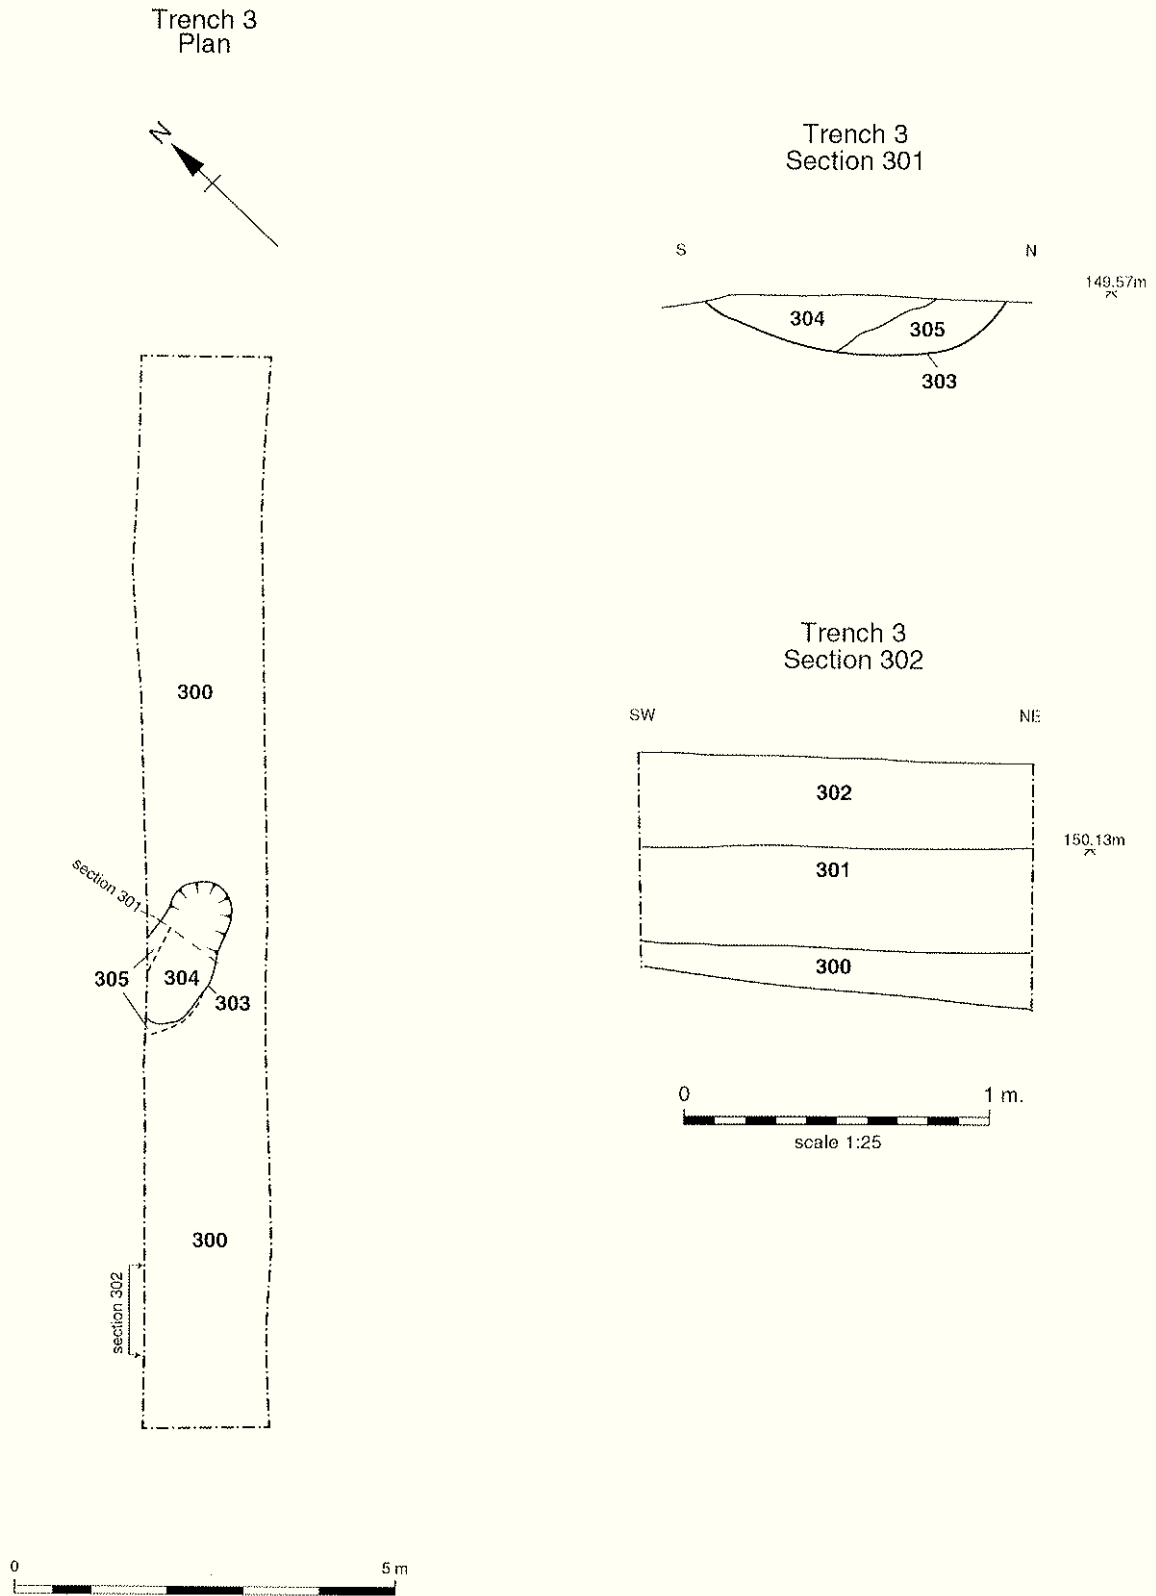
Figure 4: Trench 3, plan and sections.

Natural (300) was seen at c. 149.60 m OD (0.50 m bgl). The only feature encountered was an oblong pit (303), 0.22 m deep and measuring 2 x 1 m. It was filled by a redeposited natural chalk (305) and a clayey silt (304), which were sealed by a subsoil (301) and a topsoil (302).

A single ovoid feature was seen in Trench 3, no dating evidence was observed but the fill was very similar to that of the ditches. There is no evidence for prehistoric or medieval activity as seen in the area around the area of development or for the existence of a Neolithic long barrow recorded within the area evaluated. The only earthwork appears to be an area of modern ground make-up which was dumped over a modern northsouth aligned ditch seen in Trench 9.

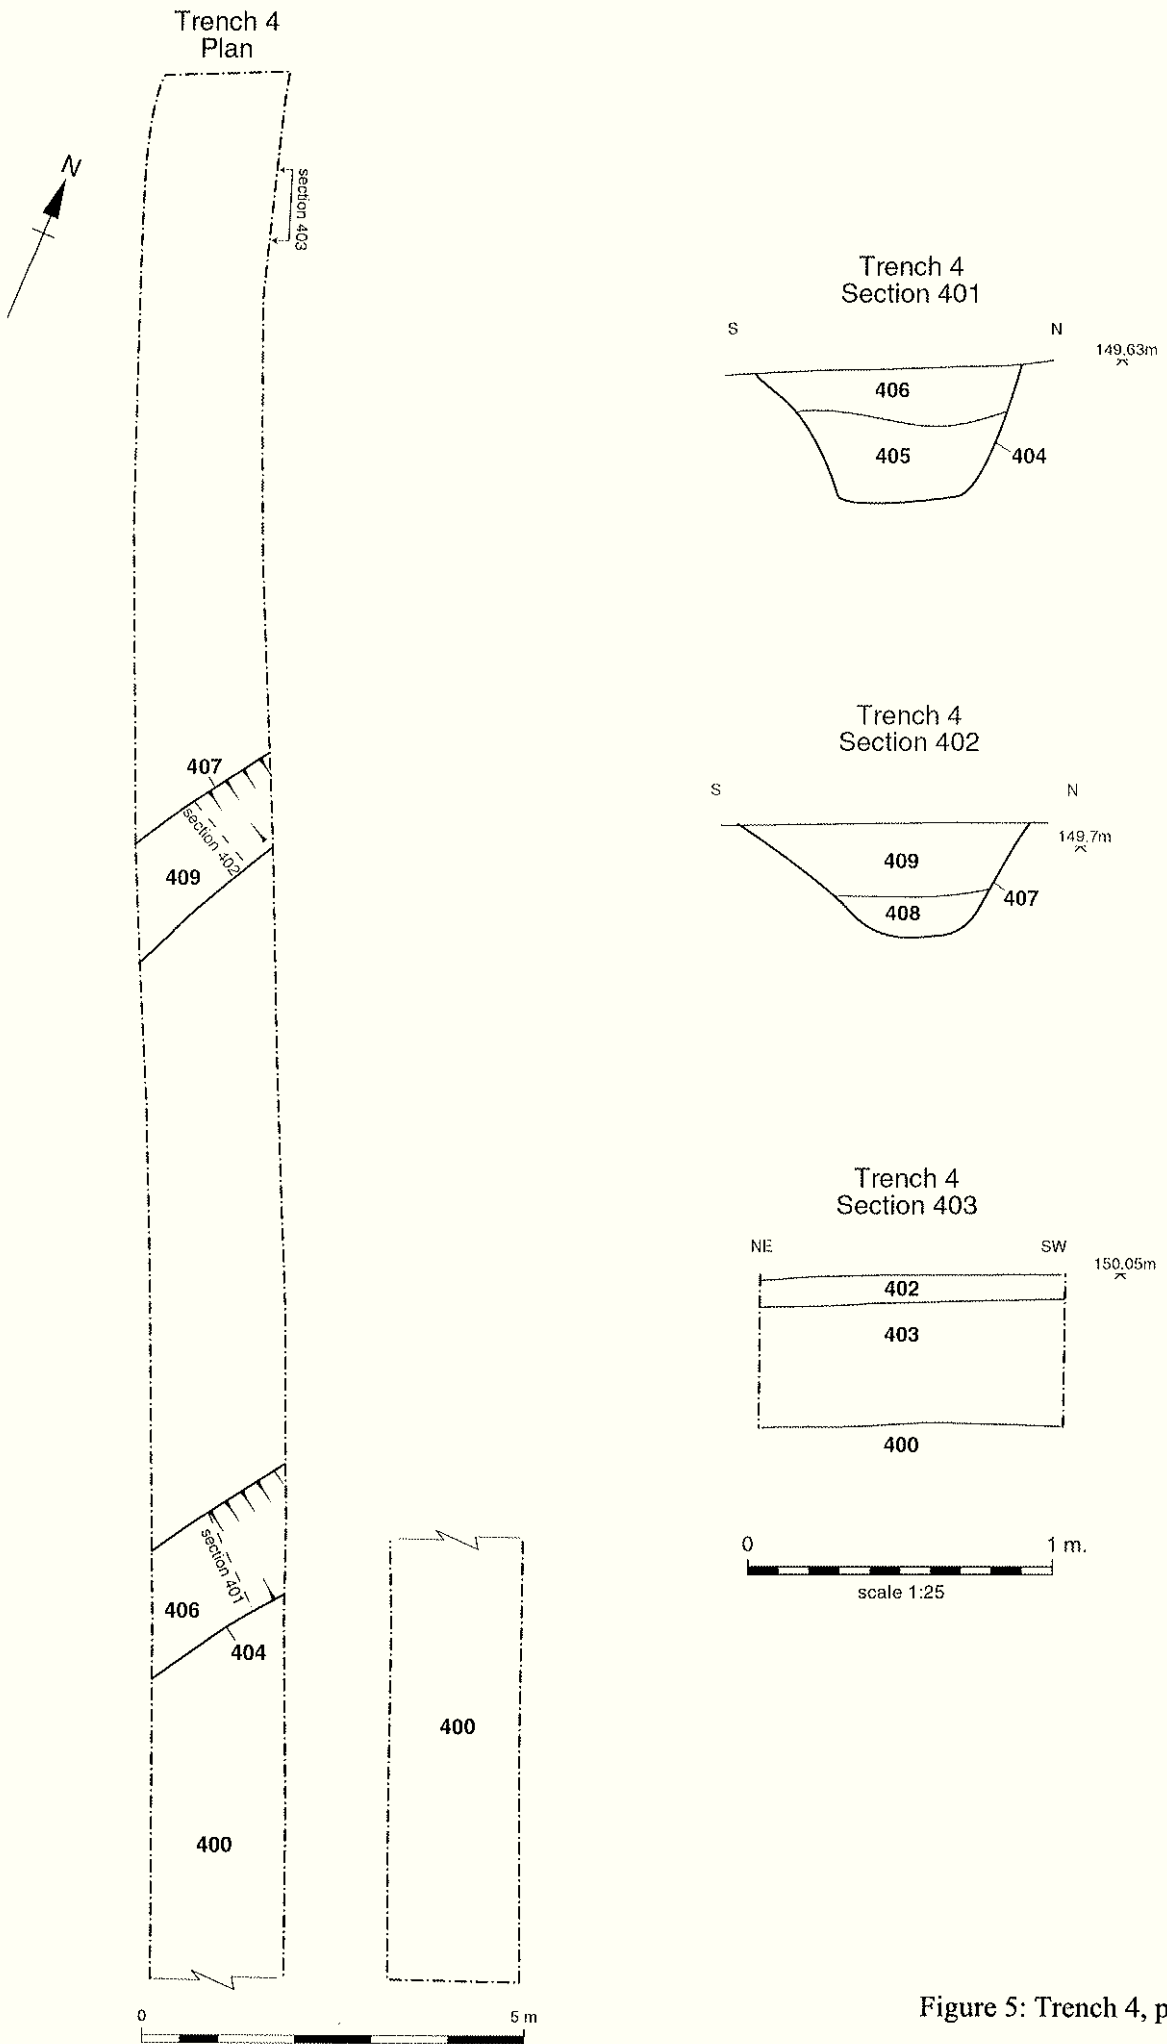
Figure 5: Trench 4, plan and sections.

In the north-east end of the trench the natural (400) was at 149.63 m OD (0.40 m bgl) and in the south-west at 149.72 m OD (0.60 m bgl). In the centre of the trench two eastwest aligned ditches were encountered; these were 7.5 m apart. At the south-west end of the trench was ditch 404, being 0.44 m deep, 0.89 m wide and with a flat base. To the north-east end of the trench was ditch 407 which was 0.40 m deep, 0.95 m wide, and with a concave base. Both ditches were filled with a redeposited natural chalk beneath a silty clay. In ditch 407 pottery was recovered from fill 409. The upper fills of both features were overlain by 403, a levelling layer.

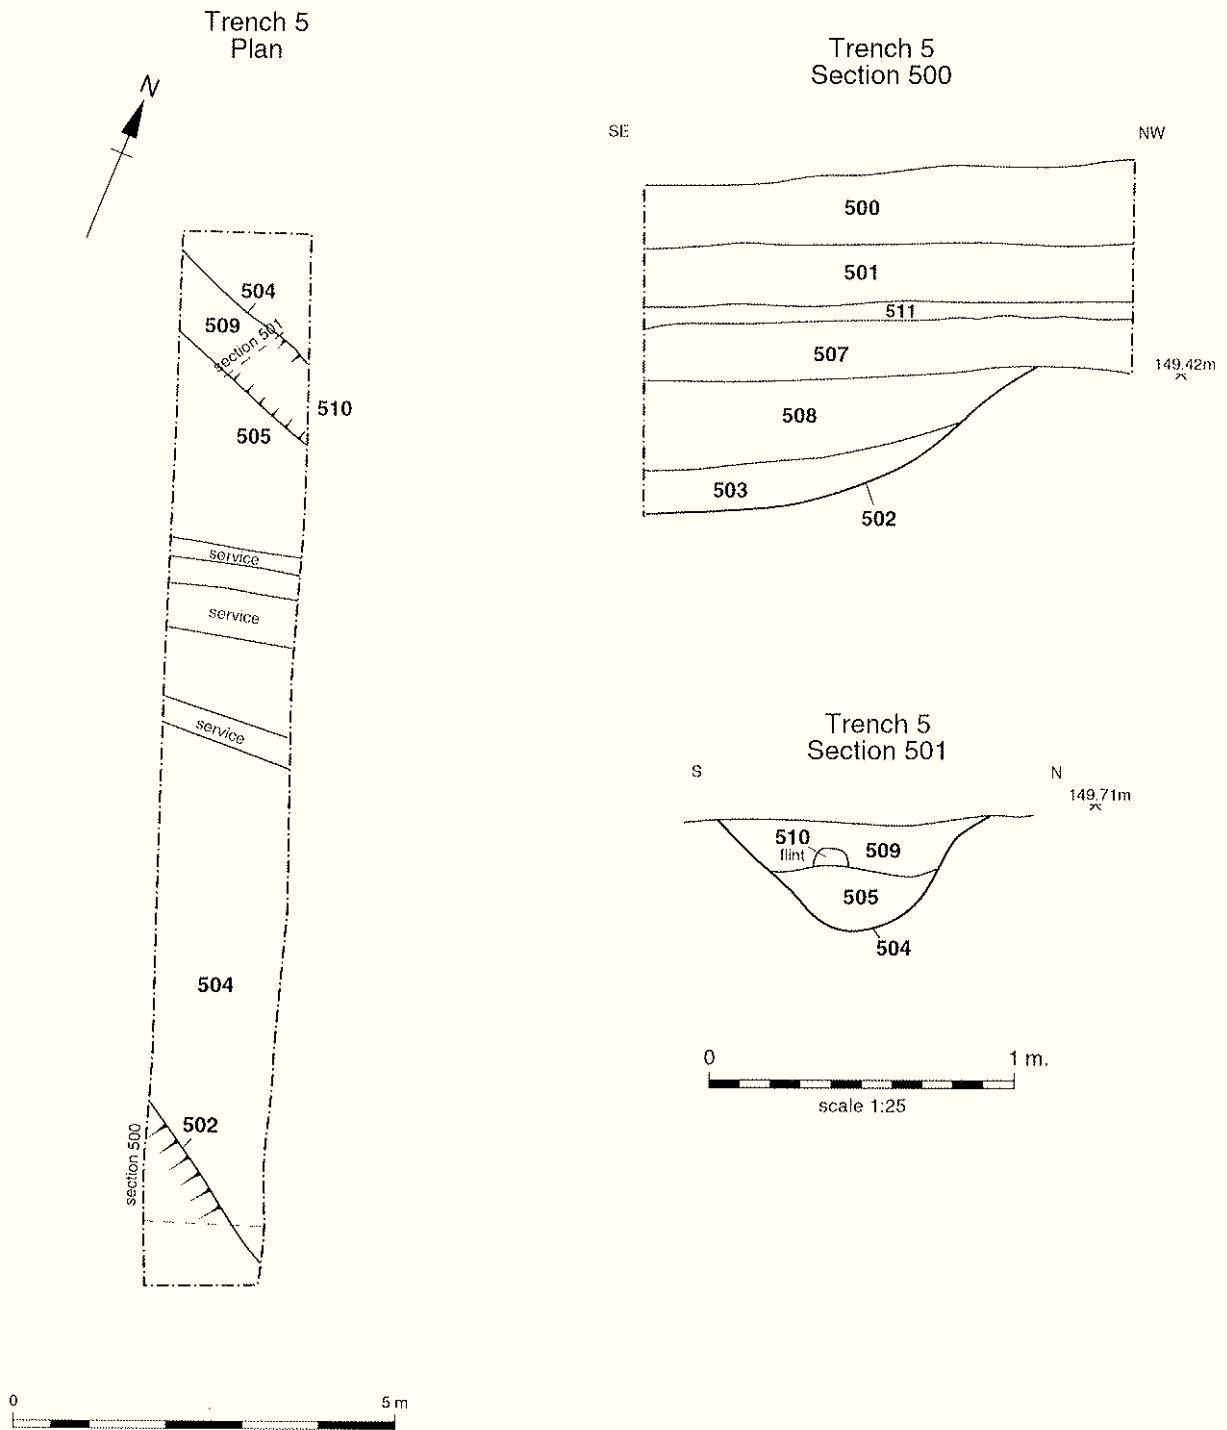
Figure 6: Trench 5, plan and sections.

Natural was seen at 149.34 m OD to the southeast (0.76 m bgl) and 149.55 m OD to the north-west (0.55 m bgl). Two eastwest aligned ditches were seen over 9.5 m apart. In the south-east of the trench was ditch 502. This was 0.40 m deep, over 0.30 m wide and with a flat base. In the northwest of the trench was ditch 604, 0.38 m deep, 0.90 m wide and had a flat base. Both ditches were filled with a redeposited natural chalk beneath a silty clay; in 504 there was a single line of unworked flint nodules (510) over the primary fill (505), and fill 509 contained bone, Iron Age and late Iron Age/early Roman pottery. Over the south-east end of the trench was an early ploughsoil (507) which was overlain by a disturbed ploughsoil and natural interface (511) between natural (506) and subsoil (501). This ran the length of the trench and spread over 507. Overlying it was 501 and then a leveling and hardstanding area (500).

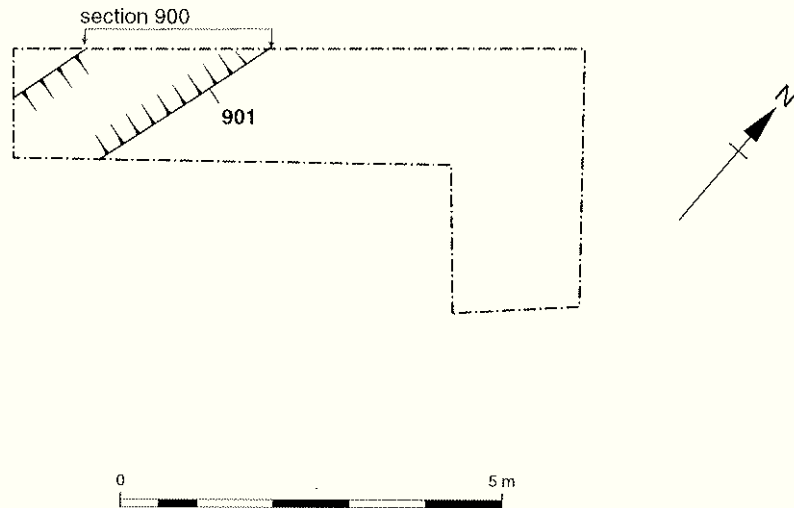
Figure 8: Trench plan and section.

The natural was seen to the south-east of the trench at 149.90 m OD (0.08m bgl) and in the north-west of the trench at 150.11 m OD (0.95 m bgl). At the north-west of the trench was a modern ditch (901) filled with weathered natural slippage (902) under redeposited topsoil (903). A dump of similar soil lies over the ditch (904) which is under a dumped subsoil (905) below topsoil 906. The ditch fills contained modern pottery, bone and fragments of modern floor material.
