Stage 1 Trial Trenching

# North East Embankment

Former Henley Cable Works  
Northfleet  
Kent

## Archaeological Evaluation Report

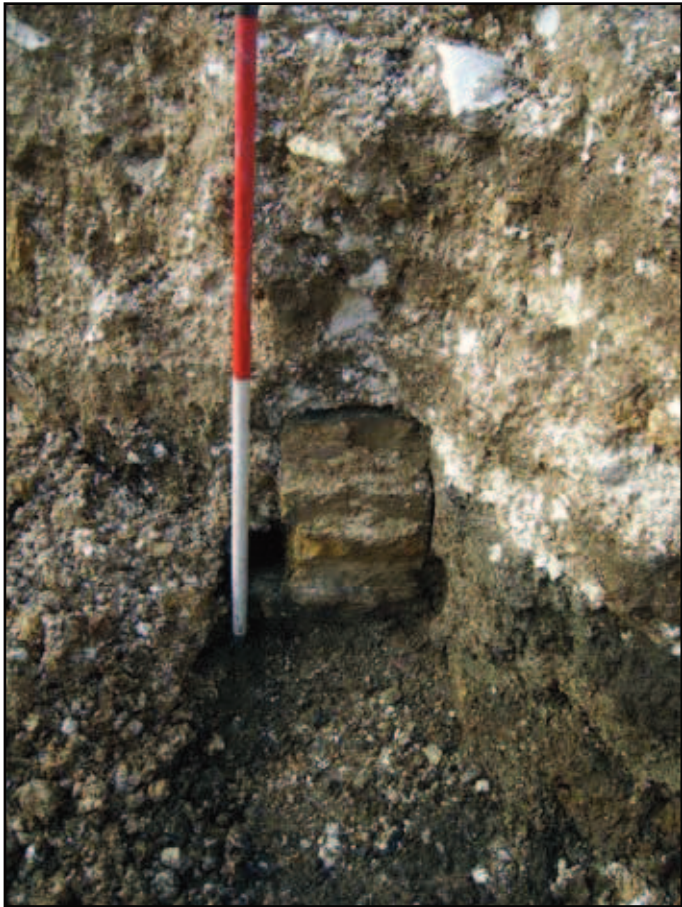
Plate 4: Brick wall, looking south-west

3.4.4 At the north-west end of the trench was the remains of a narrow wall (115), constructed from red clay brick and yellow stock brick (Fig. 5, Section 100; Plate 4). The wall was

only one brick length wide and was observed in both the SW and NE facing sections, suggesting a NNE to SSW orientation. The wall appeared to have been truncated within the trench during excavation most likely due to its insubstantial construction. The thin width of the wall suggested it was more likely to be ornamental than structural, perhaps being associated with garden landscaping.

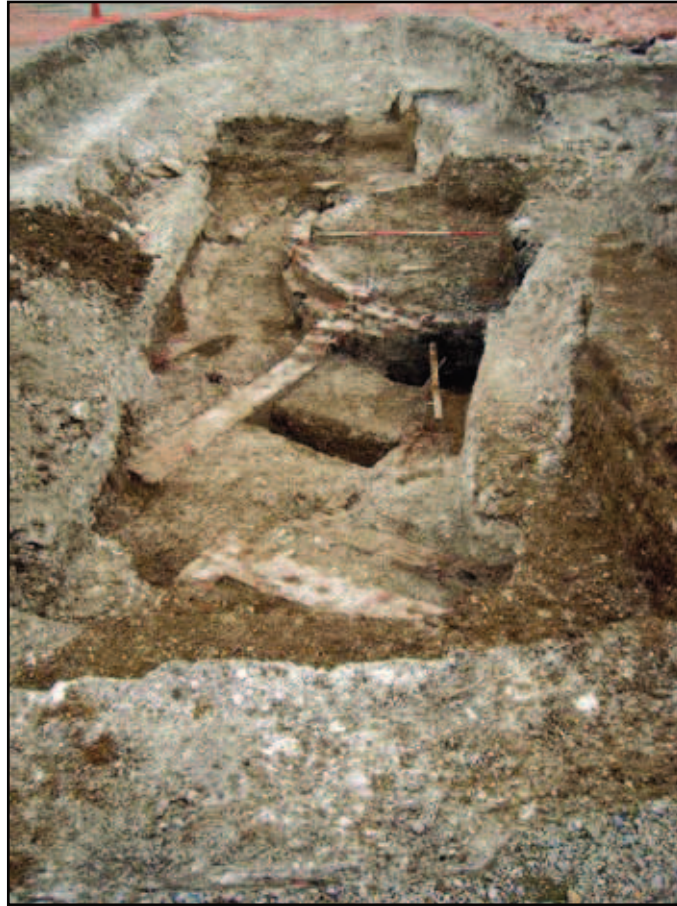
Plate 5: Trench 2. Bear pit, looking south-west

- 3.5.5 A curved chalk wall, 3003, was observed approximately 1m to the SE of the brick wall of the Bear Pit (Plate 5). It predominantly mirrored the curve of the Bear Pit until it butted against a brick wall to the NE (296). The brick wall ran under the eastern trench baulk. The chalk wall continued to mirror the brick wall to the SW. The function of this wall remains uncertain, but may be associated with the landscaping of the raised Broad Walk, perhaps acting as a retaining wall.

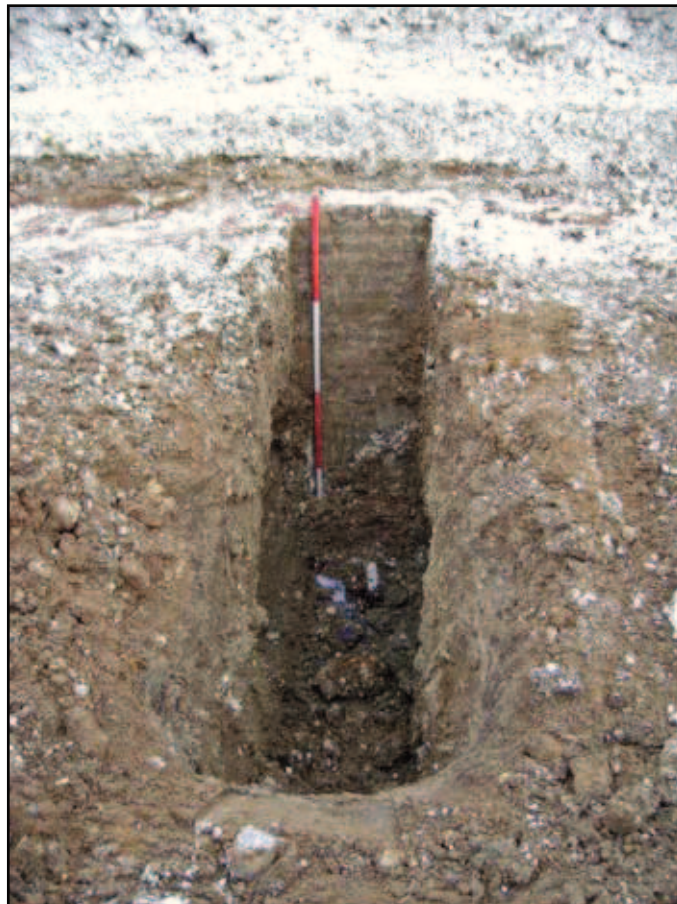
Plate 6: Base of bear pit, looking east-south-east

- 3.5.2 Trench 2 came down onto a curved brick wall (3001) at a depth of 2m from the present upper ground surface. This wall extended approximately 2.40m into the trench and appeared to be the remains of the Bear Pit (Plate 5). A machine excavated sondage was excavated through the inner backfill of this structure and determined that the walls survived to a depth of at least 1.95m. At this depth the remains of a grey slate floor was encountered and excavation ceased (Plate 6). It appears that only the bottom 2m of the Bear Pit survives and that the upper half has been truncated by the site clearance prior to the construction of the Henley Cable Works with additional disturbance during the recent remediation of the site. An extant example of a similarly dated circular Bear Pit in Sheffield Zoological Gardens is 4m deep and it is entirely likely that the Rosherville Bear Pit was of a similar depth.

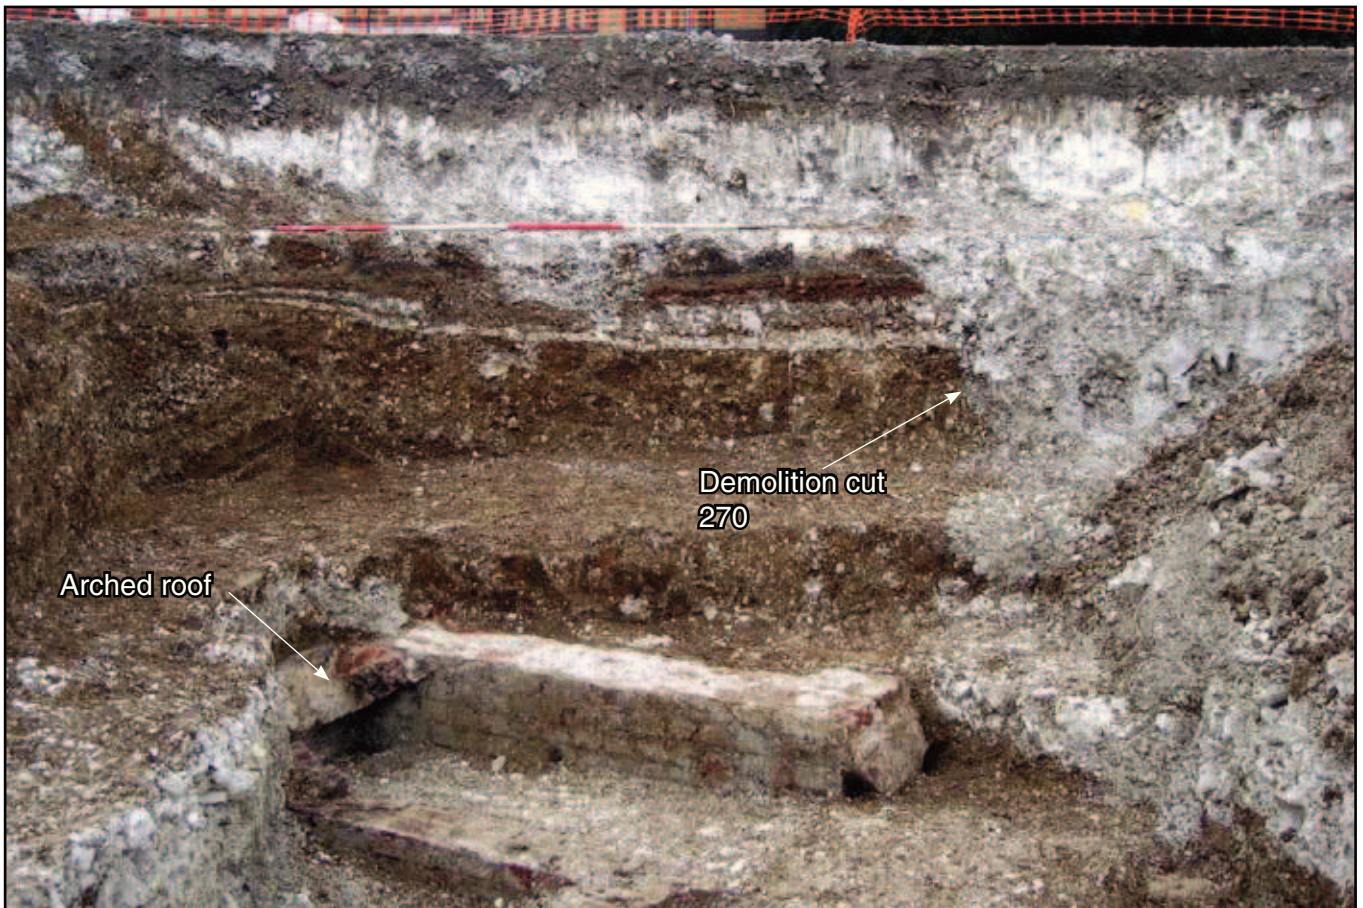
Plate 9: Walls and remains of arched roof and demolition cut 270, looking north-west

- 3.5.6 Additional brick walls are present to the NE of the Bear Pit and possibly represent rooms or corridors associated with the Bear Pit (294, 288, 287, 286) These rooms may have been where bears were kept at night or were fed, perhaps even providing access for keepers. Walls 288 and 294 appear to be contemporary with the Bear Pit and are

constructed from similar brick with similar bond and are aligned NE - SW. Wall 288 turned to run roughly E - W 3m to the NE of the Bear Pit. This wall appears to be associated with wall 286 and may form an east to west orientated 'corridor' with the remains of a possible arched roof spanning between the two structures at the western trench edge (Plate 9). It is possible that this corridor may have provided an access point between the Bear Pit and lower gardens. Several layers of sloping backfill in the adjacent section may be associated with the arched roof or perhaps the landscaping of Broad Walk and may suggest remains are better preserved immediately to the west of the trench. The layers are disturbed to the east by a wide cut (270) that may represent the demolition and levelling phase of the 1930s, suggesting that very little damage may have been done to the Bear Pit in more recent time.

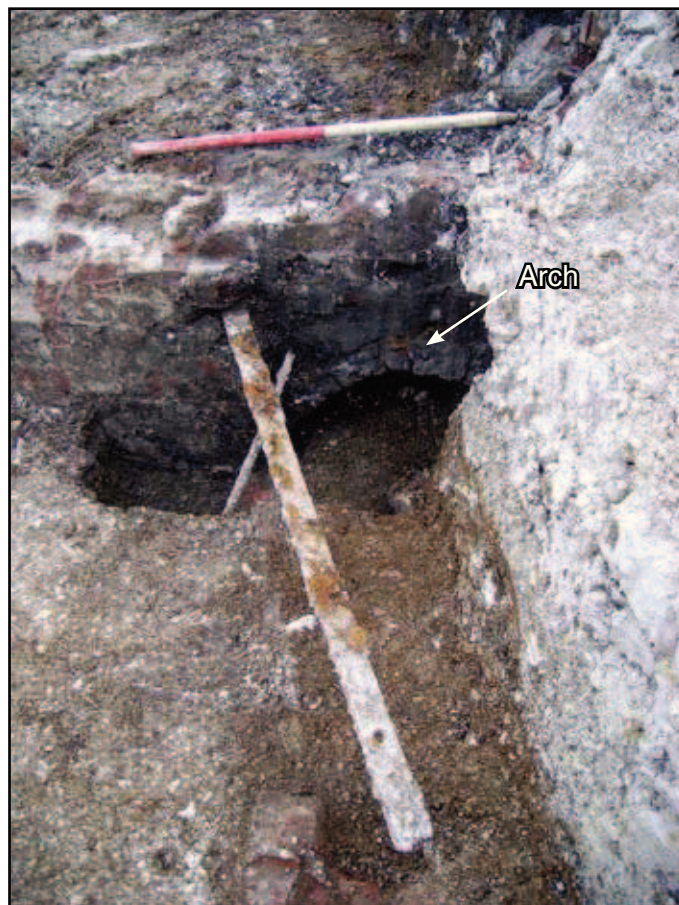
Plate 10: Iron bar and arch, looking south-west

- 3.5.7 Wall 288 appears to terminate 1m short of the Bear Pit in a brick pier centred roughly on the middle of the arched doorway, perhaps suggesting the subterranean pen had several rooms. An iron bar extended from the Bear Pit towards the pier. The bar had a number of holes through it and may be associated with a gateway separating the rooms (Plate 10).

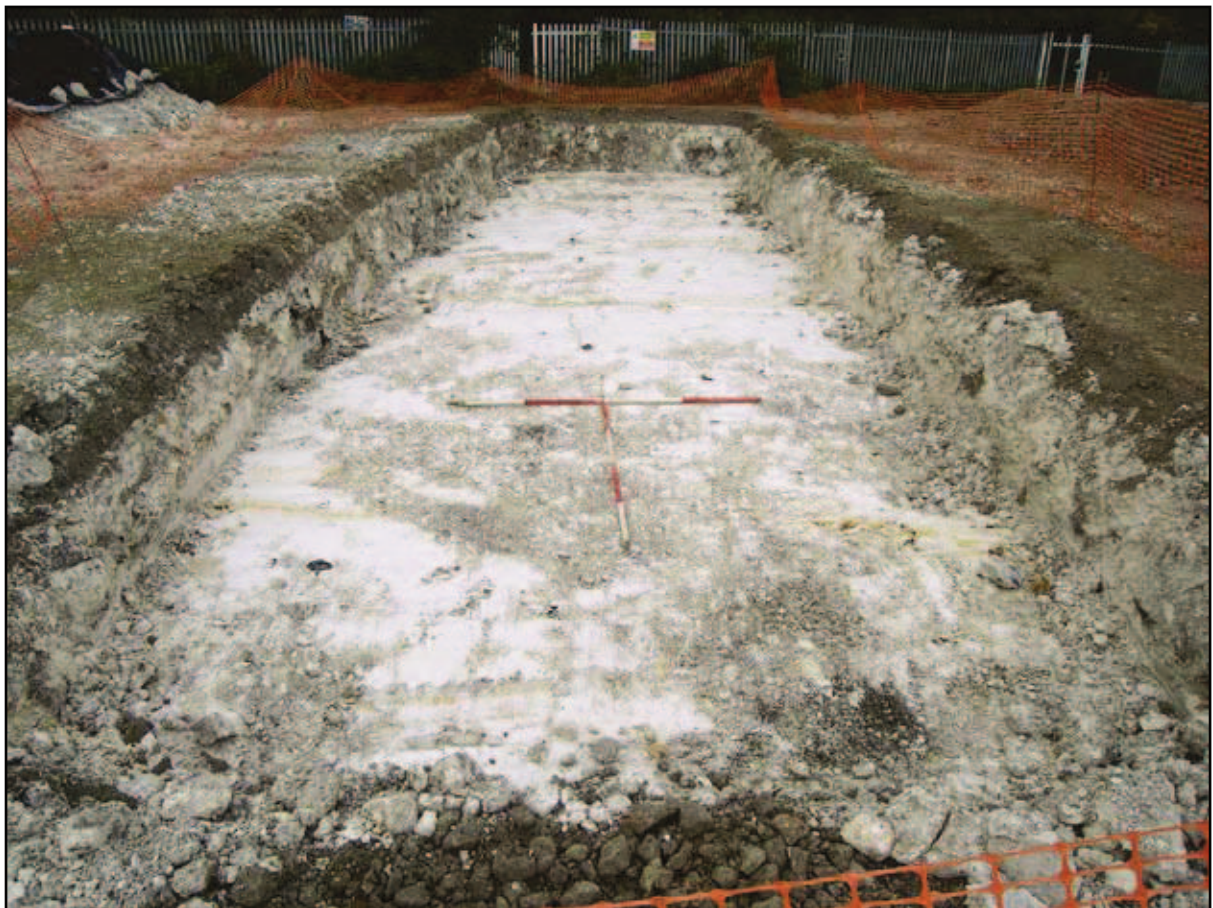
Plate 11: Trench 3, looking south

- 3.6.1 Trench 3 was excavated to the south of Trench 2 and was aligned roughly N-S (Plate 11). The trench measured 20m x 4m, and was excavated to a depth of 0.85m.
- 3.6.2 The trench was excavated to the natural chalk which was overlain by 0.55m deep deposit of redeposited chalk, which in turn was overlain by a 0.30m layer of crushed concrete and stone.
- 3.6.3 No archaeological features were observed in this trench.
