Stage 2 Trial Trenching

# North East Embankment

Former Henley Cable Works  
Northfleet  
Kent

**Archaeological  
Evaluation Report**

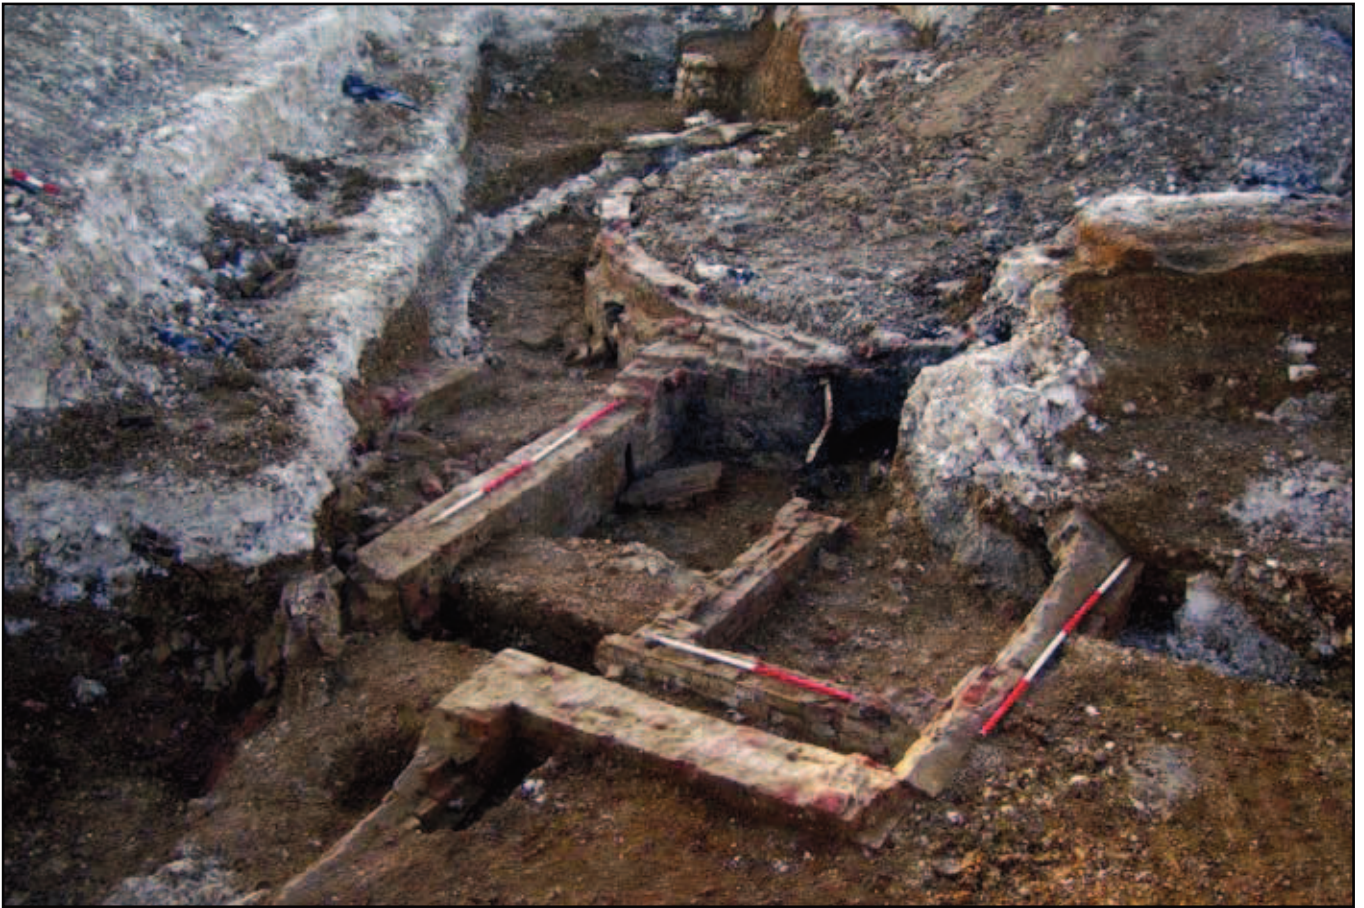
Plate 1: Trench 2. Bear Pit, looking south-west

- 3.4.5 The main circular wall (3001) for the Bear pit measured around 6.45m in diameter with an internal diameter of 6m. The pit was not intact, having sustained damage from the demolition and site clearance in the late 1930s. The south-eastern side identified during the Stage 1 works was encountered at around 1.8m bgl (3.77m OD) and survived to a depth of around 2.3m. However, the Stage 2 works quickly established that the north-western arc of the wall survived to a much greater height (3m), and was encountered at a depth of around 1m bgl (4.45m OD) and appeared to have suffered very little truncation.

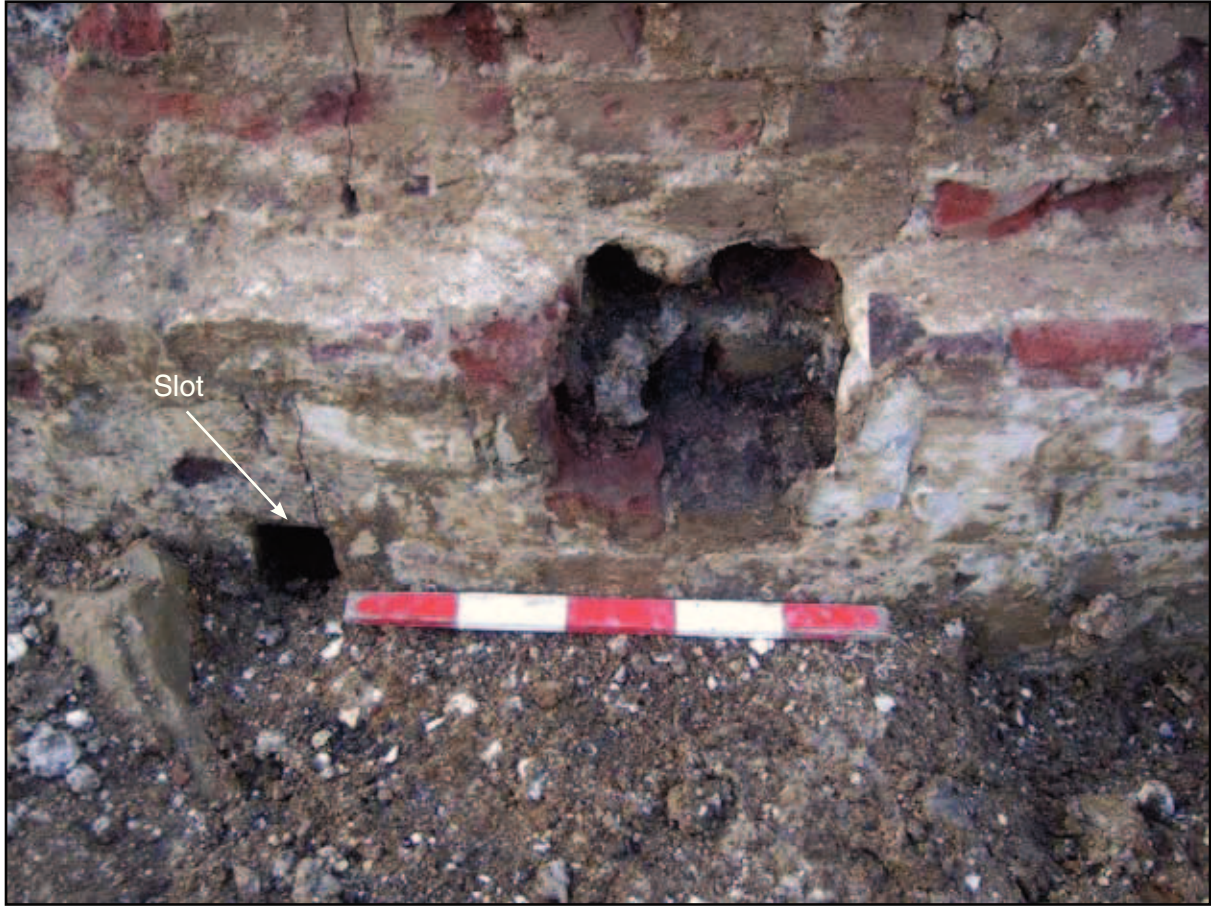
Plate 4: Trench 2. Elevation view of recess for horizontal support in wall 3001, and window slot visible, looking north-west

- 3.4.10 There was also evidence of two small vertical slots through wall 3001. These were wider on the outside than the inside and very similar to arrow slots (Plate 4). These may have been used by the keepers to observe the bear or possibly to safely goad them to entertain the viewing public. A similar slots was observed in an external room (Room 4) to the north-east of the pit (illustrated in Plate 13).

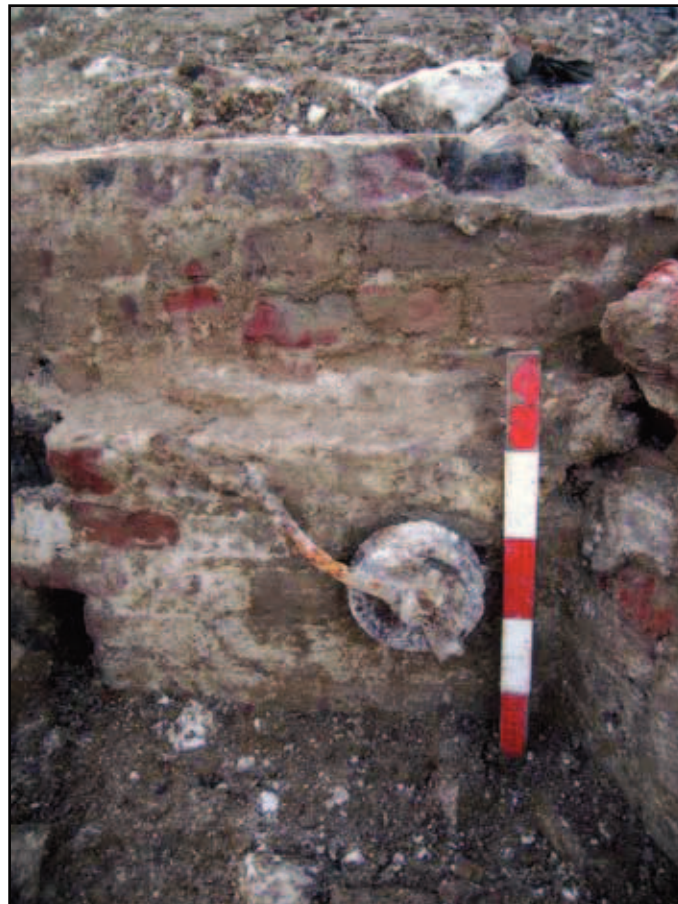
Plate 6: Trench 2. Elevation view of iron pulley and window slot in wall 3001, looking north-west

- 3.4.11 A metal pulley wheel was attached to the brick work (Plate 6) and additional metal fittings were also observed in the associated rooms. These were probably part of the operating system for subterranean cages and gates used to manage the animals.

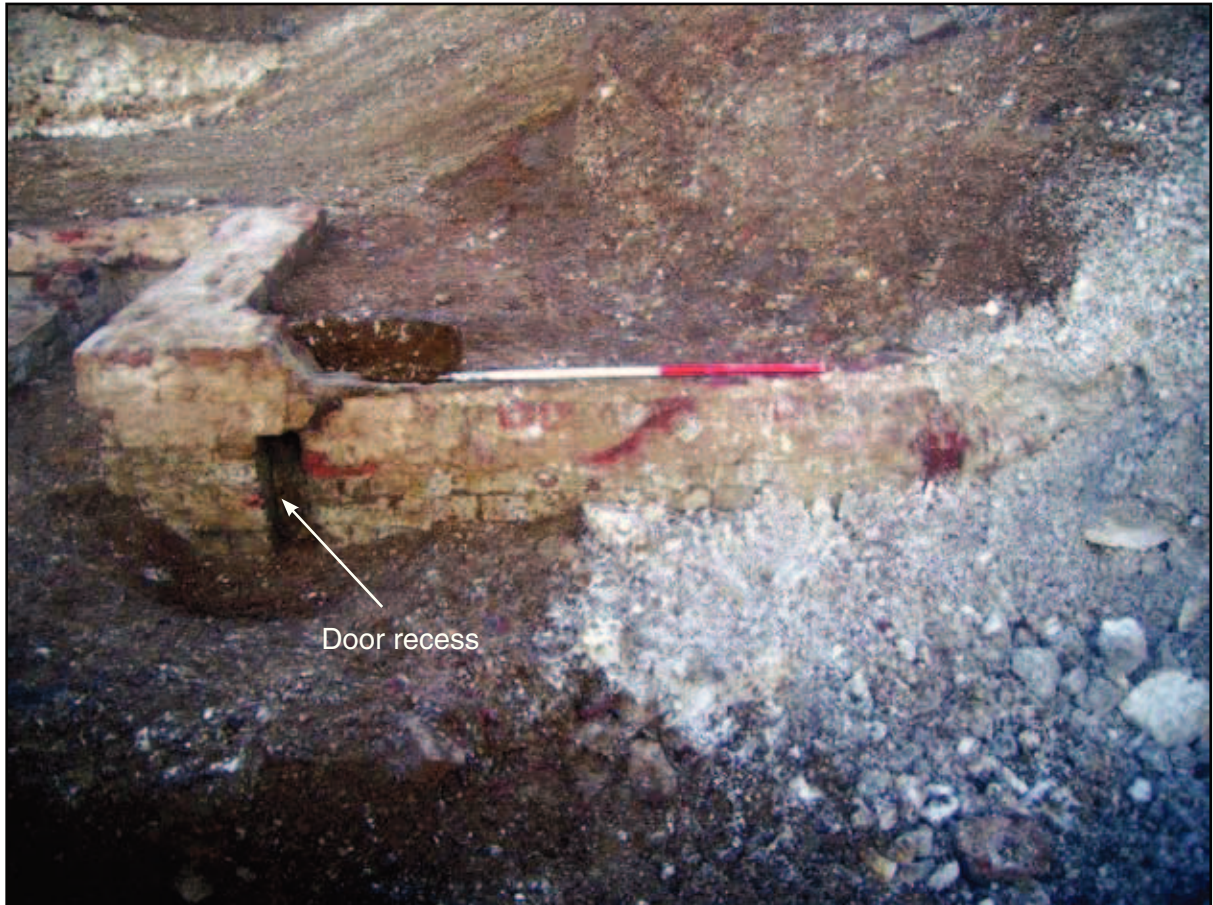
Plate 9: Trench 2. Elevation of wall 3030, door recess, looking north-west

- 3.4.14 Room 1 consisted of walls 3030, 286, 3031, 288, 3029 and part of 294 (damaged during demolition). It was a small area measuring approximately 3m x 0.6m, with a doorway to the south-west. It was presumably accessed via an entrance in the Italian Gardens to the north-east. The room shared an arched roof (287) with Room 2 to the south-west (Plate 7). The small size of Room 1 suggests it may have been used for storage and gaining a view into Room 2. Excavation in Room 1, as with all the rooms, ceased before the floor was reached (primarily for health and safety reasons). Although no evidence of a viewing slot was discovered, it seems logical that a window, like the one between Rooms 3 and 4 (Plate 13) would have been present along the north-west south-east orientated wall. Room 3 could be accessed along the south-western wall of Room 1, through a narrow entrance. The head jam for this doorway had been truncated away (Plate 8). A small recess to the north-west in wall 3030 may represent another doorway separating Room 1 from the entrance corridor (Plate 9).

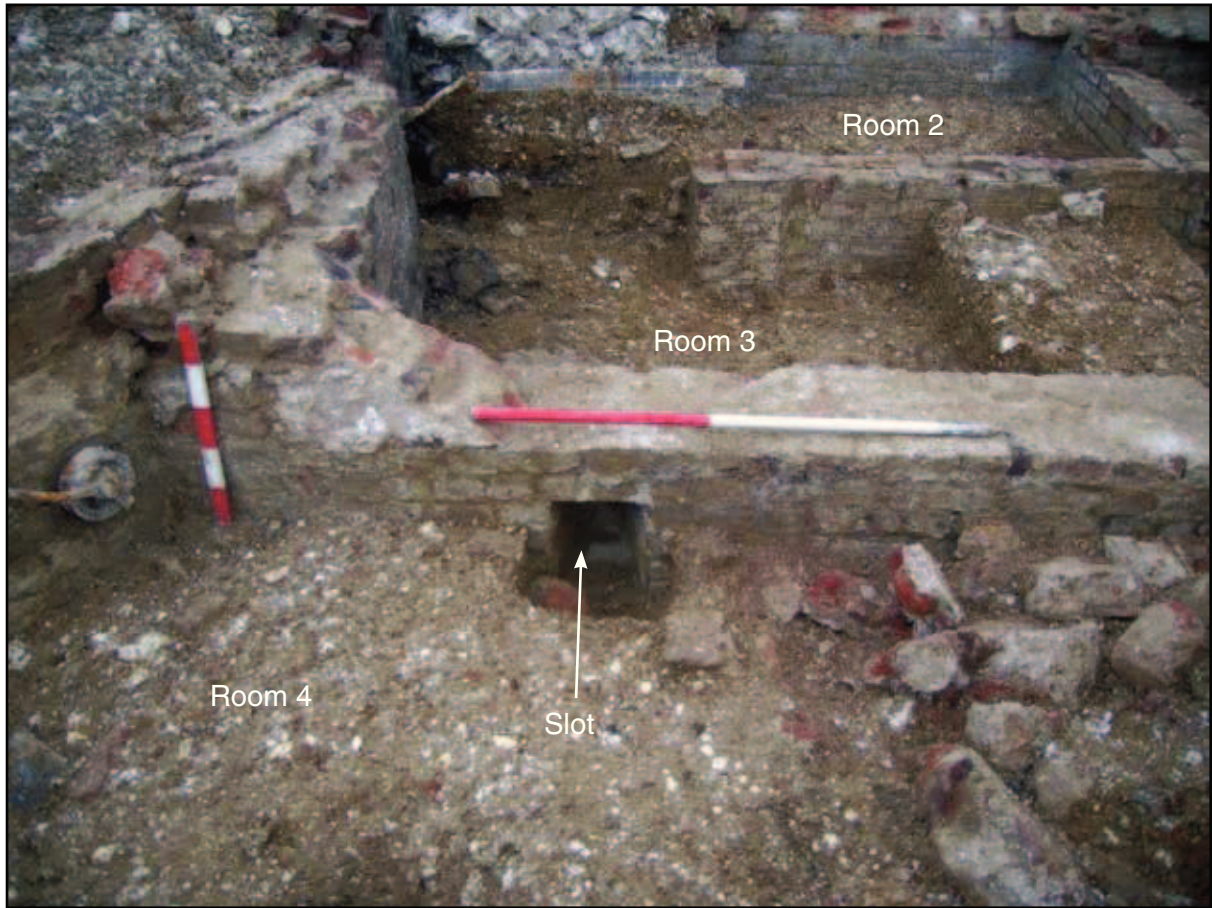
Plate 13: Trench 2. Elevation of wall 294, looking north-west

- 3.4.17 Room 4 was comprised of brick walls 294, 296, 3036, 3001 and chalk wall 3003. It appeared to be the main entrance and 'atrium' area providing access from the north-east into the subterranean enclosures below the Broad Walk. It was observed to be over 5m long and 1m wide. Within wall 294, between Rooms 3 and 4, was another slot aperture which served as a window into the pen (Plate 13).

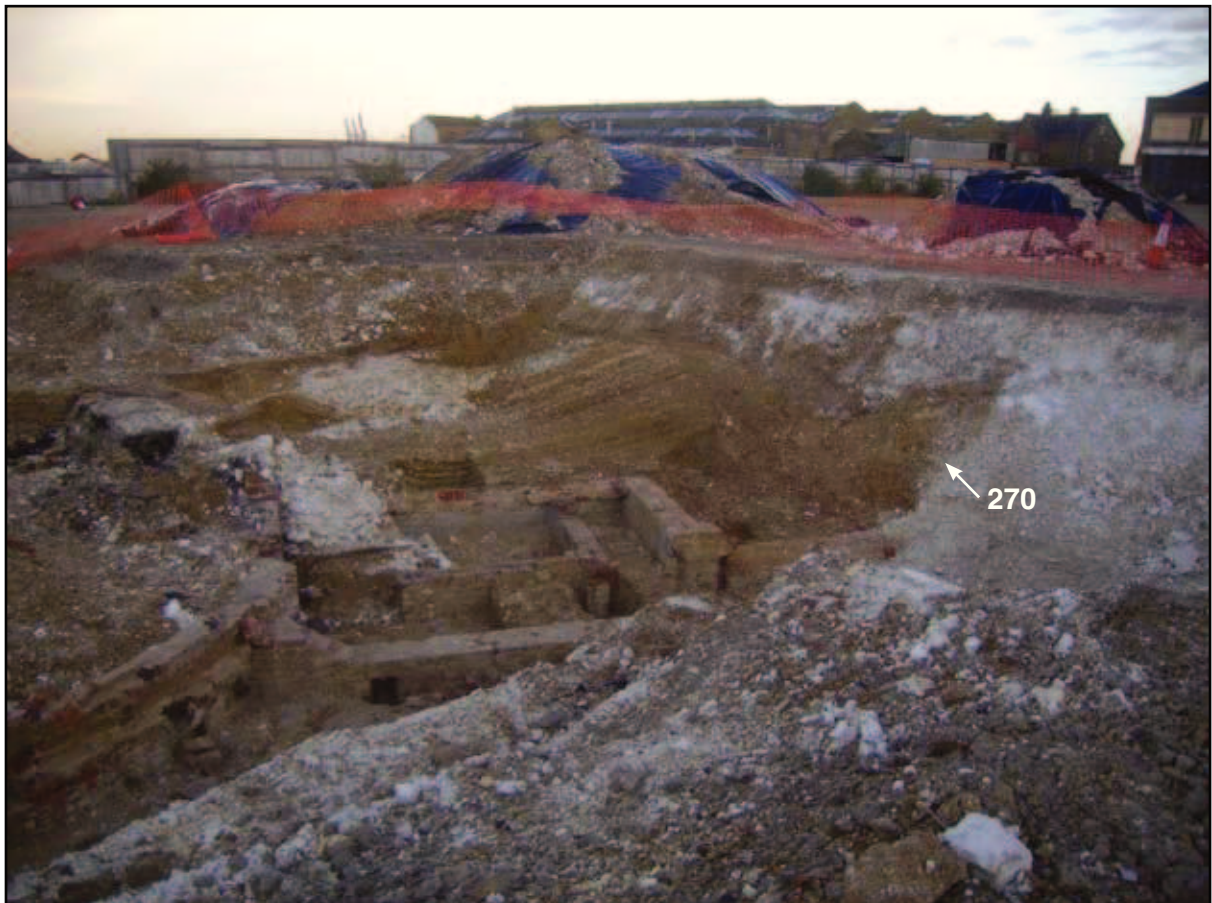
Plate 20: Trench 2. General view showing mounded deposits, looking north

- 3.4.25 Cut 270 (Plate 20) is filled with a loose disturbed chalk deposit. This, along with cut 266, visible only in the Stage 1 trenching (see Fig. 4, Stage 1 report), appears to be associated with the demolition of the Bear Pit structure and adjacent rooms shortly after Rosherville Gardens closed, probably to ensure not voids were present within the area prior to the construction of the Cable Works. This may also account for the varying degrees of preservation of the Bear Pit. The better preservation of the north-western

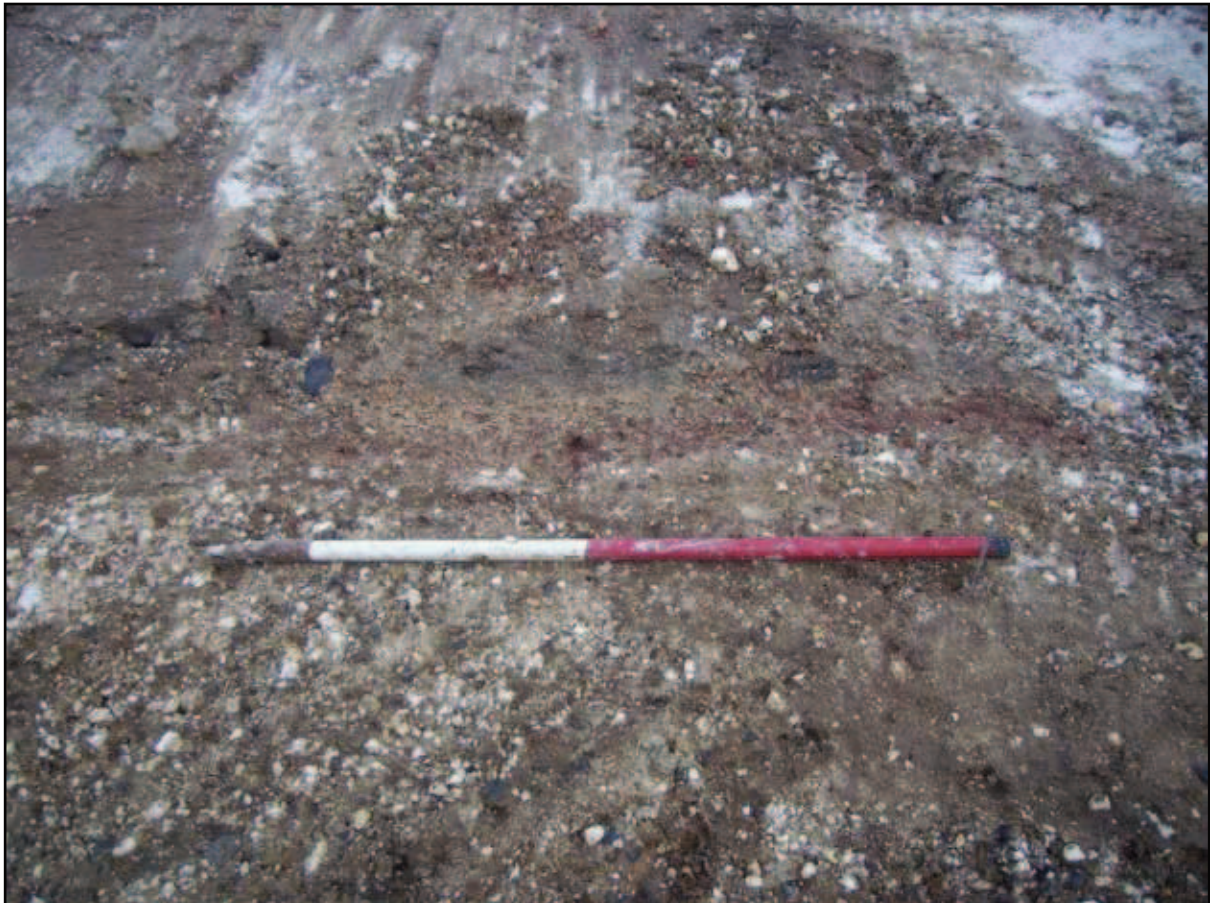
Plate 22: Trench 2. Walkway layers 263 and 262, overlying mounded deposits, looking north

- 3.4.23 At the top of the backfill sequence was the material associated with the path on the walkway. There was a dramatic change from the tipped deposits of the mound to the horizontally laid deposits. These deposits consisted of 229, 245 247-248 and 264. Overlying these was a layer of finely crushed ceramic building material (CBM) (228/263) which was probably the bedding layer for the path. This distinctive layer was also seen in Trench 7 as 737. The path material itself (262) would appear to have been shell rich and was observed intermittently (Plate 22).

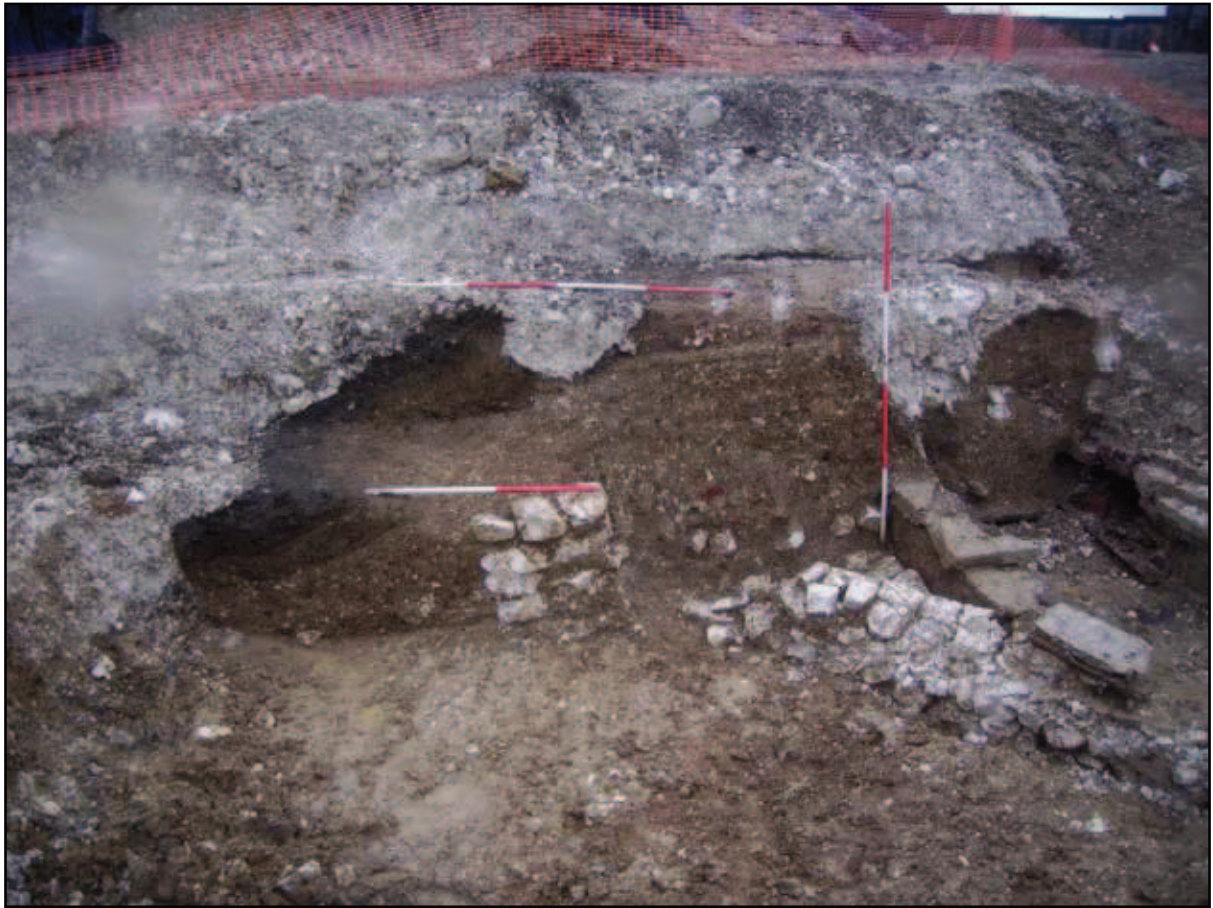
Plate 23: Trench 2. Section to the south-west of the Bear Pit, looking north-west

- 3.4.26 On the south-west side of the trench more sloping construction layers were observed (208, 209 and 3018). These were seen to tip downwards forming the south-western terminal of the mound and the rounded end of the Broad Walk; with the shell rich deposit (3017) visible at the top of the sequence (Plate 23).

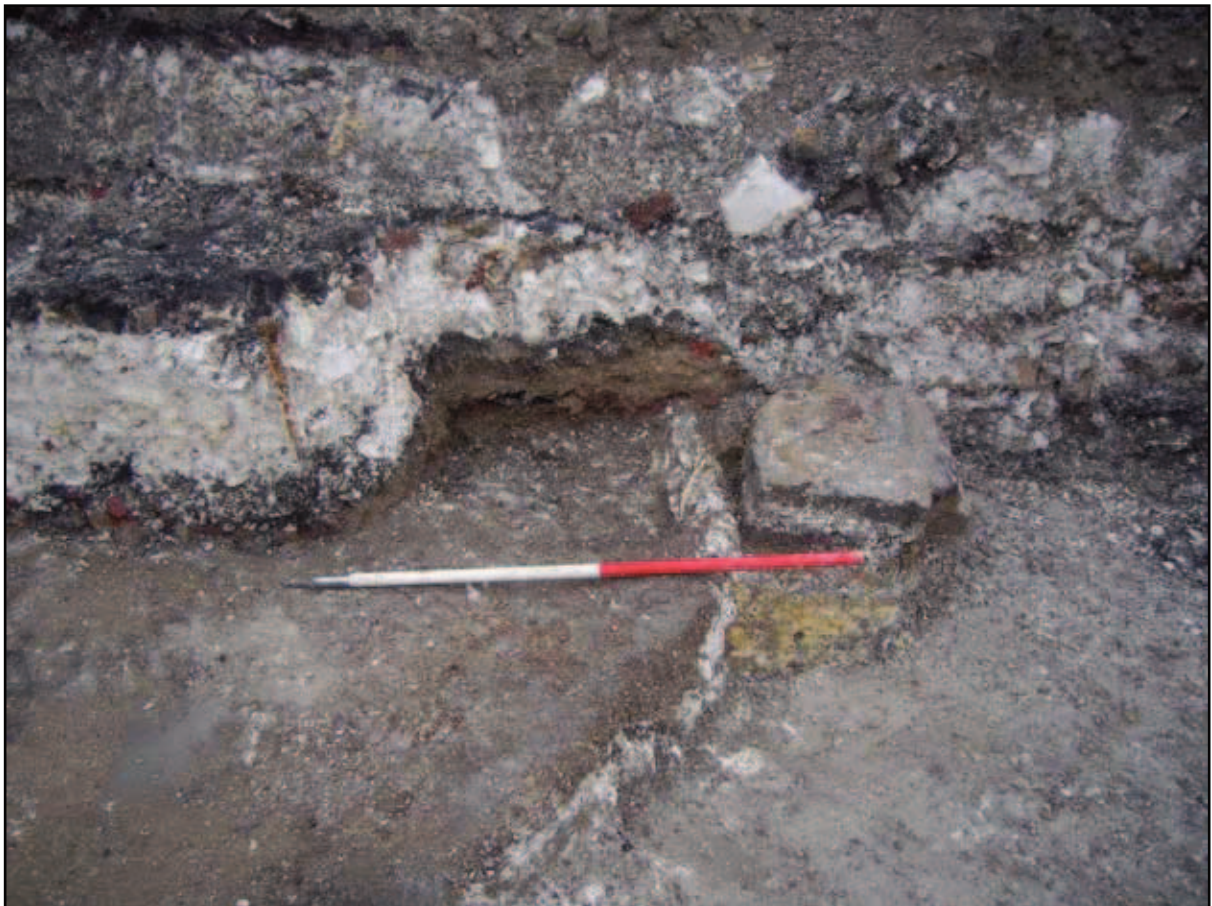
Plate 28: Trench 6. Plan view of 6012, looking south

- 3.7.5 The small squared brick structure 6012 was the probable foundation for an upright structural element seen on the northern side of the trench (Plate 28). It was unclear whether it was related to any other features or a discrete structure such as a pillar. In any case, it appeared to have been displaced from its original location.

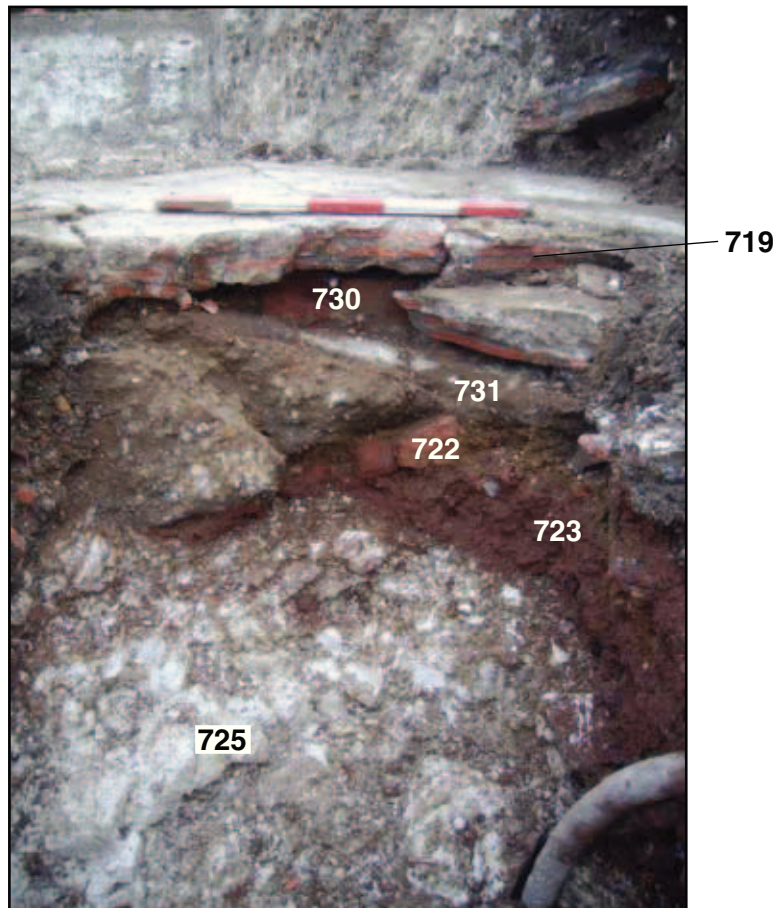
Plate 33: Trench 7. Remains of fountain base showing contexts 719, 722, 723, 730, 731, 725 and lead(?) pipe

- 3.8.5 Situated within the mound was a levelling deposit (725), on top of which were the construction layers 722 and 723 in the central area. These were overlain by a cement bedding (721 and 731) and a brick foundation (720 and 730) (Plate 33). Above the brick foundations was the tile structure 719, of the remains of the Fountain. In the central area was the remains of a metal pipework, possibly for the water or gas. The pipe appeared to be lead suggesting it was most likely used for water. However, the fountain was removed at some point in the later years of the Garden and replaced by an Urn containing a flame (Lynda Smith, pers comm.) presumably lit by gas. Abutting the external side of the brick and tile structure were three surviving square brick piers, 707 (Fig. 8). It is likely that there was a continuation of such features around the edge of the tiled fountain structure at regular intervals.

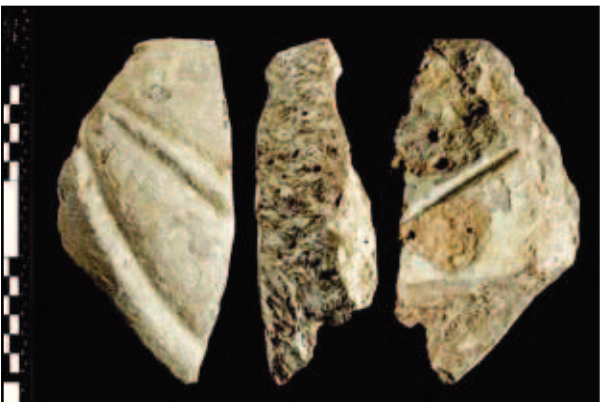
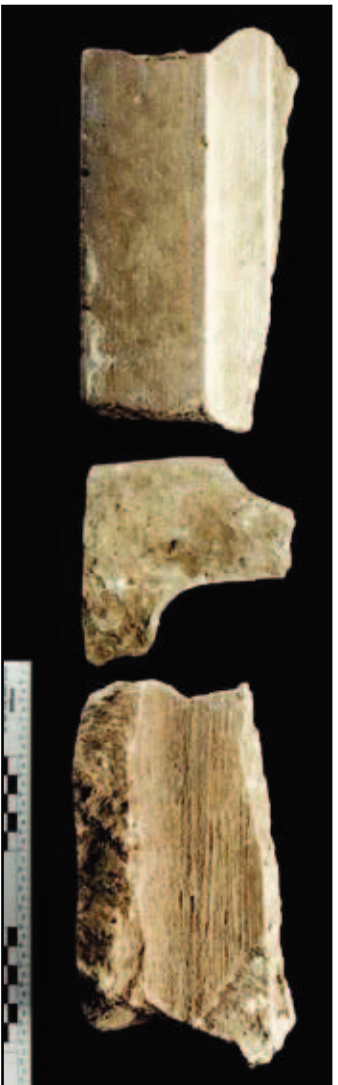
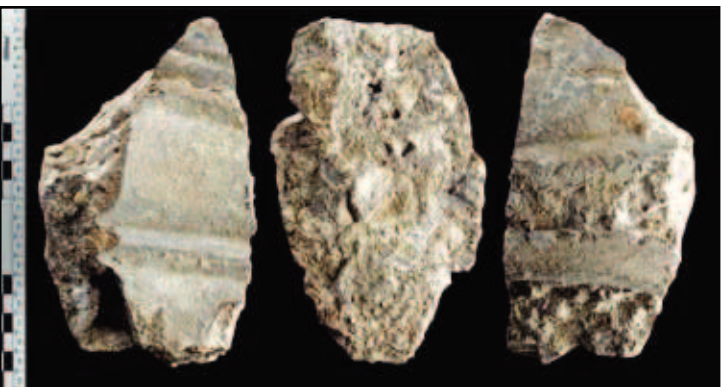
Plate 35: A selection of moulded pieces from the fountain (706)

- B.3.11 No further work is recommended, although several of the moulded pieces are worth illustrating (Plate 35).
