Holy Trinity Church, Cookham
Berkshire

Archaeological Watching Brief

Oxford Archaeological Unit
March 1992

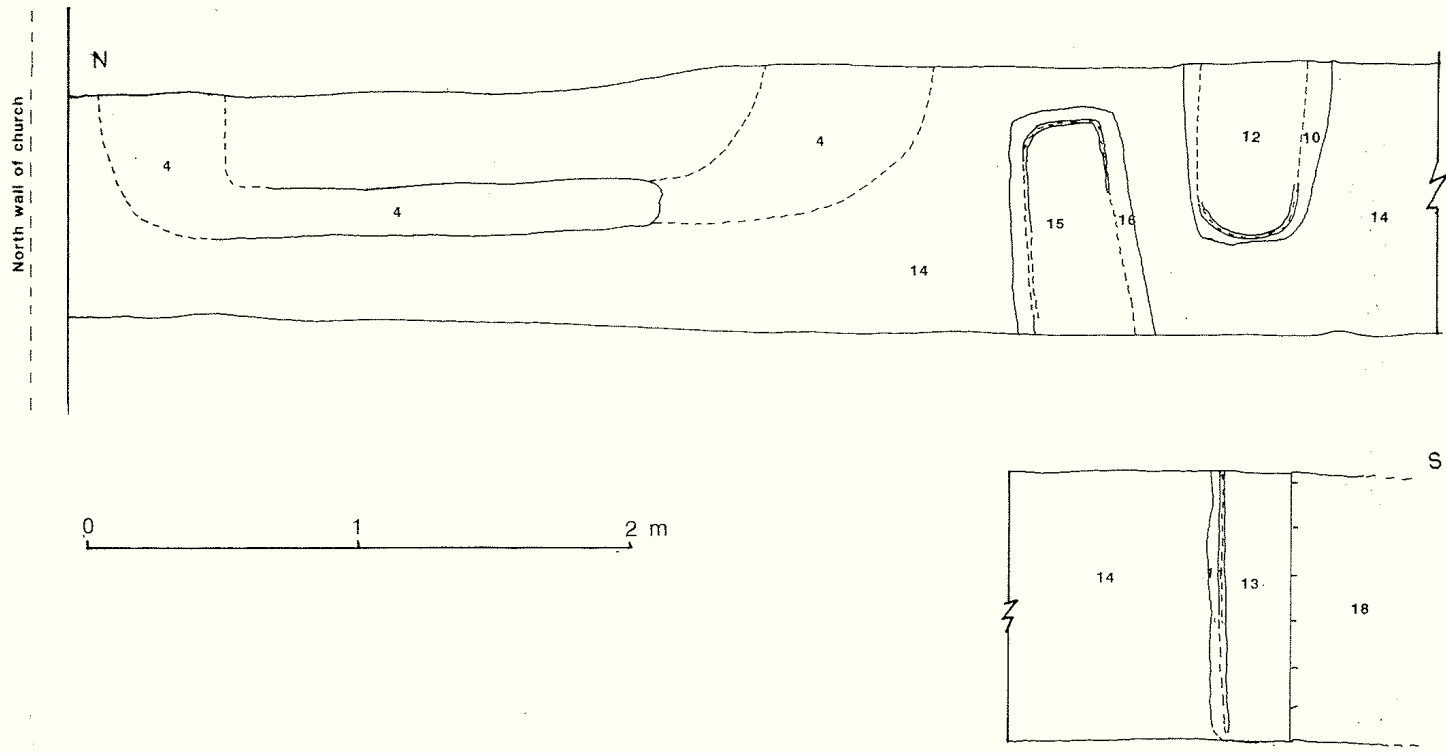
Cookham Holy Trinity Church CHTC 92 Plan no. 1 Scale 1:20

A 1:20 plan was made of the floor of the trench, and a 1:20 section of the east side.

Extending 2.2 m from the inside of the north wall was a wooden floor (1), supported on brick piers (3). This abutted the main floor of the nave, comprising 0.02 m thick clay tiles laid on a bed of bricks (2).

Immediately inside the N wall and extending 3 metres southwards was a brick and mortar vault. The upper part of the west side

Three graves (10), (11) and (16) were partially revealed, all orientated E-W and cut into layer (14).

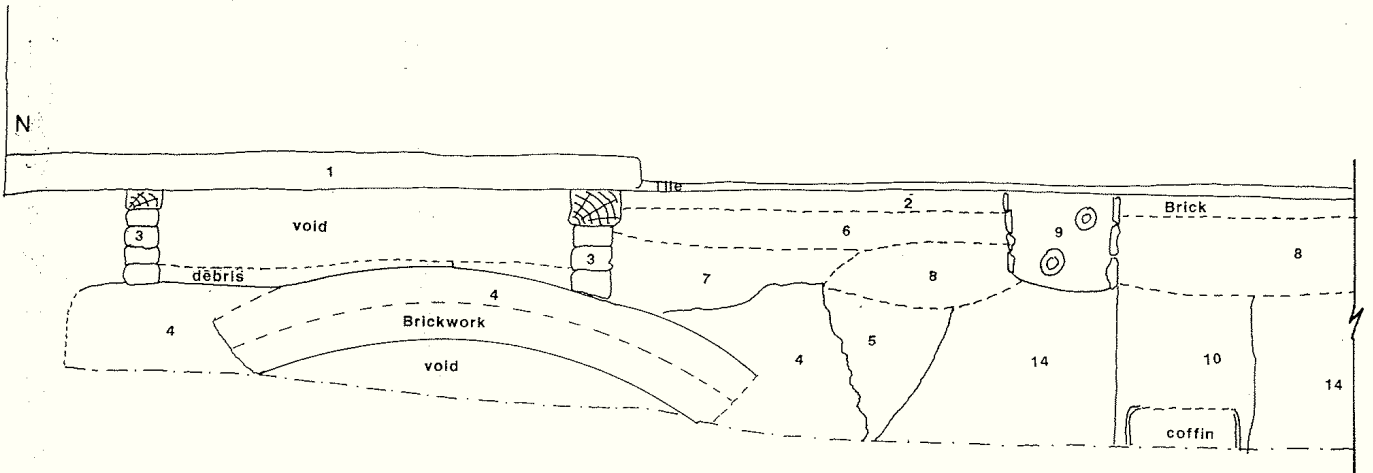
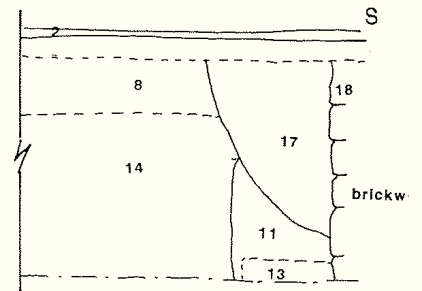
Cookham Holy Trinity Church CHTC 92 Section no.1 Scale 1:20

Underneath the present floor were dumpings of make up (6), (7) and (8), comprising gravel, mortar, small stone and tile fragments.

This was cut through by a pipe trench (9), orientated E-W, part of the earlier heating system.

The make up layer (8) was also cut at the S end of the trench by the brickwork (18) and its construction backfill (17).

Underneath the make up layers was a layer of dark brown silty loam with 30% gravel and inclusions of mortar and stone (14). This continued below the bottom of the trench.

The earlier original heating duct had evidently cut through the W side of the vault (4) and the graves (10), (11) and (16). The loose bones dumped within the vault, and those recovered from the new trench, probably come from these graves.

The brick vault and the make-up layers are contemporary. The three graves are sealed by, and therefore earlier than, the vault and make-up layers. The decoration on two of the coffins and the nameplate suggest they are early 19th century in date and the vault and existing floor are therefore mid-Victorian or later. No dating evidence was recovered from layer (14) but it is probably medieval make up.

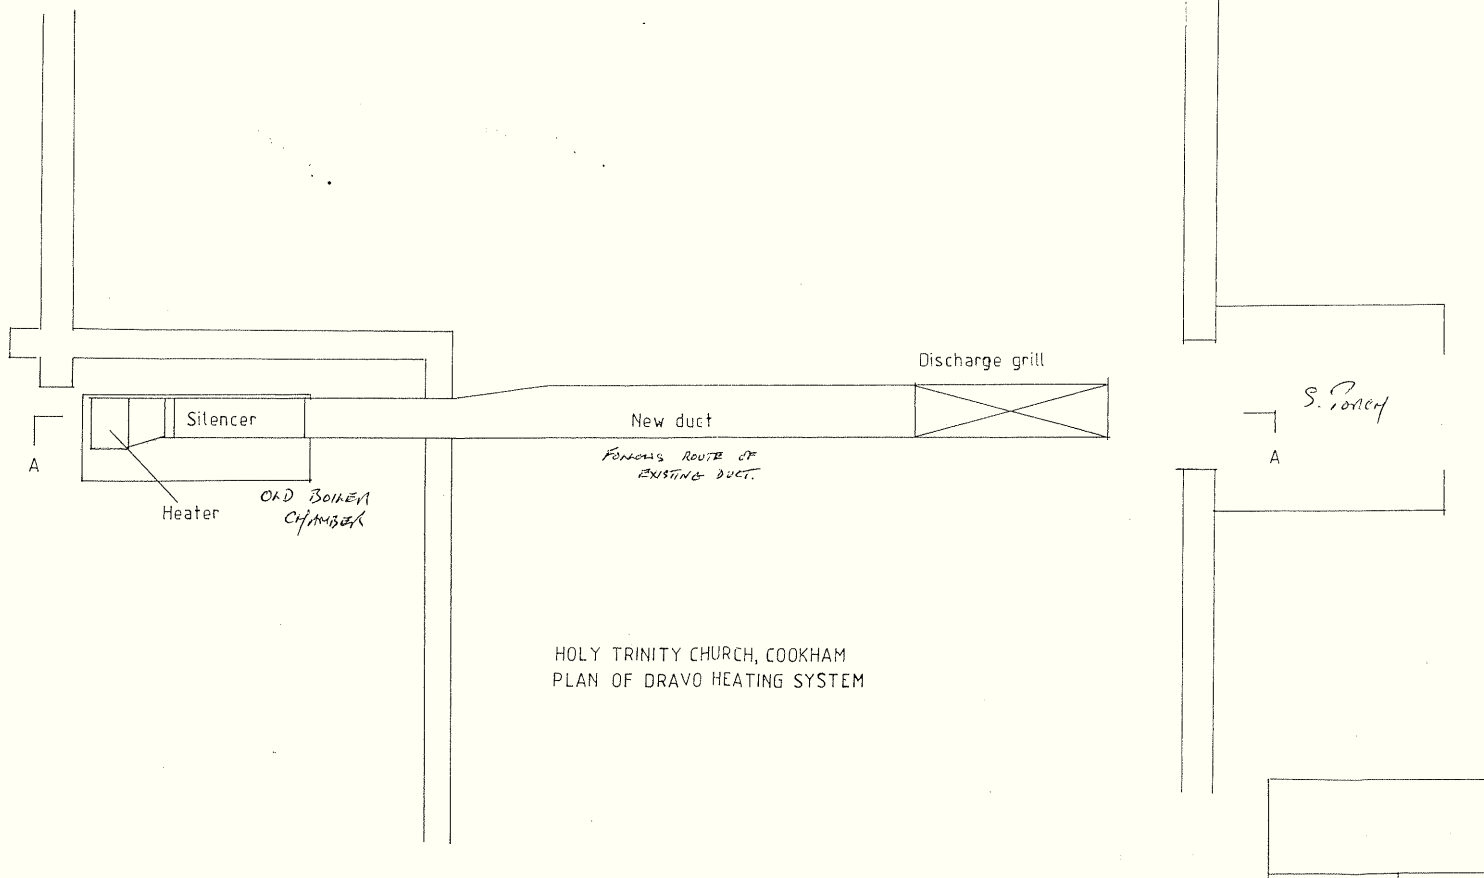
HOLY TRINITY CHURCH, COOKHAM
PLAN OF DRAVO HEATING SYSTEM

The OAU was commissioned to undertake a watching brief, during the widening of an existing heating duct under the floor of the nave, and continuing outside the north wall to the existing boiler house.
