# River Kennet Chamberhouse Draught Berkshire

## Archaeological Watching Brief Report

December 2003

Site Code: BRRVK 03

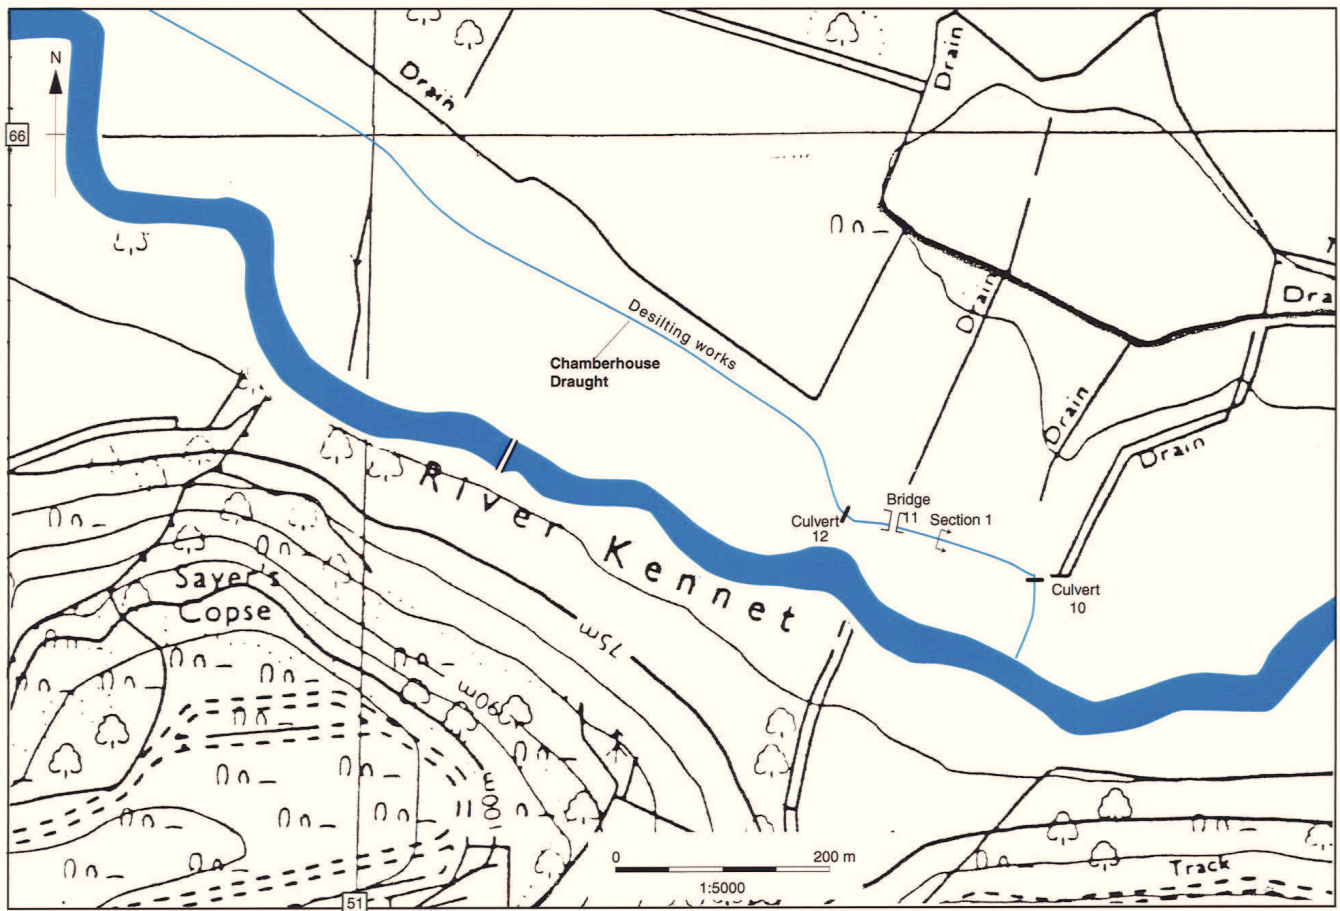
Figure 2: Extent of enhancement works

1.1.1 In November 2003 Oxford Archaeology (OA) carried out an archaeological watching brief at the Chamberhouse Draught on the River Kennet, Berkshire (NGR SU 515 655)(Fig.1). This included monitoring the desilting of the draught and later removal of one of the two culverts exposed during the initial desilting works. The work was commissioned by the Environment Agency under best practise in respect of river enhancement work.
