SITE BIQL 13		EVALUATION TRENCH RECORD SHEET		Trench No. 7
Trench orientation NE - SW		Grid reference		Field No.
Length 30m	Width 2m	Average depth to top of natural 0.48m	Was archaeology present? YES	
Plan Nos? 100		Section Nos? 100 / 101.	Were finds recovered? NO

Site Code	Invoice Code	Site Name	Accession No	OAU No
BIGL 13	BIGLEV	Gavray Drive, Chord Line, Bicester

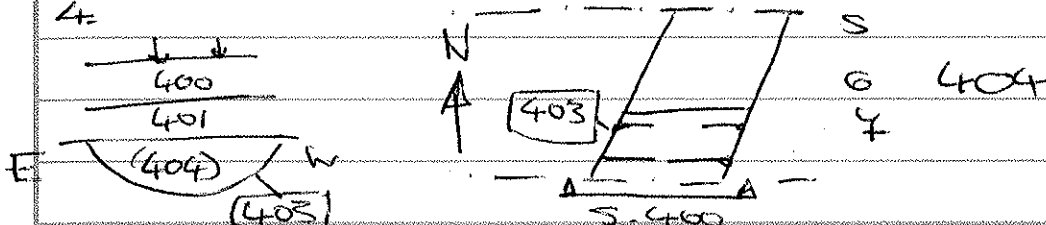
1. **LINEAR**2. **CONCAVED / REGULAR SHARP**3. **W: 1.08m D: 0.23m.**

Possible roman ditch on North-South - South
 WSD alignment.
 Concaved in shape.

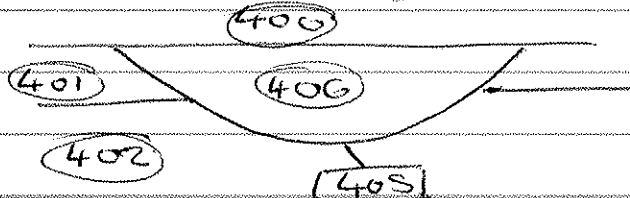
2. concaved / DEGRADED / SLOPED

3. 1.2m wide 0.2m DEE

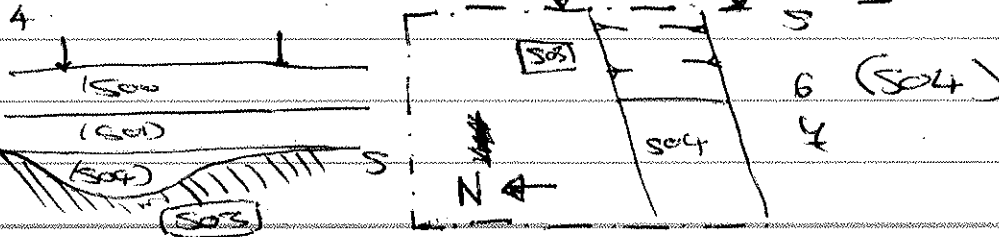
2. CONCAVED/REGULAR / SHARP

3. 1.6m WIDE 0.2m DEP

North-South aligned ditch.
 Concave base.
 Probable furrow

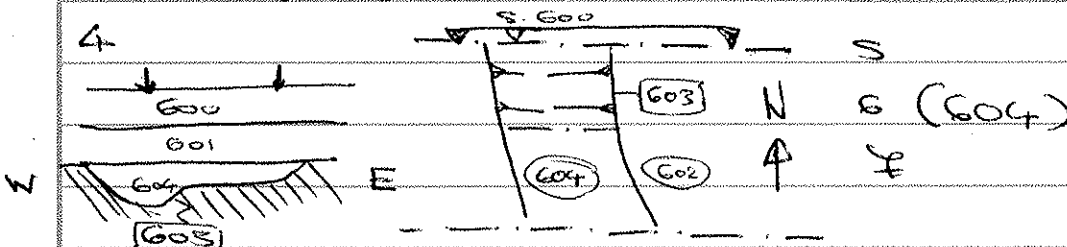
- 1 LINEAR
- 2 CONCAVED/REGULAR/SHARP
- 3 1.3m WIDE
- 4 0.15m DEEP

Linear feature on approx North - South alignment
 Westward edge is approx 45° angle of slope.
 Eastward edge shallower slope. Base is concave.

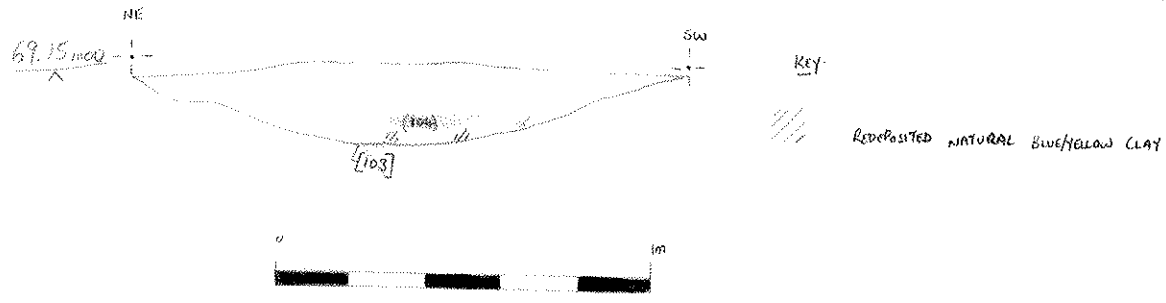
BIGLIS. TRENCH #1 SECTION #100 NORTH-WEST FACING SECTION THROUGH FURROW [103] 1:20 MWF 12/04/13

SEMI-CIRCULAR FEATURE WITH MODERATELY STEEP CONCAVE SIDES TO A MODERATELY SLOPED V-SHAPED BASE. 1.5m IN DIA x 0.2m DEEP.

SEMI-CIRCULAR REGULARLY SHAPED FEATURE. PROBABLE TREE THROW, BACKFILLED WITH NATURALLY DERIVED INFILL.

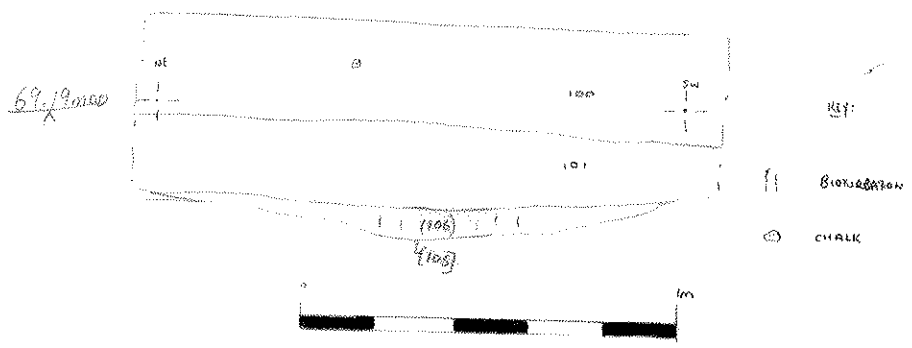
BIGLIS. TRENCH #1, SECTION #101. NORTH-WEST FACING SECTION THROUGH LINEAR FURROW/HOLLOW [105] 1:20 MWF. 12TH JUNE 2013

**LINEAR RUNNING NE - SW ACROSS TRENCH. FLAT/
UNEVEN BASE WITH STRAIGHT VERY SHALLOW EDGES.
0.1m DEEP x 1.9m WIDE.**

**LINEAR FEATURE RUNNING NE - SW ACROSS TRENCH. POSSIBLE FURROW BUT UNCERTAIN AS VERY
AMBIGUOUS EDGES, POSSIBLE NATURAL HOLLOW**

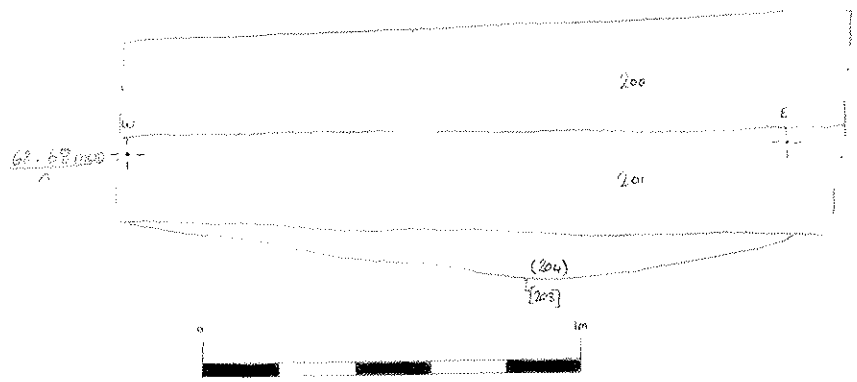
BIGLIS TRENCH #2 SOUTH-FACING SECTION OF LINEAR [208], SECTION #200
1:26 MWF 12th JUNE 2013

LINEAR WITH SLOPED SHALLOW BASE MAINLY SLOPING

WEST TO EAST. SHALLOW STRAIGHT SIDES.

ROUGHLY 1.7m WIDE x 0.15m DEEP.

LINEAR FURROW RUNNING ROUGHLY NORTH-SOUTH ACROSS SITE, FORMING PART OF OLD FIELD

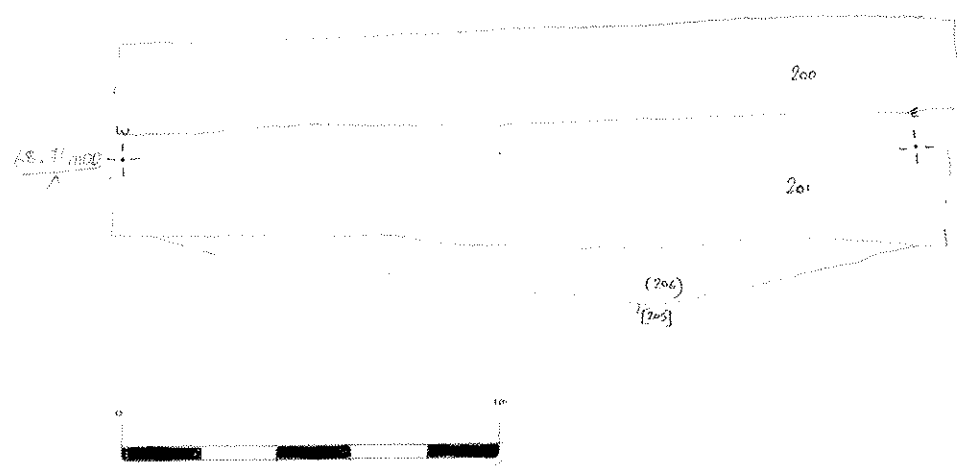
BIGLIS TRENCH #2 SOUTH-FACING SECTION OF LINEAR [205], SECTION #201
1:26 MWF 12th JUNE 2013

LINEAR FEATURE RUNNING NORTH-SOUTH ACROSS TRENCH. SHALLOW STRAIGHT SIDES TO SHALLOW SLOPED BASE (GENERALLY SLOPED TOWARD EAST) ROUGHLY 1.9m WIDE x 0.15m DEEP. FILLED BY (206)

LINEAR FURROW RUNNING NORTH-SOUTH ACROSS SITE, PART OF ANTIQUATED FIELD SYSTEM. NO FINDS
