Albion Mill Mill Street Worcester Worcestershire

Archaeological Evaluation Report and Historic Buildings Assessment

Oxford Archaeology

29th April 2003

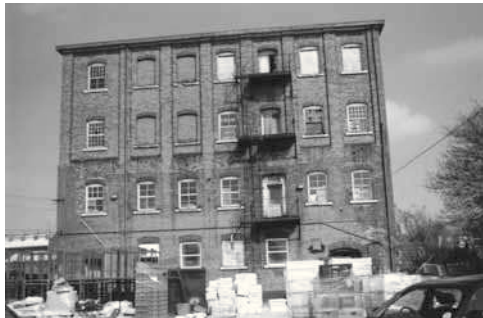
Plate 1: Block A from the east

1.1.69 A four storey rectangular brick built building oriented north south (see plate 1). To the west it adjoins other blocks and to the south lay (a now missing) block which was demolished after fire. The block has a very low-pitched roof, this is a replacement however for a missing floor destroyed by fire. The shallow red brick pilasters which

- 1.1.70 The windows are all rectangular with shallow arches above although on the north side facing the canal are two rounded headed arched windows set in blue brick arches with a round window in the spandrels. Many window retain their glazing although in places these have been replaced by modern plate glass. Iron fire escapes are sited on the centre of the east elevation.

- 1.1.72 The building appears to be earlier than many of the other mill structures. The fire has caused extensive damage and the loss of an entire floor detracts somewhat from its significance. The presence of many original windows however and the architectural elegance of the building add to its importance.

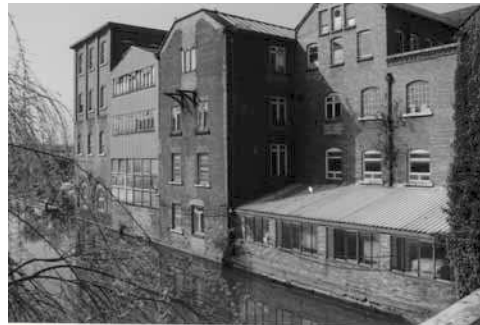
Plate 2: The River Frontage (from foreground) blocks I, E,D,C,B,A

1.1.76 A brick built block with a somewhat plain elevation fronting the canal. The glazed roof covering and part of the upper brickwork have evidently been replaced in the later 20th century as have most of the windows. The windows are rectangular with stone cills. A pair of earlier sash windows remains on the first floor level. The iron supports of a winch balcony project over the canal and the bricked up access door is visible above.

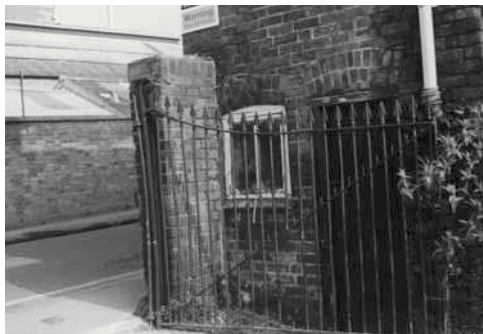
Plate 3: The Iron Gates
(detail)

1.1.115 The yard to the south of the mill is bounded by a brick wall, which seems to exhibit several phases of repair and alteration. The yard is entered from Mill Street via iron gates lying to the south of block H. Despite being damaged the gates (plate 3) are fine examples of the blacksmiths art and include hand forged spearheads set in drifted bars.

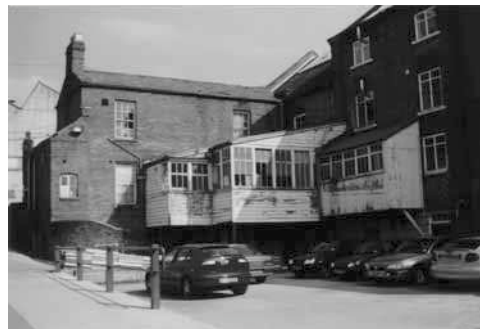
Plate 4: Blocks H, J and K

- 1.1.102 This massive brick built block (made of the pinkish brick seen so frequently in the mill) forms the core of the later mill and all the other mill buildings are connected to it (see plate 4). The block is four stories tall and is a massive rectangular structure with a shallow pitched roof. The roof itself is mostly glazed although this is a later modification. The main elevation faces the yard to the south and is rather plain. All the windows have been replaced and a number of doors on all levels have been blocked and replaced by windows.
