# An Archaeological Watching Brief at The Church of St Peter and St Paul, West Newton, Norfolk

## Archaeological Watching Brief Report

OA East Report No: 1562

*OA Site Code:* XNFWNC13  
*NHER No.* ENF132671  
*Date of Works:* 11/11/2013  
*OASIS Record No:* oxfordar3-168862  
*Report No:* 1562  
*Excavator:* John Diffey  
*Client:* Sandringham Estate  
*Report Date:* December 2013

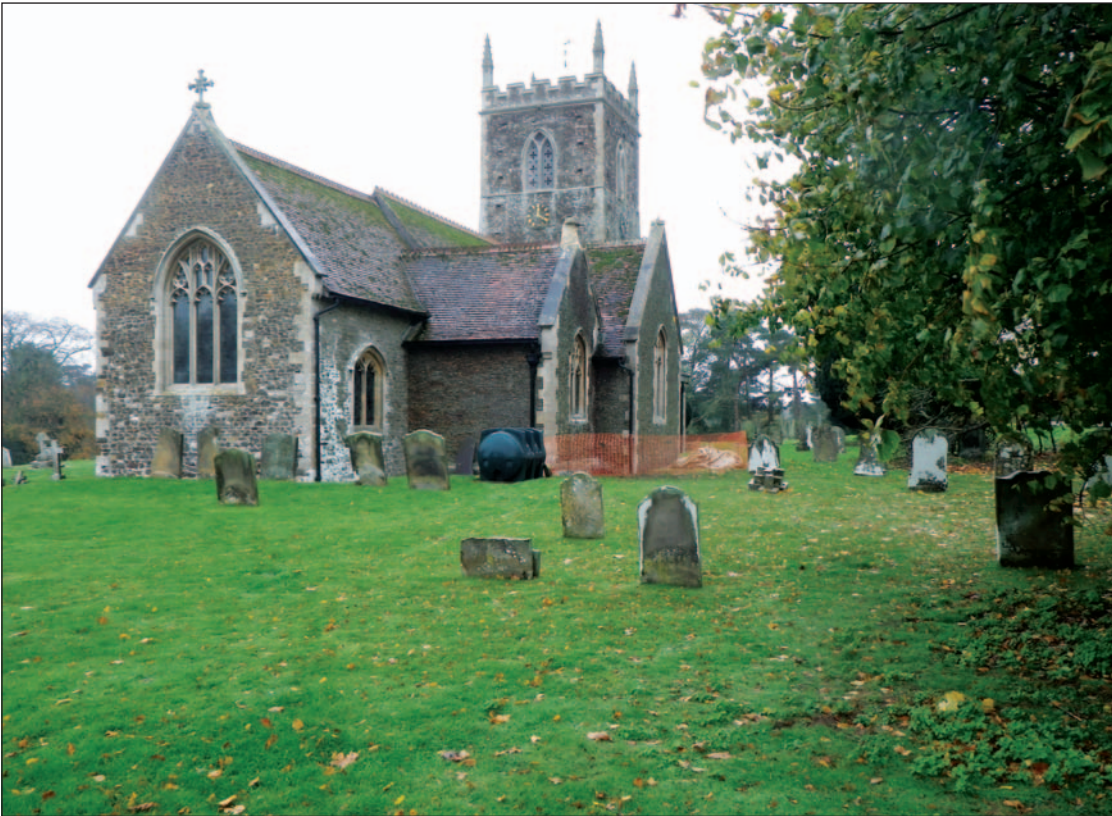
Plate 1: Site Overview looking east south east

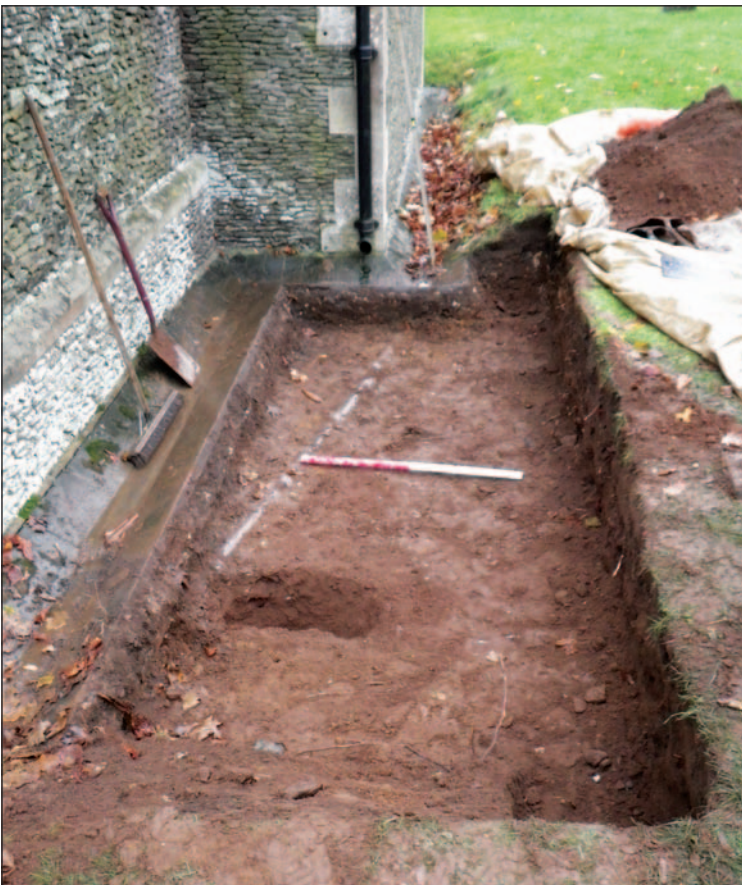
Plate 2: Trench Overview looking east

- 4.1.1 Excavation on site took place in an area 1.6 x 4.5m north of the northern chancel extension wall and east of the eastern vestry wall immediately adjacent to an open brick collector drain that runs around the periphery of the building. The excavation cut through a 0.4m high bank that slopes down to this drain resulting in a ground reduction of 0.3m at the base of the slope against the drain itself and a reduction of 0.7m on the northern side of the excavation where the ground was cut from the top of the bank. The natural geology was just reached at the base of the excavation at a level of 29.92mOD.

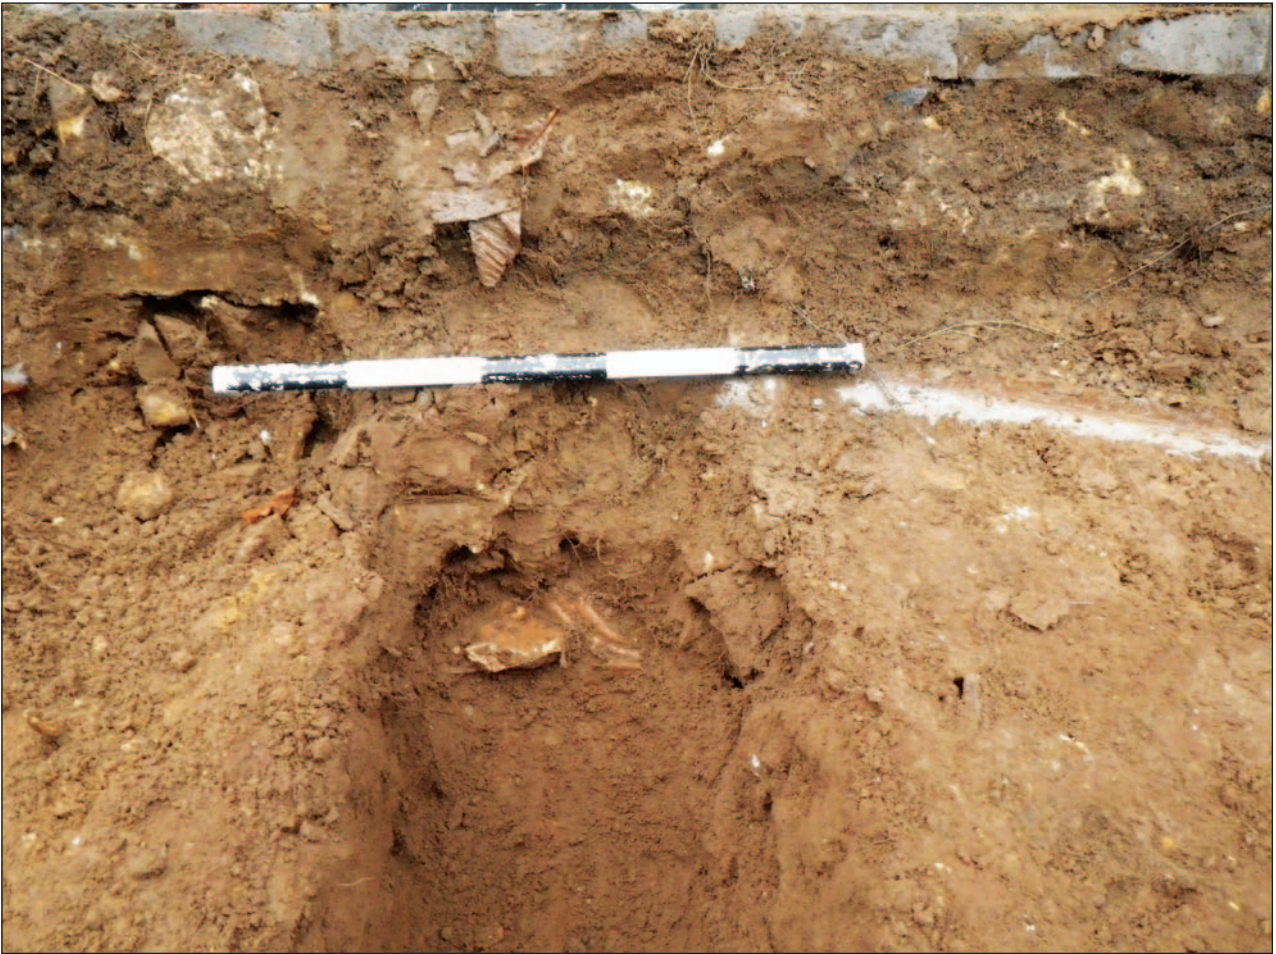
Plate 3: *In situ* Human Remains looking south

- 4.2.1 On completion of the foundation pad for the new oil tank a small single spade width sondage 0.3 x 0.6m x 0.24m was dug against the northern edge of the drain that skirted the northern chancel extension wall with a view to digging beneath the drain to allow a pipe to be drilled through the adjacent wall. During excavation of this sondage two bones identified on site as human arm bones, specifically the ulna and radius, were disturbed by digging. Careful cleaning of the sondage revealed a human pelvis and lower ribs still in situ in section (see plate 2). The burial was situated immediately against the northern wall of the chancel below the late 19<sup>th</sup> century drain and only 0.1m below the ceramic 19<sup>th</sup> century drainpipe that ran across the excavated area. From the small section of skeleton visible it was possible to deduce that the burial is situated along the wall in a supine position with the head toward the west as is typical of Christian burial. No clear grave cut was identified and the material surrounding the remains appeared to be redeposited material from the natural geology in which the grave must have been cut. The bones appeared in good condition and the burial appeared to be in tact despite the close proximity of the 19<sup>th</sup> century drain and pipe overlying it. No material culture was identified as relating to the burial to allow dating of the remains. The likely extent of the burial has been marked on Plan 1 (Fig.2) while section 1 shows the position of the remains beneath the 19<sup>th</sup> century drain and pipe. On completion of recording the disturbed ulna and radius were reinterred adjacent to the insitu remains and the sondage was backfilled with plans to route the new oil pipe approximately 0.3m above the burial through the brick drain.

- 5.2.1 The burial however must pre-date these renovation works because of its position below the 19<sup>th</sup> century surface drain and pipe. Although the date of this burial is unknown it can be said to be typical of Christian burial practice laid east-west in a supine position. The positioning of the body against the northern chancel extension wall is also of interest. The positioning of burials within a medieval cemetery has been greatly debated and numerous conflicting examples of folklore relating to hierarchical burial
