Willow Walk, North Hinksey,  
Oxford

## Archaeological Watching Brief Report

December 2011

**Client:** Environment Agency

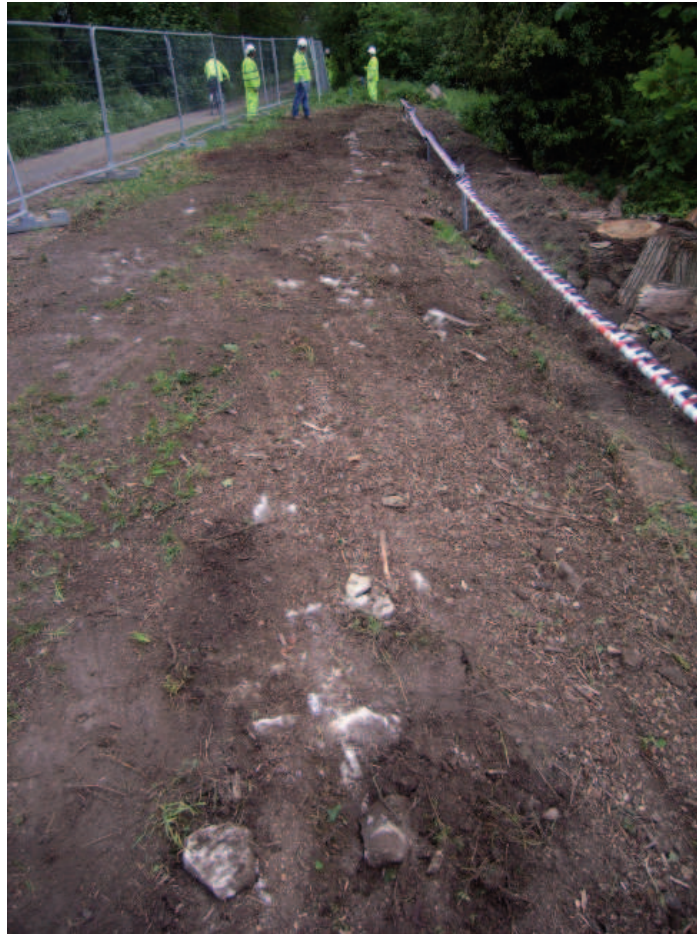
Plate 1: Area of pipe trench pre-excitation, showing stones of footpath, looking north-east

- 3.1.1 The trench was located parallel to Willow Walk along its southern side, (Figure 1 and Plate 1). The trench was observed for a 12m stretch to define the nature of the works and to characterise the sequence of deposits, (Plate 2). The trench was 12m long by 1.3 m wide and dug to an overall depth of 3.1m below ground level (bgl), which was at 53.57 m AOD.

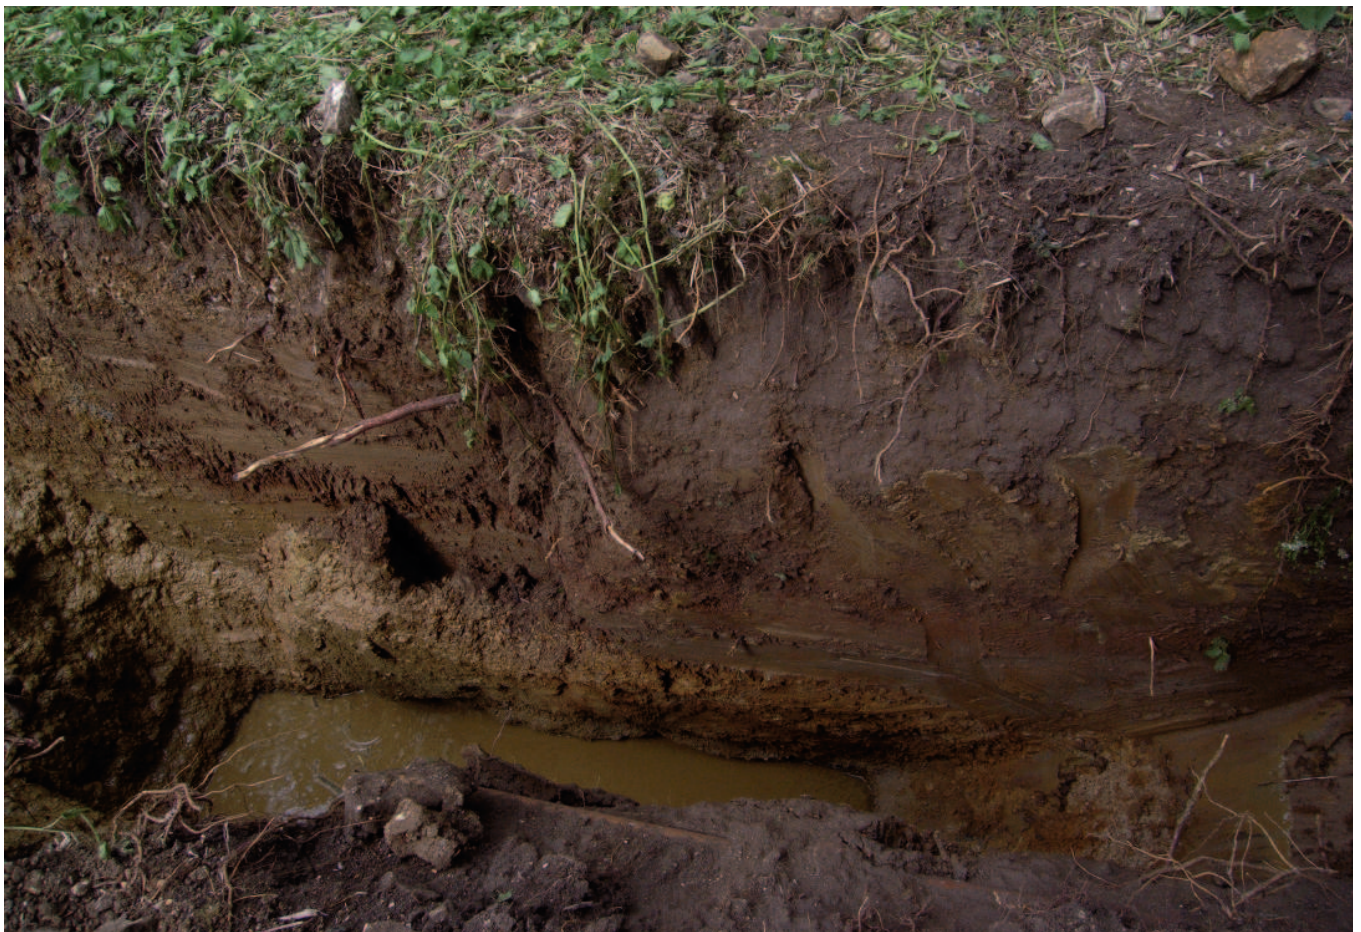
Plate 2: Area of pipe trench observed, section view, looking north-west

- 3.1.2 The sequence of deposits revealed that at the base of the trench were natural gravels. The gravels were seen at a depth of 1.5 m BGL (55.17 m AOD), and continued for a further depth of 1.6m to the lowest extent of excavation. At the time of excavation the water table was reached at 2.0 m bgl. Above the gravels was a 1 m thick layer of sterile grey clay with reddish brown mottling.

- 3.1.3 Above this was a 0.25 m thick layer of yellowish brown sandy gravel which was unsorted and was interpreted as being makeup or bedding material associated with the adjacent pathway. At the top of the sequence was 0.32 m of topsoil and turf.

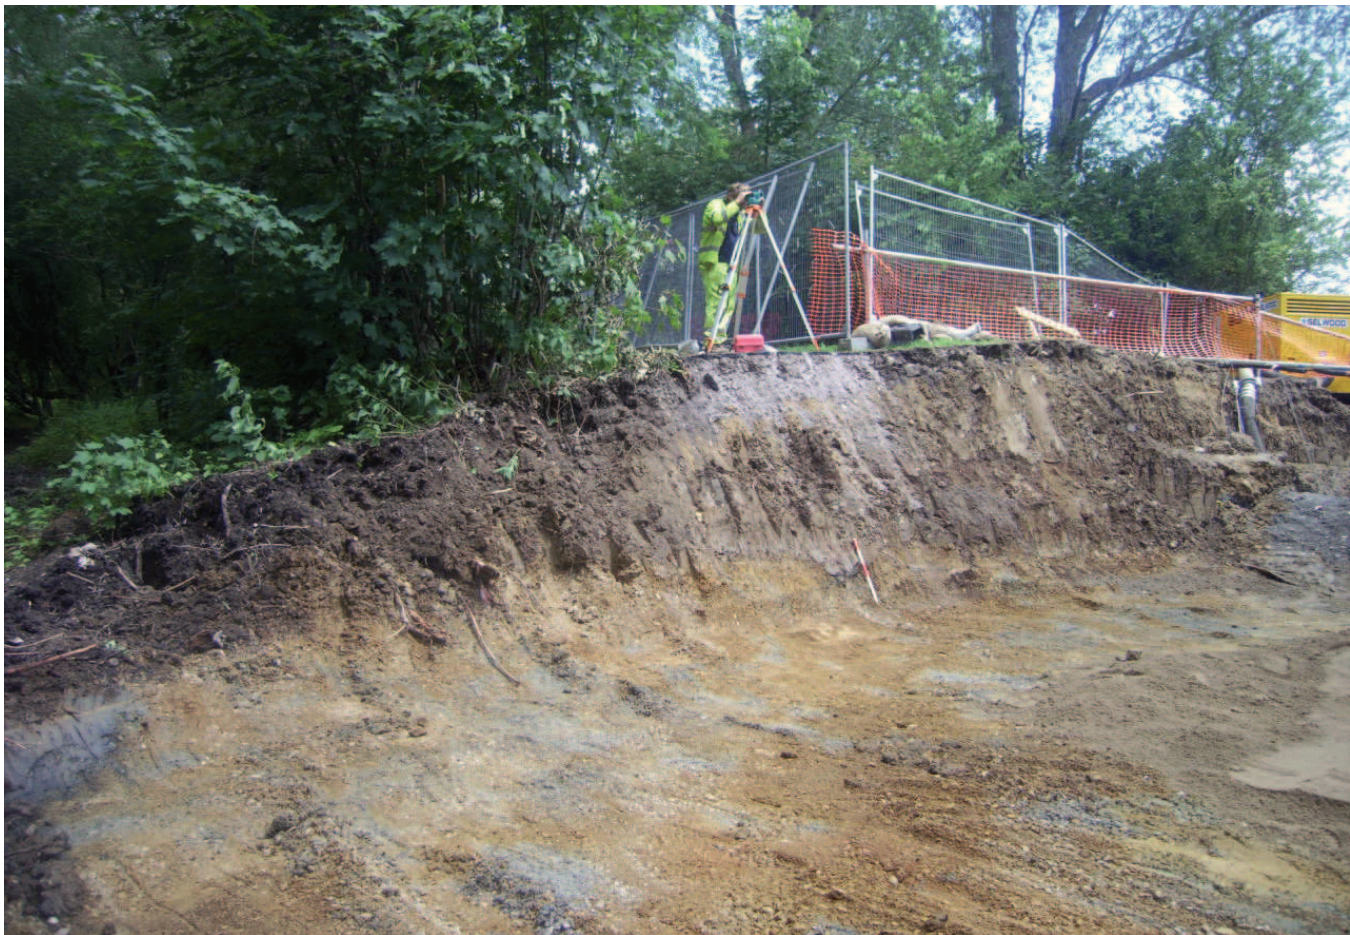
Plate 3: Culvert 2: north part of section, looking east

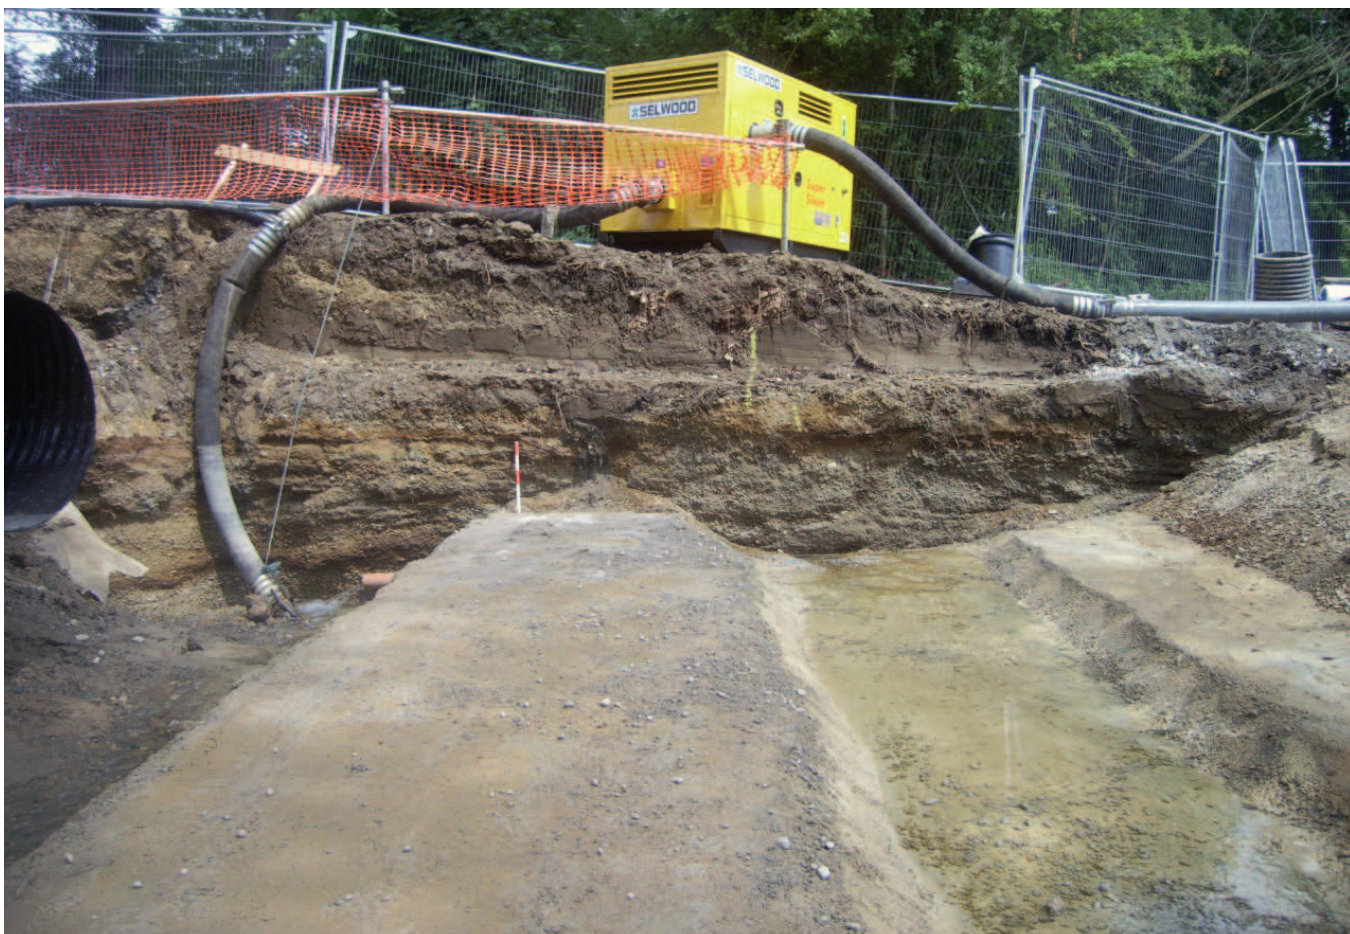
Plate 4: Culvert 2: south part of section, looking north-east

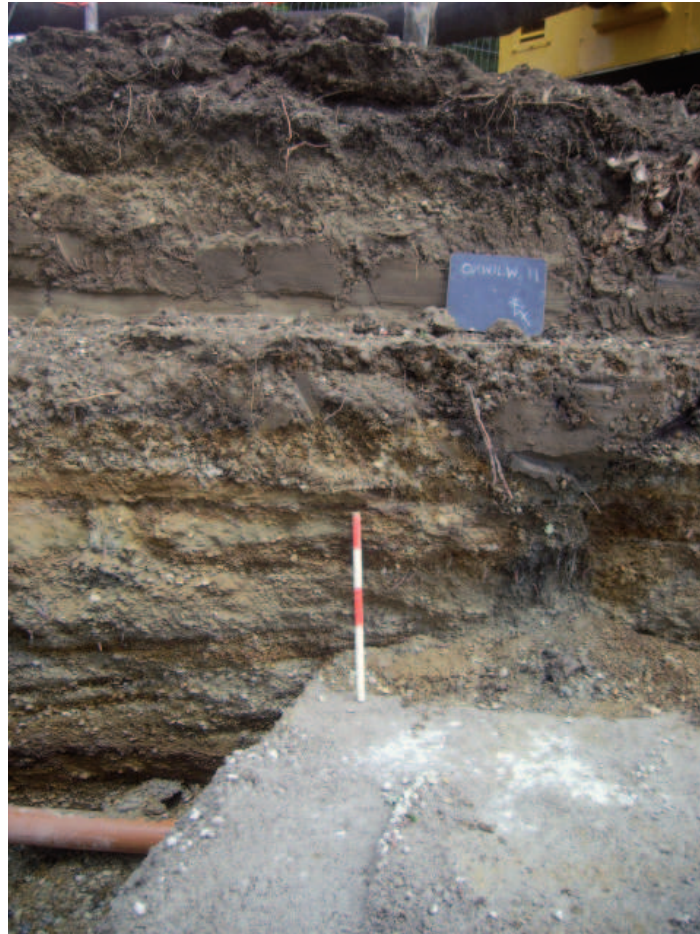
Plate 5: Culvert 2: south part of section, close up of gravel layers, looking north-east

- 3.1.5 The trench for Culvert 2 measured 20 m by 9 m and was dug to a maximum depth of 2.6 m, (54 m AOD). The sequence of deposits was compatible with that of Trench 1, with approximately 1.6m of gravels at the base of the area. The gravels varied in colouration and showed slight variations in the size sorting of the inclusions. Most were greyish or orange in hue and contained nearly 100% small rounded pebbles. The gravels were laid in horizontal bands indicative of deposition in a high energy fluvial environment. One band in particular, towards the base of the visible sequence, had a dark brownish colouration and this may have resulted from iron staining from water.
