Gully wall at Scarisbrick Hall, Scarisbrick, Lancashire

Archaeological Building Recording

Oxford Archaeology North

June 2013

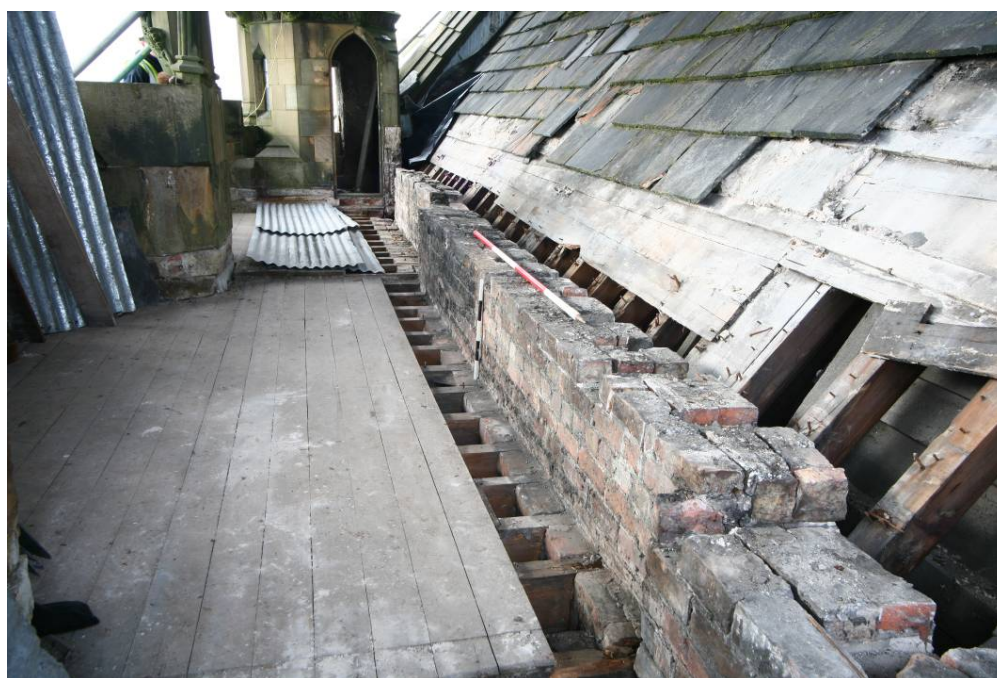
Plate 1: Location of the wall subject to survey

- 3.2.1 The wall lies adjacent to the base of the south-facing slope of roof of the Great Hall (Plate 1, Fig 2), the south-facing elevation of which is highly decorative and is attributed to AWN Pugin (Purcell 2011). The wall measures 10.1m long (approximately 33 feet), and consists of three sections, which are progressively stepped to the east (Fig 3). The western most section of wall measures 3.2m (10 ½ feet) long by approximately 0.6m (approximately 2 feet) high; the middle section measures 4.5m (14 feet 9 inches long) by approximately 0.52m (1 feet 8 inches) high; the eastern most section measures some 2.35m (7 feet 8 inches) long by approximately 0.7m (3 feet 3 inches) high. The western section is two wythes thick (0.26m or 10 ½ inches) and the other two sections are three wythes thick (0.35m or 14 inches), the facing wythe of the east section is not bonded to the others. Both ends of the wall are crumbling and it is evident that it originally extended further at each end (Plates 2 and 3).

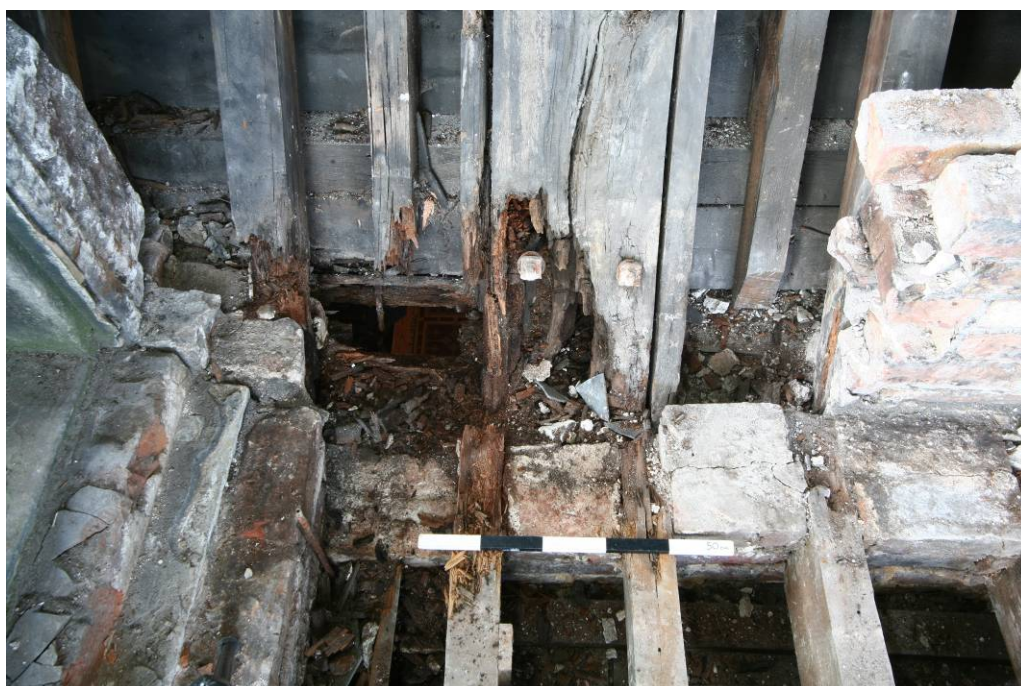
Plate 3: West end of the wall showing rotted rafters and low wall below floor level

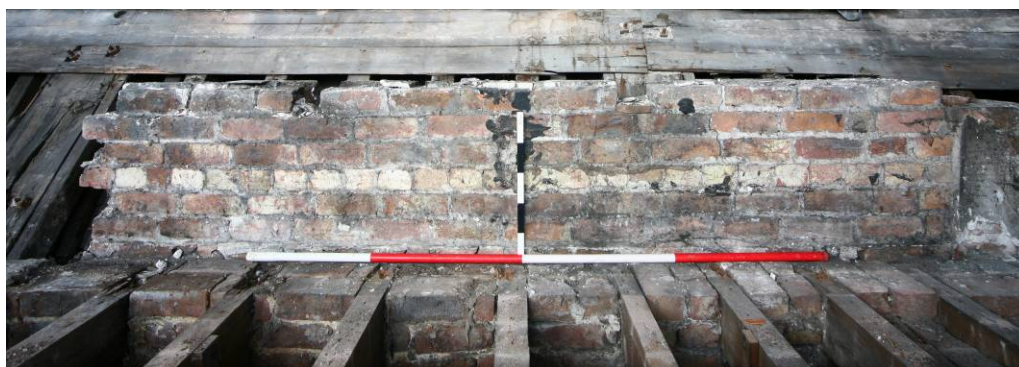
Plate 4: West section of the wall showing the low wall below floor level

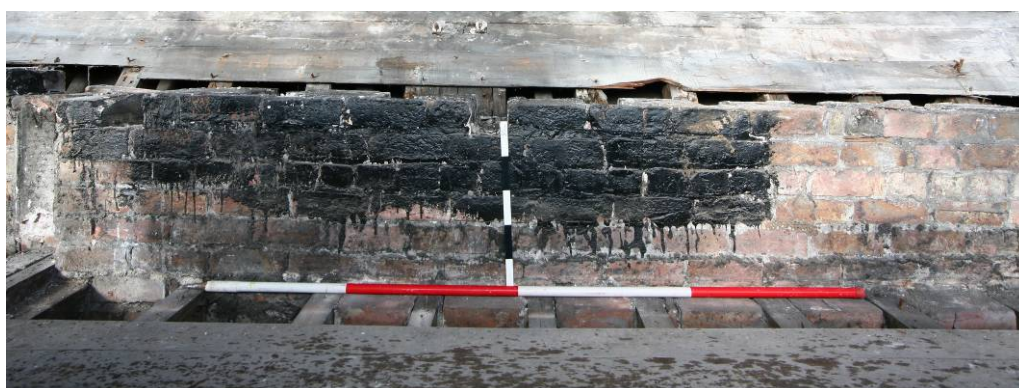
Plate 5: Part of the middle section of the wall

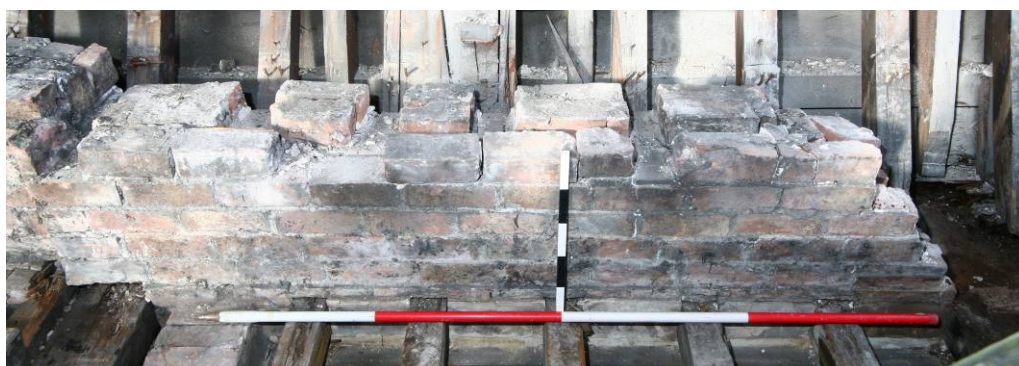
- 3.2.2 Each brick in all three sections of the wall measures approximately 0.23m (9 inches) long by 0.115 (4 ½ inches) wide by 0.075m (3 inches) deep. All of the bricks appear to be hand made. The bond used is mainly stretcher bond with a row of headers four courses up from the base on the western and middle sections (Plates 4 and 5). There are no visible headers on the east section of the wall (Plate 6).

Plate 6: East section of the wall

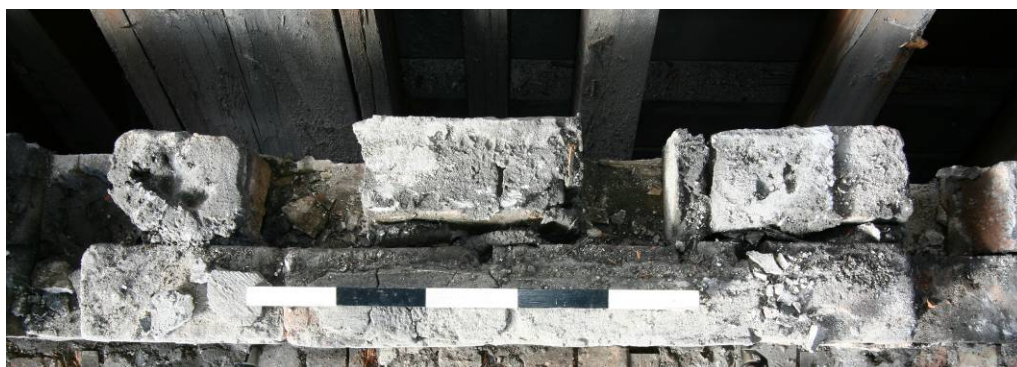
- 3.2.3 The wall contains several evenly-spaced gaps in the top one or two courses that correspond to the position of the common rafters on the adjacent roof (Plate 7, Figs 3-5). These appear to have housed spurs, that were attached to the rafters (both principal and common). Plans supplied by the client show these *in situ*, and they appear to have been nailed to the rafters. It is apparent that these formed part of the support structure for the lead-lined gutter.

Plate 7: Gaps in the wall for the spurs forming the support structure of the lead lined gutter/channel

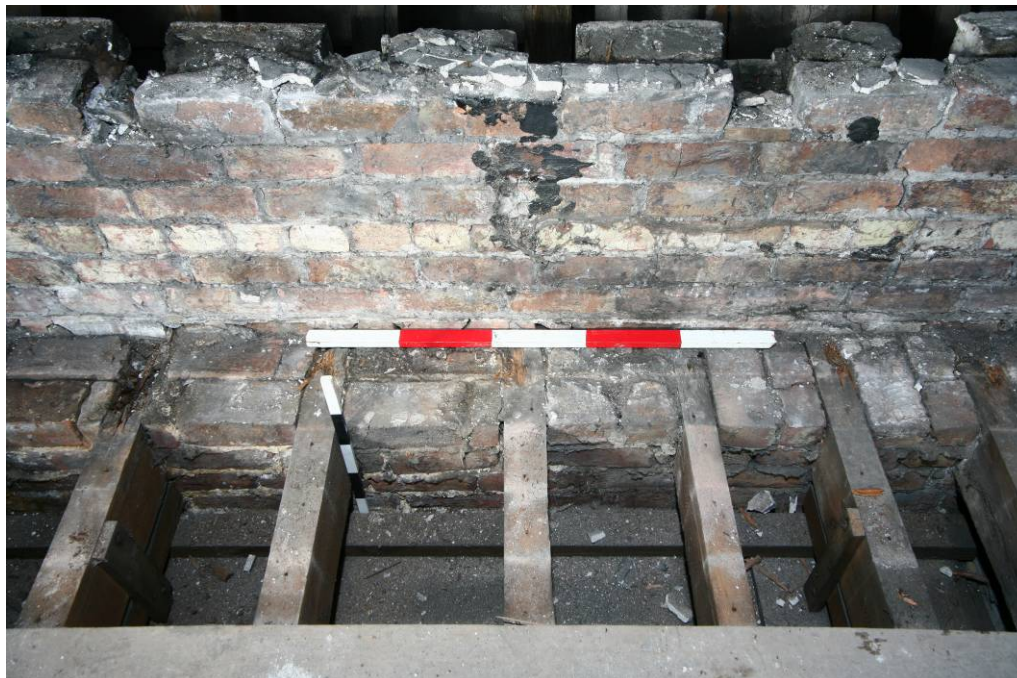
- 3.2.4 Below the western and eastern sections of the wall is a further wall upon which the central section of wall is partially built (Plate 8). Set into this lower wall are the northern ends of numerous joists, measuring 0.08m (3 inches) wide by 0.16m (6 ¼ inches) deep, that form part of the ceiling above the two projecting bays of the Great Hall (Plate 1). The general appearance of this lower wall is similar to that already described, the bricks being of the same dimensions. The spacing between each of the joists differs slightly, the brickwork in between consisting of both full and closer bricks to suit. It is probable that the wall has been constructed around pre-existing rafters. There are two wythes visible at the western end and a single wythe in the middle section. This lower wall is possibly contemporary with the upper.

Plate 8: Low section of wall showing how the joists are fitted

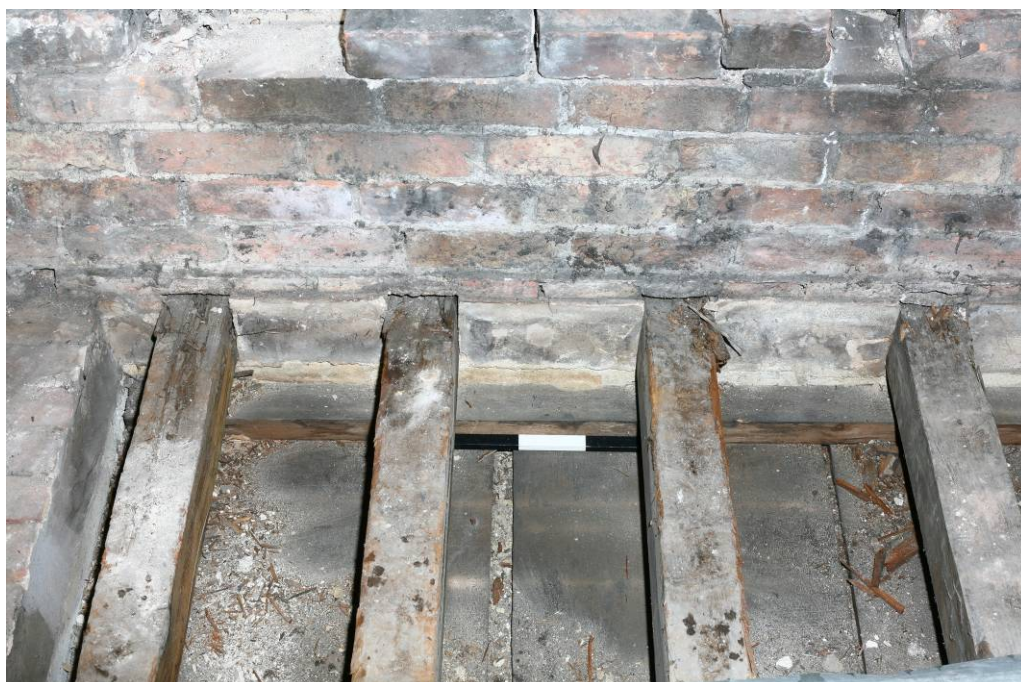
joists and none of them are visible from below. The decorative nature of the joists at the east end suggests they were once visible from below, or they have been reused. Plaster adhering to the lower part of the eastern section of wall, together with a horizontal scar indicative of a former, higher, ceiling suggest the ceiling was once higher here (Plate 9). These beams are of the same dimensions as some of the common rafters of the roof (which exhibit similarly moulded soffits), measuring 0.09m wide (3 ¾ inches) by 0.15m (6 inches) deep. Two rows of brick at right angles to the wall cross the space above the level of the current ceiling (Fig 3). The purpose of these, and what they are built upon is unclear.

Plate 9: Plaster in-between the decorative beams at the base of the eastern section of wall indicating a former ceiling

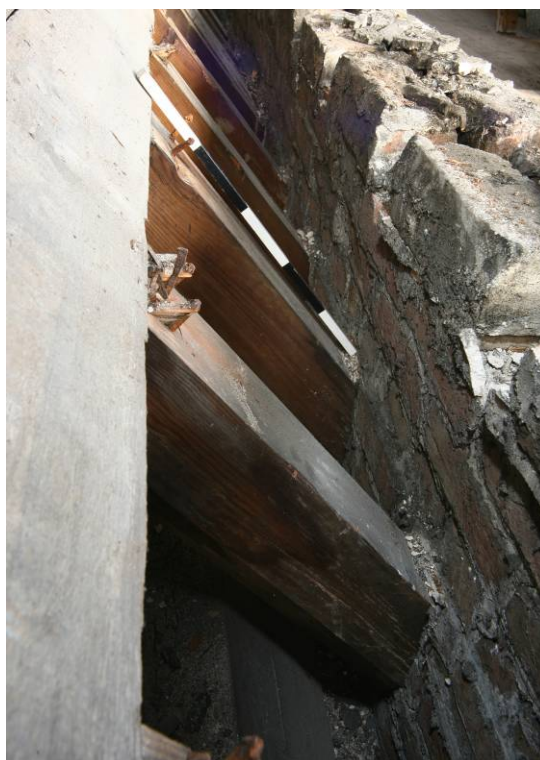
- 3.2.6 The rear side of the wall faces right up to the lower part of the roof slope, and inspection revealed that each of the feet of the principal and common rafters can clearly be seen to be embedded in the wall (Plate 10). The wall was evidently built around each rafter, suggested by closer bricks around each entry point, smeared mortar on some of the timber, as well as cut bricks in section (Plate 11). Some spaces in between the timber and brickwork has been infilled with (lime) mortar. The relationship is clearly visible in section at the west end of the wall (Plate 11).

Plate 10: Rear of the wall showing the rafters entering the wall

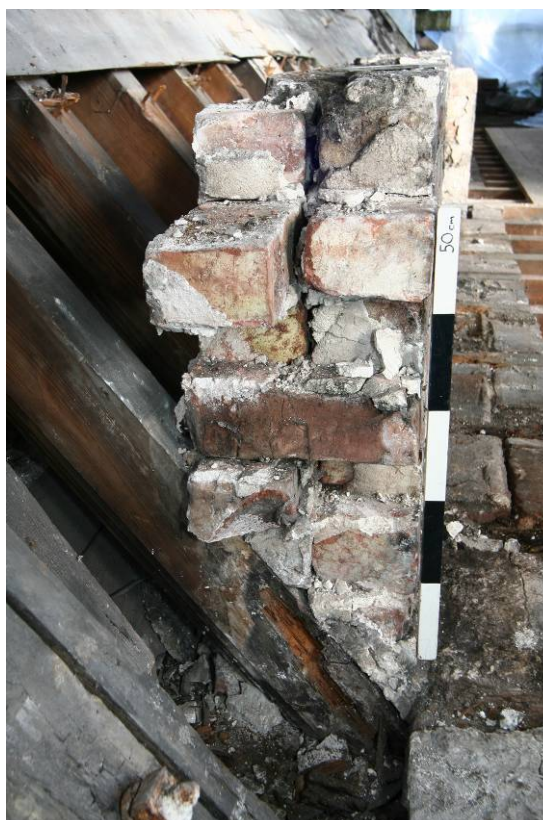
Plate 11: Relationship between the brick wall and rafter
