The Old Vicarage, Hornby, Lancashire

Archaeological Evaluation Report

Oxford Archaeology North

July 2012

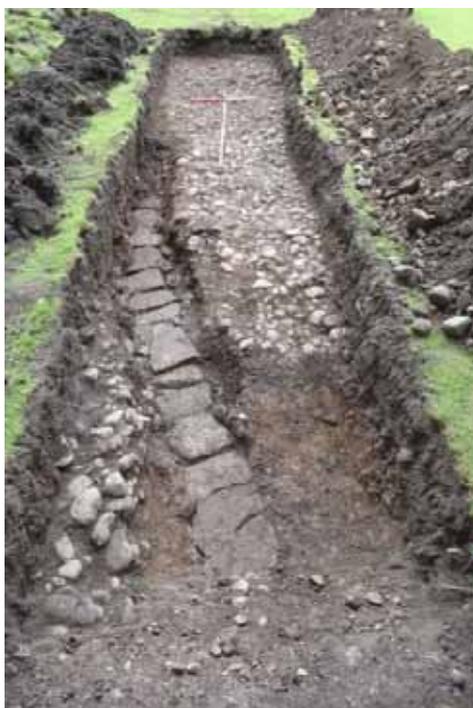
Plate 1: General trench view, looking west

3.2.1 The trial trench (Figs 2 and 3; Plate 1) was positioned in front of the gate into the castle grounds, and ran roughly east/west across the Old Vicarage gardens. It measured 10m in length, 2m in width, and reached a maximum depth of 0.82m. The trench comprised a dark silty topsoil (**01**), which was 0.34m thick, overlying a levelling layer of reddish-brown, clayey-silt (**02**), containing frequent angular pebbles, that was 0.19m thick. No finds were recovered from either of these deposits. Layer **02**, in turn, sealed two features of archaeological interest, a cobbled surface (**03**) and a stone-lined culvert (**04**). The cobbled surface was rough in nature and comprised rounded and sub-rounded, waterworn cobbles, up to 300mm in diameter. A slot excavated towards the western end of the trench indicated that they had been laid directly into the natural geology (**07**; Plate 2). No edges were identified, so the full extent of the feature could not be ascertained. Fragments of pottery and animal bone were recovered (*Section 3.3*).

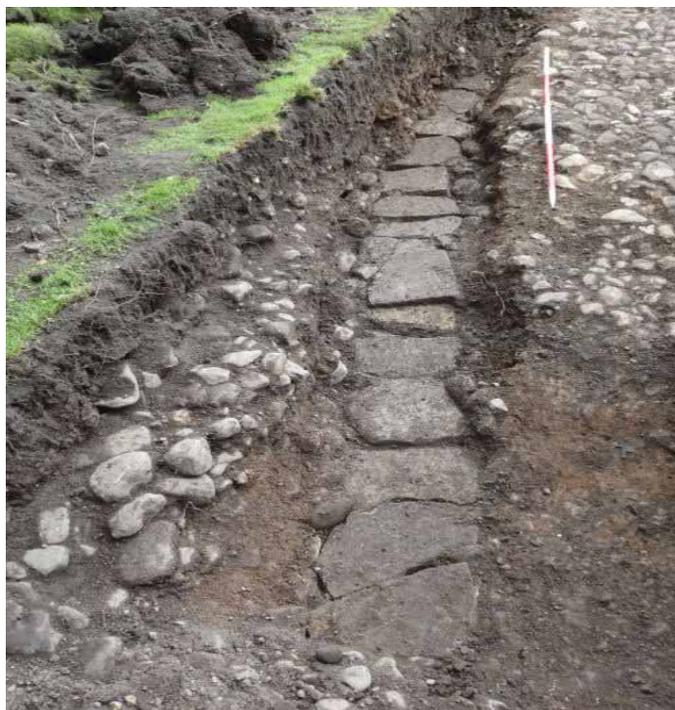
Plate 3: Detail of culvert 04, looking south-west

3.2.2 Running north-east/south-west, and truncating the cobbled surface, the stone-lined culvert was formed by construction cut 05, and stone-lining 04 (Plate 3). This lining comprised waterworn cobbles, forming the sides, and roughly-hewn sandstone slabs forming the floor and capping. It was backfilled with a loose, stone-rich material (06; Plate 4), which produced several fragments of pottery, similar to those from the cobbled surface (03). No further features or deposits were encountered.

- 4.1.2 Although no direct mention has been made of moving the castle access in the documentary sources, it was well known that major rebuilding and landscaping work took place at Hornby Castle in the nineteenth century (LCC 2006). It is possible that this alteration formed part of these works. Therefore, it is also likely that the stone-lined culvert (04) was constructed during the nineteenth century refurbishments.

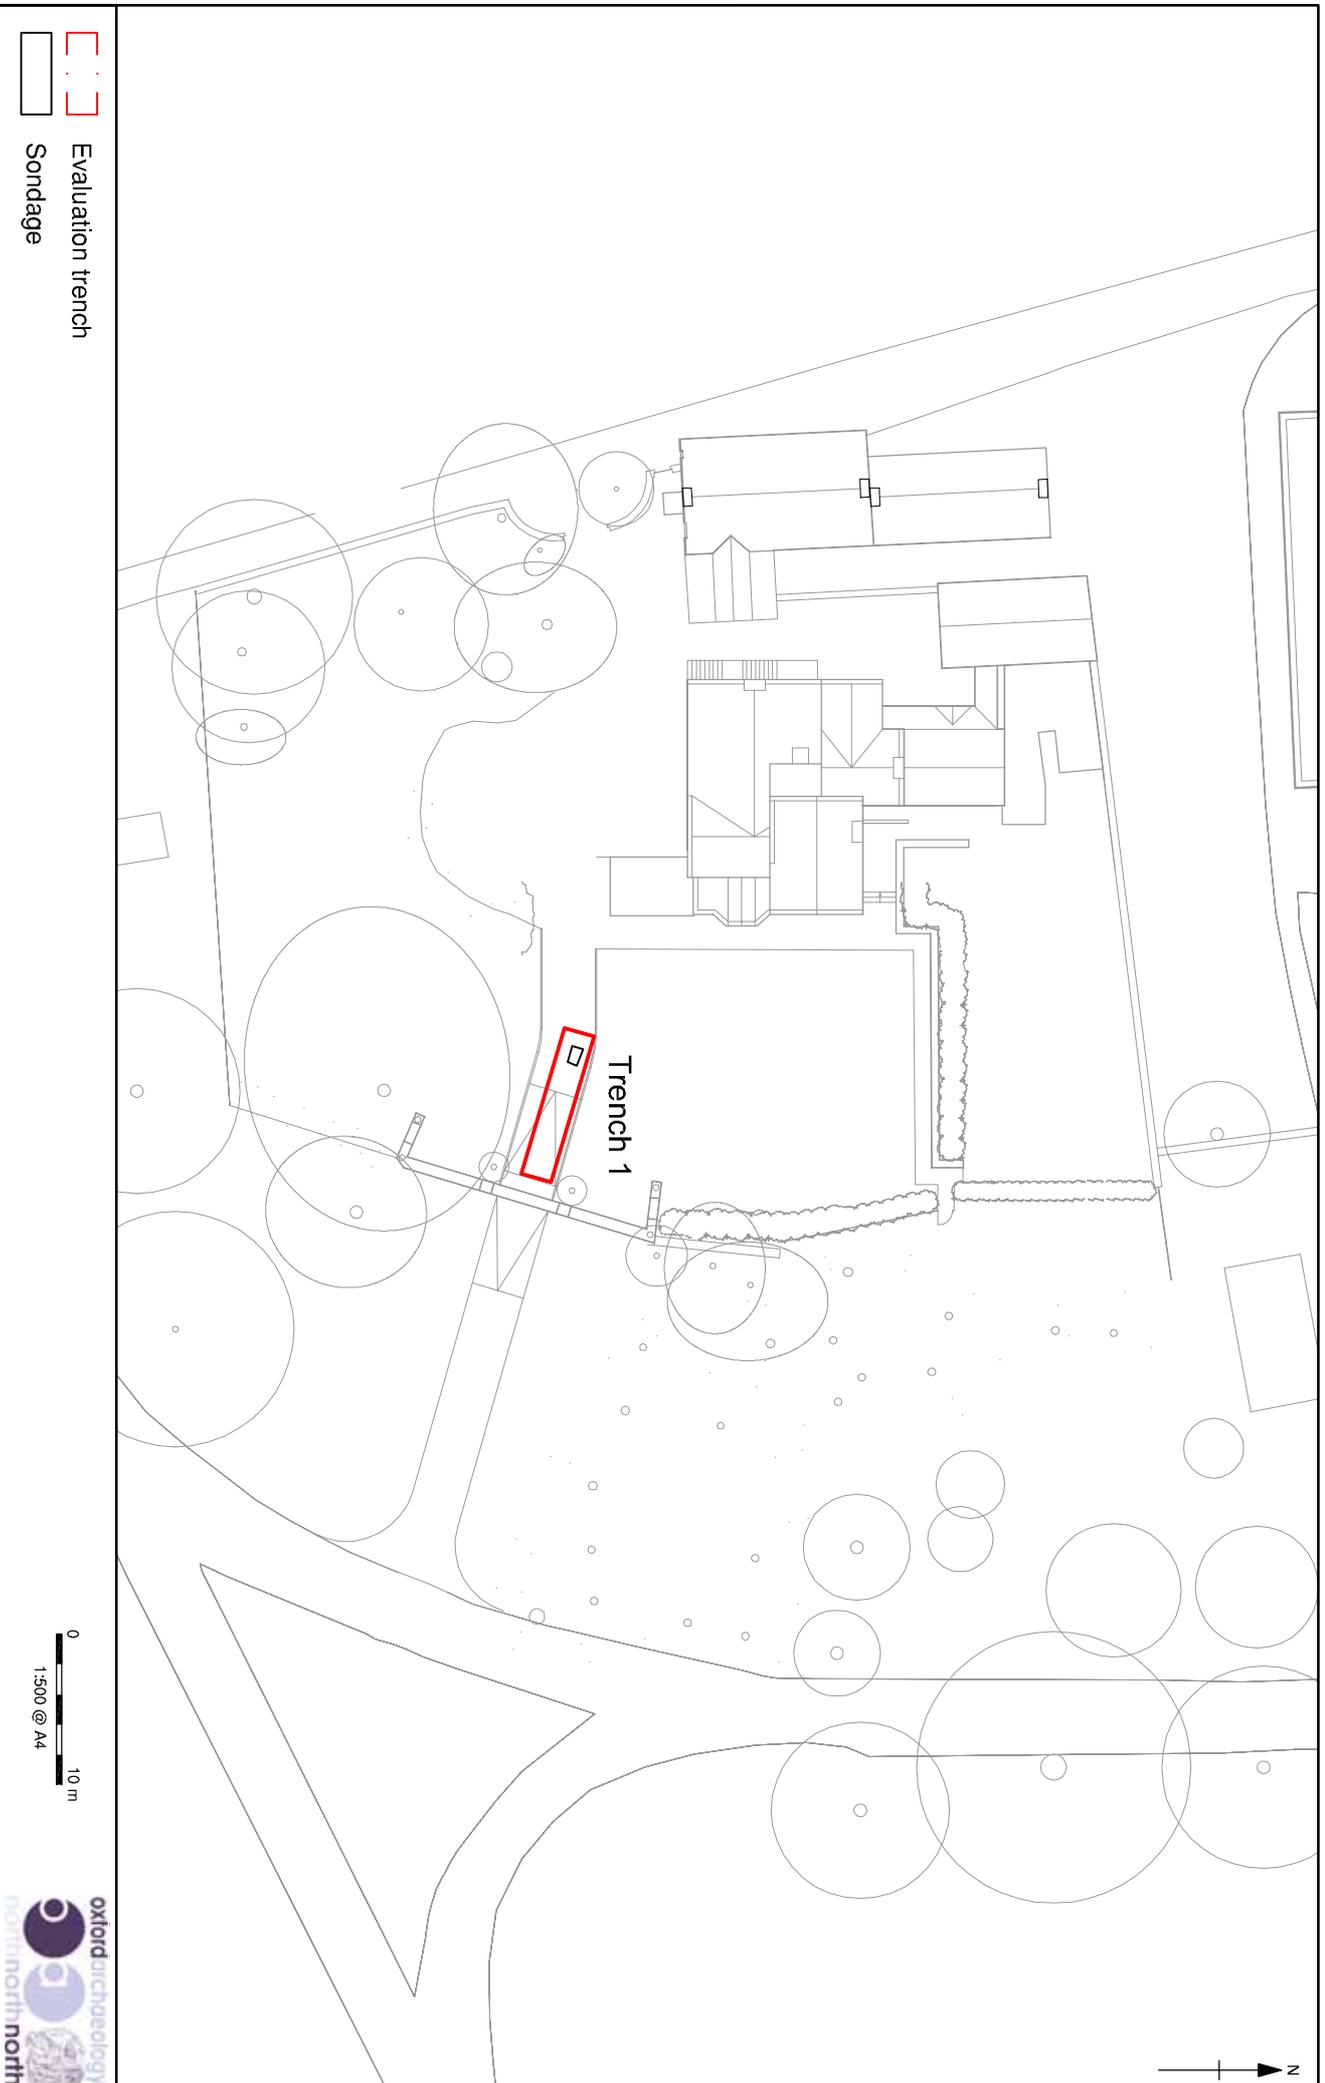
Figure 2: Trench location plan

2.2.1 A single trial trench was excavated in the garden to the rear of the Old Vicarage (Fig 2). It measured 10m in length and 2m in width, and was excavated to the level of the first archaeological deposits encountered. The trench was opened by a three tonne, 360°, rubber-tracked mechanical excavator, fitted with a 0.9m toothless ditching bucket, and under the constant supervision of an archaeologist.

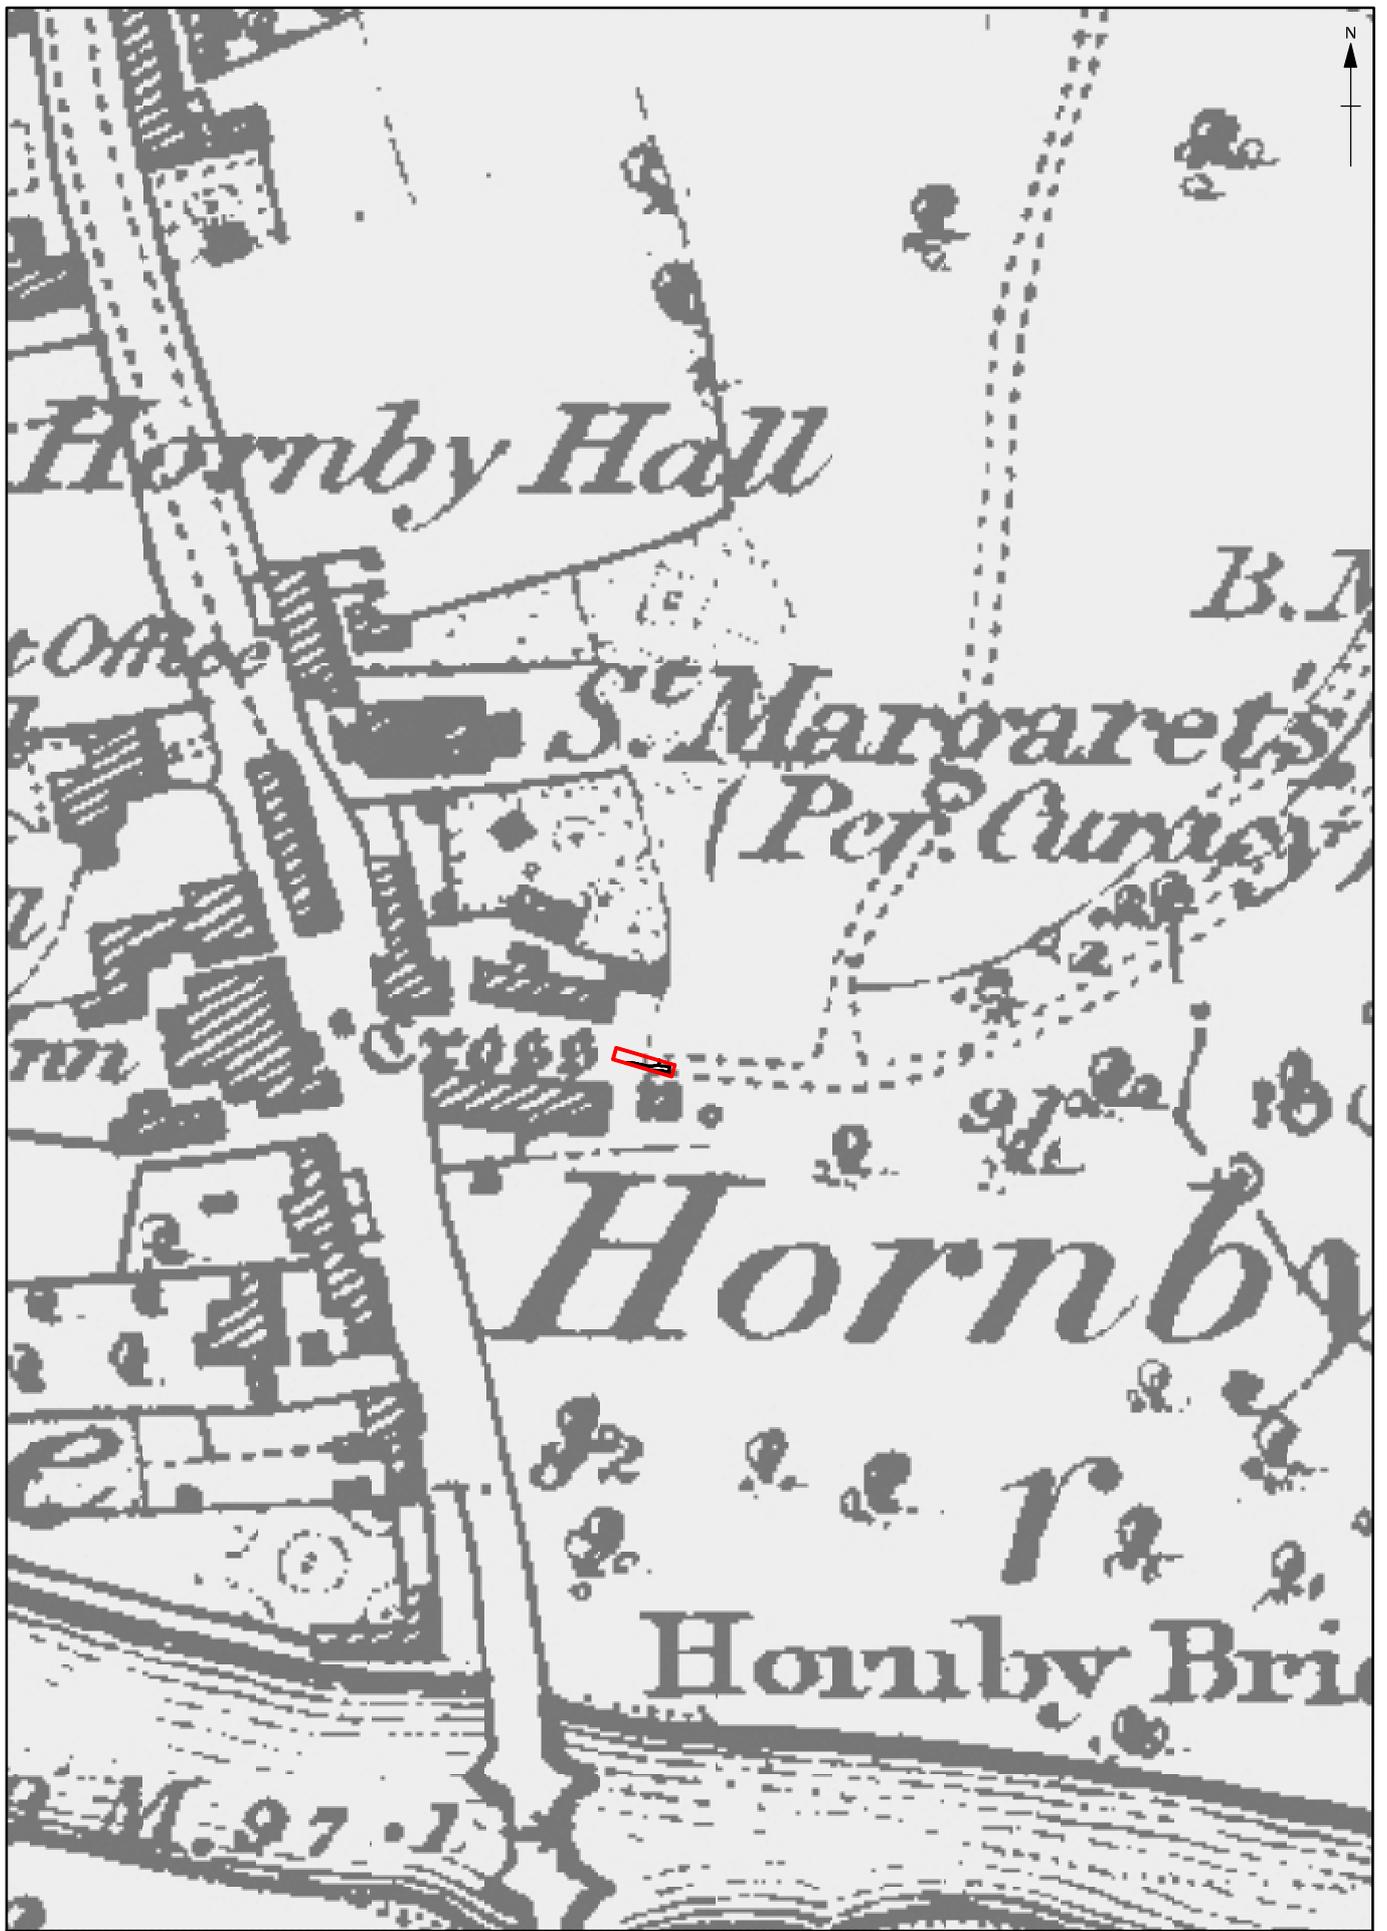
Figure 4: Evaluation Trench superimposed on Ordnance Survey first edition 6":1 mile map, 1841

- 4.1.1 The evaluation trench excavated in the grounds of the Old Vicarage contained a rough cobbled surface, which had been heavily disturbed, and a stone-lined culvert. The first edition of the Ordnance Survey (OS 1841; Fig 4) illustrates the main entrance to the castle running through the Old Vicarage gate. To the north lies the current retirement home building, and a small structure immediately to its north-east. To the south was a second, large building that is no longer extant, and is now occupied by the Old Vicarage garden. It was likely that the space between the two larger properties formed a small courtyard and access to the castle, to which the cobbled surface (03) relates. By the 1890 edition of the OS map (Fig 5) the main entrance had been moved to the south, and the Lodge had been built. The second building to the south of the Old Vicarage had been demolished, and the access from the castle to the former courtyard has gone, blocked by a wooded area. A path running north/south through the Old Vicarage garden would indicate that the area had been landscaped.

- 4.2.3 The remains of two buildings, which are no longer extant, seen on the OS 6" first edition (1841, Fig 4), may exist below ground in the Old Vicarage garden. The smaller of the buildings, to the immediate east of the current Old Vicarage, will have both of the proposed trial trenches positioned over it. It is highly likely that archaeological remains will be encountered in the next phase of works.

- 4.2.2 NPPF (DCLG 2012) guidance requires that *'developers [are] to record and advance understanding of the significance of any heritage assets to be lost (wholly or in part) in a manner proportionate to their importance and the impact'*. Therefore, it is recommended that the proposed access road groundworks are subject to permanent archaeological monitoring in the form of a watching brief.
