# **NORTHSIDE BRIDGE, PERMANENT REPLACEMENT, WORKINGTON, Cumbria**

## **Archaeological Watching Brief Report**

**Oxford Archaeology North**

January 2012

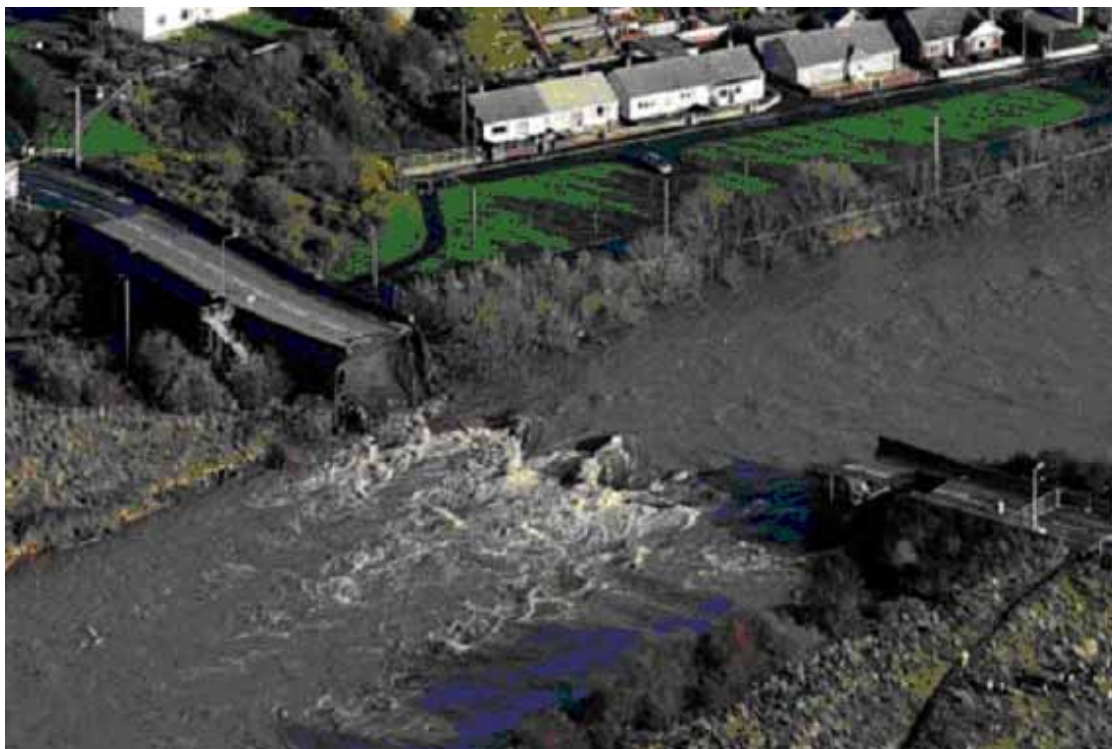
Plate 2: View of Northside Bridge following its collapse in November 2009

- 1.3.7 **Modern Period:** although the town reached its economic peak in the nineteenth century, Workington continued to develop throughout the twentieth century. As a result of the location of Workington, in the angle formed by the west coast and the river Derwent, the area has represented an important foci for communication routes linking the town with the northern coastal areas throughout the post-medieval period and into the present day. In 1901 construction began on the Northside Bridge (Plate 1), and it was opened in 1904, being also known as the New Bridge (Wikia 2011). During its construction there was controversy regarding changes to its design, the quality of the girders used and its cost (*ibid*). It appears to have replaced an earlier bridge in a similar location, shown on various maps in 1787 (Cary 1787) and 1805 (Cole 1805). This bridge was not depicted on subsequent maps produced in 1818 (Otley 1818) and 1846 (Hughes 1846), suggesting it had been destroyed by this time. The Cockermouth to Workington railway line ran beneath Northside Bridge (Wallace 2005, 94), as did the Maryport to Workington road. The Cockermouth railway line was recommended for closure in the Beeching Report of 1963, and the last passenger train ran in 1972 (Cumbrian Railways Association 2010). Northside Bridge was remodelled in the early 2000s, with the Maryport road rerouted along the former railway line and its former bridge span backfilled. Northside Bridge was subsequently destroyed by flood water on the 19<sup>th</sup> of November 2009 (Plate 2).

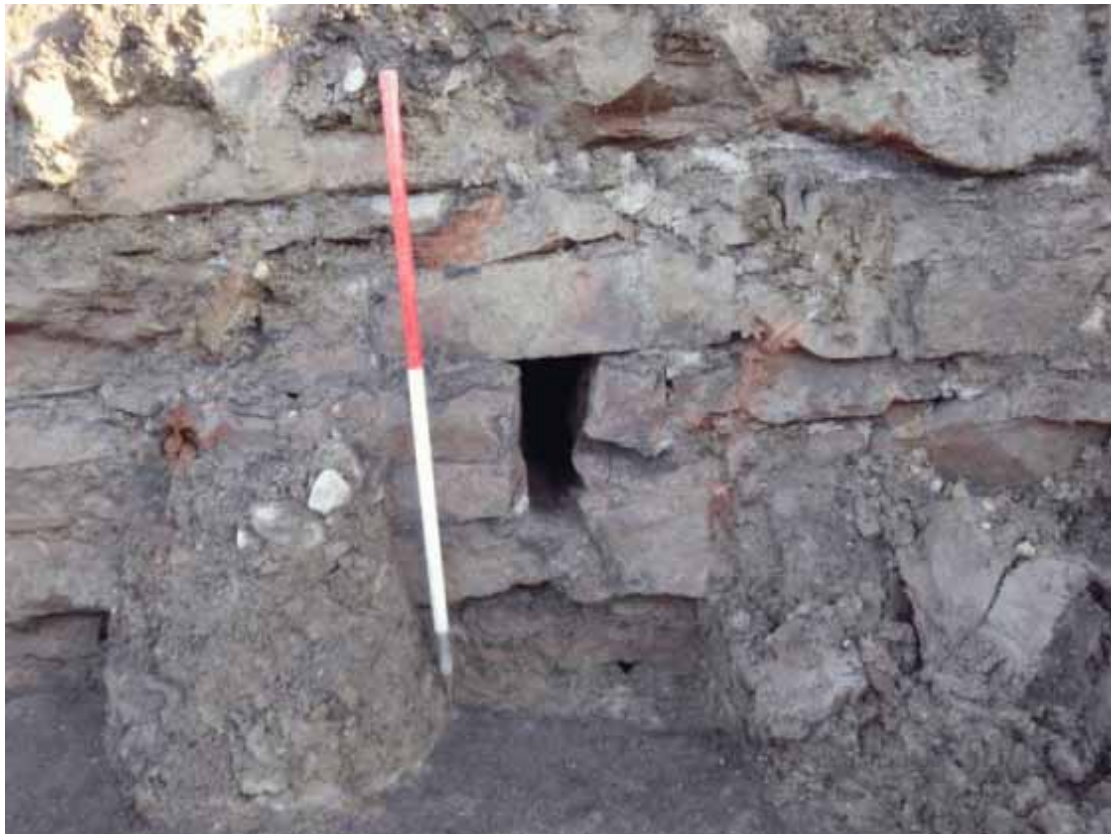
Plate 3: Drain *1024* in wall *1016* and construction cut *1050*

- 4.1.4 In the base of wall **1016** three drains or weep holes, **1024**, **1025**, **1026**, were uncovered (Plate 3; Fig 2). These produced a number of finds including an earring, pieces of wood, plastic, and fourteen marbles. Two marbles with coloured swirls were manufactured as toys for children. The remaining twelve marbles had been removed from the necks of glass bottles to be used as toys. These finds would have entered the drains from inlets at the base of the wall alongside the old Northside Road. The weep holes allowed water to seep from the interior of this section of the bridge and prevented damage to the structure from a build up of pressure from trapped water.

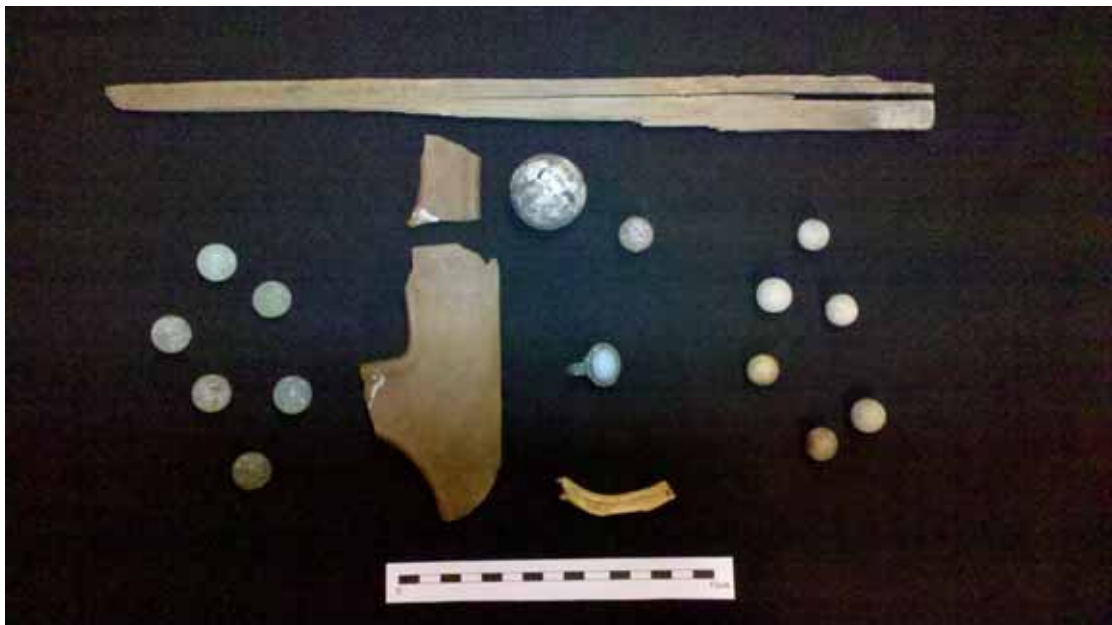
Plate 4: The finds from drain *1024*

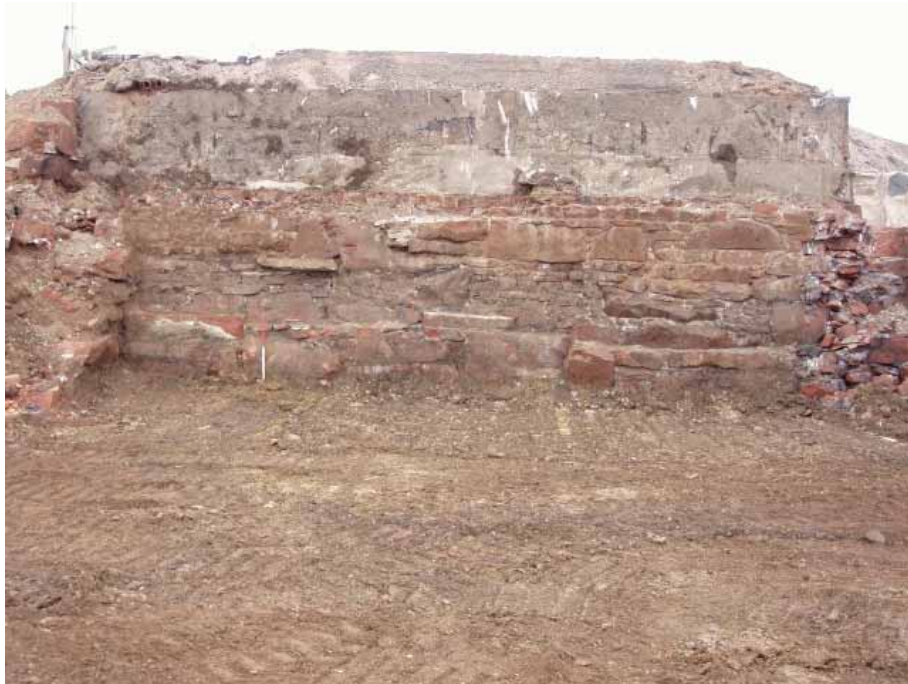
Plate 5: The south-facing concrete slab **1004** and inner wall **1016**

- 3.2.7 The north wall, **1016**, was the highest remaining part of the old Northside Bridge and its upper section was a concrete slab, **1004**, that measured 10.5m

long by 1.5m deep, and a minimum of 0.2m wide (Plate 5; Fig 2). It is possible that this concrete deposit was used to seal the open end of the former road tunnel that ran beneath the bridge prior to its infill with a deposit of air-filled concrete, **1005**, or grout, in 2000 (Fig 2). This had extruded from the void at its south-eastern corner and was a medium bluish-grey lower deposit with a light-pinkish yellow above, and a swirled mixing of both colours where they met. Part of an iron girder, **1006**, was also revealed at the south-eastern corner (Plate 6), along with part of a girder, **1020**, exposed in a shallow trench dug to locate an electricity cable (Fig 2). These girders were part of the original twentieth century bridge over the old Northside Road. Excavation revealed the truncated remains of New Bridge Road, which comprised a former road surface, **1002**, that lay beneath the present road surface, **1014** (Plate 7; Fig 2). Both surfaces comprised tarmac laid over layers of sub-surface material of gravel and small stones, and were approximately 0.9m thick. An extant section of wall, **1000**, bordering New Bridge Road, was partly demolished during groundworks, with the stone retained for reuse (Fig 2).

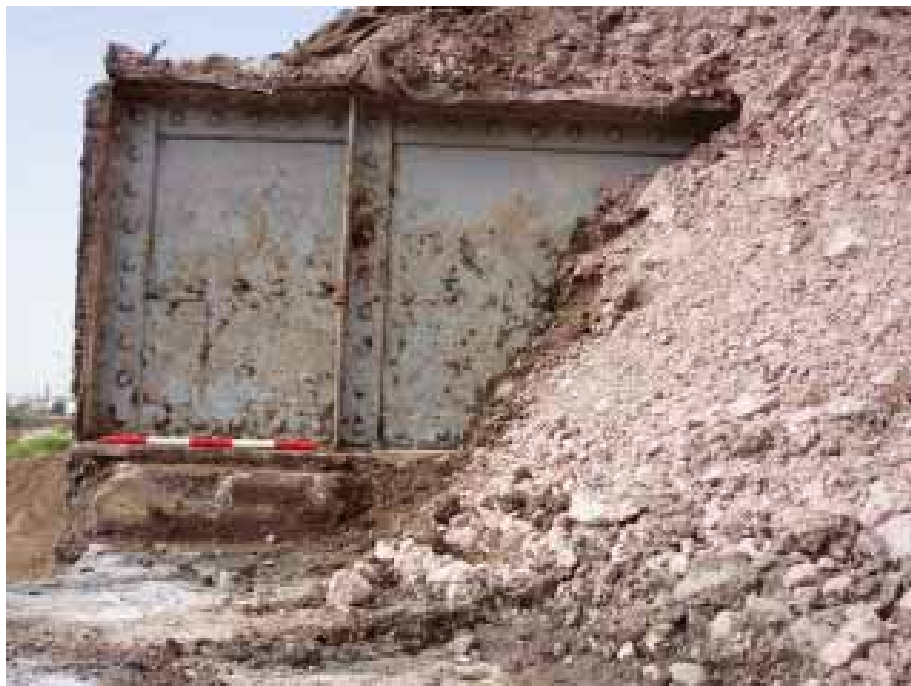
Plate 6: Part of an iron girder **1006**

- 4.1.2 **Area A:** the old Northside Bridge originally spanned the river Derwent, the Workington to Cockermouth railway line and the old Northside Road. The arch over the river was built of red sandstone and those over the railway line and road were iron girders. The pier of the bridge between the railway line and the road had been within Area A (Plate 12). The span over the old Northside Road was infilled in the early 2000s, and the road re-routed along the now disused railway line, with the bridge reduced to a couple of spans. The excavations revealed features of this pier and the former span over the old road. The section of wall **1000**, bordering the pavement on New Bridge Road, was constructed of red sandstone, some of which had been reused from an earlier structure (Fig 2). The wall was built to match that on the approach road at the southern end of the bridge. It is probable that this wall was built when the northern end of the bridge was remodelled in the early 2000s. Metalled surface **1002**, lying 0.9m beneath the present road surface **1014**, was probably the road level prior to the remodelling of the bridge (Plate 7; Fig 2). Two iron girders, **1006** and **1020**, were exposed and these had spanned the old Northside Road prior to it being re-routed (Plate 6; Fig 2).

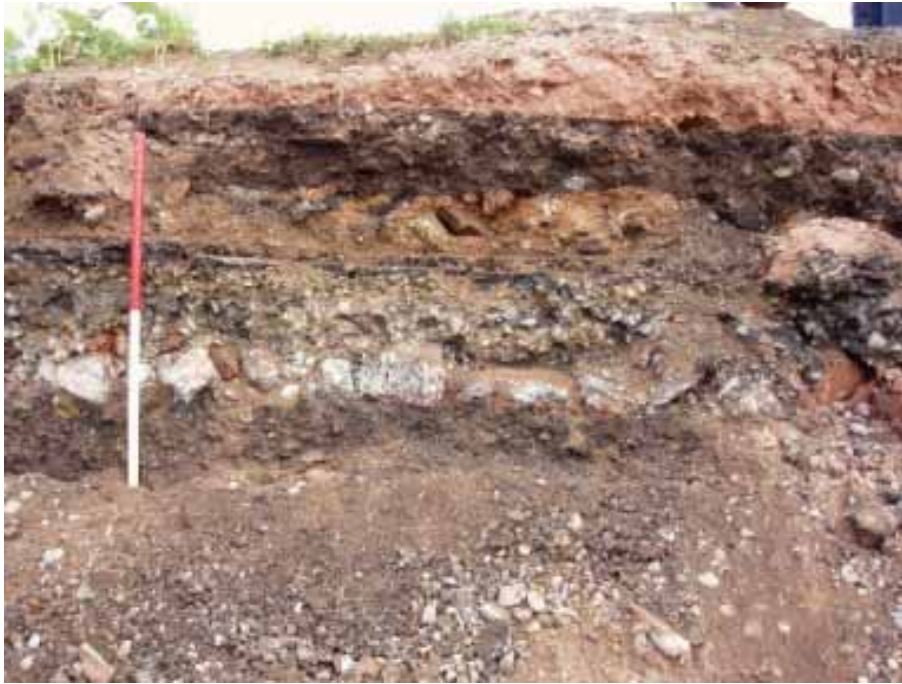
Plate 7: Former road surface **1002** beneath the present surface **1014**

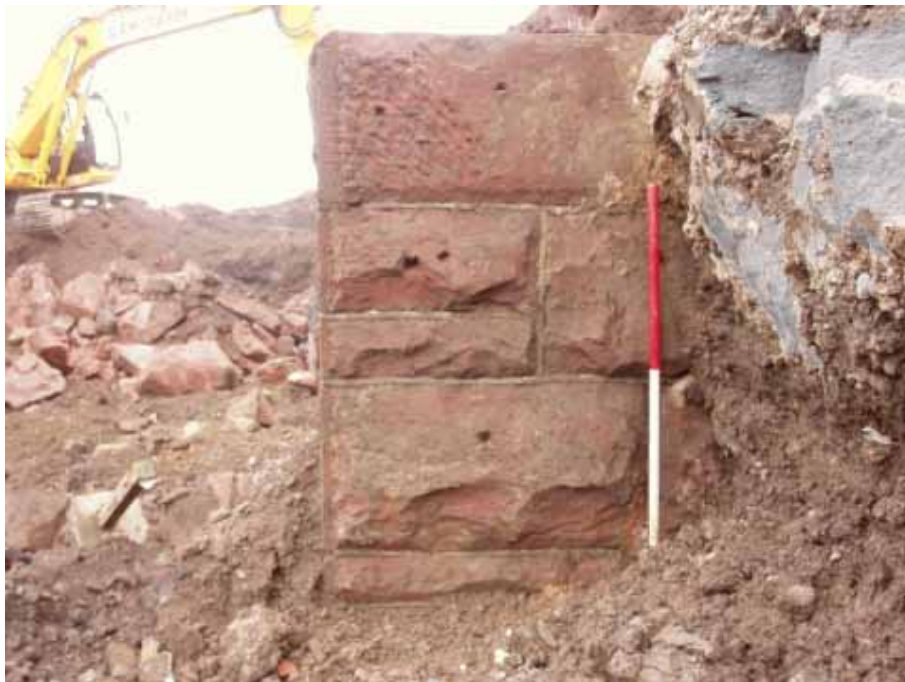
Plate 8: The outer face of the east wing wall **1009**

- 3.2.10 The outer face **1009** comprised worked and shaped blocks of red sandstone, measuring from 0.4m by 0.2m to 2.2m by 0.55m (Plate 8; Fig 2). At some point, a section of the outer face had been buried by a landscaped bank comprising dump deposits, **1003**, of mainly clayey-silt with whole bricks and building rubble. This may have been following the demolition of Brick Row or during the remodelling of the bridge in the early 2000s. Landscape bank deposit, **1003**, was topped with terram, **1058**, topsoil, **1001**, and planted with trees and shrubs.

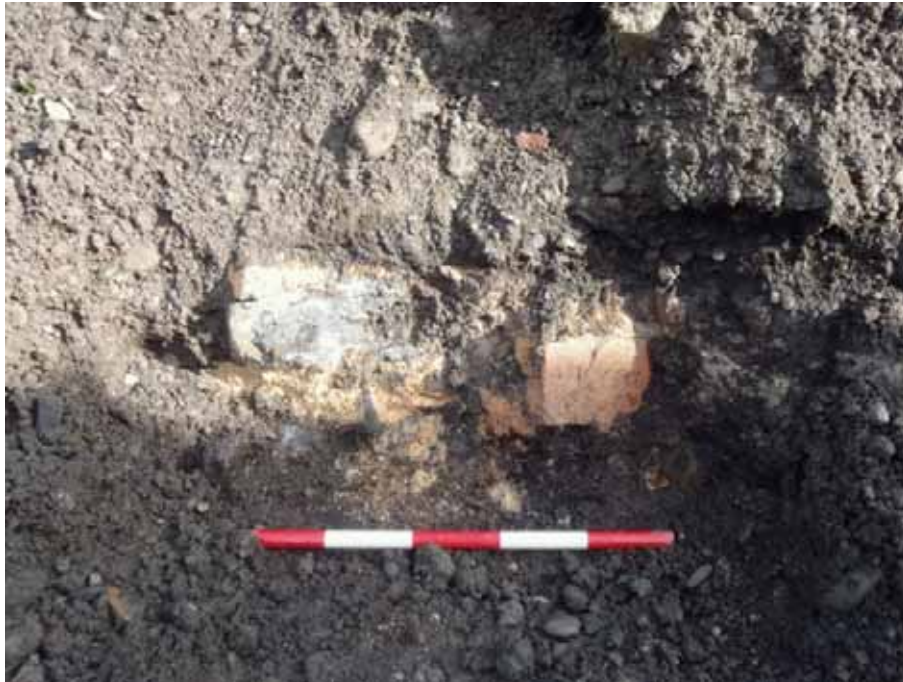
Plate 9: Brick wall **1042**, part of Brick Row terraced housing

- 3.2.11 To the north of **1021**, brick foundations, **1042**, were uncovered (Plate 9; Fig 2). The exposed section lay beneath landscaped bank **1003**, and measured 0.6m long by 0.3m deep. The bricks were a light whitish-yellow with 50% flecks of red and were crumbly, and bonded by a dark bluish-black mortar

with 5% small white inclusions. These were the same as the materials used to construct drain **1030**, and this feature was probably associated with Brick Row. Also beneath **1003**, at the southern end of **1009** bordering the present road, was a modern drain, **1043**, that measured 0.62m square with a visible depth of 0.8m. This was on the former route of the Workington to Cockermouth railway line (Fig 2). This drain was not removed, but backfilled, so it was not possible to determine its relationship with surrounding contexts.

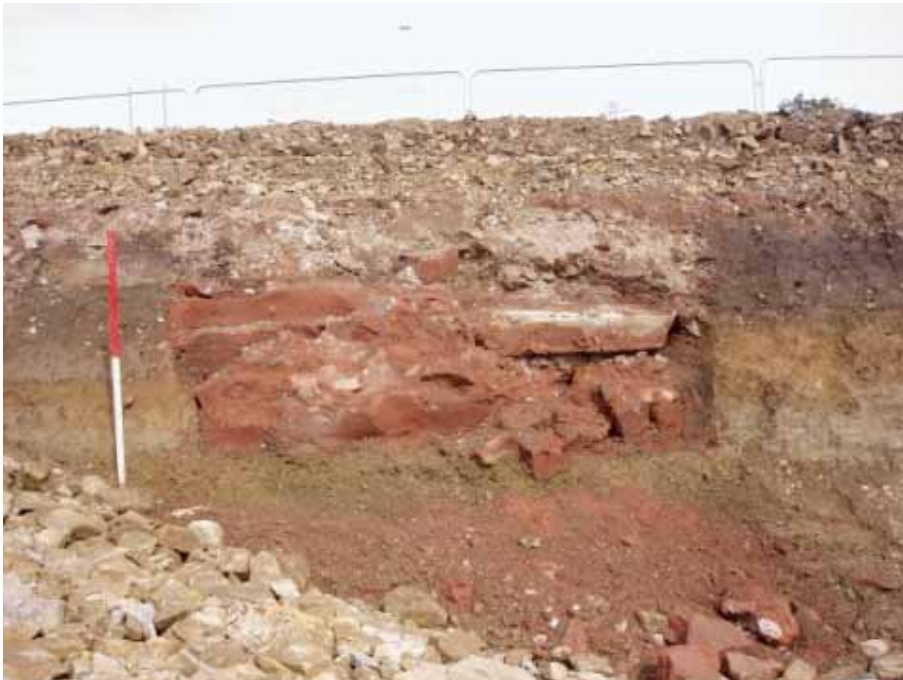
Plate 10: The remains of the foundations of the east wing **3010** of the north pier

| <b>3010</b> | Foundation stones of east wing on north pier of bridge. | 2.5m wide by 0.95m high and 5m long | Constructed of roughly-hewn blocks of red sandstone with a thin bonding of light pinkish - brown cement. Two courses high and two wide with rubble between the inner and outer faces. |

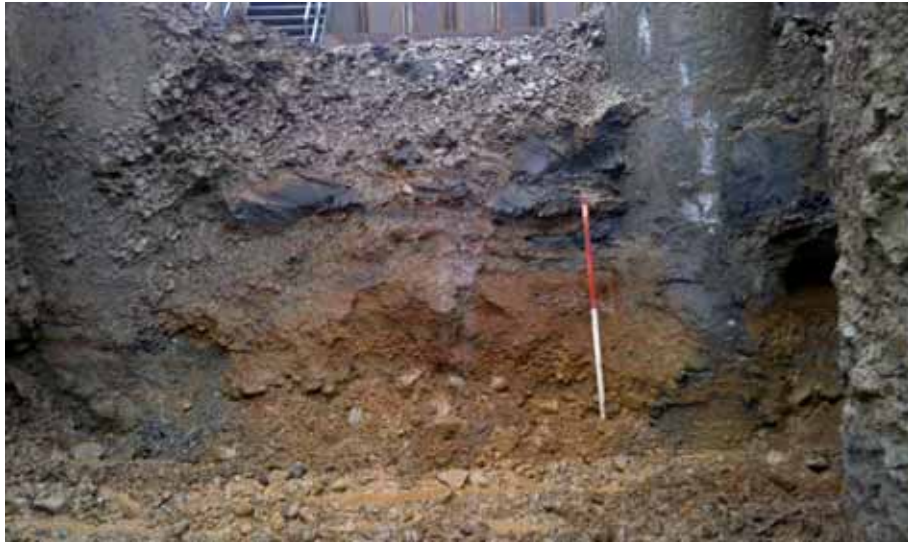
Plate 11: Uppermost deposit **3027** and layers of deposits beneath, exposed during final ground reduction in Area C

sand with 60% pebbles and small stones. Levelling deposit **3027** was a dark brownish-grey compact silty-clay containing 80% inclusions of small stones, pebbles, angular fragments of stone and fragments of brick (Plate 11). The depths of deposits **3016** and **3027** were shallower at the northern side of the site and deeper on the southern or riverside of the site. Large granite rocks, **3015**, had been deposited along the riverbank following demolition to protect the area from erosion by the river. The area had been levelled with **3002**, rubble that comprised dark greyish-brown loose sandy-silt with 60% inclusions of fragments of red sandstone, concrete, brick and cobbles. The depth of this deposit varied. A hard standing, **3001**, a medium pinkish-brown sandy-silt with fragments of tarmac, small stones and fragments of concrete, about 0.2m thick, lay above **3002**. The final levelling layer was **3000**, a poor quality topsoil that was dark brownish-grey clayey-silt, with 20% gravel and small water-rounded pebbles of approximate depth of 0.2m.
