STUBBYLEE BARN, BACUP,

LANCASHIRE

Building Survey Report

June 2012

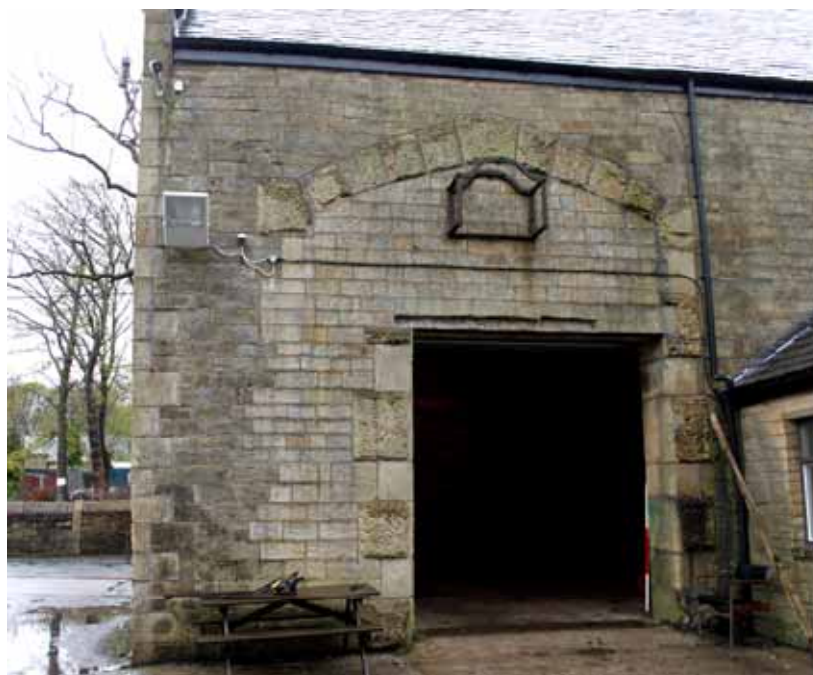
Plate 1: South-western carriage entrance to the barn

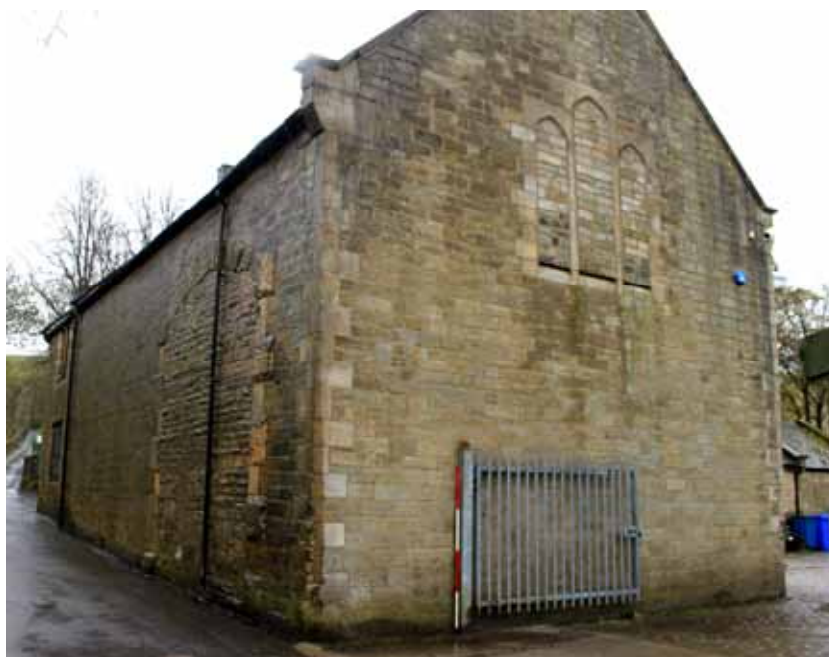
Plate 2: North-west gable elevation of the barn showing the blocked lancet window

3.3.2 The north-western gable contains a triple lancet window, placed centrally, the base of which is at approximately the height of the wagon doors in the long walls (Plate 2). It is of ashlar construction with square-section mullions, chamfered sills and single-piece four-centred lintels. The windows are all blocked with similar stone to that used to block the north-eastern wagon door (Plates 1 and 11). A vertically set stone in the top of the central, raised lancet, strongly suggests that an owl hole was incorporated within the original blocking of the window, and has only been blocked more recently. Both gables of the barn have ashlar coped kneelers (Plates 2 and 15), with raised chamfered copings forming a low parapet to the ridge (Plate 15).

- 4.1.6 The distinctive arrangement of three arched lancet windows, with outer quoined stones and two inner mullions, may actually be inspired by ecclesiastical architecture. The presence of an earlier chapel has not been uncovered by the map and archive survey; however, Fishwick (1889, 514) makes reference to stones lying about the yard 'about the premises are several loose stones, tops of pillars, window arches etc which belonged to the older edifice'. This may suggest that the window arrangement may have been recycled from remnants of the 1872 renovations. It is also possible that the window arches were remnants from the building of St. Saviour's Church in 1864-5 which James Maden Holt financed and oversaw, although the two architectural styles are not comparable.

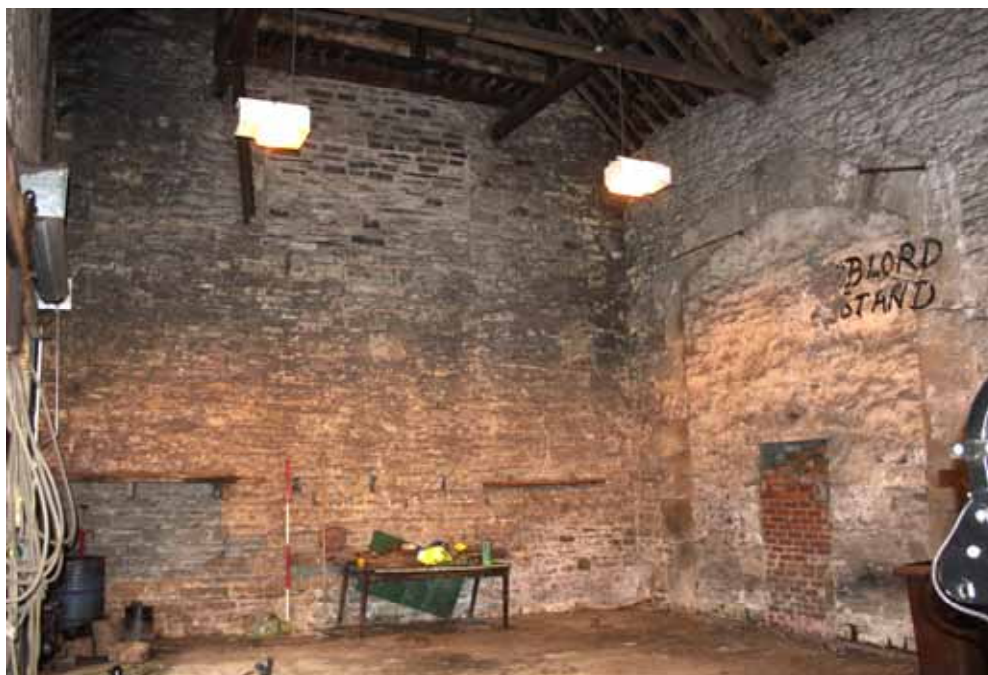
3.4.1 Internally the barn is almost devoid of features (Plate 16). The north-western 5m retains a sandstone flag floor, although the precise metric distance suggests that this may have been relaid during the recent renovation of the barn. A 6.2m² area of edge-set sandstone cobbles, adjacent to the south-western wagon door (Plate 14), probably represents a repair of the original flooring of the passageway between the two wagon doors. Elsewhere the floor has been replaced with a concrete skim. The north-western gable contains a triple lancet window, and is described above (Section 3.3.2) (Plate 3).

Plate 3: The north-west internal elevation of the barn, and the blocked north-eastern carriage entrance

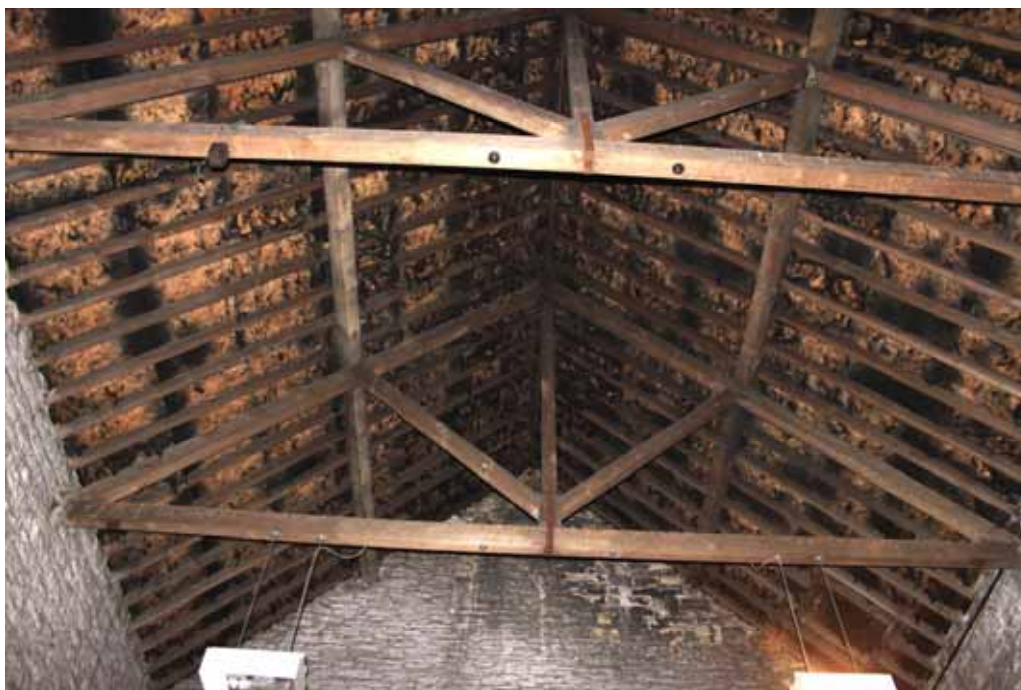
- 3.4.3 The pitched roof comprised three king post trusses, each with slender posts, jowled to receive the braces and principal rafters (Fig 12; Plate 4). The slender ridge board, typical of Victorian roofs, was clasped by the king post, and was butted by the rafters, which were carried on a single square-section purlin to each pitch, which was trenched into each principal rafter, and quite possibly butt-jointed in the same position. All joints into the tie beam were bolted, with an additional stirrup placed around the tie beam below the king post. The slate roof has recently been refurbished and comprises fibre-wool insulation below felt and bitumen, sealing the underside of the undiagnostic, almost certainly imported slate that was laid in regular coursing.

Plate 4: The barn roof structure

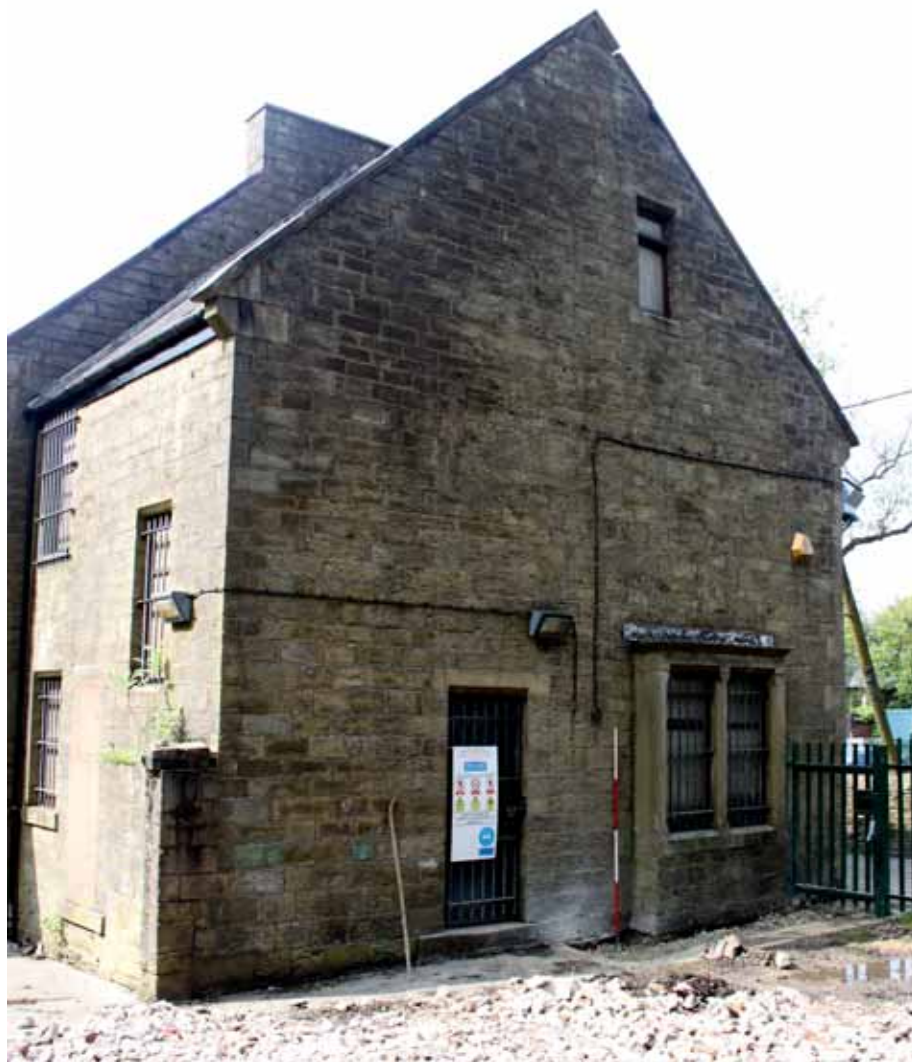
Plate 5: South-eastern gable elevation of the cottage

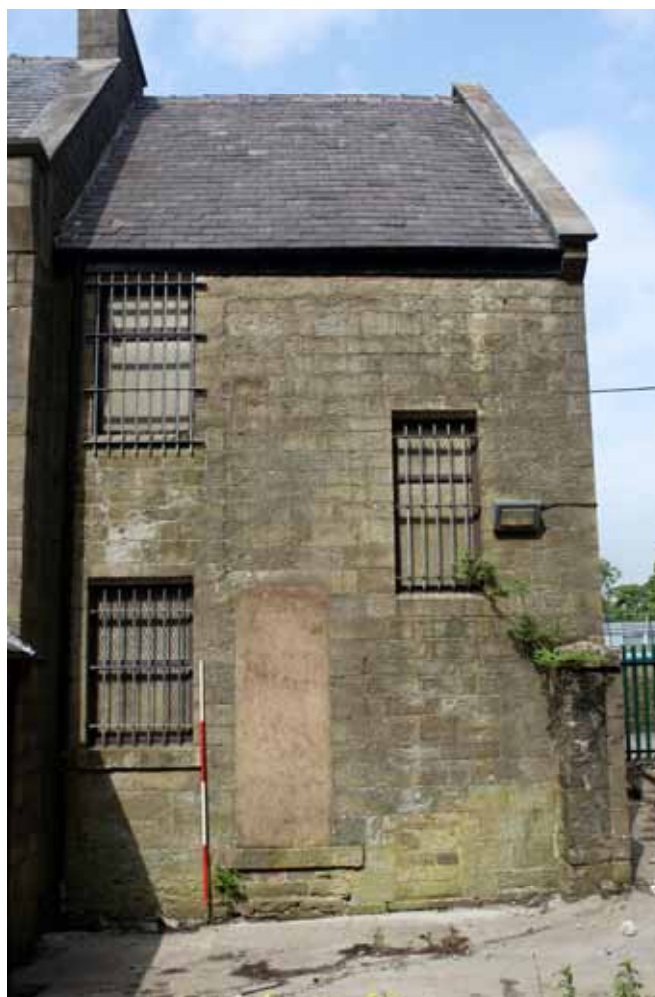
- 3.5.1 **External:** the south-eastern 12' (3.66m) section of the barn building was a two storeyed domestic cottage (Rooms G1-4) that was narrower than the barn (Fig 11). The north-eastern elevation had chamfered mullioned windows to both floors; the mullion on the ground floor having been lost. Both windows have been replaced, most probably in the late twentieth century, and would almost certainly have housed sash windows. The principal, south-eastern elevation has an offset doorway, flanked by a projecting bay window with similar surrounds to those on the south-eastern wall (Plates 5 and 18). A small plain window afforded light into the attic in the south-eastern side of the gable. The south-western elevation had simple windows, which again almost certainly originally housed vertical sashes, above projecting sandstone sills (Plate 6). These are very typical of the region in this period. A similar window afforded light to the stairwell on the south-western elevation; a doorway, placed above ground level with a projecting threshold (Plate 6) originally afforded access to the property but has subsequently been blocked and rendered externally. A 21" (0.53m) wide, stone-blocked aperture adjacent to the door at ground level (Fig 11; Plate 6) was almost certainly a coal-hole.

Plate 6: South-western elevation of the cottage

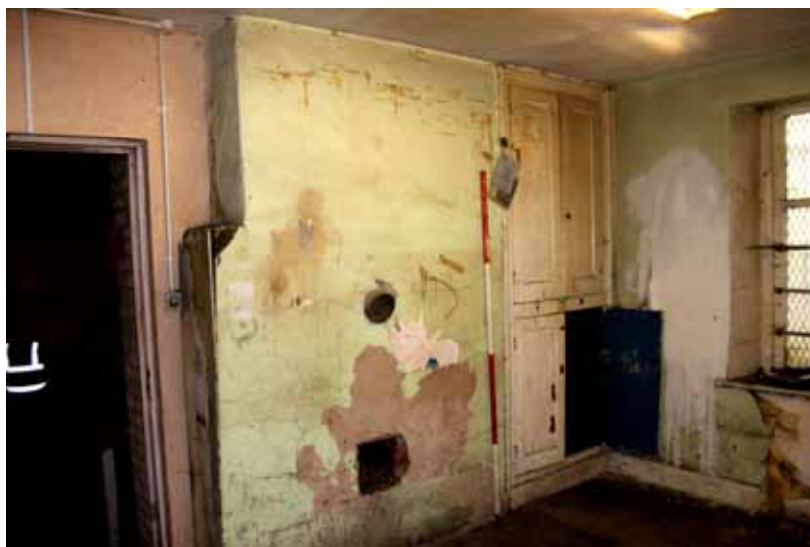
Plate 7: Room G3 of the cottage looking north

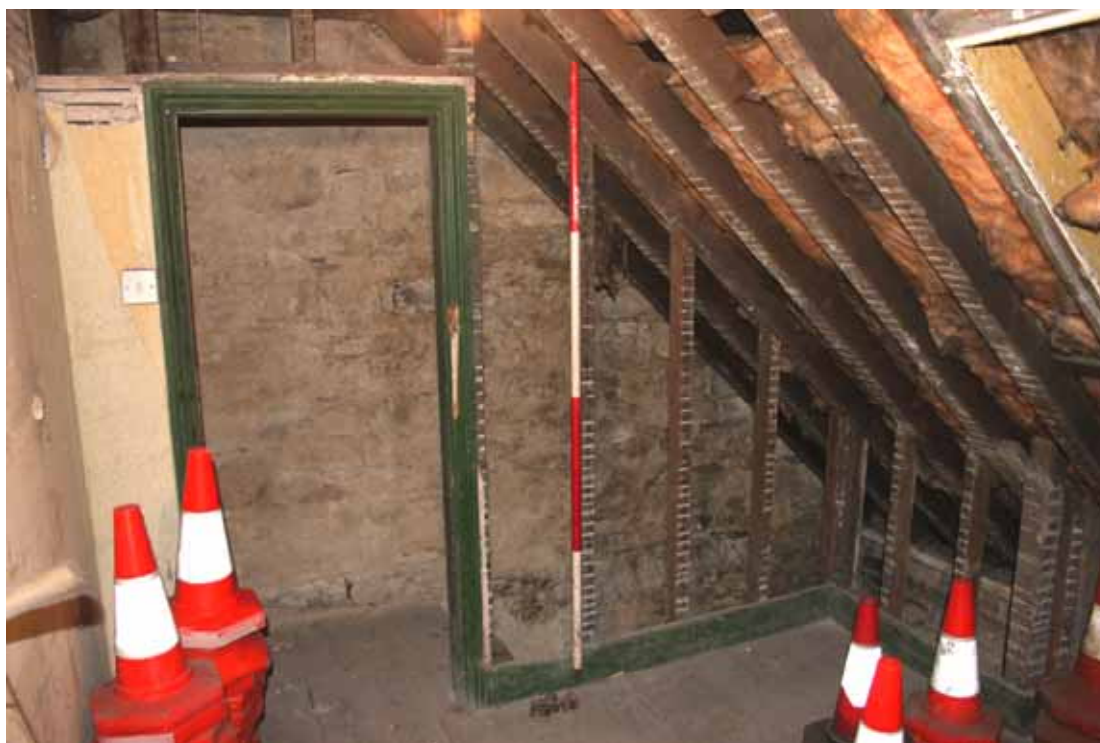
- 3.5.10 **Attic:** the staircase rose to the attic space, which was used for accommodation, and was similarly split into two rooms (Plate 8). However, unlike the floors below, the attic partitions were constructed of timber stud framing, with a lath and plaster covering. The roof was constructed of simple common rafter trusses, without collars, and with the slender tie beams forming the floor joist of the attic space. This enabled the roof space to be utilised as further accommodation, without hindrance from roof timbers. Both flues against the north-western wall raked to the centre of the wall, where they rose in a single four-pot chimney stack; the chimney pots have subsequently been lost. Neither room had fireplaces set into the chimney breast. The eaves were partitioned from the room by simple lath and plaster stud walls on both pitches, immediately below the lower of a pair of purlins to each pitch. The ceilings were of similar construction.

Plate 8: Attic interior looking south-west

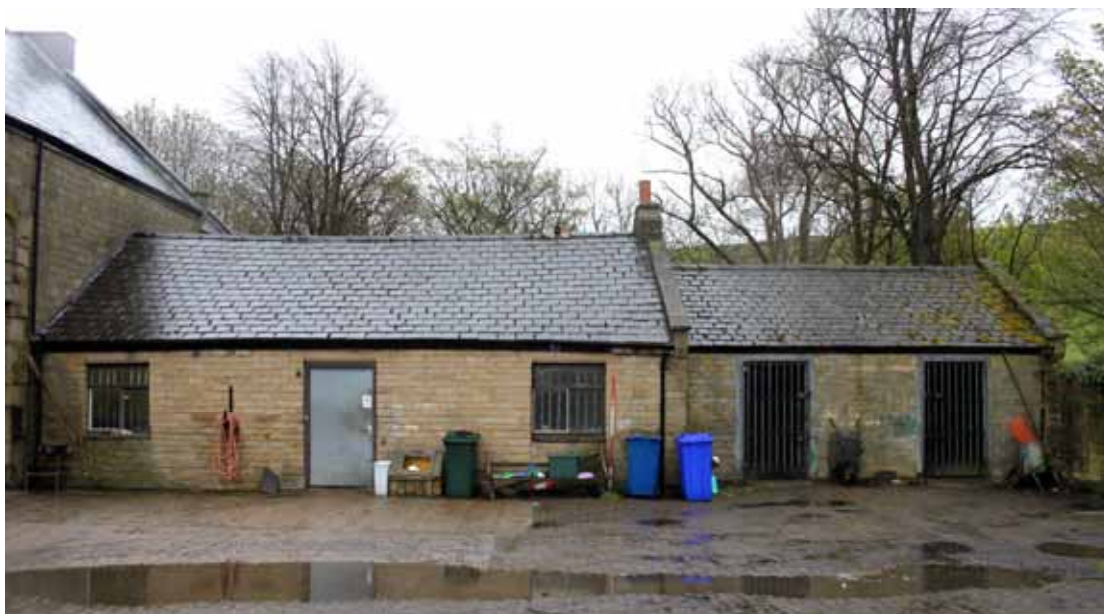
Plate 9: North-west elevation of Buildings B and C

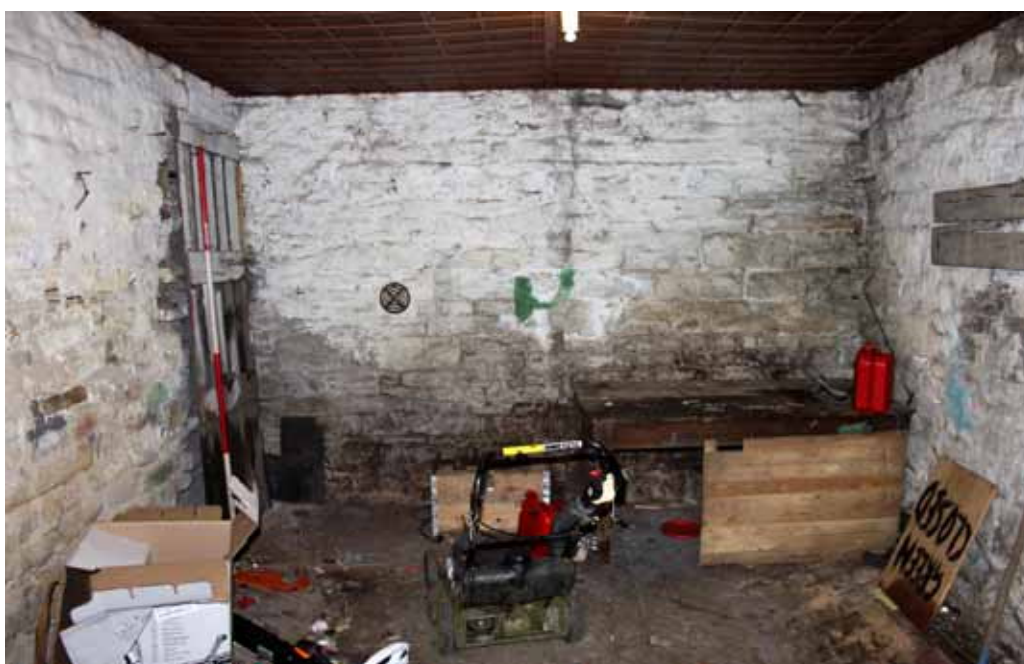
- 3.7.2 The only surviving entrance into south-western room was from the courtyard, with the doorway into the adjacent room being very roughly blocked (Plate 10). Although the floor was of concrete, it retained two drainage channels, or manuring passages, suggesting that this room formerly had two stalls, or possibly a stall and a loose box, given the original access from the adjacent room.

Plate 10: The south-western room of Building C looking south-east

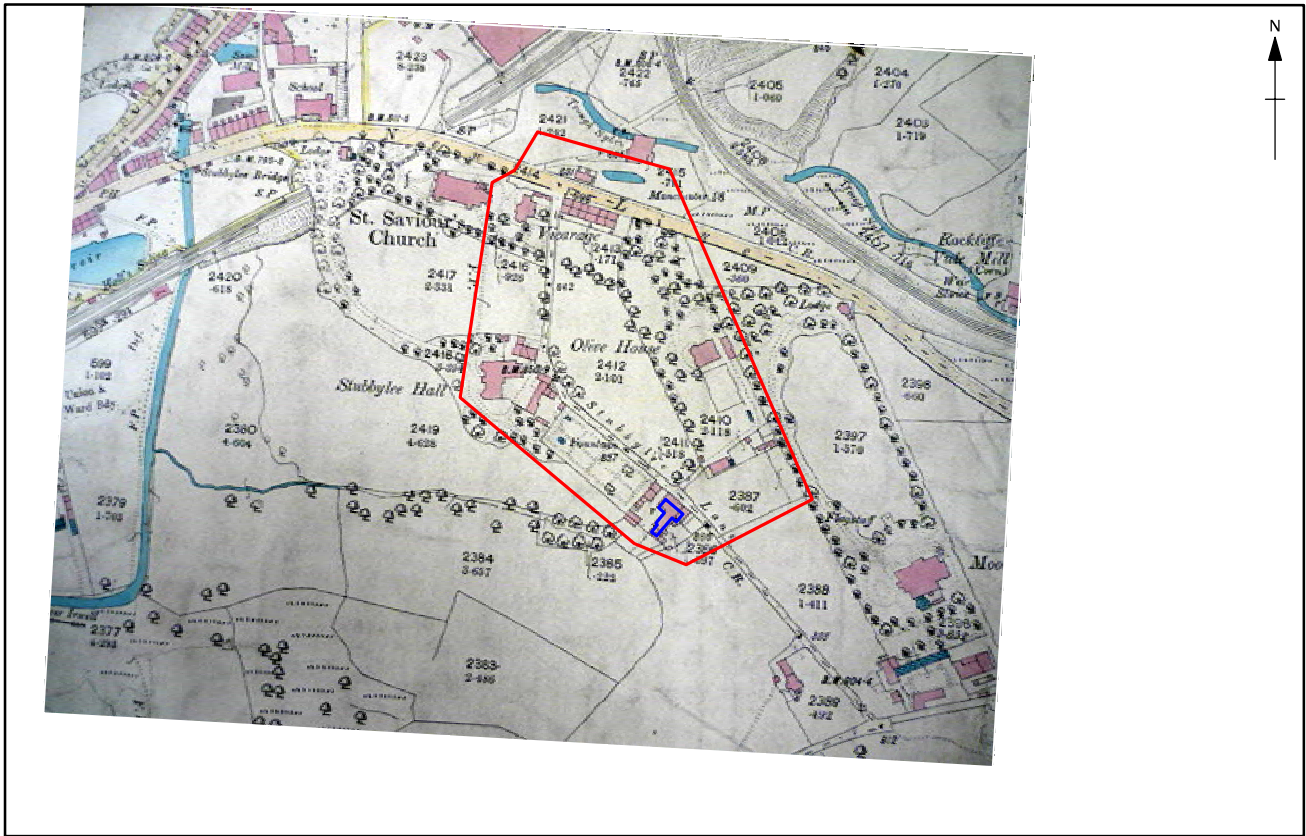
Figure 6: Extract from the Ordnance Survey map, 25" to 1 mile, 1893

- 1.4.5 The 1893 25" edition (Fig 6) clearly shows the 'barn' complex albeit as unlabelled buildings; it comprises an informal quadrangle arranged around an irregular central courtyard with three entrances. The building now known as the 'Barn' is on the north-eastern end of the 'T' shaped building, and on the north-western edge of the plot lay other small square buildings, perhaps sheds, butting against the garden wall. This map also shows the formal paths and flowerbeds of the garden.

- 1.4.10 There seem to be slight differences through time in the shape of the building that is now known as the 'Barn; The building depicted in the two earlier 1: 2,500 maps of 1893 (Fig 6) and 1910 (Fig 8) showed an approximately north-east/south-west L-shaped building with a small eastern abutment. The 1961-4 1:2,500 map (Fig 10) omits the internal line that defined the eastern abutment, but it is probable that this can be attributed to differences in cartography rather than changes to the building.

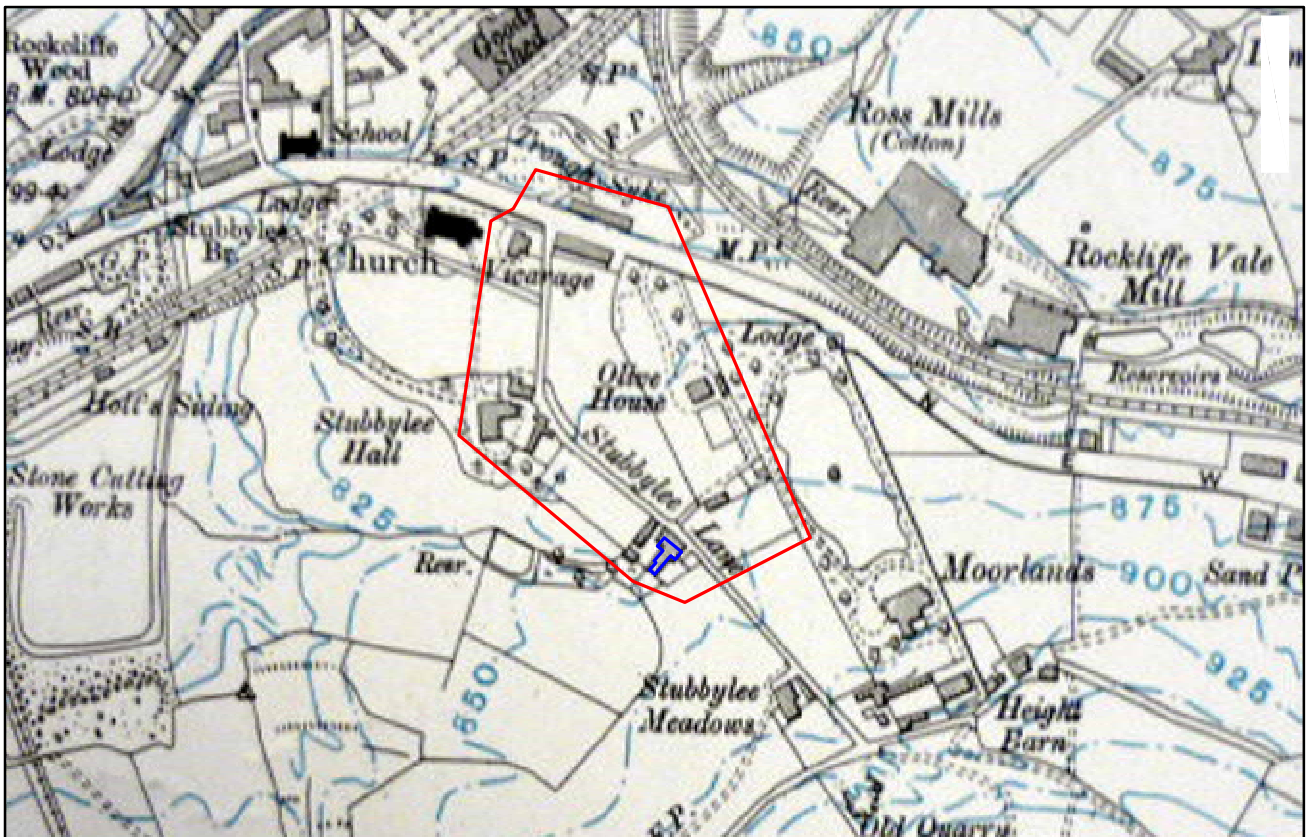
Figure 7: Extract from the Ordnance Survey map, 6" to 1 mile, 1909

- 1.4.6 The 1909 (Fig 7) and 1910 (Fig 8) edition maps were published prior to the donation of the Hall to the Municipal Council and showed a similar plan to that of 1893. They still included all the earlier buildings to the south-east of the garden, which were again unlabelled, although the 1910 map does show the building outline and internal subdivisions in a greater level of detail than many of the previous historic maps.

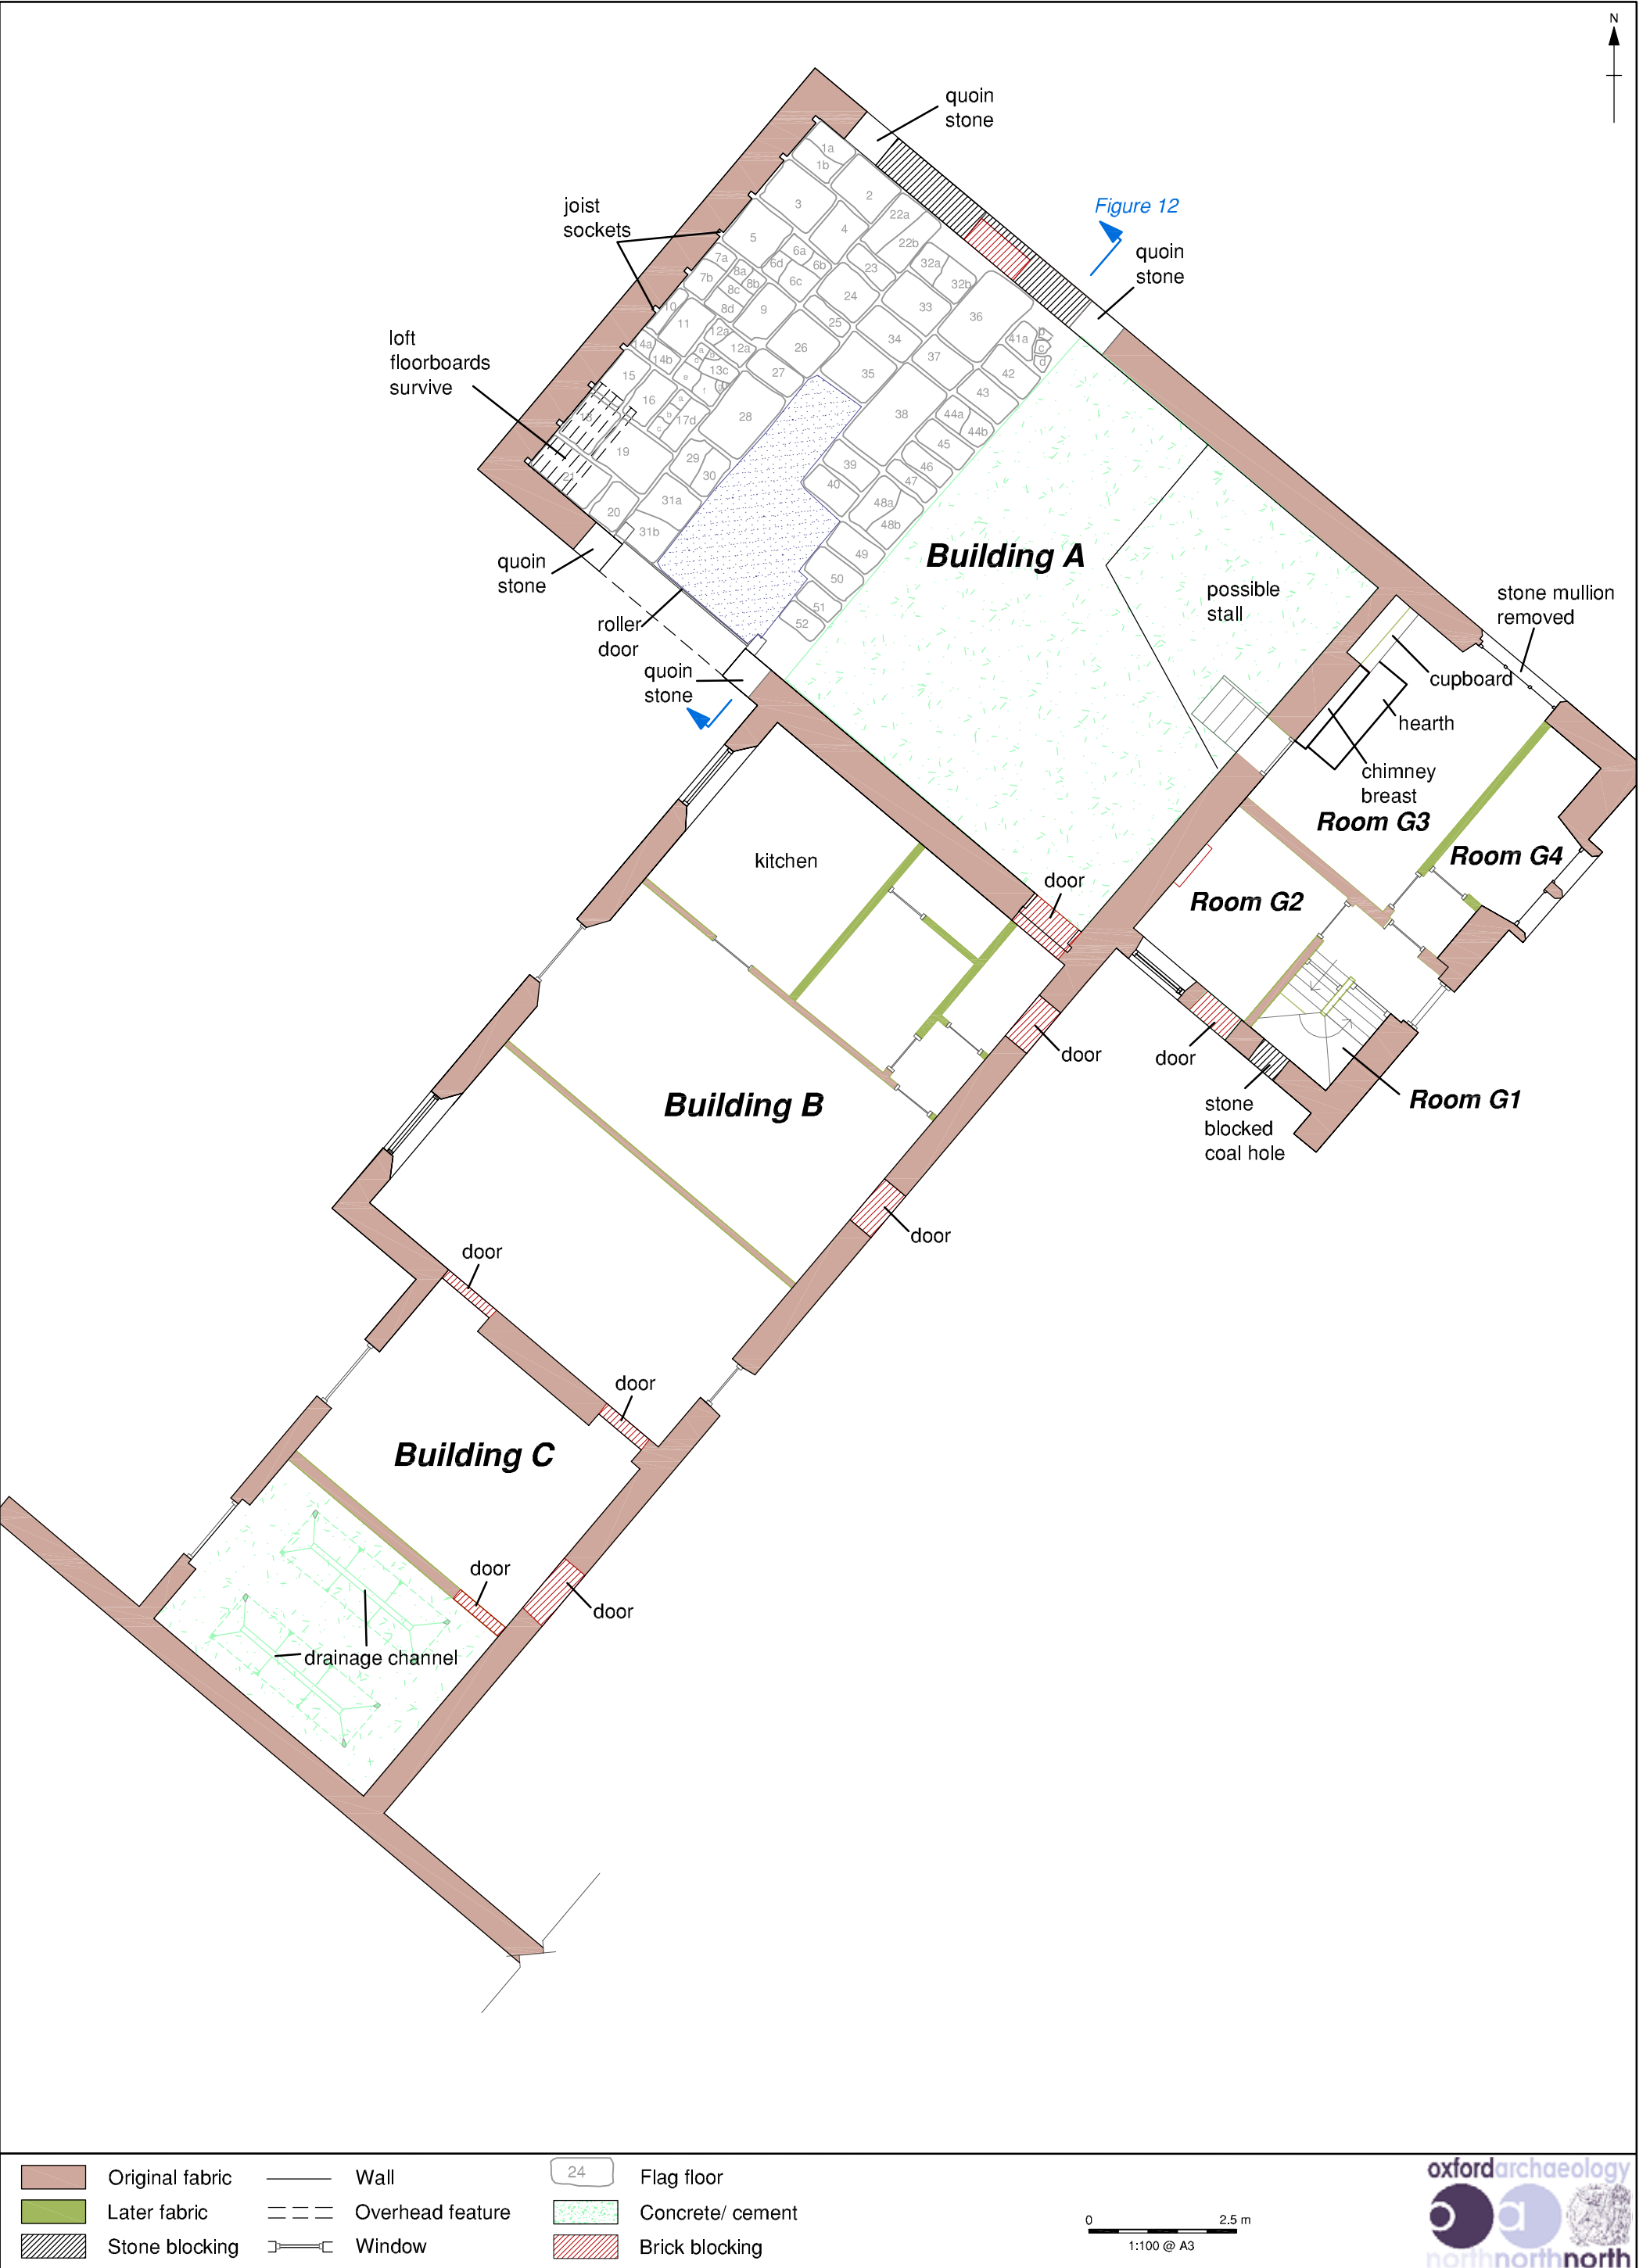
Figure 11: Ground floor plan of Stubblee Barn

- 2.3.4 **Slab Plan:** a plan of the floor slabs in Building A was produced by the client (AA Projects) and has been incorporated into the main ground floor plan (Fig 11). At the request of the planning authority the floor slabs were lifted, numbered and stored for potential reuse at the site. The numbers were marked in paint on the reverse of each slab and the number is depicted on Figure 11. Following the removal of the slabs a pair of adjacent, stone sided, square voids were revealed in front of the south-western carriage entrance. Photographs of the voids have been incorporated into the present report but, they were not examined as part of the present archaeological recording programme, and have not been planned.

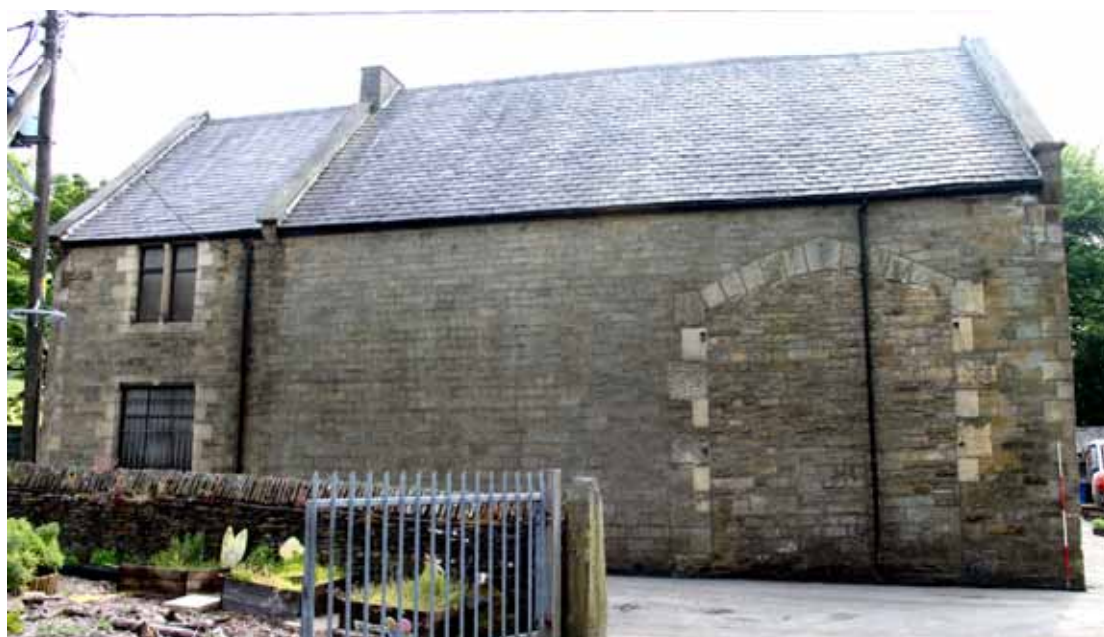
Plate 11: North-eastern elevation of Building A showing blocked coach doorway

- 4.2.2 **Building A:** in subsequent uses of the building the very large carriage doors were superfluous, and that to the north-east was blocked, while that to the south-west was substantially reduced in size. Initially this restricted aperture was provided with a sliding door, but this was subsequently modified with a large mechanised roller-shutter. The three lancet windows were latterly blocked, possibly at the same time as the south-western carriage door was narrowed as the blocking materials are similar. The floor has been subject to repairs and replacements with the original sandstone slabs surviving on the surface only at the north-western end; elsewhere it has been repaired with cobbles or had a concrete skim applied.

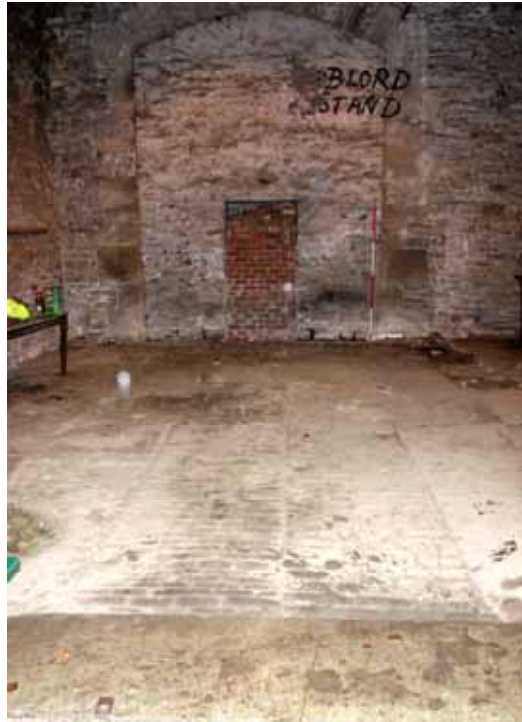
subsequently with stone facing, and with machine-made brick internally (Fig 11; Plate 13), suggesting a late twentieth-century date for this final intervention. The south-western doorway is more heavily remodelled, having been reduced to a width of only 9' (2.74m (Fig 11; Plate 1)). This was undertaken using dressed sandstone blocks, with the original quoins reused below the inserted I-section steel lintel, which was externally faced with stone. The style and quality of this remodelling suggests a late twentieth-century date, almost certainly related to the replacement of an earlier sliding timber door (Plate 14) with a more secure mechanised roller-shutter.

Plate 13: internal face of the blocked north-eastern carriage entrance of the barn

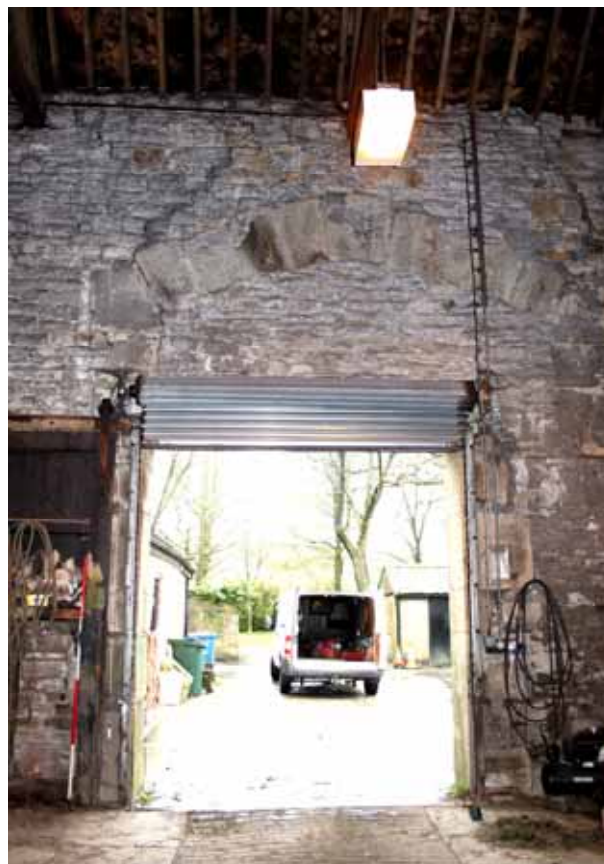
Plate 14: Internal face of the partially blocked south-western carriage entrance of the barn

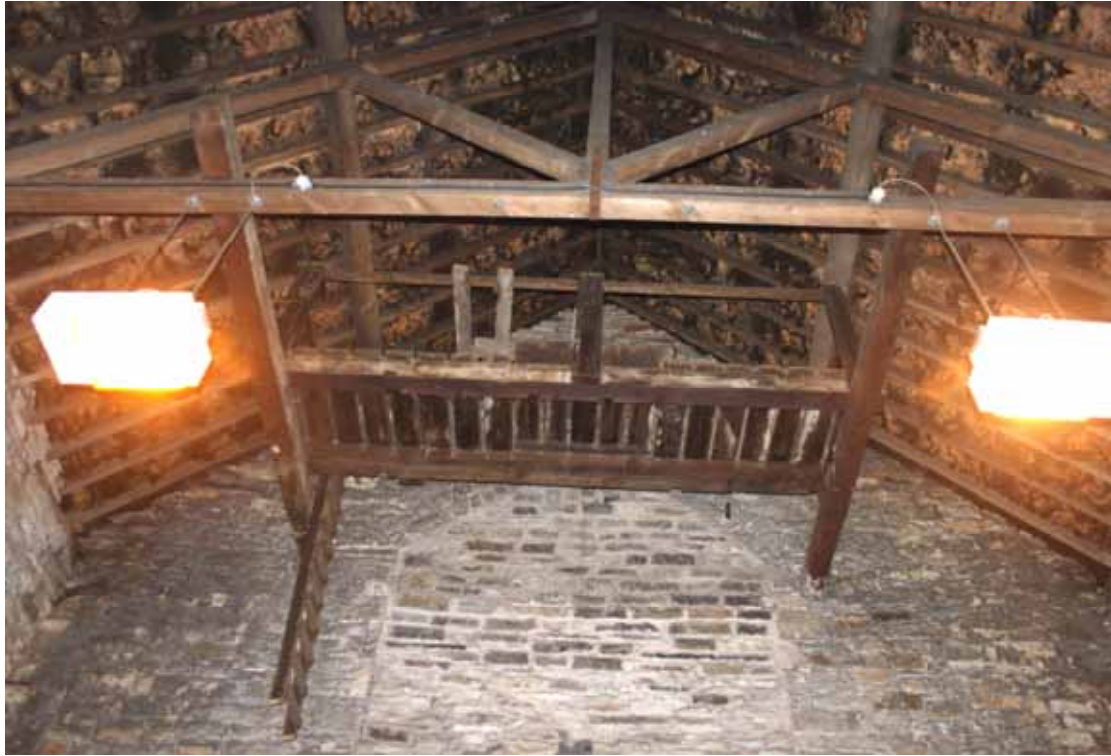
level, and comprised two beams from the tie beam, socketed into the gable wall, carrying the rails of the gantry. The deck was formed of slightly separated timber planks, and posts placed at either end, and the mid-section, supported a slender handrail. The purpose for the gantry is unclear.

Plate 17: Wooden gantry set into the roof space of the north-western end of the barn

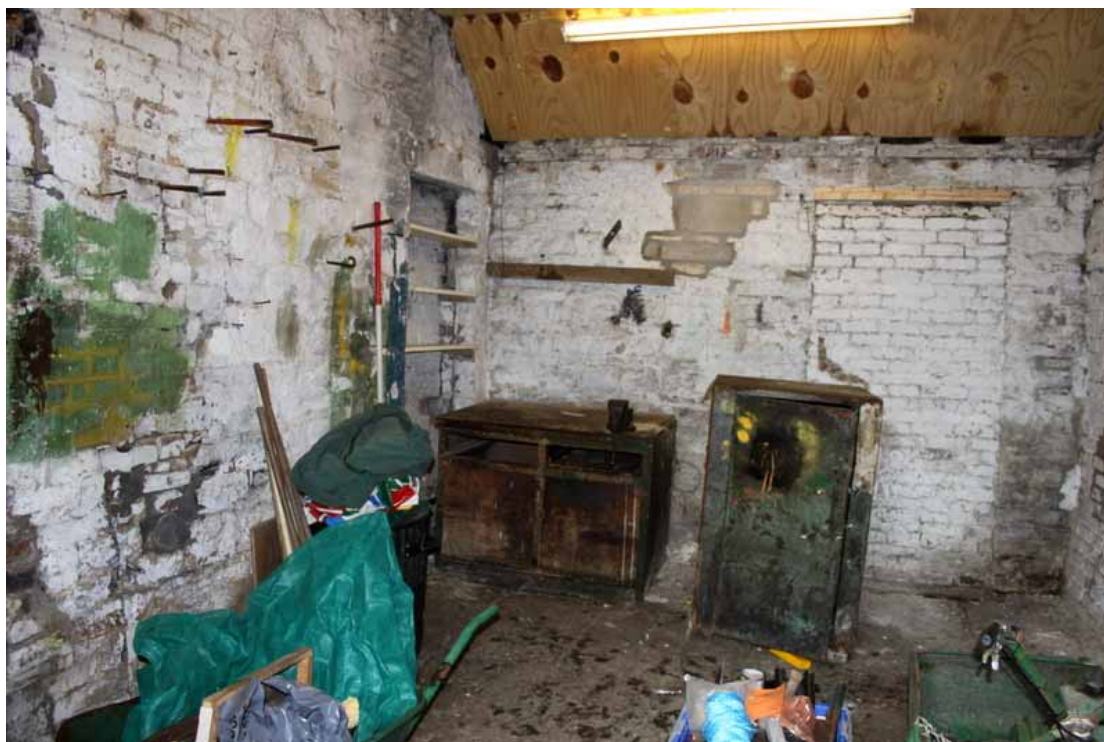
Plate 21: North-eastern room of Building C, looking east

- 3.7.1 This building was narrower than Building B, to the north-east, but was of contemporary construction, having a continuous rear, south-eastern wall (Fig 11; Plate 25). It comprised two small rooms, the north-eastern of which had two communicating doorways at either end of the wall into Building B (Plate 21), and further doorways in the north-east and south-west walls. All, bar that into the courtyard, had been blocked subsequently with brick (Plates 22 and 25), that in the south-east wall being faced externally with stone.

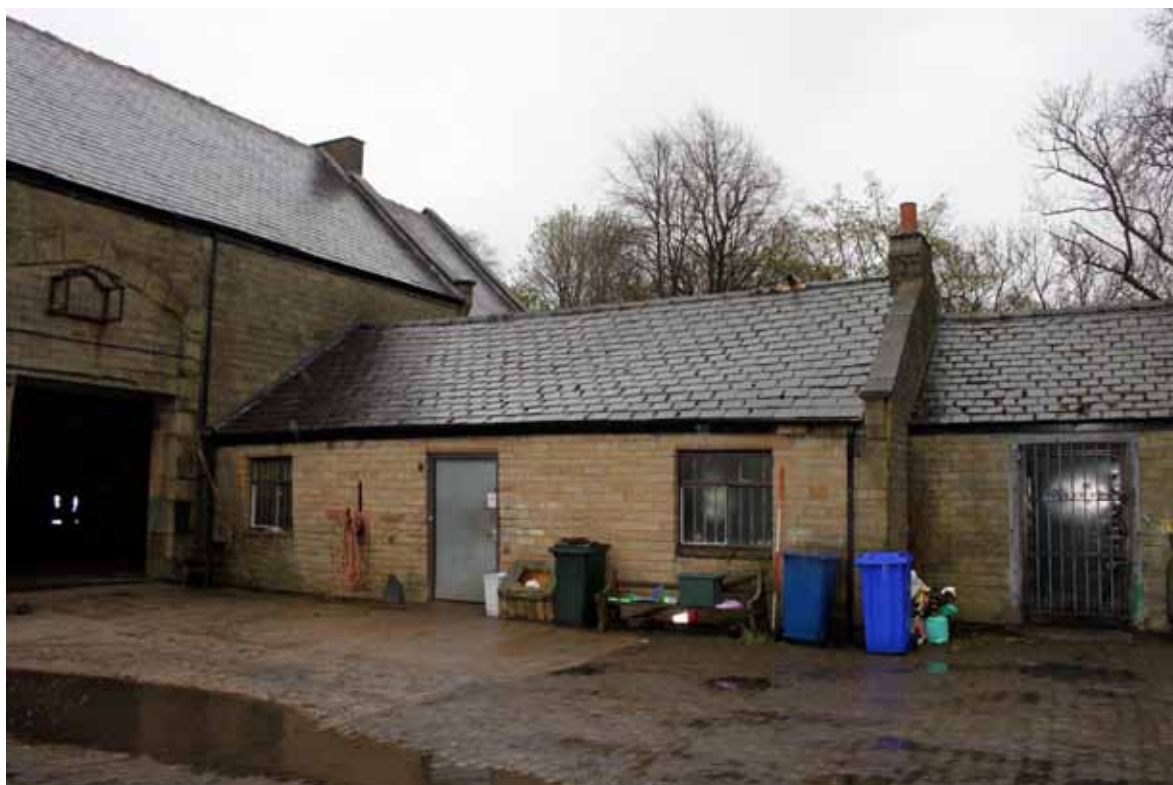
Plate 22: North-west elevation of Buildings B and C

3.6.1 This single storey structure represents a contemporary building to the main barn and dwelling to the south-east, and was constructed perpendicular to Building A, to form a T-shaped plan (Fig 11). The building comprised three rooms, all with communicating doorways, and originally with doorways in the north-west and south-east external walls, affording access into both the northern courtyard and a probable yard to the south-east. All but two of these doorways have since been blocked, with the doorways from the courtyard into the outer rooms of the building being remodelled to form windows (Plates 9 and 22), whilst the central doorway was retained (Plate 23).

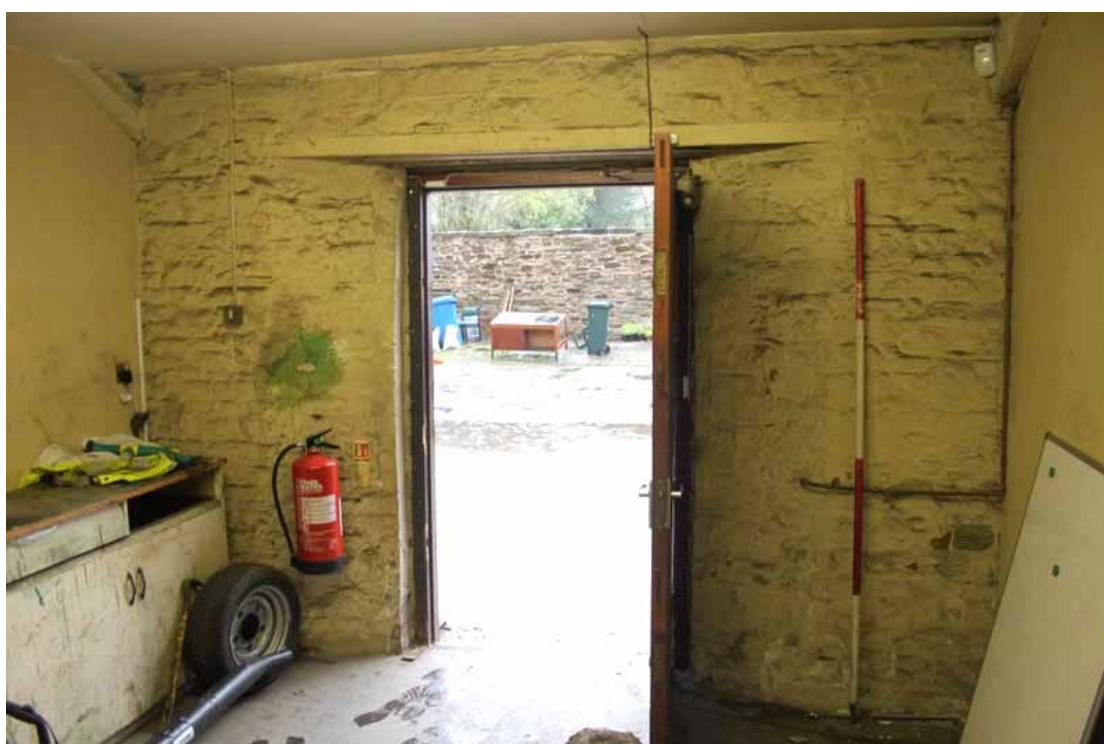
Plate 24: Central room of building B looking north-west

- 3.6.2 Internally this doorway had heavily splayed jambs (Plate 24), suggesting that a narrow access was required, possibly around internal stalling partitions. The south-western room retained a doorway to the yard to the south-east, and had two further blocked doorways in the south-western wall into Building C. A chimney stack, retaining a single cylindrical clay pot, survived above the south-western gable, with the flue from a blocked fireplace incorporated into the wall thickness below. An exposed horizontal pipe suggests that the fireplace was blocked for the insertion of a gas heater.

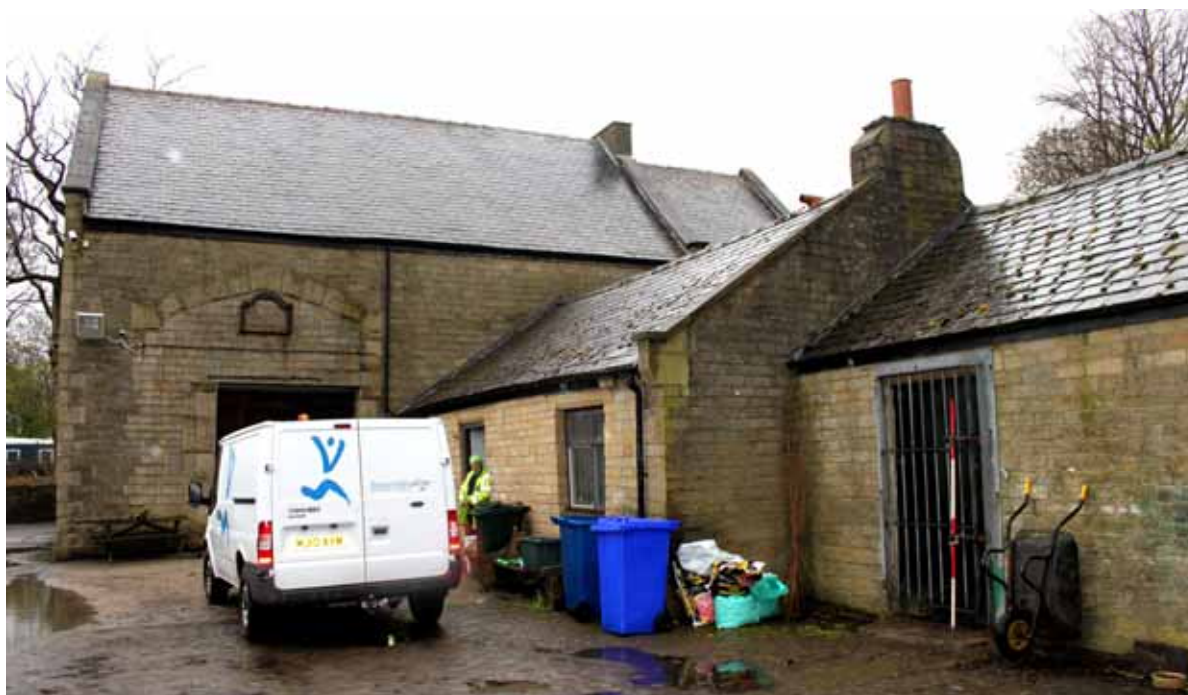
Plate 26: Buildings A, B and C looking North-East

3.2.2 The barn (Building A) comprises two distinct elements: a large open-plan area, comprising approximately 75% of the north-eastern end of the structure, and a two-storey dwelling at its south-western end, which is slightly narrower on its rear face and has a lower roof (Plate 26). The two elements appear contemporary, as do the single storey structures (Buildings B and C) to the south-west, and the boundary wall. This is clearly demonstrated at the south-western return of the south-west wall of the barn, where the adjoining building (Building B) is keyed into the return elevations, with the quoins of the barn commencing immediately above the roofline of the lower structure (Plate 12). This arrangement would represent an unfeasible amount of remodelling for the addition of a single storey extension, which could have simply been built against the external face of the barn, and it is therefore probable that they were constructed at the same time.

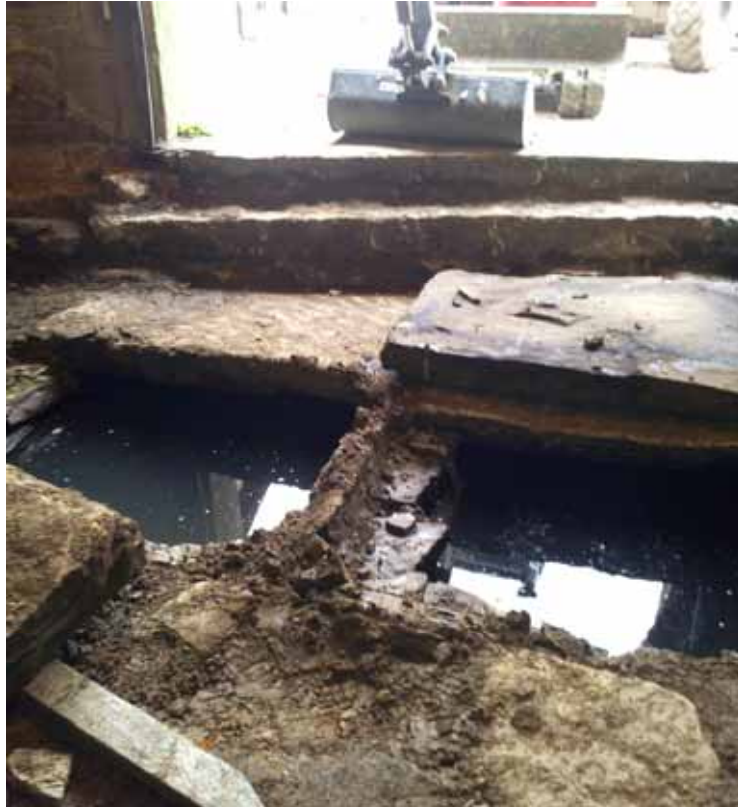
Plate 27: Water-filled voids discovered beneath the floor in front of the south-western carriage entrance of Buildings A
