STUBBYLEE BARN, BACUP,

LANCASHIRE

Building Survey Report

June 2012

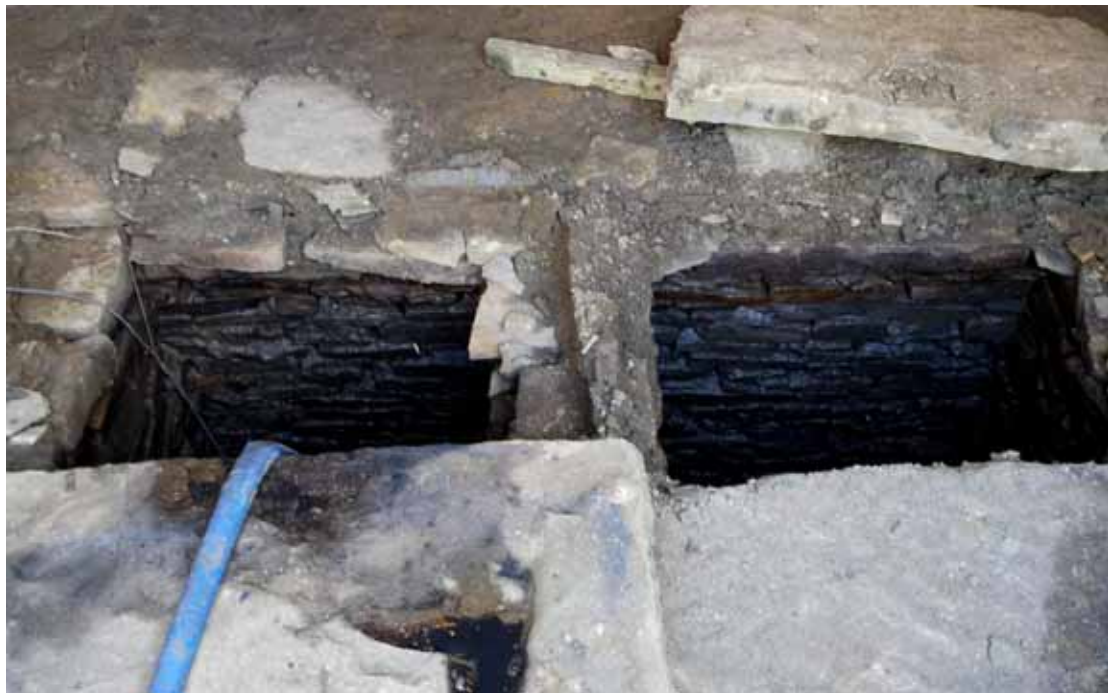
Plate 28: The voids looking north-east following removal of water

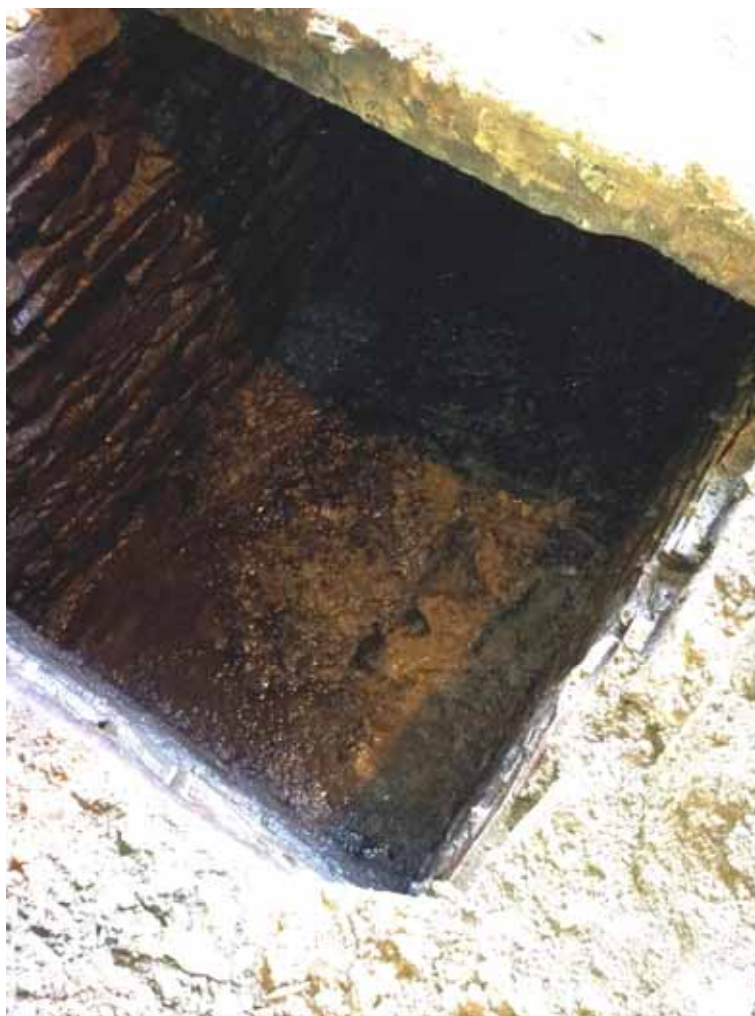
Plate 29: The interior of one of the rectangular stone lined voids.
