Abbeytown Wastewater Treatment Works, Revised Pipeline Route, Cumbria

Archaeological Watching Brief

Oxford Archaeology North

September 2011

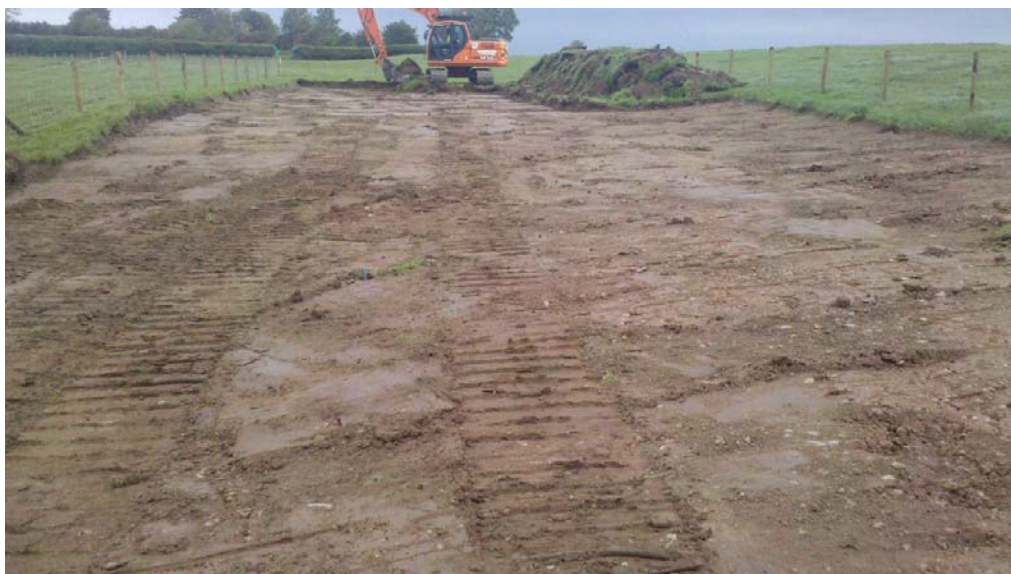
- 4.1.2 **Results:** the topsoil varied between approximately 0.2m and 0.4m thick and overlay a mid-grey and orange deposit of natural clay. The underlying natural was only occasionally exposed in small patches and a skim of topsoil remained across most of the stripped areas meaning that an intensive examination of a clean natural horizon was precluded (Plate 2).

Plate 2: A portion of the pipeline easement following the removal of topsoil

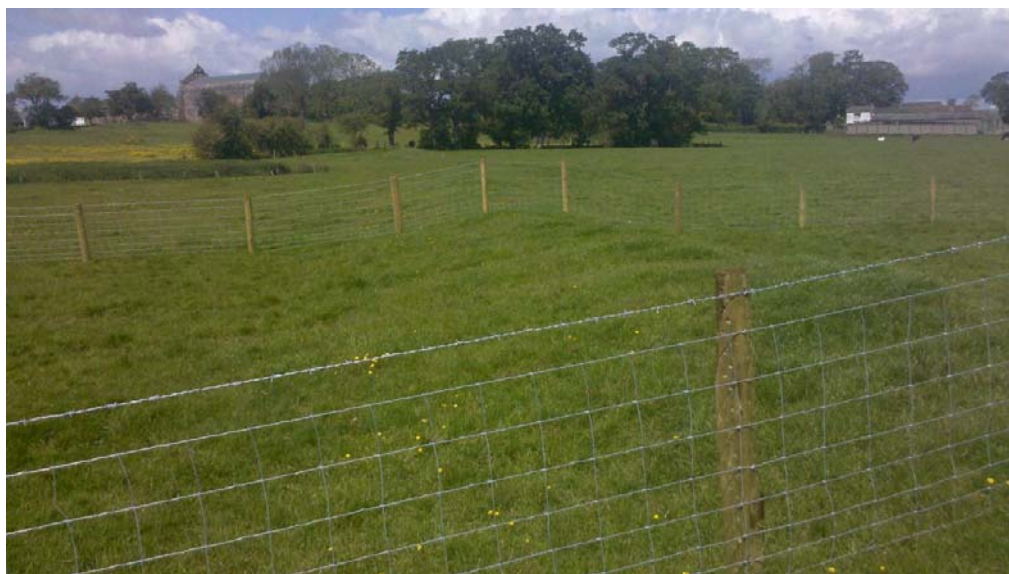
- 4.1.3 A linear bank was observed within the path of the easement to the east of St Mary's Church. The bank measured approximately 7-8m wide and 0.7m high and was aligned south-east/north-west (Plate 3; Fig 2). When the topsoil was removed in this area there was no clear indication of a discrete feature and only a slight rise in the level of the topsoil was observable.

Plate 3: A linear bank observed running south-east/north-west to the east of St Mary's Church

5.2.1 The only feature of possible archaeological interest that was observed within the pipeline easement comprised a raised linear bank that was aligned south-east/north-west and lay to the east of St Mary's Church (Plate 3). This feature was also visible on aerial photographs (Plates 5 and 6) as a slightly irregular linear bank that was visible running from the western side of the former Kirtlebridge, Annan, and Brayton Branch Railway and ran westwards to the boundary of the scheduled area associated with St Mary's Abbey, Holm Cultram (SM 302). A continuation of the bank appeared to lead south-west from the boundary of the scheduled area.

5.2.2 As the aerial photographs show the eastern end of the bank stopping abruptly at the former railway embankment, with no indication that it turned at this point, it appears likely that the feature was truncated by the railway and, therefore, pre-dates the establishment of the line in 1866-9 (NMR 1674). There were no field boundaries, or other corresponding features, shown in this area on the Ordnance Survey (OS) maps that were published between 1866 and the present day and it is, therefore, possible that the bank had become obsolete by the mid nineteenth century. The bank is of unknown function or date and might have been associated with activity occurring within the scheduled area (SM 302), as the westward extension of the linear passed into this area. However, in the absence of further study, it can not be ascertained whether this activity was contemporary with, or associated with, St Mary's Abbey.

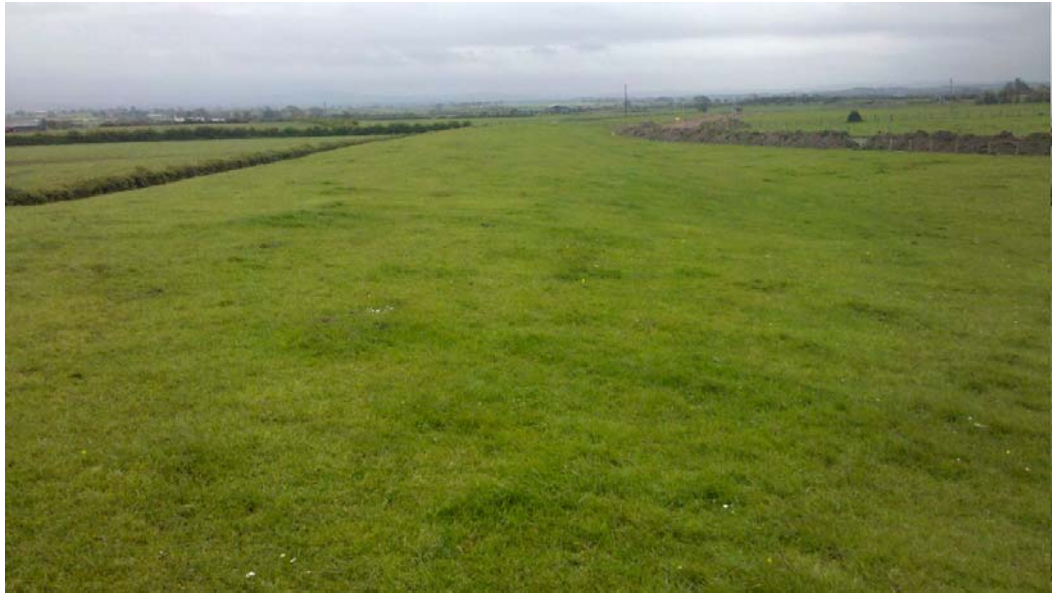
- 4.1.4 The pipeline route ran to the west of the dismantled Kirtlebridge, Annan, and Brayton Branch Railway (NMR 1674), which remains as a raised linear embankment (Plate 4), but no associated features were encountered. The pipeline route also crossed the course of the former Carlisle and Silloth Branch Railway, which was included as Gazetter Site 15 in the preceding archaeological desk-based assessment (OA North 2009). The course of the railway in this area was not indicated by visible earthworks and no associated features were identified following the removal of the topsoil. With the

Plate 4: The raised linear embankment of the former Kirtlebridge, Annan, and Brayton Branch Railway

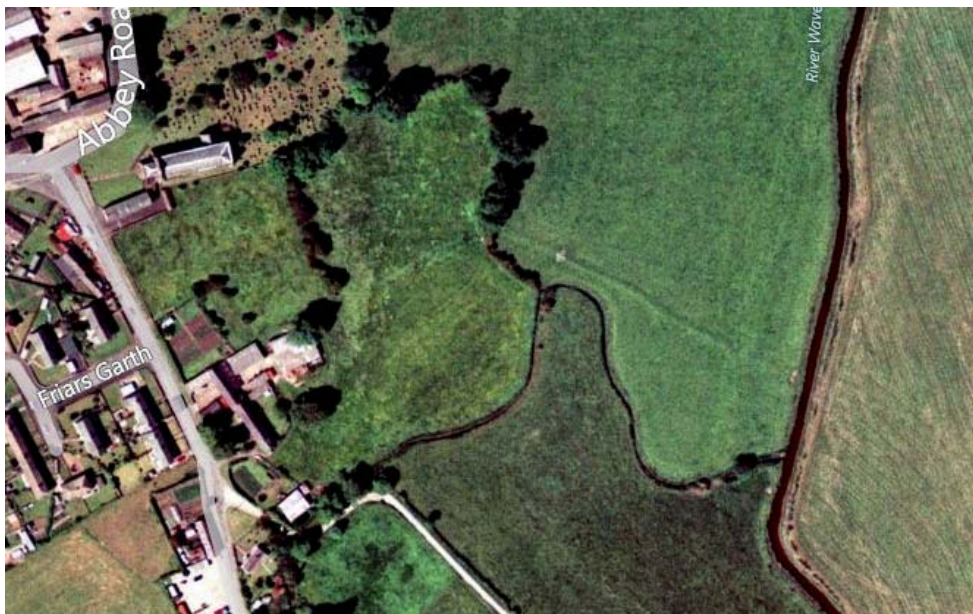
Plate 5: An aerial view of the linear bank lying to the north of the crooked Stank Beck
