## Longbyre to Gilsland, Northumberland

Archaeological Evaluation and Watching Brief Report

**Oxford Archaeology North**

March 2011

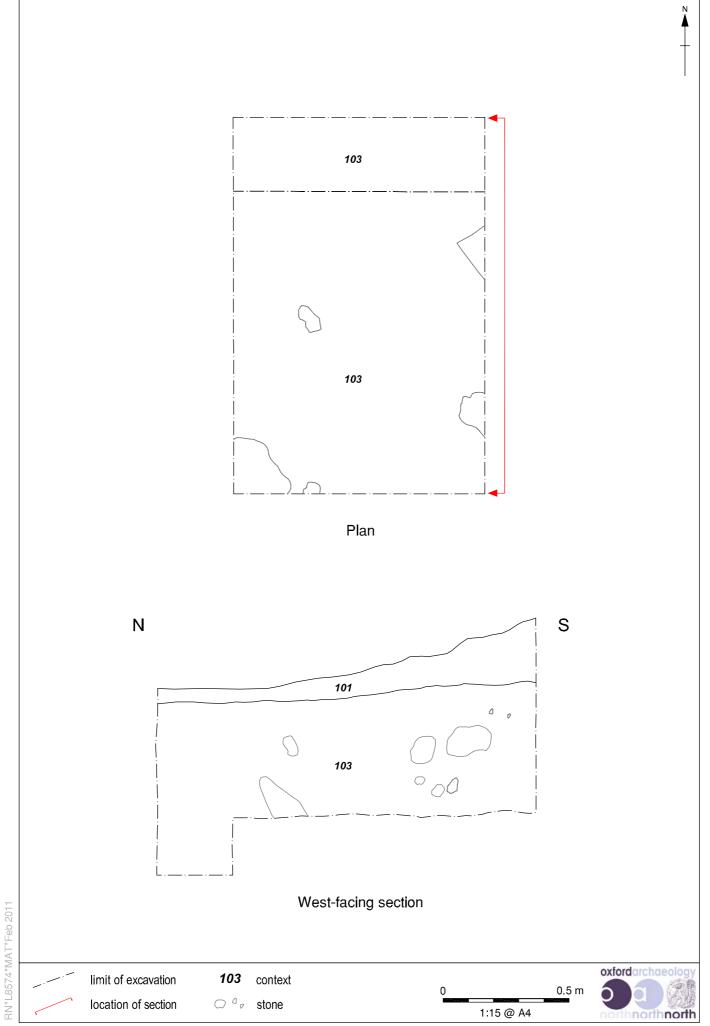
Figure 2: Plan and west-facing section of Site 1

4.2.1 The trench at Site 1 was excavated at NY 6492 6608 (Fig 1) on a north/south alignment, and measuring 1.5m by 1m (Fig 2; Plate 1), immediately to the north of Milecastle 47. Prior to the excavation, a section of the drystone boundary wall extending northwards from the boundary apparently on the line of Hadrian's Wall was dismantled to accommodate the proposed new gate, its foundation being recorded as structure 102. The trench was excavated to a maximum depth of 0.74m (Fig 2; Plate 2), through topsoil 101 and subsoil 103. A sondage was excavated into deposit 103 at the northern end of the trench, but this did not locate the natural geology. No archaeologically significant deposits were encountered within the trench, which confirms that the line of Hadrian's Wall lies to the south, presumably under the modern field wall. Given that the ground drops away steeply to the north, it can be concluded that the site is on the berm to the north of the Wall, which here has not been obviously modified.

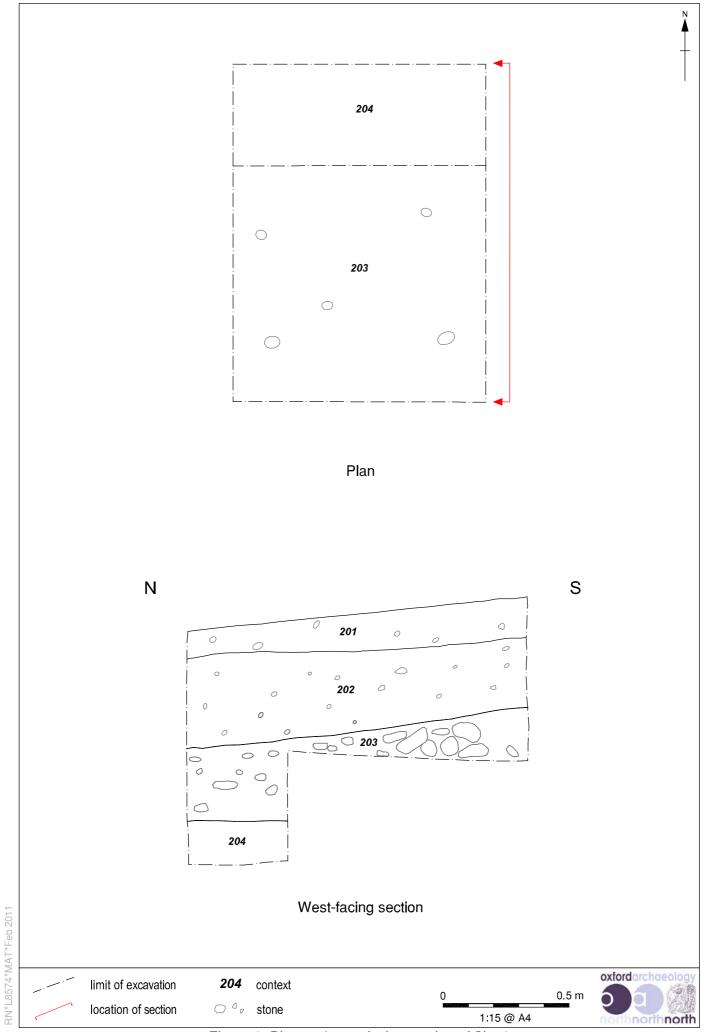
Figure 3: Plan and west-facing section of Site 2

4.3.1 The trench at Site 2 was excavated at NY 6473 6609 (Fig 1) on a north/south alignment, measuring 1.5m by 1m in size (Fig 3; Plate 3), and adjacent to Hadrian's Wall. Prior to the excavation, a section of the boundary fence extending northwards from the boundary apparently on the line of Hadrian's Wall was dismantled to accommodate the proposed new gate. The trench was excavated to a maximum depth of 0.6m, within a sondage at the northern end of the trench (Fig 3; Plate 4). Topsoil 201 was removed, following which the excavation examined three layers of fluvial deposits, 202, 203, and 204. The natural glacial geology was not located in the trench. No archaeologically significant deposits were encountered, which confirms that the line of Hadrian's Wall lies to the south, presumably under the modern field wall. Again, there was no evidence of modification to the berm.

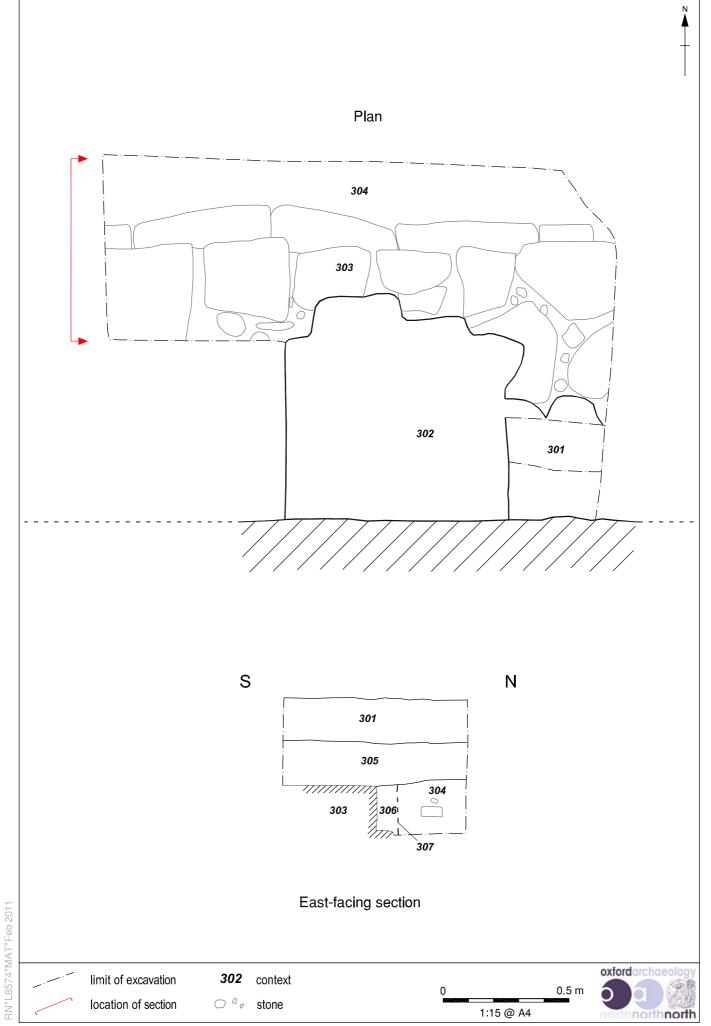
Figure 4: Plan and east-facing section of Site 3

- maximum of 0.54m deep (Fig 4; Plate 5). The trench was placed across an area of demolished north/south-aligned drystone boundary wall, 302, extending northwards from the boundary on the apparent line of Hadrian's Wall, and this had to be partially cleared prior to the excavation of the trench.

- 4.4.2 The trench was excavated through topsoil *301* and subsoil *305*, to a depth of 0.38m, whereupon the northern face of Hadrian's Wall (*303*) was encountered. Two courses of the Wall were visible. An upper course comprised random rubble, forming a rough northern side, which tapered inwards, the stones measuring a maximum of 0.35m by 0.38m by 0.19m in size. The underlying course, of which only the upper side was partially visible, appeared to comprise roughly rectangular blocks of stone, producing an even northern edge. This course projected *c* 0.20m to the north of the overlying course, the stone within it measuring up to 0.50m in length. It seemed that the stones were bonded with a soft mortar.

- 4.4.3 Layer **304**, seemingly glacial till, was encountered at a depth of 0.32m below the ground surface, to the north of Wall **303**. Some slight evidence for a construction cut (**307**) through layer **304** was identified (Fig 4; Plate 6), although it was difficult to establish with certainty in the very limited area of excavation. The backfill between the putative cut and the masonry, deposit **306**, was almost identical to deposit **304**.

- 4.4.4 The overlying drystone boundary wall, *302*, had evidently been constructed directly onto the remains of Hadrian's Wall (Fig 4; Plate 7), as had the east/west-aligned boundary wall, still standing in a good state of repair. This seems to have been constructed over the southern side of Hadrian's Wall.

- 6.1.2 At Site 3, the north face of the Stone Wall was located at a depth of 0.38m below the present ground surface. The foundations of the existing post-medieval boundary walls were found to have been built directly on top of the surviving Roman stonework. It is likely that the existing east to west boundary wall follows the line of the Wall, and was constructed directly upon the denuded remains of its south face.

- 6.1.3 Two courses of masonry were observed, the north face of the uppermost seemingly being offset to the south by 0.2m. The larger dressed stones in the lower course appear to have formed part of the Wall foundation, and may have been set in a shallow construction trench, rather than being laid directly on the ground, though this was not entirely certain. Both forms of construction have been attested by excavation at other sites (Breeze 2006, 53). Too little was seen for the remains to be characterised in more detail, but the Broad Wall foundation has been noted at several places in the sector between the River North Tyne and the River Irthing (op cit, 56-7), and a fragment of Broad Wall three courses high survives immediately west of the B6318 (op cit, 283), a little over 1km east of Site 3. The Broad Wall foundation was usually about 3.2m wide, though variations between 2.97m and 3.5m have been recorded (op cit, 53). The fragment recorded at Site 3 was up to 0.75m wide, meaning that probably some 2.22m of the foundation's full width lay beyond the investigated area, if it was indeed part of the Broad Wall foundation.

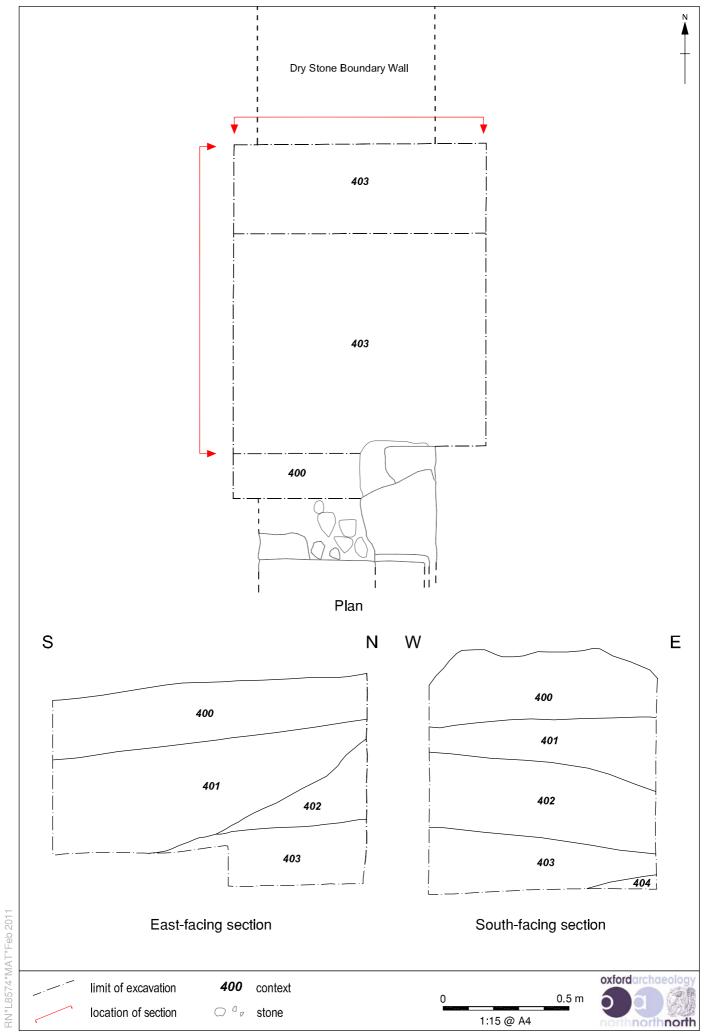
Figure 5: Plan and south-facing and east-facing sections of Site 4

- 4.5.1 The trench at Site 4 was excavated at NY 6544 6606 (Fig 1), on a north/south alignment in the vicinity of the Wall ditch, and measured 1.2m long and 1m wide (Fig 5; Plate 10). Prior to the work, part of the existing drystone boundary wall was dismantled to accommodate the proposed new gate.
- 4.5.2 Topsoil **400** was removed, following which the excavation examined a series of four deposits (Fig 5; Plate 11). These sediments, comprising largely sandy silts, clearly formed the upper fills of the Wall ditch, and predominantly

derived from surrounding eroding soils and horizons, although deposit 402 appeared to contain large quantities of small stones, presumably derived from the glacial till. There was some indication that at least some of the material was deposited from the north (Fig 5). No finds were recovered from these ditch fills, and the limited size of the excavations prevents any further interpretation.

- 6.1.4 Site 4, located just over 1km east of Site 3, was situated entirely within the Wall ditch, with neither the ditch edges nor the base being encountered. On average, the Wall ditch was *c* 8.23-8.53m wide and 2.74m deep, with a V-shaped profile (Breeze 2006, 62), but in places within Wall Miles 46 and 47, including just to the west, it was unusually large, at up to 15.2m wide (*op cit*, 284). At Site 4, only a fragment of the feature, 1.2m wide and up to 1m deep (including 0.3m of modern topsoil), was investigated. Beneath the topsoil, a sequence of four fills was recorded which, in view of their position in the top of the ditch, were probably of comparatively recent (post-Roman) date, though none yielded any dating evidence. They appear to represent gradual infilling of the upper part of the ditch, perhaps over a prolonged period.

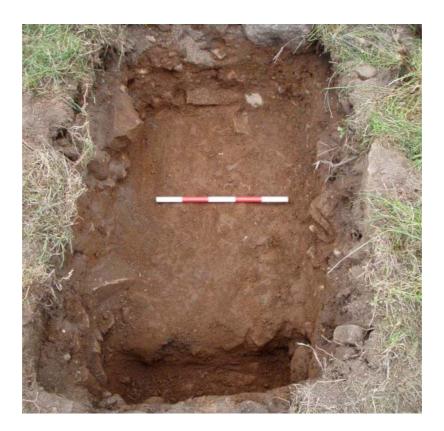
Plate 1: Site 1, looking south

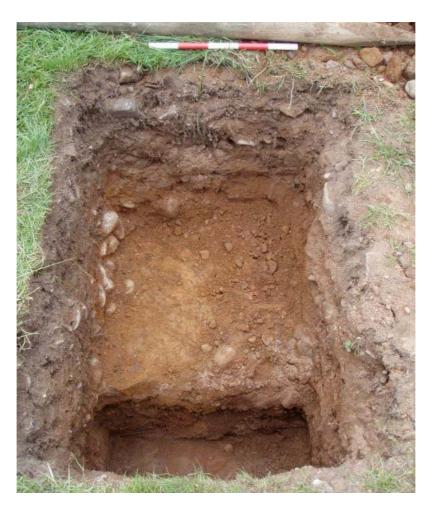
Plate 3: Site 2, looking south

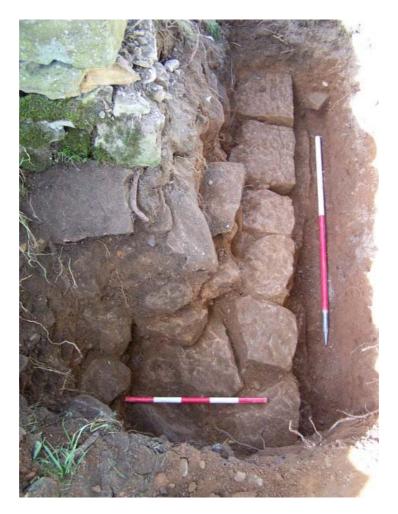
Plate 5: Site 3, looking west, showing the north face of Hadrian's Wall

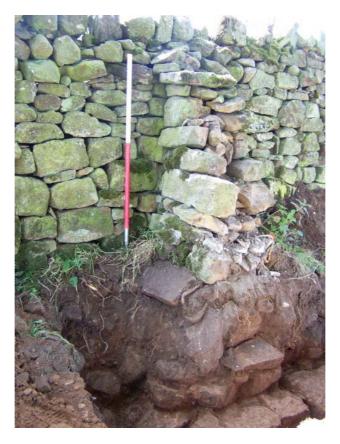
Plate 7: Boundary wall 302, sitting directly upon Hadrian's Wall (303), looking south-west

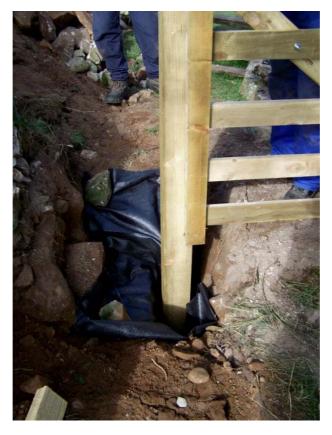
Plate 8: Post of new gateway set adjacent to Hadrian's Wall (303), looking west

- 4.4.5 No further excavation was undertaken. The remains of Hadrian's Wall were covered by a permeable membrane, with the post for the new gate being placed immediately to the north of the Wall (Plate 8). The trench was then backfilled, with packing stones placed around the new post to hold it steady, as agreed at a site meeting with English Heritage.

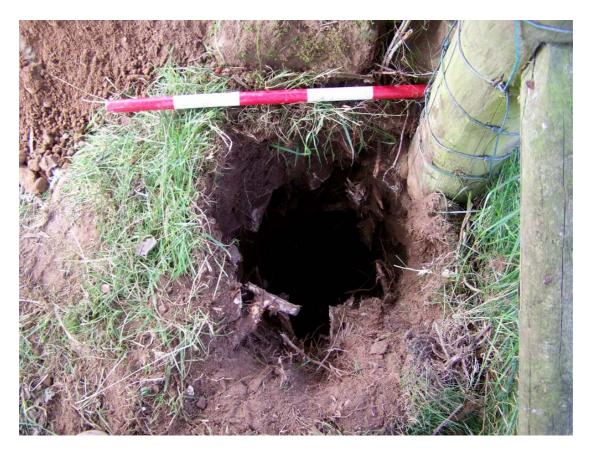
- 4.4.6 In addition, a posthole for a second post was excavated to the north of the evaluation trench for the opposing gatepost. This measured 0.44m by 0.33m in size, and was excavated 1.07m to the north of the evaluation trench, to a maximum depth of 0.73m (Plate 9). This posthole was excavated through 0.40m of topsoil 301, and 0.33m of sediment identical to 304. No archaeologically significant deposits were encountered in this, apparently confirming that the berm in this area was unmodified.

Plate 9: New posthole excavated to the north of Site 3, looking south

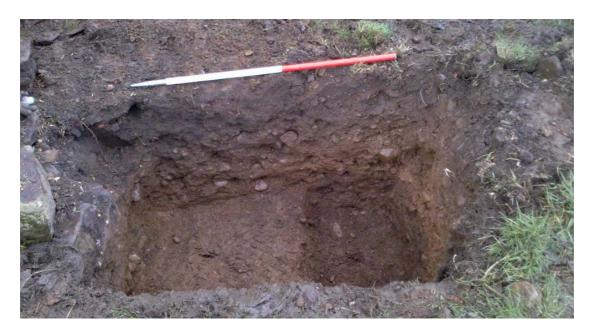
Plate 10: Site 4, looking west

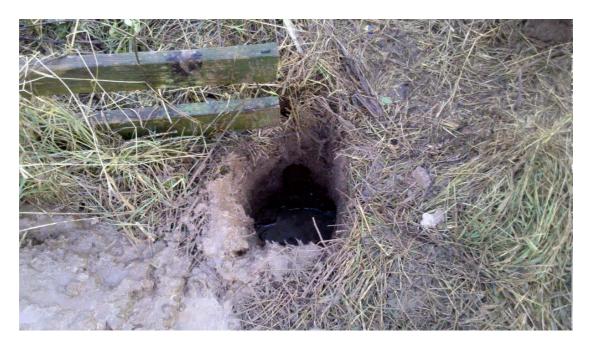
- 4.6.1 A watching brief was maintained on the excavation of two postholes, 1.2m apart, for a new gate at NY 6573 6591 (Fig 1; Plate 12). This structure was in the vicinity of the Vallum, although on the roadside verge. The excavations measured 0.35m square, and reached a maximum depth of 0.9m.
- 4.6.2 The excavations removed 0.2m of mid-grey brown sandy silt topsoil, and 0.5m of dark brown clayey silt subsoil, containing occasional small- to medium-sized sub-rounded stone inclusions. Below the subsoil, a pale grey silt was encountered, but this soon became highly waterlogged. No archaeologically significant deposits were identified by the watching brief.

Plate 12: North-westernmost posthole of Watching Brief 1, looking east

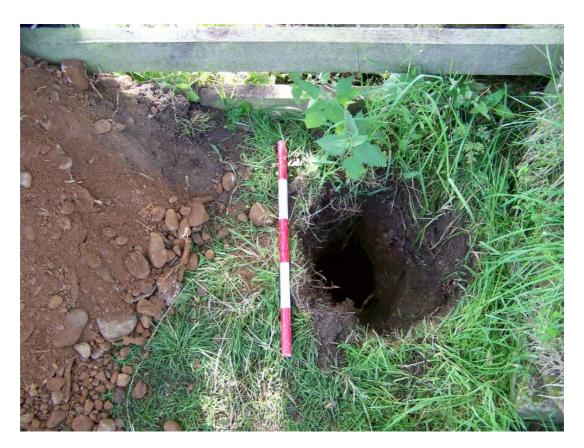
4.9.1 A watching brief was maintained on the excavation of two postholes, each measuring 0.30m square and 0.80m deep, for a new gate at NY 6368 6624 (Fig 1; Plate 15), in the vicinity of the Wall ditch. The excavations removed a mid-brown sandy silt with occasional small rounded stone inclusions, heavily disturbed by rooting activity. No archaeologically significant deposits were encountered.

Plate 15: Southernmost posthole of Watching Brief 4, looking west

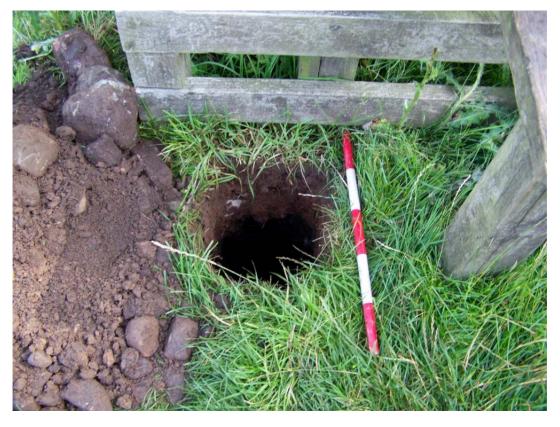
4.10.1 A watching brief was maintained on the excavation of two postholes, measuring 0.3m square and 0.80m deep, for a new gate at NY 6366 6624 (Fig 1; Plate 16), again in the vicinity of the Wall ditch. The excavations proceeded through a mid-brown sandy silt topsoil, with occasional small- to medium-sized rounded stone inclusions. No archaeologically significant deposits were encountered.

Plate 16: Easternmost posthole of Watching Brief 5, looking north-east

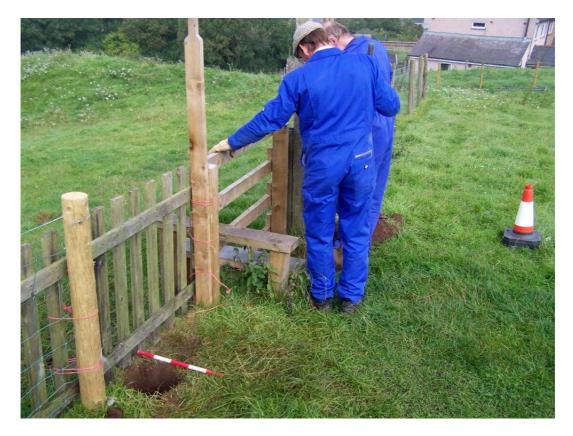
4.11.1 A watching brief was maintained on the excavation of two postholes, each measuring 0.30m square and 0.80m deep, for a new gate at NY 6357 6624 (Fig 1; Plate 17), also in the vicinity of the Wall ditch. The excavations removed a mid-brown sandy silt topsoil, with occasional small rounded stone inclusions. No archaeologically significant deposits were encountered.

Plate 17: Excavating postholes during Watching Brief 6, looking south
