RAVENGLASS ROMAN FORT BATH HOUSE, RAVENGLASS, CUMBRIA

Archaeological Watching Brief

Oxford Archaeology North

March 2011

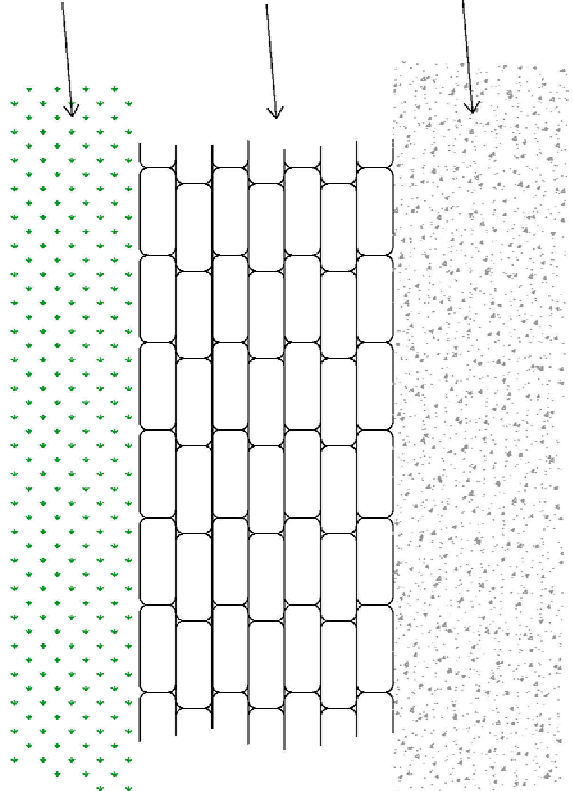
Cobbled section prior to improvements

New access route over previously cobbled section, showing mesh and drainage pipe

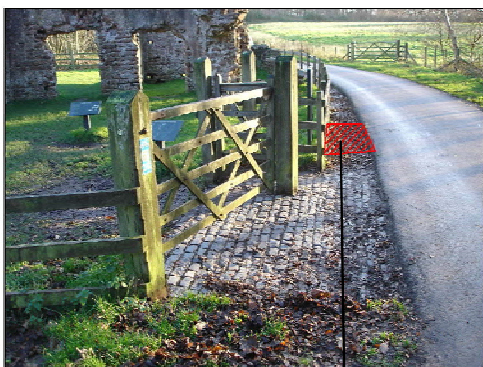
Figure 3: Details of improvements to access from the road to the newly-laid path

Southward view of area of cobbles removed for access improvements

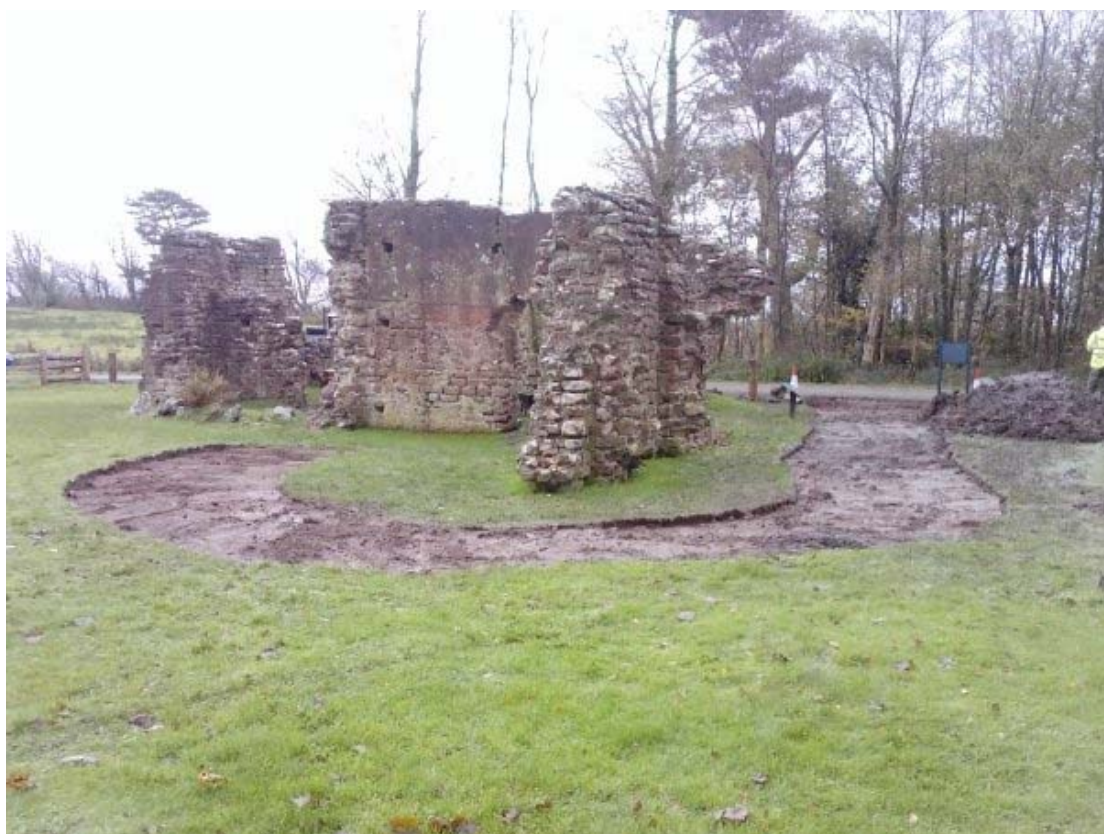
Plate 1: View of the excavated pathway around the north side of the bathhouse

3.1.1 The groundworks commenced with the mechanical excavation of the topsoil from the area of the proposed disabled access path, removing overlying deposits to a maximum depth of 250mm (Fig 2, Plate 1), in preparation for the laying of the strengthening mesh. Alongside the road, the existing fence line was removed and fence posts pulled up along with their concrete footings, in order that the holes could be re-used for the new bollards (Figs 2 and 4; Plate 2). An area of cobbles was removed under archaeological supervision to level the surface between the road and access path for disabled visitors and, within this, a drainage pipe was installed to ease the accumulation of ground water (Fig 3 and Plate 3). The occurrence of regular heavy ground water across the site has also led to erosion in areas of high footfall, particularly through the doorways, which necessitated the laying of strengthening mesh in these areas. Both the removal of deposits and levelling up, where necessary, was undertaken under archaeological supervision (Plate 5). A small post hole was excavated to a depth of 250mm for the drop-down bollard (Fig 2) under archaeological supervision, and the existing signage removed.

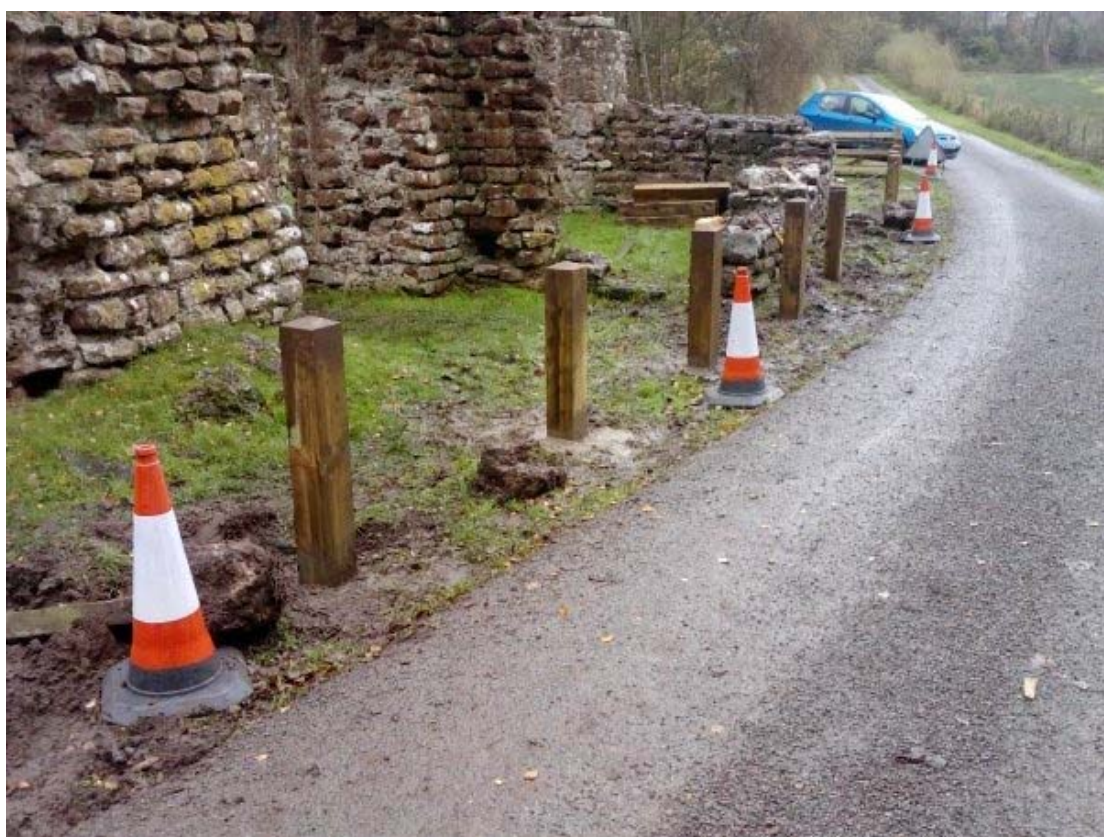
Plate 2: Bollards on roadside

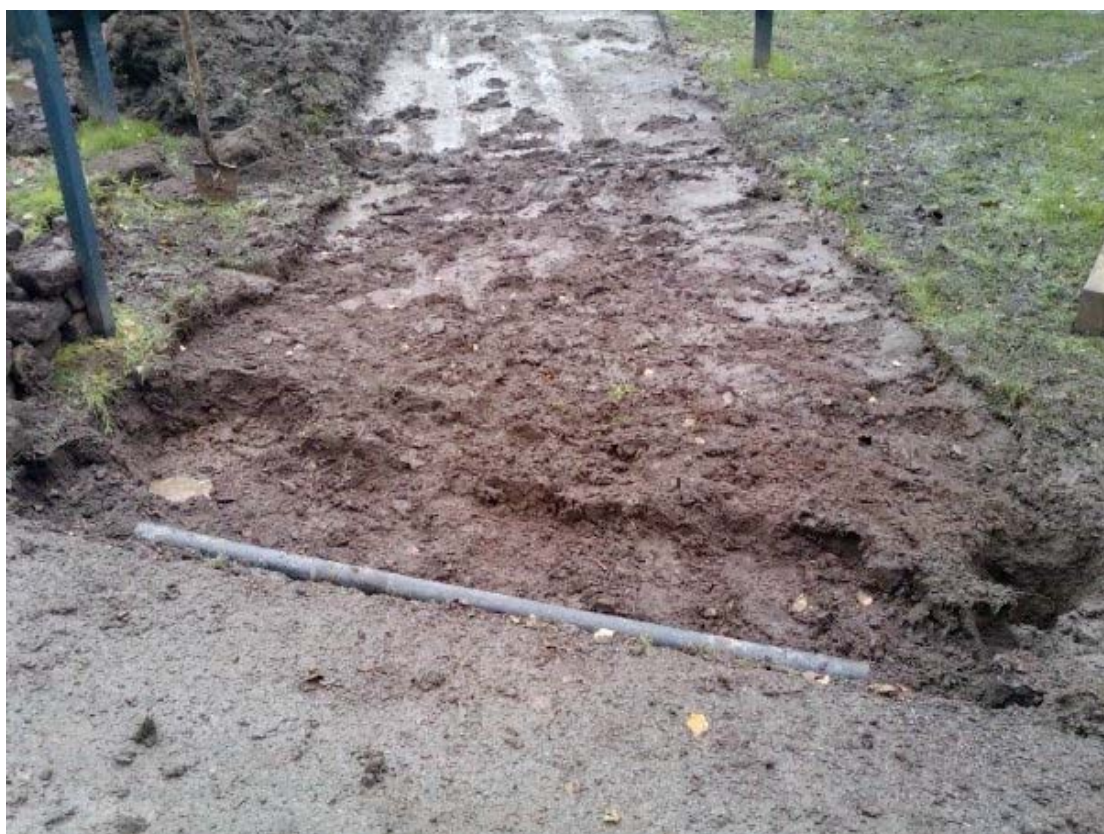
Plate 3: View of the access path following removal of the cobbles and installation of the pipe

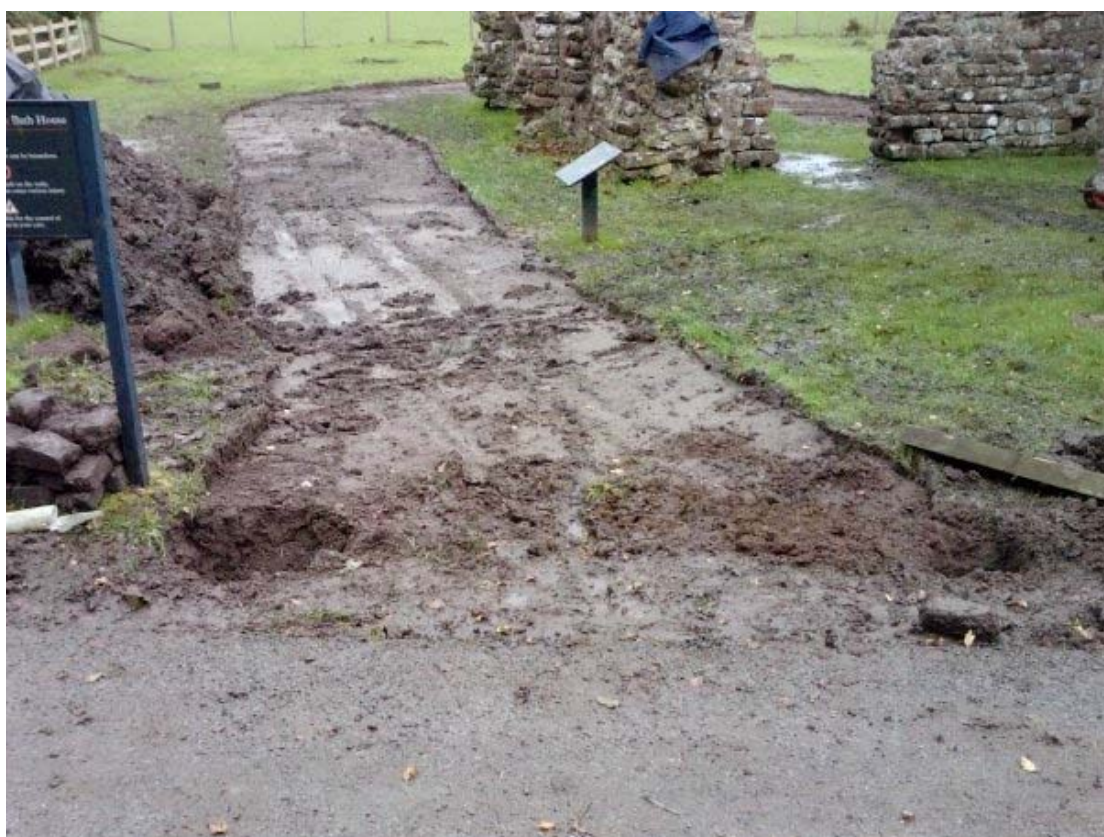
3.2.1 All of the groundworks were carried out in wet conditions, which slowed progress considerably. The excavated areas for the disabled access path, the doorways, and the removal of the cobbled surface, together with the removal of existing signage, were within topsoil and subsoil deposits and did not disturb the archaeological remains. The bollards were installed within previously disturbed deposits. With each event no archaeological remains were encountered, and no artefacts were observed during the course of the archaeological monitoring.

Plate 4: View of the wet conditions along the excavated pathway

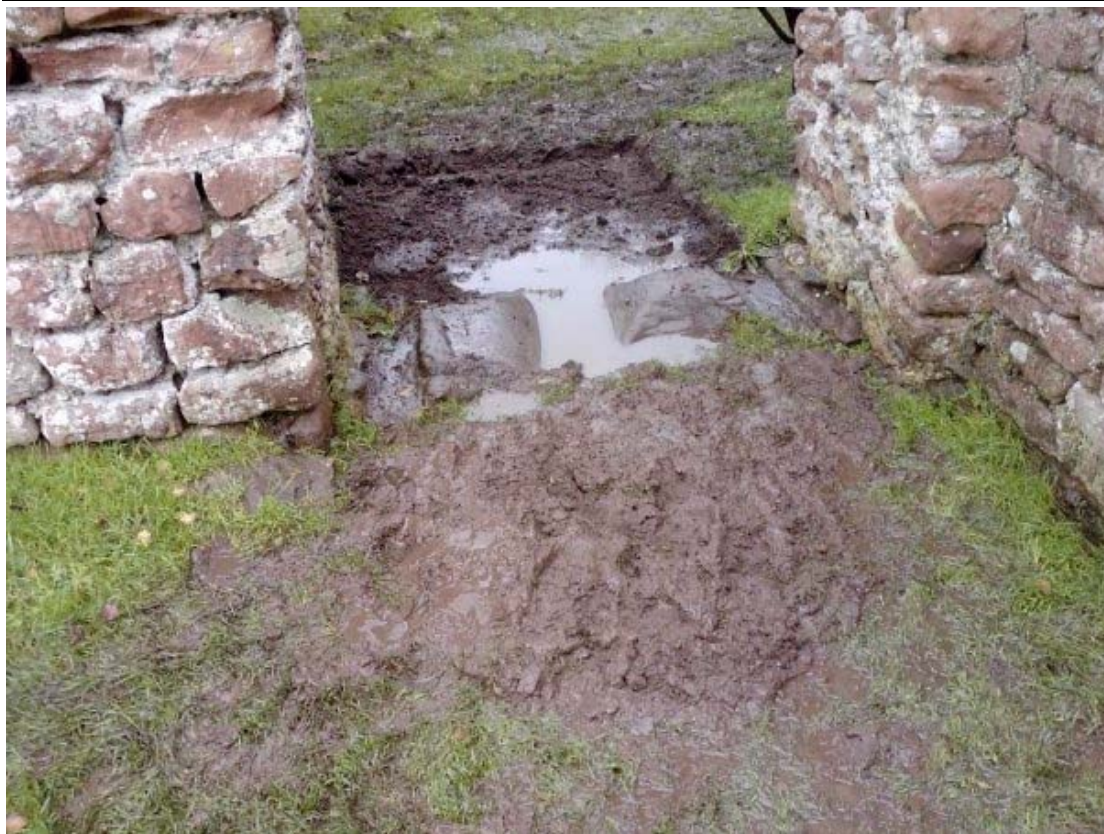
Plate 5: View of one of the doorways that has been excavated on one side and levelled up on the other side prior to the laying of the strengthening mesh
