MID CHESHIRE 3 PIPELINE,

Cheshire East

Archaeological Watching Brief – Supplementary Report

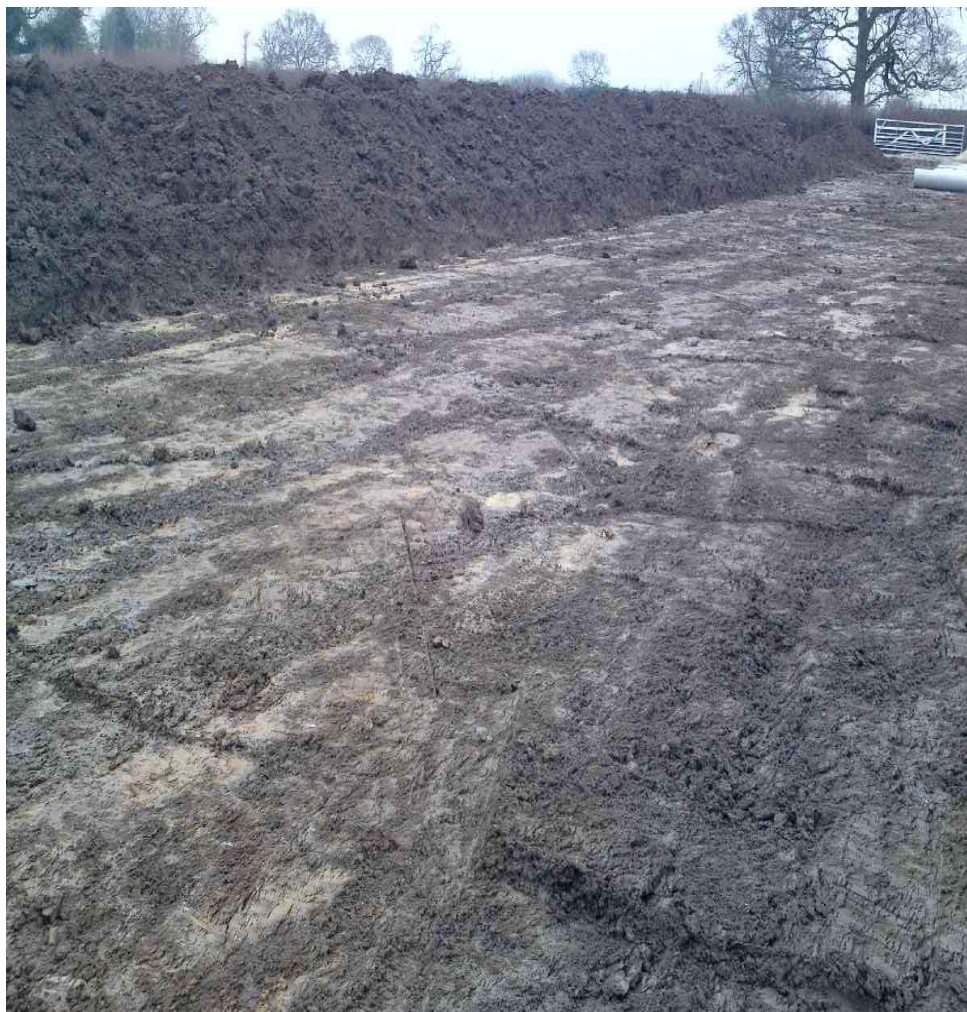
Plate 1: General view of the compound area showing plough scars cut into natural deposits in Field 2

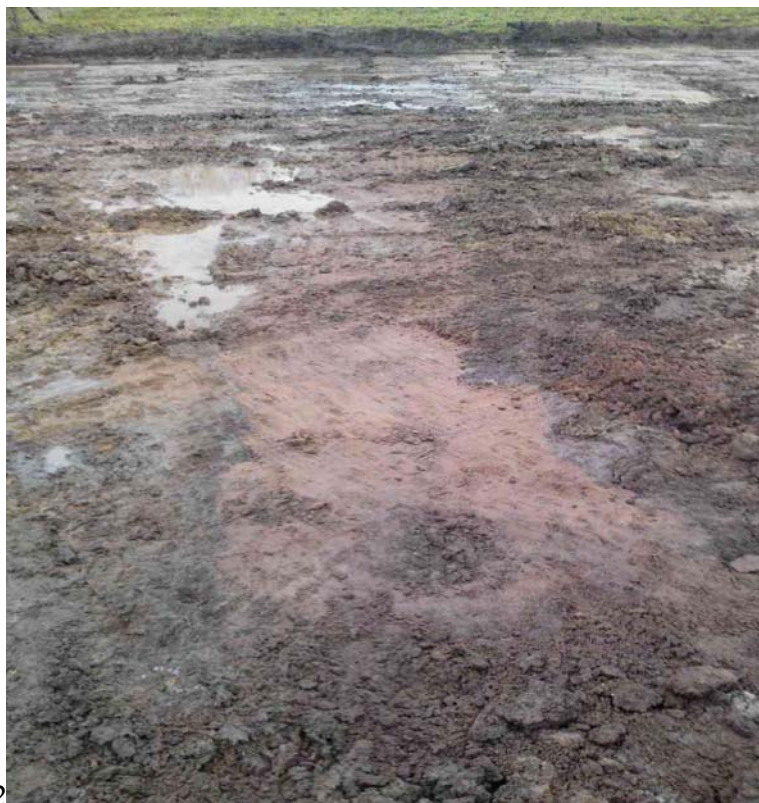
3.2.2 To the west of the compound, topsoil stripping of the easement revealed two north/south aligned former field boundaries, **202** and **205**. The easternmost, **202**, being a ditch (Plate 2), and the western (**205**), a relict hedgerow. Located between these two features was a small charcoal-rich rubbish dump.

Plate 2: Boundary Ditch 202 in Field 2

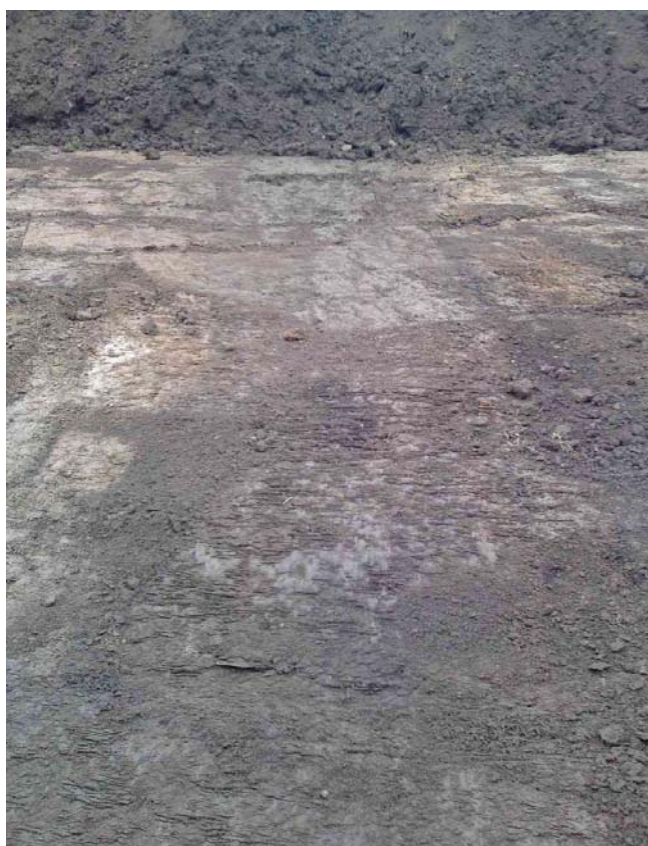
Plate 3: Relict hedgerow in Field 2

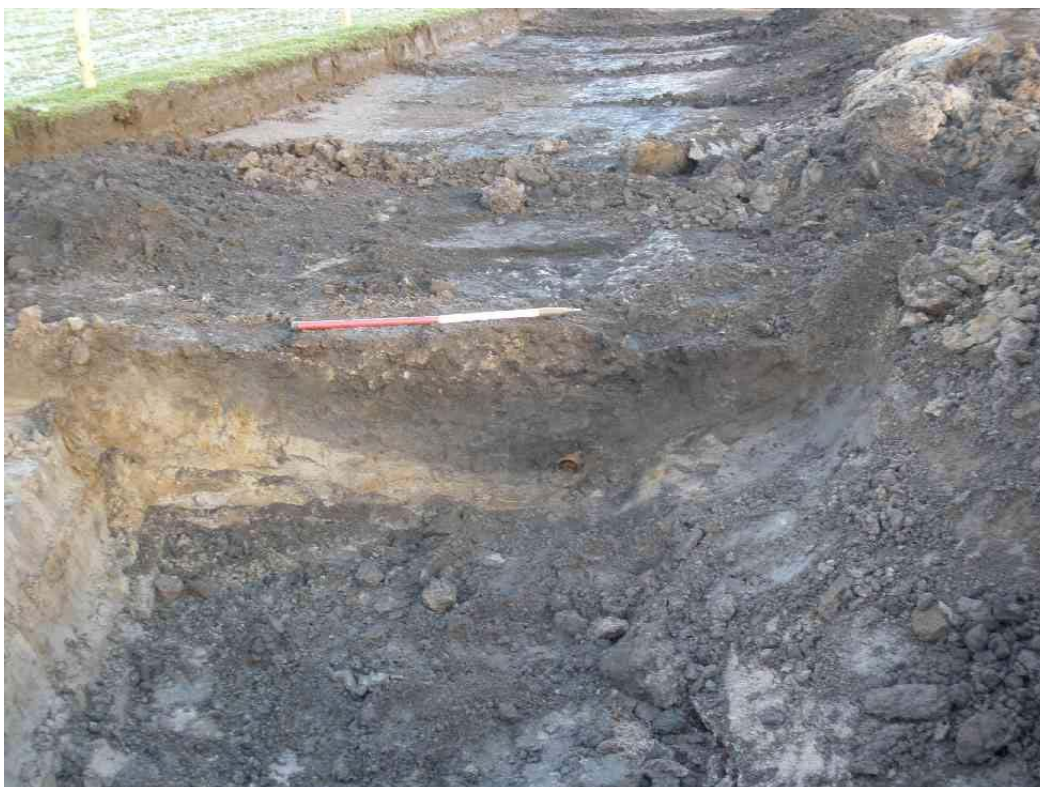
3.2.3 **Fields 6 and 7:** a north/south aligned ditch was thought to be observed within field 7. However, upon further investigation it was revealed to be a modern field drain, approximately 3m in width and 0.80m in depth. No other features or deposits of archaeological significance were identified across the easement.

Plate 4: Section excavated through a field drain within Field 7

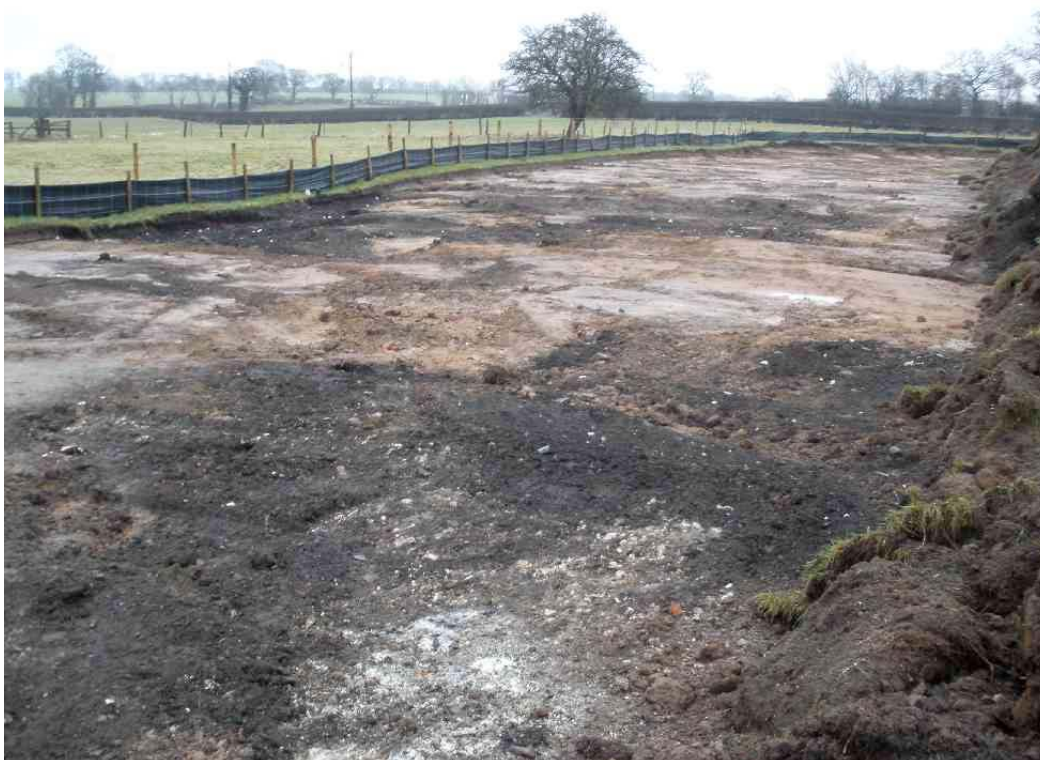
- 3.2.9 **Fields 17 and 20:** several pits and deposits of modern debris were located within these fields. These features equated to Sites **50** (a mound), **58** (quarry pit) and **61** (earth bank), while the earthwork identified as Site **57** appeared to be natural in origin. The rubbish pits and dumps varied in size from 1.5m by 2m, to 6m by 7m, and were filled with a dark blackish material (high ash content), stone fragments, brick rubble, lime, bone, glass bottles, iron objects, pottery and fragments of clay pipe. All the material dated to the nineteenth and twentieth centuries (see *Section 4*, below). A single area of crushed brick or burnt clay, measuring 1.8m by 2m, was identified midway along the easement.

Plate 5: Numerous rubbish dumps or middens within Field 20

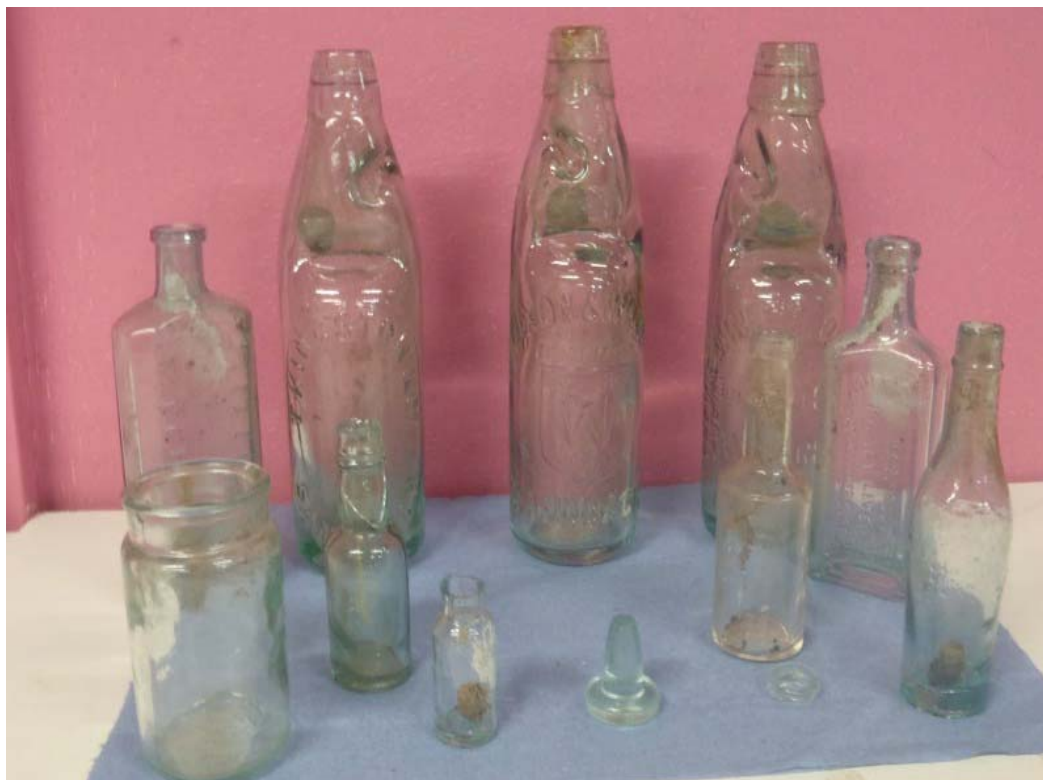
- 4.3.1 The assemblage is dominated by several complete bottles and jars (11) of varying type (Plate 7), deriving from a rubbish dump in Field 17. These largely date to the nineteenth and early twentieth centuries, and included three locally produced mineral water codd bottles, two pharmaceutical bottles, four miniatures, a small jar, stopper and a bottleneck. Of these, four were embossed with manufacturers marks including DR KILMERS SWAMP ROOT medicine, an American firm based in London during the late nineteenth century. Of the local manufacturers these included; Nixon & Wood based at the Excelsior Works, and T Kingston & Co, both firms from Sandbach. Kingston is listed in Kelly's 1896 Directory of Cheshire as residing at Wheelock Road, but by 1902 is based at Hope Street, Sandbach. The company is not listed in the 1914 directory suggesting it had gone out of business by this time. The remaining bottle was manufactured by Redfearn bottle makers in

Plate 7: Complete bottles and jars dating between late 19th-early 20th century recovered from a rubbish dump in Field 17

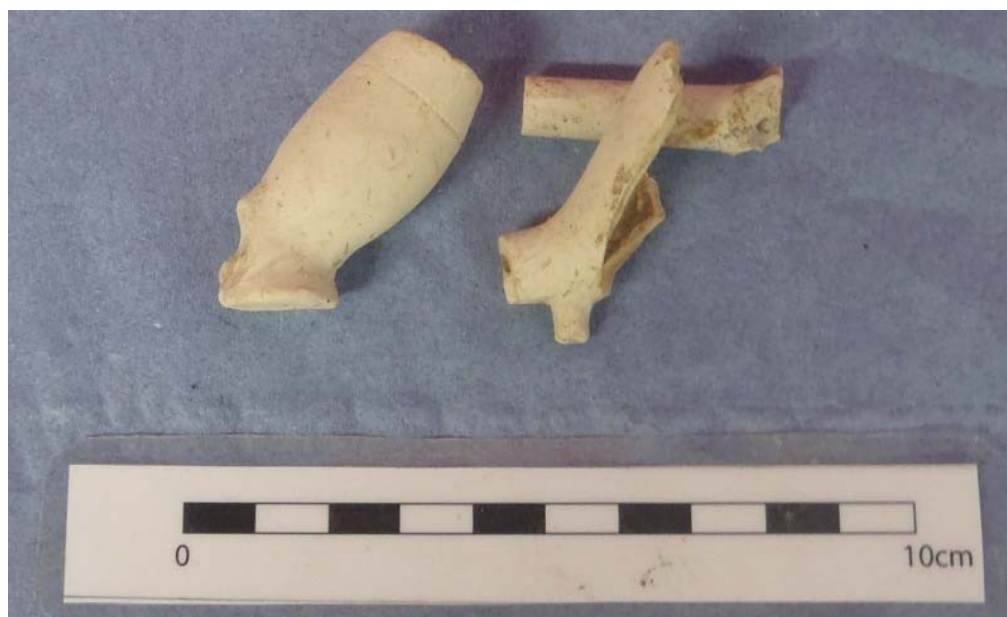
- 4.4.3 The stems included five coarse, medium-bored types, which probably date no later than the eighteenth century, and a smooth narrow-bored type of nineteenth century date (Plate 8).
- 4.4.4 Two fragments of interest were recovered from Field 17. These include a tapered, thick, smooth clay, and elaborately decorated stem, with a small rounded spur in the form of a tree branch (Plate 9). It is probable that this was manufactured at the Broseley kilns in Shropshire during the late nineteenth century. The other comprised a trapezoid-shaped hollow clay object, which is tentatively interpreted as a candle snuffer (Plate 10).

Plate 8: Clay tobacco pipes dating to the late 17th-early 18th century pipe (left) and 18th century (right)

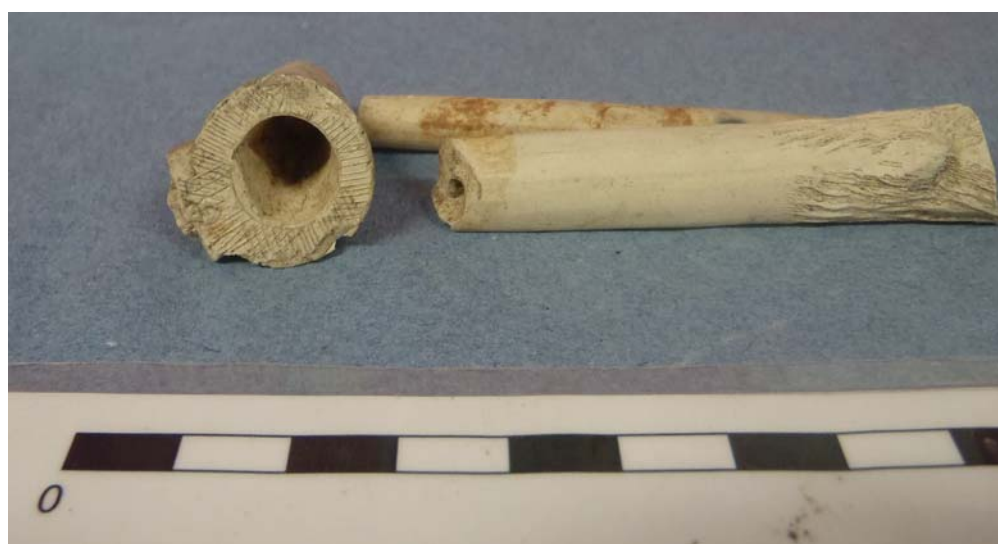
Plate 9: Pipe clay object and clay tobacco pipe recovered from Field 17

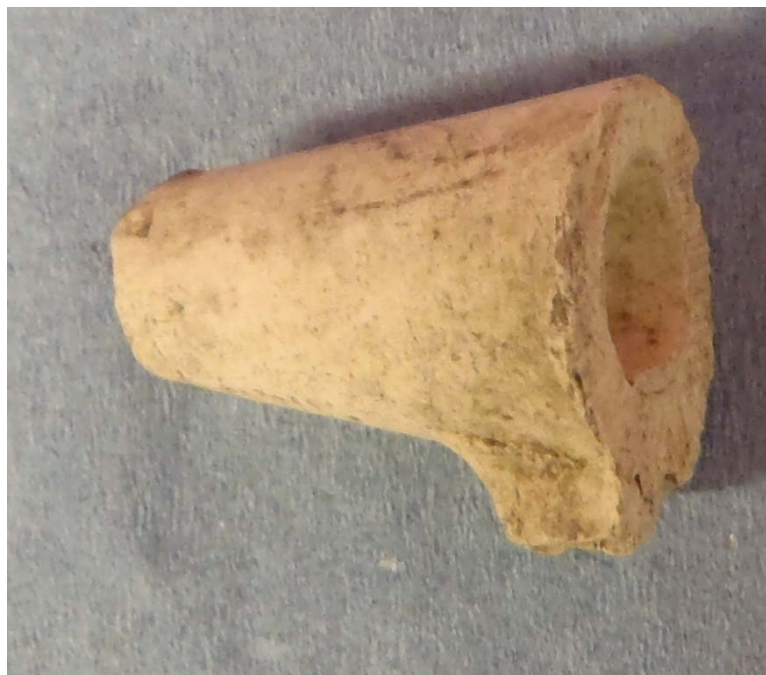
Plate 10: Side view of candle snuffer from Field 17

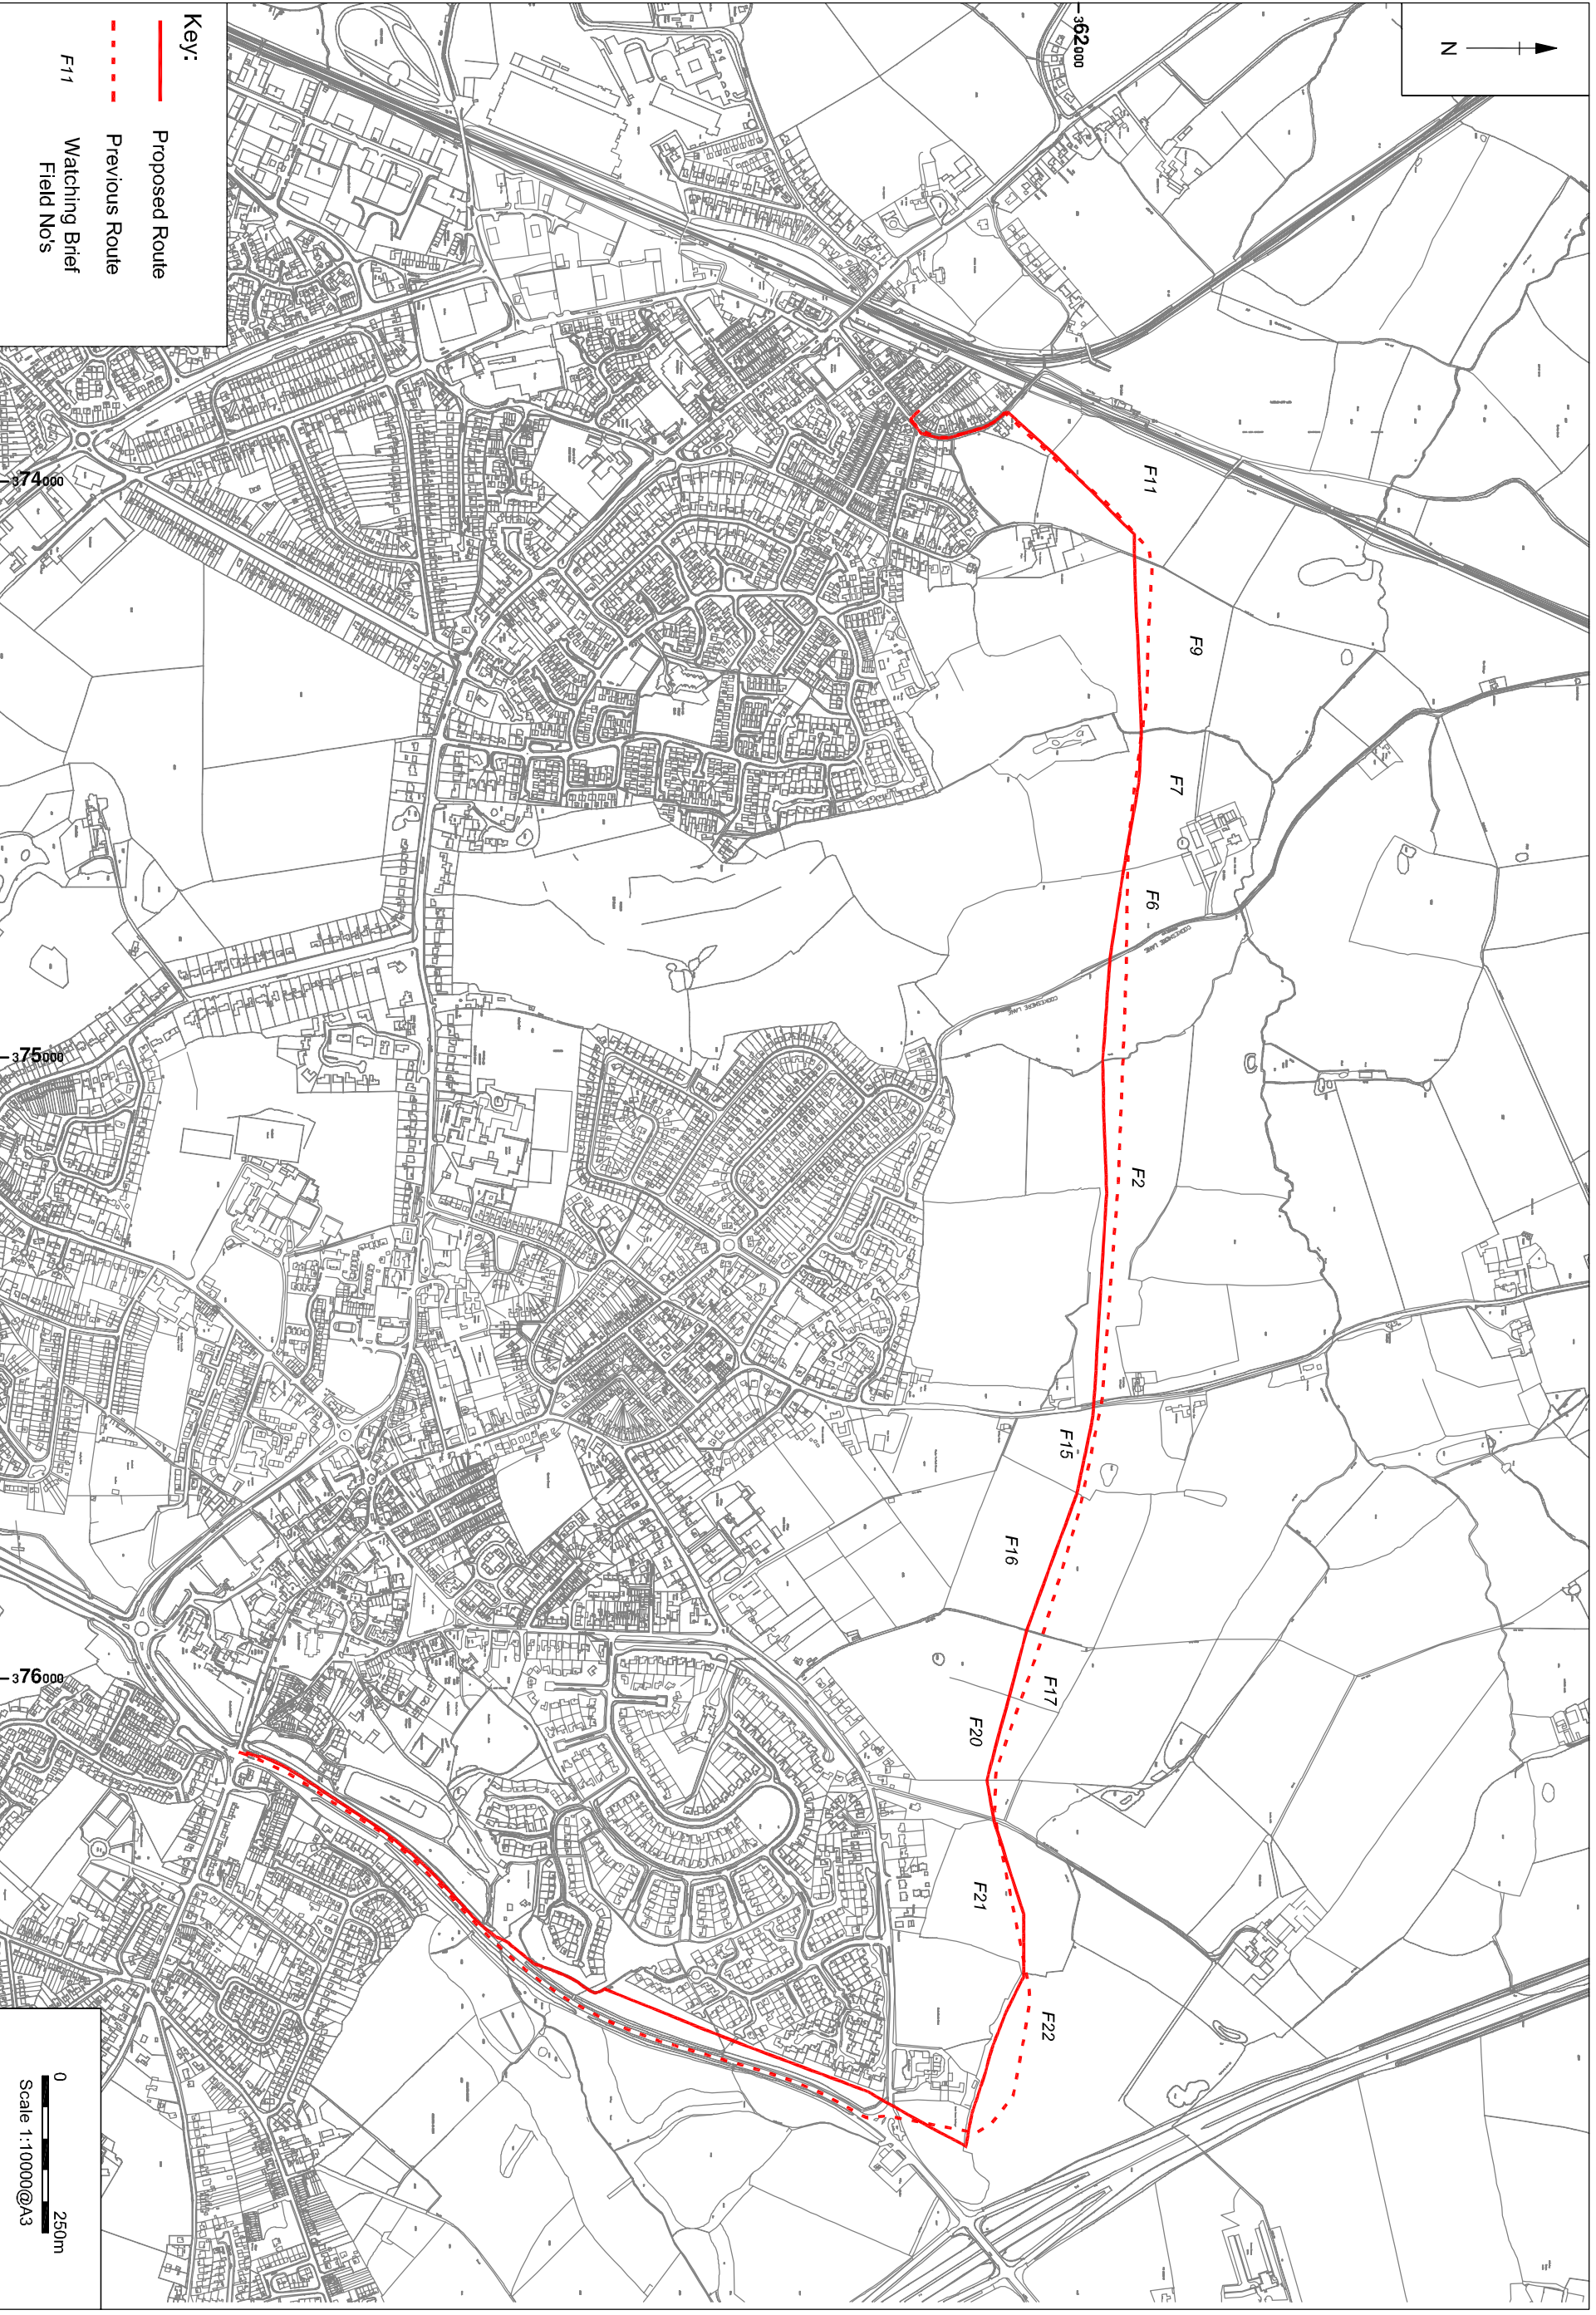
Figure 2: Plan showing fields subject to the watching brief

2.2.1 The archaeological watching brief monitored the topsoil stripping of 11 fields distributed along the length of the pipeline; these comprised Fields 2, 6, 7, 9, 11, 15, 16, 17, 20, 21, and 22 (Fig 2). The field numbers are taken from the OA North 2009 report. The overburden was removed by a 360° mechanical excavator, fitted with a 2m wide ditching bucket, down to natural geology, under the constant supervision of an archaeologist. Field 15, however, was stripped using a mini-digger due to the presence of overhead cables.

3.1.1 The following section provides an outline of the watching brief results on a field by field basis, noting the presence and the nature of any archaeological features and deposits identified. Site numbers refer to the site gazetteer presented in the OA North 2009 report. The numbered fields are shown on Figure 2.
