Bollinhurst Impounded Reservoir, Disley, Cheshire East

Archaeological Watching Brief - Supplementary Report

Oxford Archaeology North

February 2011

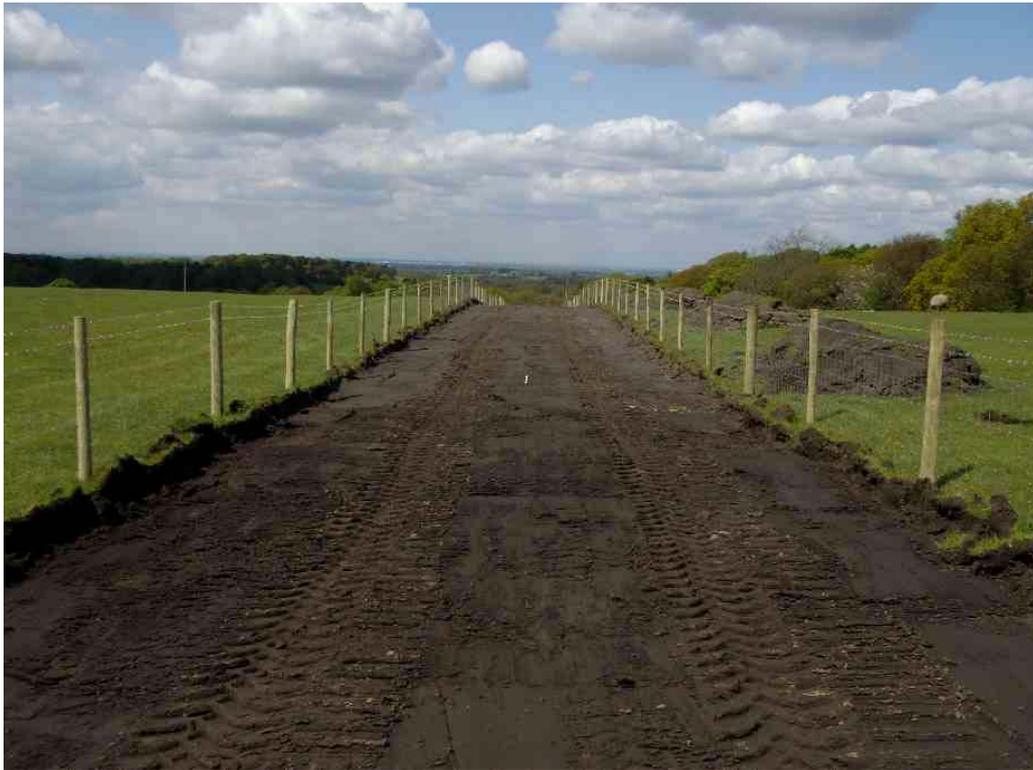
- 3.2.2 The stripping of the access road was undertaken in short sections, and, similarly not all of the topsoil was removed. It was promptly overlain with stone. No archaeological features were observed along the length of the access road (Plate 1).

Plate 1: View of the access road illustrating the shallow nature of the topsoil strip

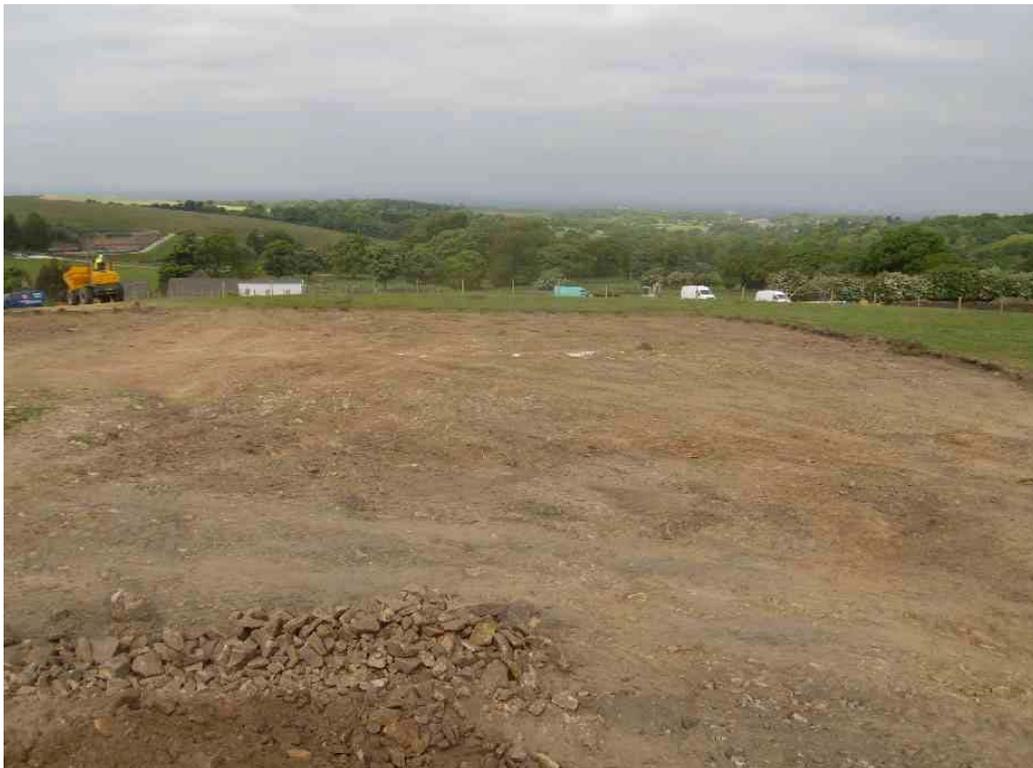
- 3.2.3 The stone extraction site was stripped of topsoil down to stone-rich deposits, and often directly on to bedrock (Plate 2). The topsoil was a mid brown sandy-silt up to 0.4m in depth, overlying a subsoil of orange/yellow clayey-silt (0.3m maximum depth). This in turn overlay a pinkish glacial till. During this process a dry-stone wall (OA North Site 27) was demolished.

Plate 2: Rock removal area showing the stone-rich deposits

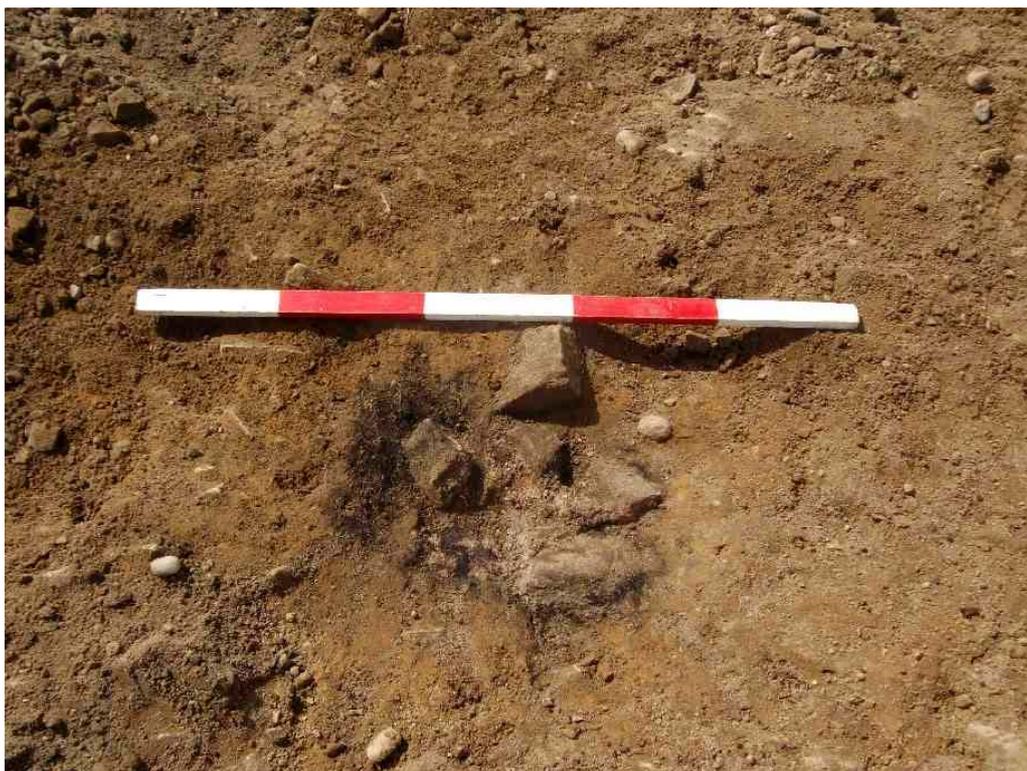
- 3.2.4 A small pit (Plate 3) filled with a burnt deposit was exposed in the north-east corner of the stripped area. The oval-shaped pit was shallow, measuring 0.43m in length x 0.28m in depth. The fill comprised very fragmented charcoal, with stones to the base. It is possible that this was a fire pit, but a total lack of finds makes, and the fragmented nature of the charcoal it impossible to ascribe a date or function to this feature.

Plate 3: Plan view of the base of the shallow pit observed within the rock removal area

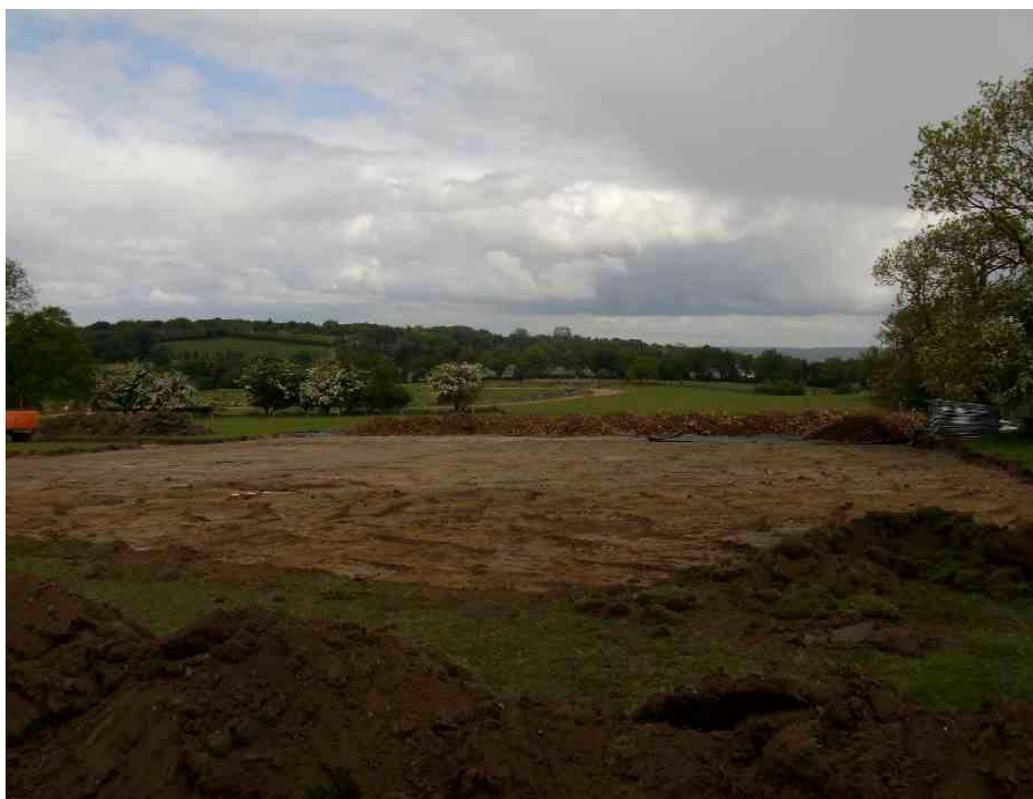
- 3.2.5 Further topsoil stripping in the north-east corner of the rock removal area (Plate 4) exposed subsoil and glacial till the same as those within the general area of the extraction site. No archaeological features were noted in this area.

Plate 4: Stripped compound area to the north-east of rock removal area

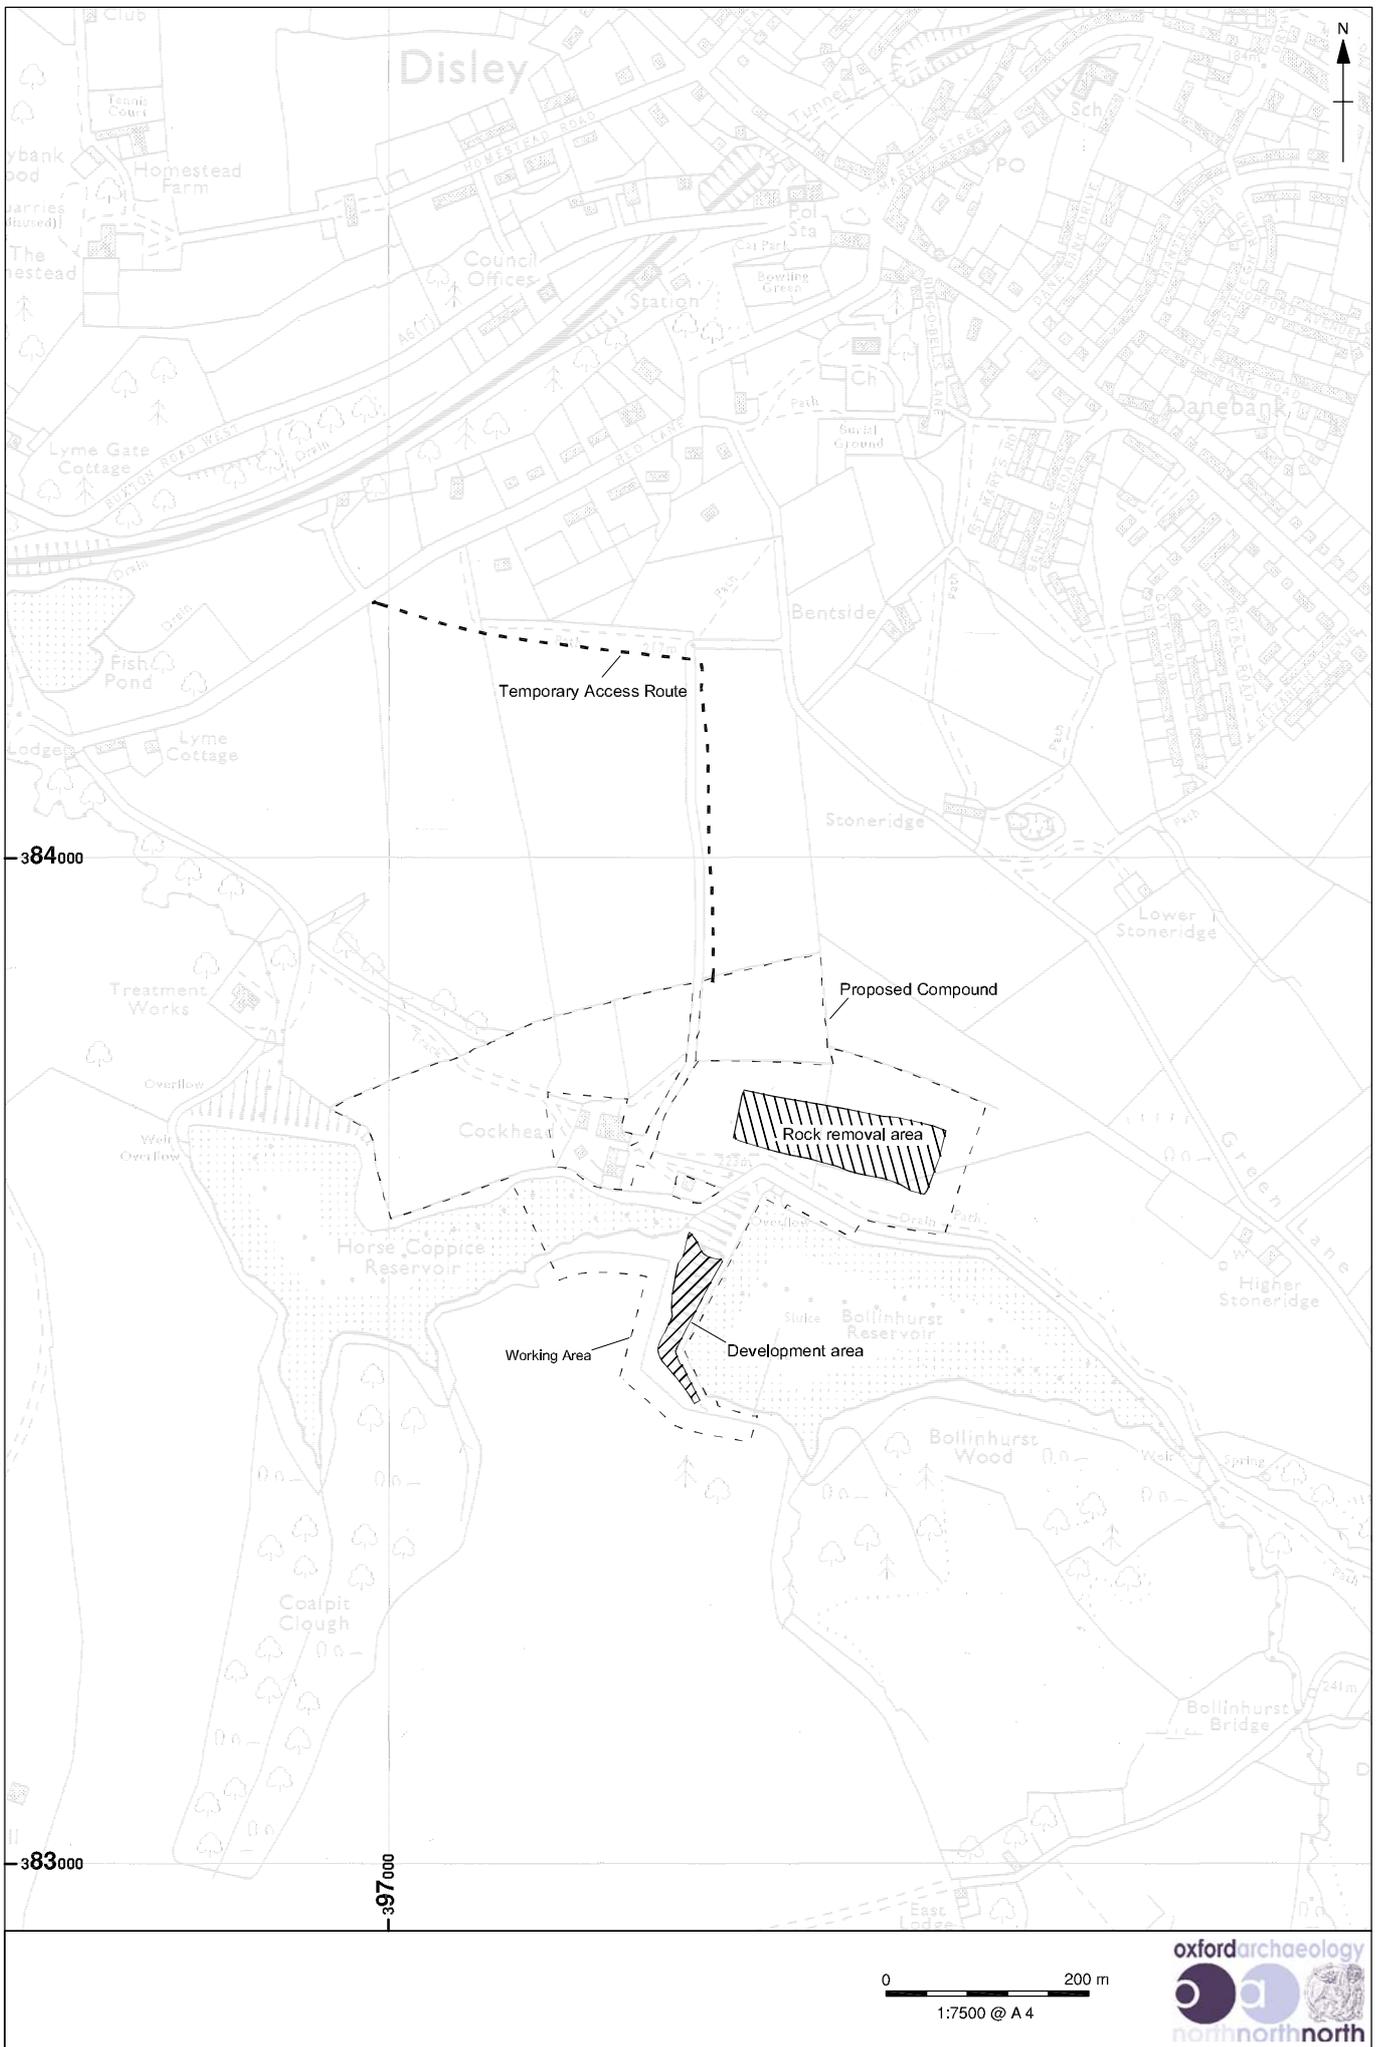
Figure 2: Areas subject to watching brief

- 3.1.1 The watching brief carried out during May and June 2010 aimed to identify any previously unrecorded sites within the proposed area of work (Fig 2).
- 3.1.2 Initially, a compound area was stripped at the northernmost end of the temporary access route, just off Red Lane. At the same time, the stripping of the overburden in the rock removal area exposed stone-rich natural geology. This was widened in a piecemeal fashion, whilst the access road was stripped. A further compound was located at the reservoir site.
- 3.1.3 All topsoil stripping was carried out using a 20 ton tracked mechanical excavator fitted with a toothless ditching bucket.
