Chapter 2: Historic buildings recording of the crypt and archaeological investigations within the churchyard

by Jon Gill, Ceridwen Boston and Jane Phimester

RECORDING THE CRYPT

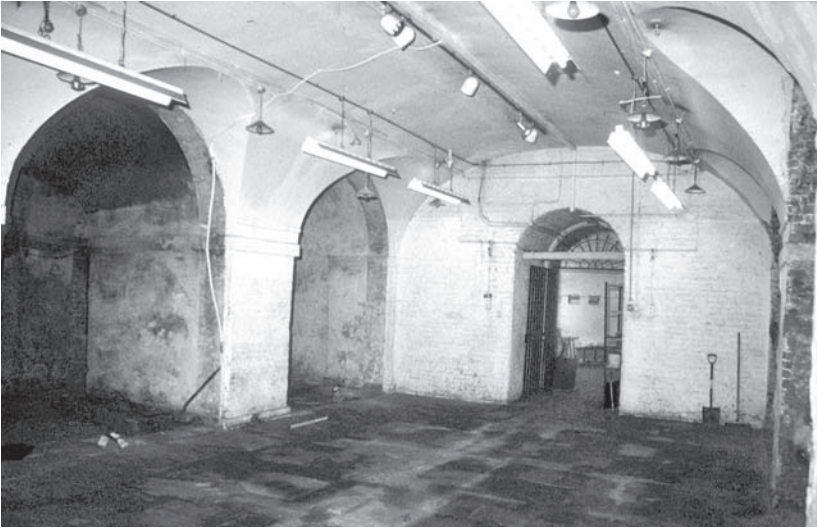
Plate 2.1 Main central vault looking S. The doorway leads through to the E-W vault and the main stairs.

The main body of the crypt comprises a long, vaulted north to south room along the spine of the building with five smaller vaults to each side (Plate 2.1). In addition there is a further, separate east to west vault at the south end of the crypt (Plate 2.2), which incorporated a staircase at either end. These stairs form the main entrance to the crypt. There is a short passageway between this east-west vault and the main body of the crypt (Plate 2.1). At the north end of the crypt there is also a single set of concrete steps at which was inserted in the 20th century (Plate 2.3) together with a further contemporary vault (7). Vault 7 was immediately to the west the new stairs.

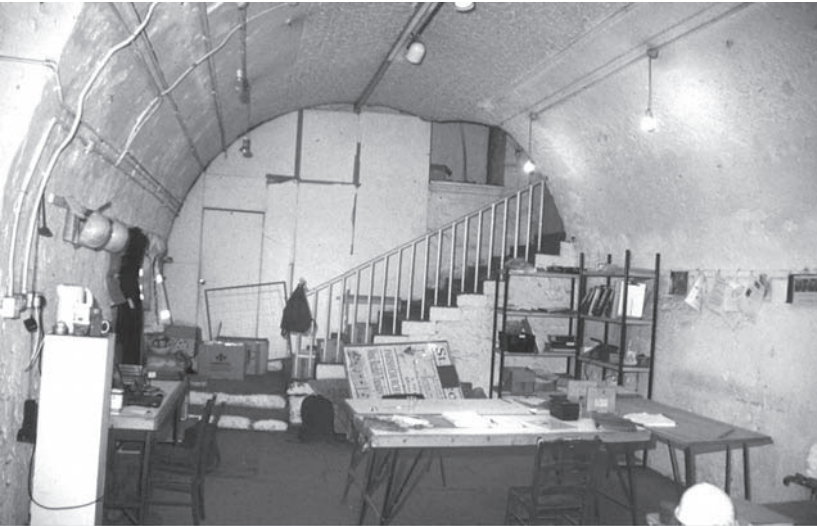
Plate 2.2 E-W Vault to the S of the main central vault of the crypt, showing one of the main stairways at the E end of the vault

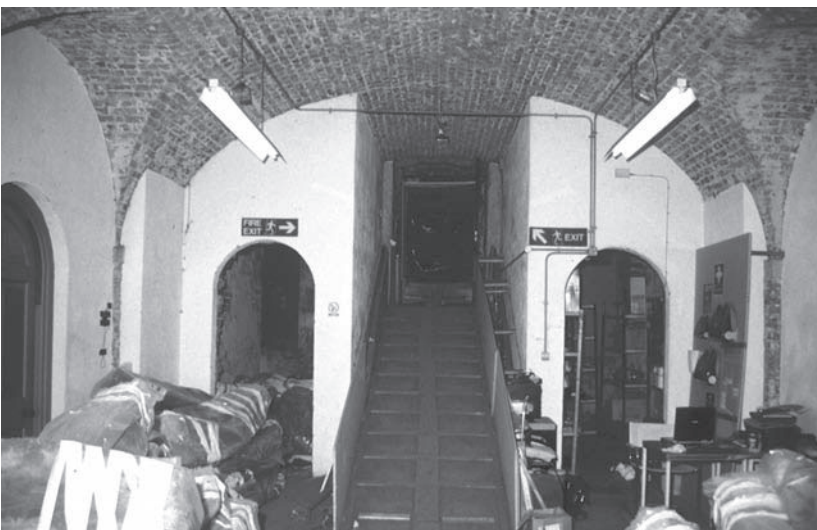
Plate 2.3 Central vault, N end, showing inserted modern stairs with Vault 7 to the left. To either side of the main vault, the fillets or buttresses in front of the main arch springs can be seen clearly.

Vault 7 is a small vault located at the northern end of the crypt immediately to the west of the central staircase at this end of the building (see Plate 2.3). Both the staircase and vault are of mid 20th-century date and subdivide the northern 3.5 m of the main vaulted crypt. The ceiling and west wall of Vault 7 are primary and plastered (Plate 2.17). The east wall is formed with mid 20th-century bricks but the south wall is formed with reused 19th-century bricks (Plate 2.18). It may be that the vault was originally open at its south end and that it was later blocked with the reused bricks. Regular holes in the west and east walls may be evidence of a former racking system for supporting coffins.

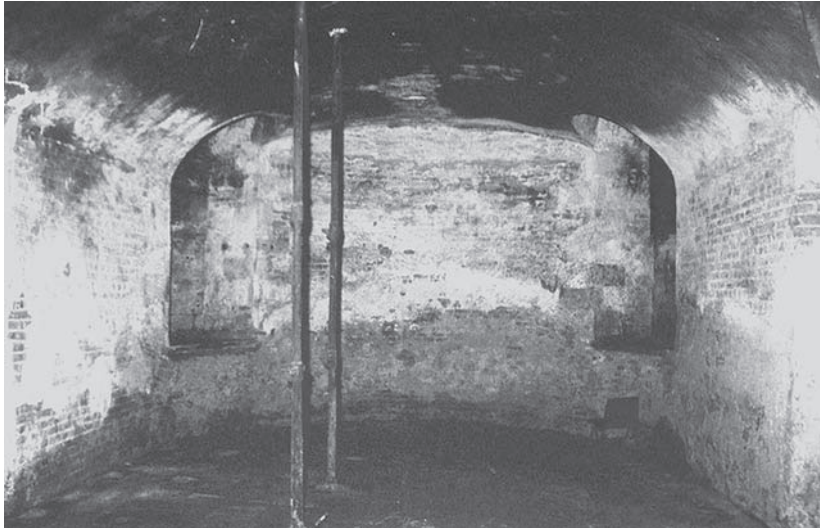
Plate 2.4 Vault 1 looking E. Note the two cast iron uprights originally designed to support the racking for coffins.

the north side of the central line of the vault (Plate 2.4). Each post has two brackets (at 1.17 m and 2.3 m above the floor) that would have supported shelves to hold the coffins (Plate 2.5). The posts are set on inserted, shallow stone bases, and their tops continued vertically through small holes cut into the ceiling of the vault. In the northern half of the room are 15 further similar stone bases on which further cast iron posts would presumably have sat (Plate 2.6). Each base has a square hole for the former post but there are no corresponding holes in the vault ceiling above each base. It may be that the main structural supports were those posts that survive and the shelving was additionally supported by lesser struts that did not continue to the ceiling.

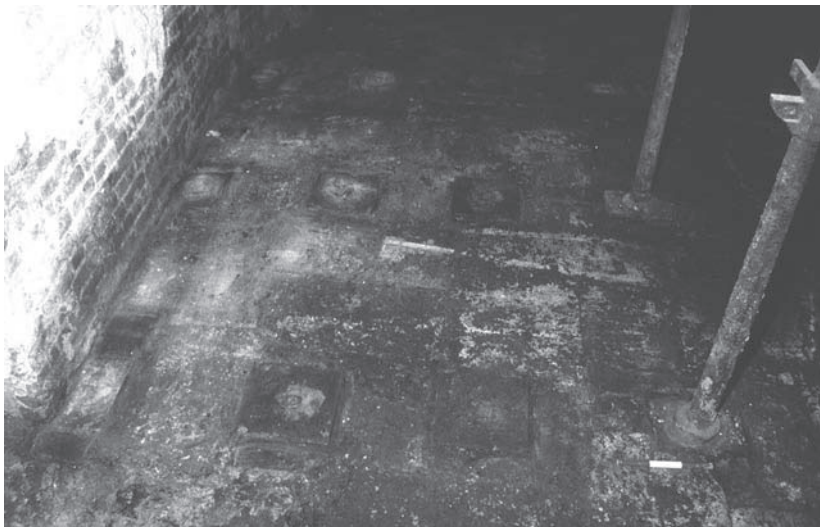
Plate 2.6 Stone post bases and extant cast iron posts for shelving in Vault 1

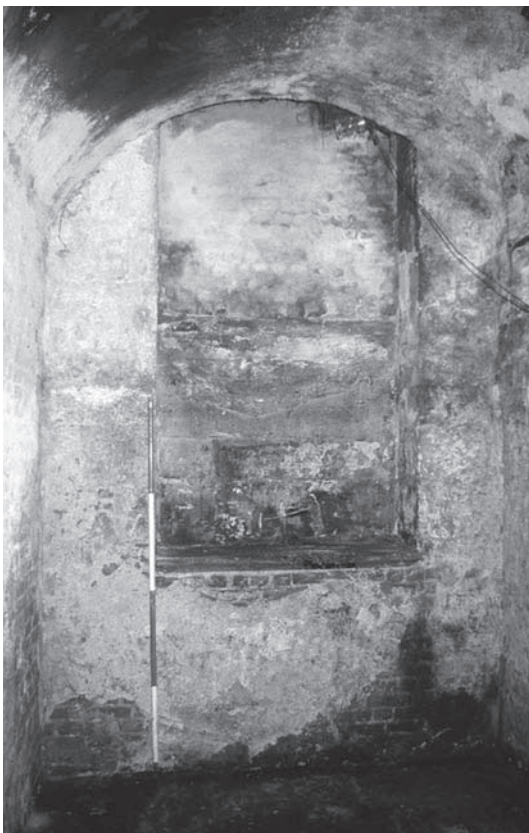
Plate 2.7 Vault 2 looking E, showing recess with raised sill and blocked window

Vault 2 immediately to the south of Vault 1, is substantially smaller (2.4 m wide x 5.1 m long x 3.6 m tall) and, unlike Vault 1, has a semi-circular vaulted ceiling. The vault has a rectangular plan and at its east end it has a recess with a deep stone sill at the base with a moulded lip and a higher stone sill indicating the base of a former window which was blocked with bricks almost certainly when the vault was sealed in the mid 19th century (Plate 2.7). The vault again has a stone plinth and

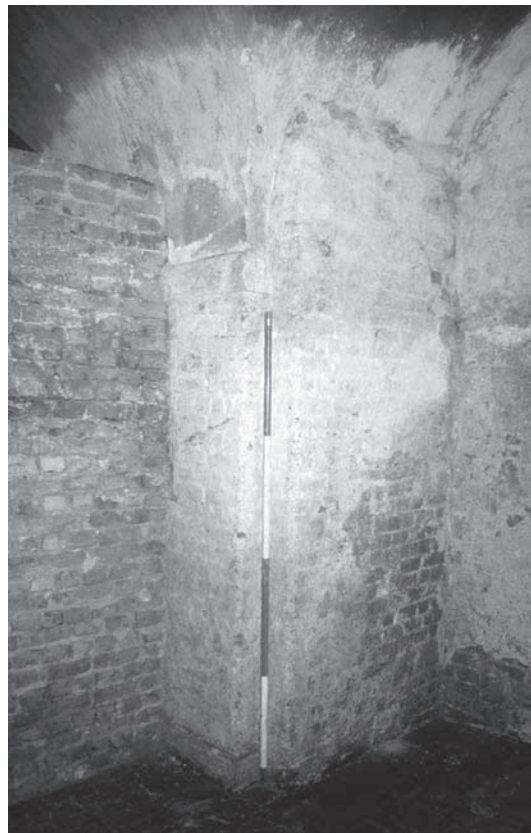
Plate 2.8 Vault 2 looking N, showing to the left the brick blocking of the opening through to Vault 1

string course around the primary walls but these did not extend around the infill walls blocking the archways to the two adjacent vaults to the north and south (Plate 2.8). The northern archway is smaller than that to the south, and reflects the relative size of the adjacent vaults. The blocking is 19th-century brickwork. The blocking wall to the south has smooth faced brickwork in Vault 2, but the opposite face in Vault 3 was rough suggesting that Vault 3 was sealed before Vault 2. The west wall, which sealed the vault from the main crypt, was formed of similar 19th-century bricks and the removal of this in the current works has shown that the historic plaster continued beneath it.

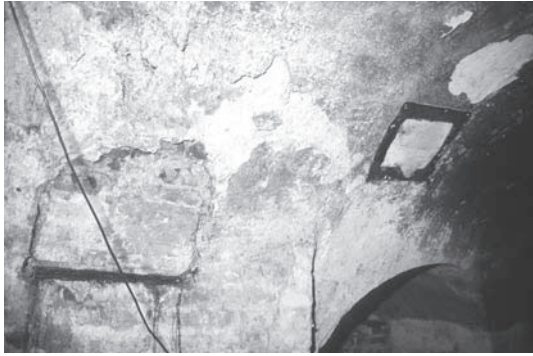
Plate 2.9 Vault 2, later features: to the left an iron bar supporting inserted brickwork, and to the right is a blocked rectilinear opening with an iron lining

Among the minor features of interest in Vault 2 include two secondary alterations in the vault ceiling towards the south-east corner (Plate 2.9). The first alteration is located at the intersection of the wall and the barrel vault and appears to comprise a wrought iron bar below an area of brick infill 45 cm wide. This brickwork does not appear to be rebuilding or patching due to a structural fault, but rather the filling of a hole. Presumably the hole was formed after the vault was sealed to give access into the vault. The second feature is in the vault ceiling itself and appears to be a sheet-iron lining around a former opening or feature (e.g. vent or shaft). The lining is bolted to the ceiling and forms a square with a large square hole (now blocked) in the centre.

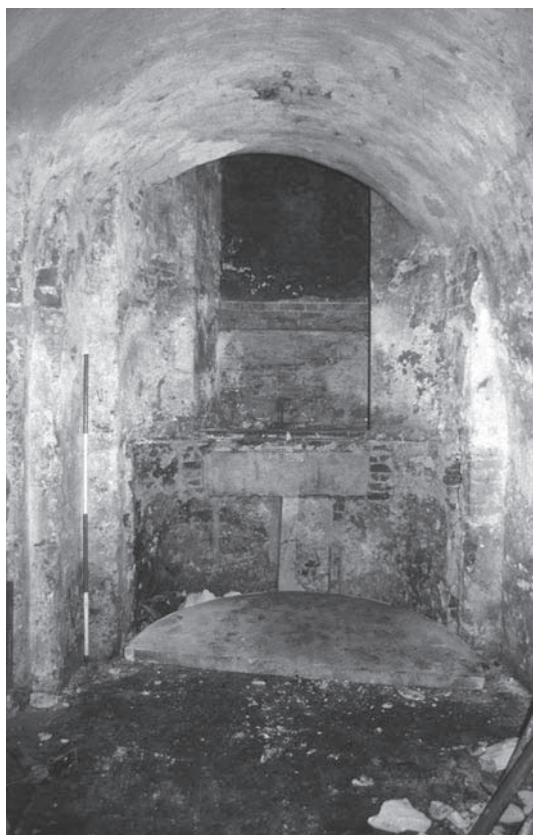
Plate 2.10 Vault 3 looking E, showing slightly skewed window recess with private tomb 3500 beneath. The semi-circular lid of the tomb is lying on the floor

been blocked when the vault was sealed (Plate 2.10). The jambs of the window are skewed slightly southwards so that the window fits into the building's external, architectural composition and the base of the window itself is 90 cm above the main deep sill (reflecting the external ground level). Between the deep sill with the moulded lip and the window sill itself is primary ashlar. The former window continues up in a light well and there is a somewhat awkward intersection created by the semi-circular apse, the vault and the skewed window. There are curved ashlar quoins to the window jambs but these have been plastered over and are largely hidden. The former base of the window is indicated by a plain sill and above this are 19th-century yellow/pink bricks with chalky mortar. This brick is contemporary with the blocked passage to Vault 2 (detailed above) (Plate 2.11).

Within the semi-circular apse at the east end of the vault are the remains of an early 19th-century family tomb (Plate 2.10) and the walls within the tomb are plastered, unlike the brick insertions associated with the tomb (for example for the lintel). The fact that the plastered walls continued into the

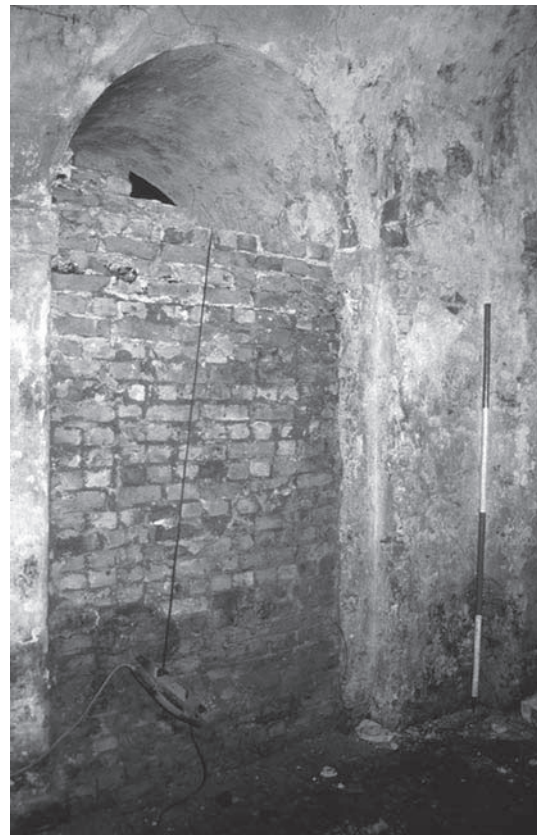
Plate 2.11 Vault 3 looking N, showing brick blocking between Vault 3 and Vault 2

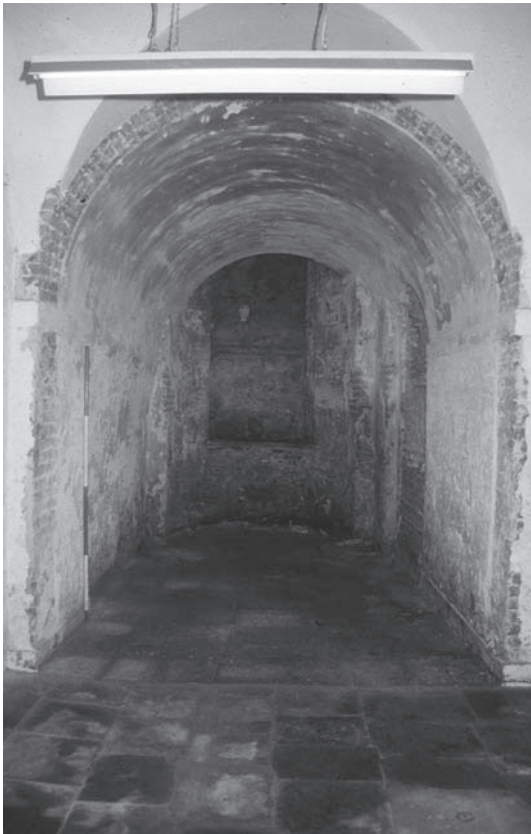
Plate 2.12 Vault 4 looking W. The skewed window recess in the apse at the end of the vault is clear

like west end with a blocked window the jambs of which is again skewed slightly to link with the external opening (Plate 2.12). The window again has stone quoins, a low sill with moulded lip, a higher sill, which indicated the former base of the window, and 19th-century brick infill above this. Beneath the brick infill and the window sill is primary ashlar. The stone flags have been largely removed from the west end of the floor and replaced with brick pavers. The primary passage to Vault 5 to the north had been blocked with rough 19th-century pinky yellow stock bricks. At the former location of the mid 19th-century wall which sealed the east side of the vault there are only faint traces of the former plaster pre-dating the sealing of the vault and much less than in the other vaults.

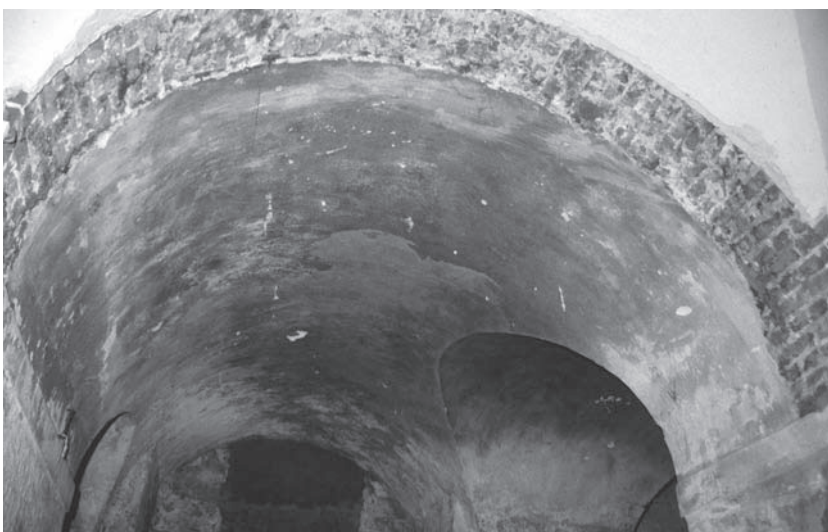
Plate 2.13 Vault 5 showing exposed brickwork where the 19th-century sealing wall has been removed

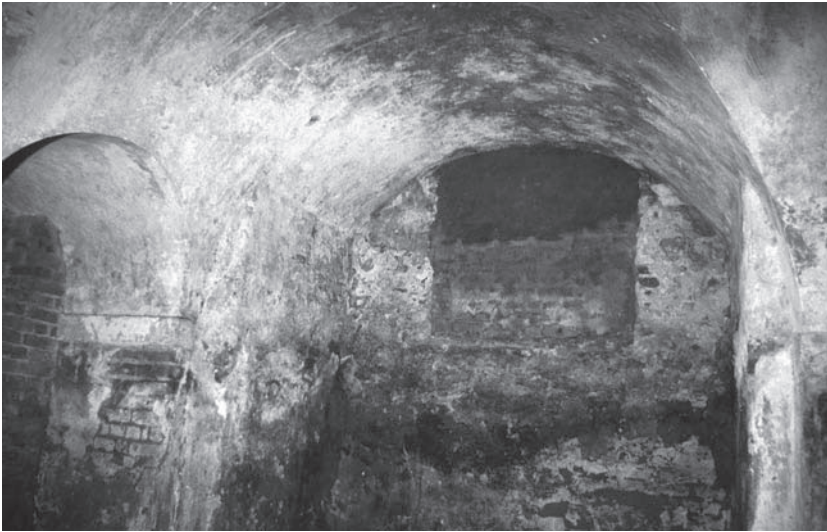
Plate 2.14 Vault 5 looking W, showing square end of vault and blocked window. To the left is the block archway to Vault 4. To the right the fillet or buttress in front of the arch spring can be seen clearly

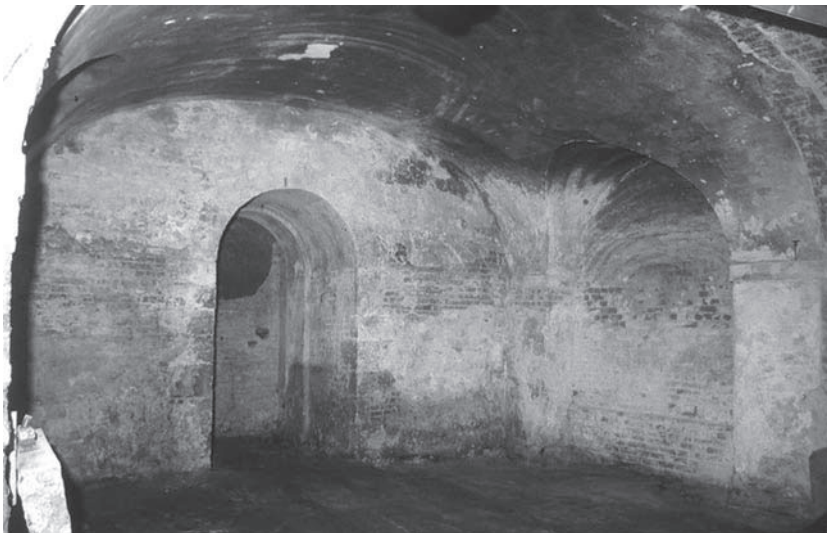
Plate 2.15 Vault 6 looking W. The block doorway to the base of the tower is clear

squared rather than semi-circular (Plate 2.15). At the centre of the west wall is an opening and a 2.3 m long vaulted passage which is blocked at its west end (Plate 2.15). There is a large patch of render towards the top of this blocking and this passage led to the base of the tower and to the curved staircase giving access to ground level. The passage has stone quoins and stone voussoirs to the arch (Plate 2.16). At the west end of Vault 6 is a 25 cm² hole in the crest of the main, tall vault with a hard cement surround which clearly must have linked to something on the floor above (possibly a vent). As with the other vaults, there were originally two open passages linking with the adjacent vaults but only that to the south remained open. The northern passage has been blocked with a relatively early, probably 18th-century, infill brick. As elsewhere, much of the floor is covered with stone flags but these have been removed from around the two former passages to the adjacent vaults. On the north side of the vault is a small looped candle holder, similar to that in Vault 5.

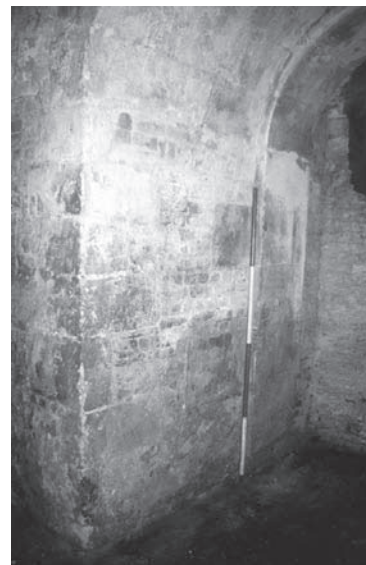
Plate 2.16 Vault 6, details of the stone quoins of the archway to the tower

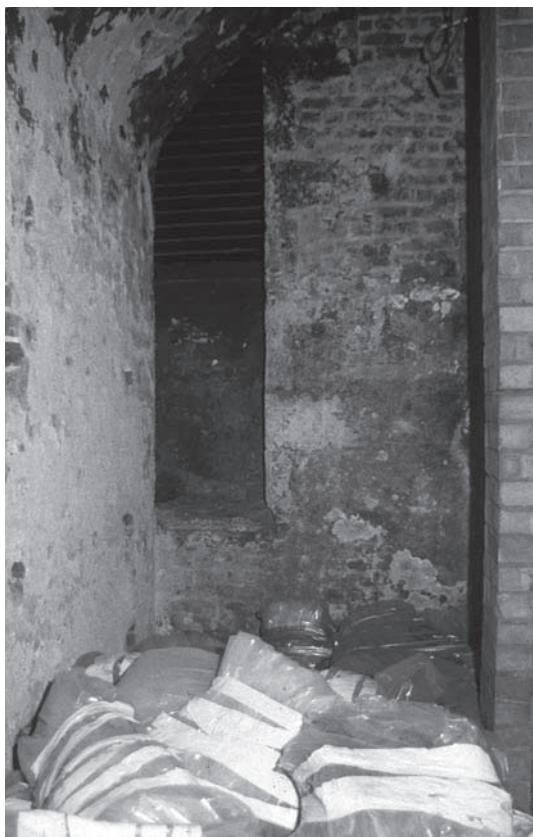
Plate 2.17 Vault 7 looking N. The original wall and vault to the left are primary, the wall to the right is a 20th-century insertion. The awkward positioning of the window at the north end of the vault is clear

The northern end of the western wall of Vault 7 awkwardly abuts a window despite these both apparently being primary features (Plate 2.17). This must reflect the conflict between the internal layout, based on the practical needs and use of the crypt, and the desired external aesthetics or architectural composition. The window in the west part of the north wall continues to the west behind the primary west wall of the vault. This window has a primary moulded stone sill but it is only the width of the opening in Vault 7. The east jamb of the window has stone quoins and the window has a set of louvre

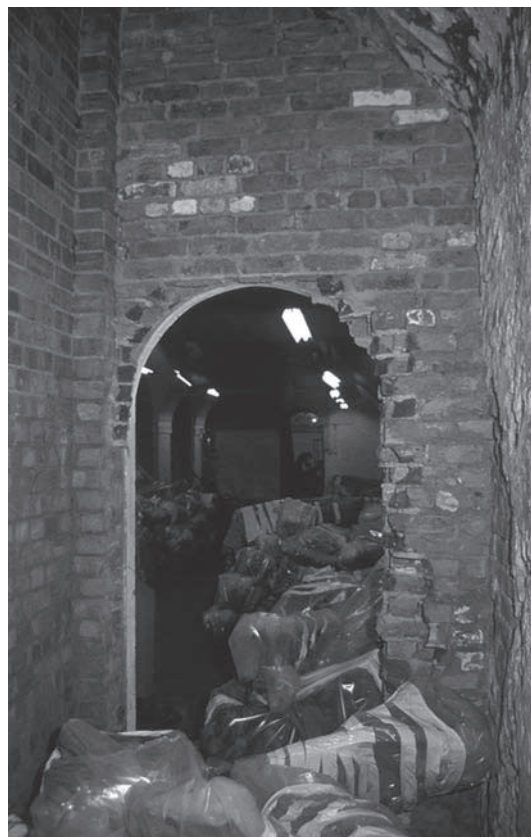
Plate 2.18 Vault 7 looking S. The S wall is built of 19th-century bricks, the E wall to the left is built of 20th-century bricks

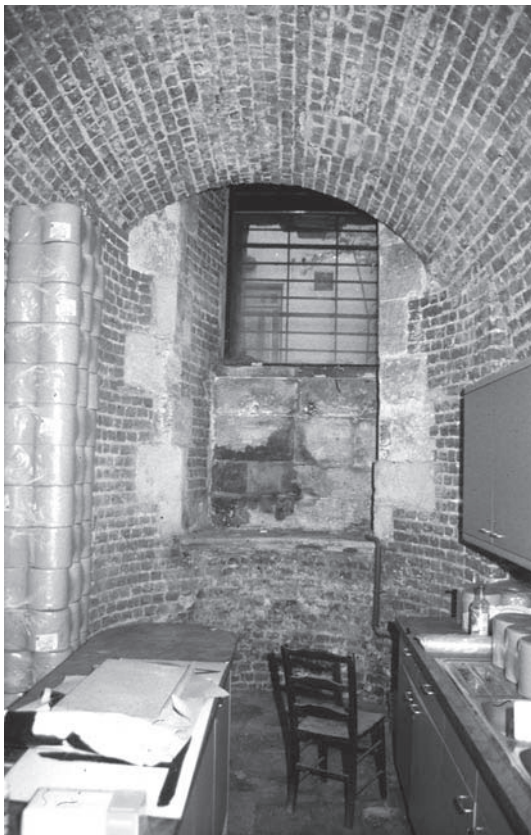
Plate 2.19 Vault 8 containing kitchen. View looking W. Note the apsidal end and skewed window opening

contemporary with the kitchen (Plate 2.19). It may be that the window was blocked in the 19th century when coffins were interred, but that it was unblocked in the mid to later 20th century when the kitchen was installed.

The removal of plaster had exposed the structure of the walls and confirmed several common details less visible in other vaults (Plates 2.19-2.20). Among these details were the edges of the intersecting vaults at right angles to each other, which were formed with special, fine bricks clearly distinct from the stock bricks that form the main walls and vaults. The other feature revealed was that the long buttresses which flank the walls supporting the vault were keyed into the rest of the structure and were clearly primary despite the fact that the string course and skirting did not continue around them.

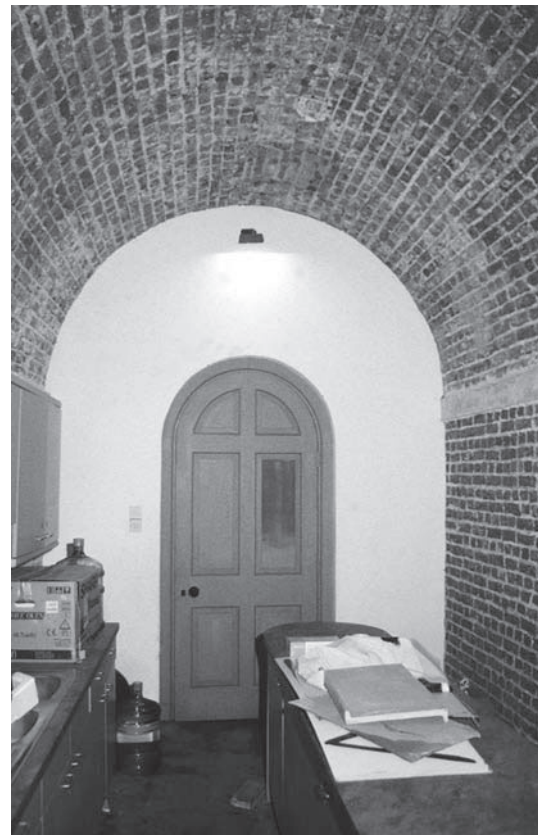
Plate 2.20 Vault 8 looking E.
