St Laurence Church South Hinksey Oxford

Archaeological Watching Brief Report

February 2009

Church of St Laurence, South Hinksey, Oxfordshire

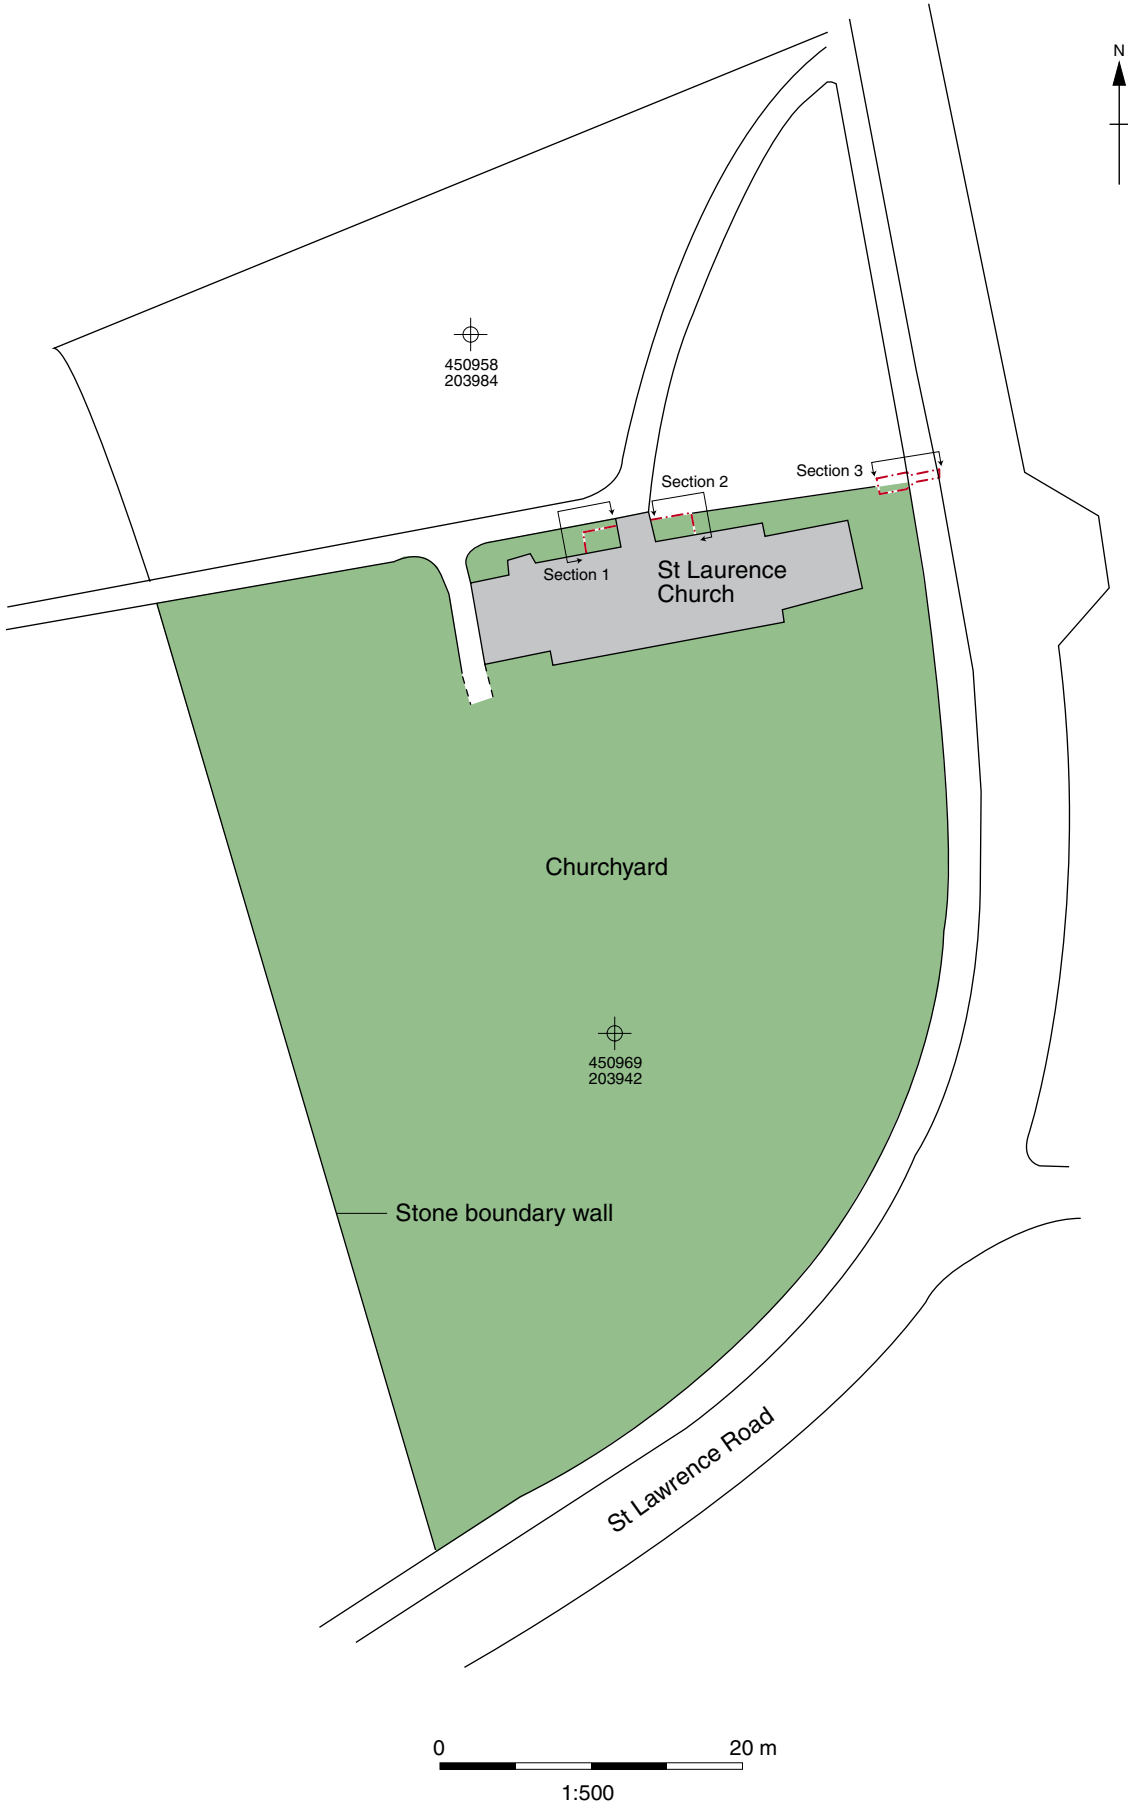
Figure 2: Plan of works

- 1.1.1 In January 2009, Oxford Archaeology (OA) carried out an archaeological watching brief at the Church of St Laurence, South Hinksey, Oxfordshire (NGR: SP 509 039). The work was commissioned by the Parochial Church Council in advance of the construction of a toilet block and storeroom on the north side of the church and the excavation of a new drainage trench (Fig. 2).
- 1.1.2 A project design was agreed between OA and the PCC prior to the commencement of works.

- 3.1.1 This consisted of an excavation 2.4 m long by 1.7 m wide located adjacent to the porch (Fig. 2 and Fig. 3). This was excavated to a depth of up to 1.2 m below the current ground level.

- 3.1.6 This consisted of an excavation also 2.4 m long by 1.7 m wide located adjacent to the porch and a service trench leading to an access chamber adjacent to the churchyard boundary wall (Fig: 2 and Fig. 3). This was excavated to a depth of up to 1.25 m below the current ground level in the area next to the porch deepening to 2.5 m below ground level during the excavation of the access chamber.
