# Drainage Trenching Kenwood House Hampstead Lane London

## Archaeological Watching Brief Report

**Document Title:** Drainage Trenching, Kenwood House, Hampstead Lane,  
London

**Document Type:** Watching Brief

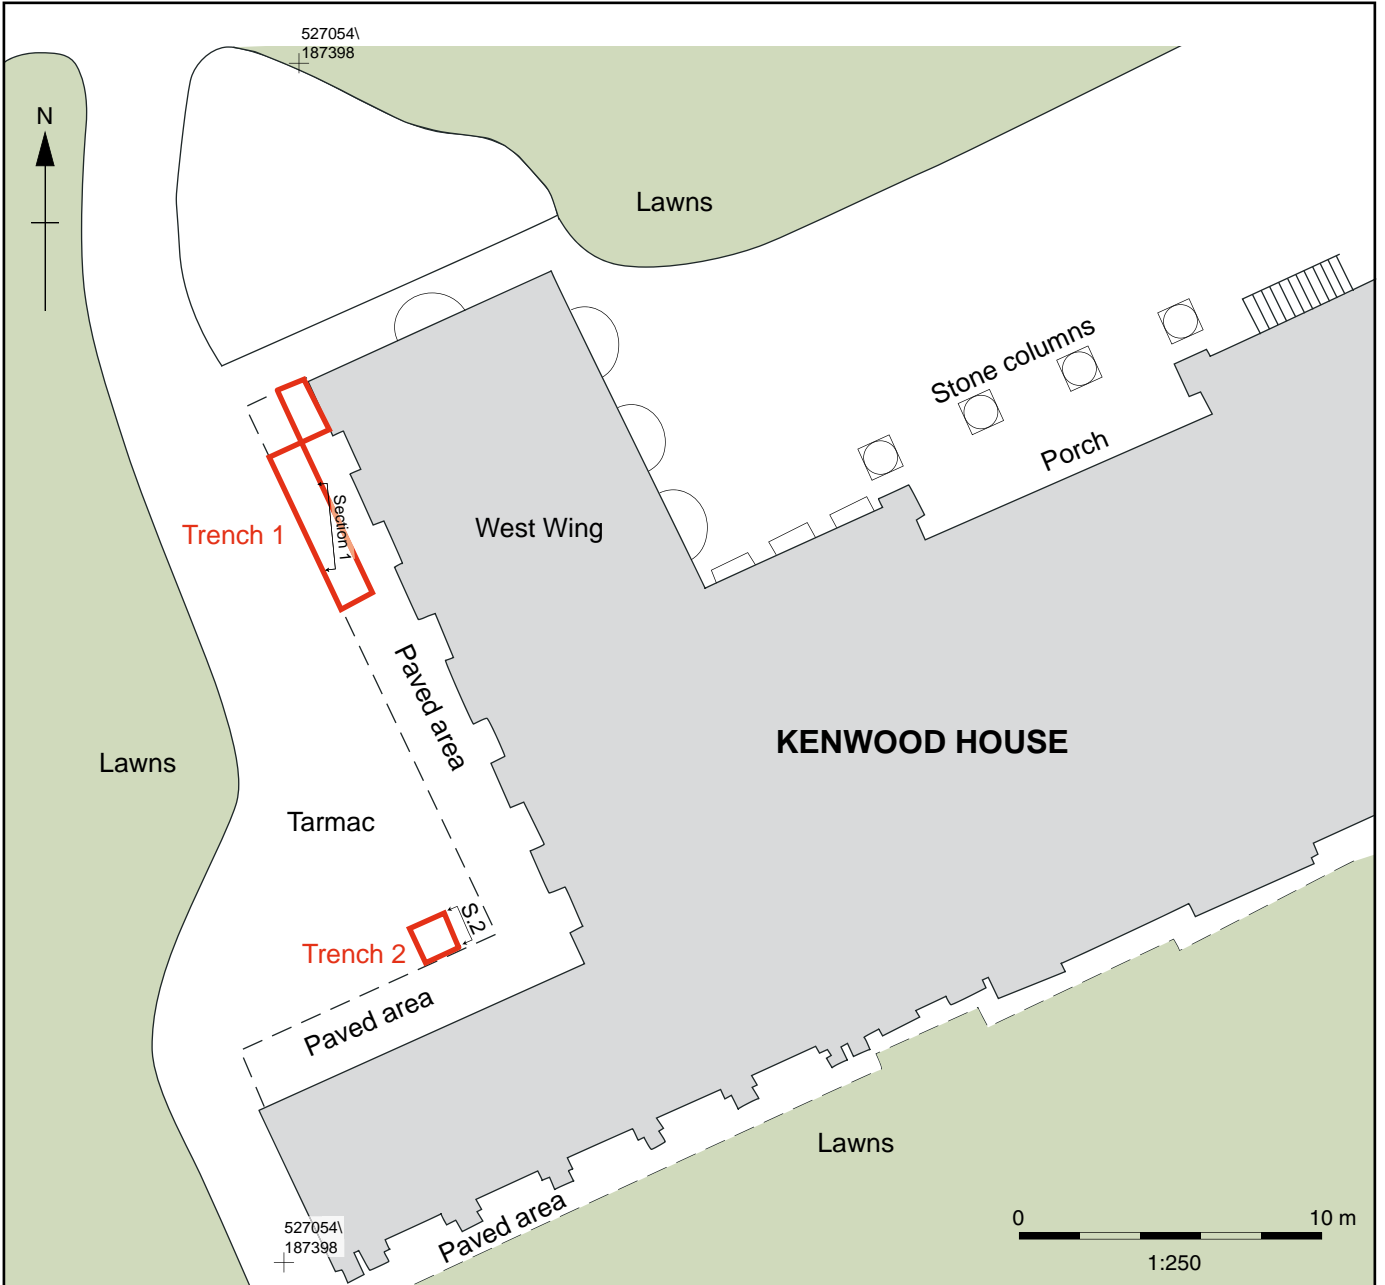
Figure 2: Site plan

- 3.1.1 These excavations consisted of approximately 7 m length of 0.35 m wide trench dug to a maximum depth of 0.48 m within the paved area adjacent to the north-west corner of the west wing (Figs. 2 and 3)

- 3.1.4 These excavations consisted of trenching measuring approximately 1.3 m square located adjacent to the paved area against the south-west corner of the house (Fig. 2). These works were conducted in order to connect to new drains to the existing system.
- 3.1.5 An overall layer of made ground composed of demolition rubble and domestic refuse including butchered bone, oyster shell and post-medieval pottery (8), was encountered at a depth of 0.2 m below the current ground level (Fig. 3, Section 2). This was sealed by a layer of small hardcore (7) 0.1 m deep forming a levelling layer for the tarmac surface (6).

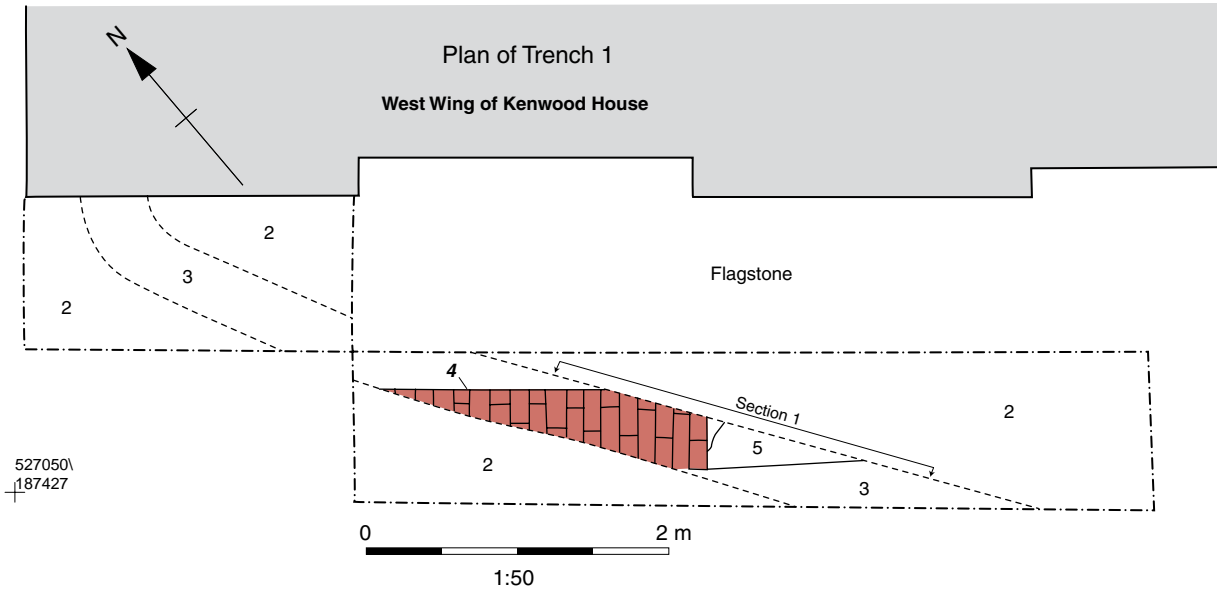
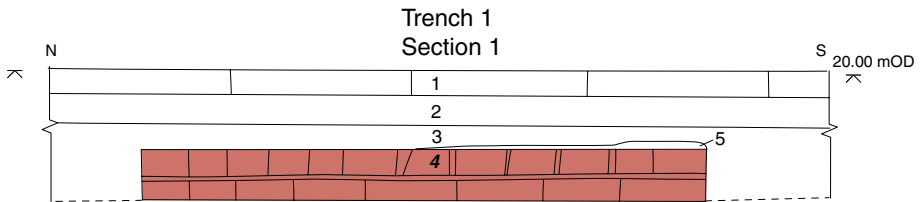
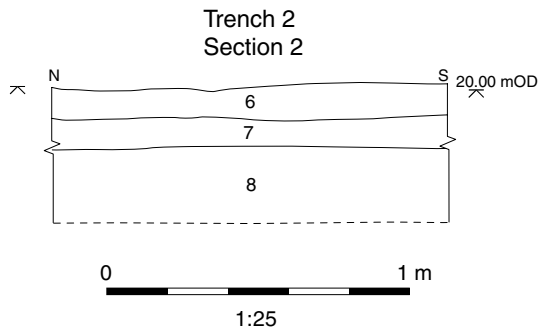
Figure 3: Plan and sections

- 3.1.2 A brick wall (4) composed of red hand made bricks measuring 0.225 m x 0.102 m x 0.062 m was encountered at a depth of 0.35 m below the current ground level (Fig. 3, Section 1). This was aligned south-east to north-west and ran parallel to the west wall of the house. Partially bonded to the wall at its southern end was a layer of lime mortar and slate (5), the remnants of a probable damp proof layer. The presence of the damp proof course suggests that this wall was structural (ie part of a building) rather than forming part of a boundary or ornamental wall such as a balustrade.

- 3.1.3 This was overlaid by a layer of demolition debris, crushed bricks etc (3), in excess of 0.4 m deep. Sealing this deposit was a 0.08 m deep layer of sandy clay silt (2), forming a bed for the stone slabs running alongside the wing (1).

- 4.1.2 As has been previously noted Wall 4 was probably structural due to the presence of the damp proof course (5). Its location and alignment closely approximates that of the east wall of the service wing shown on the plan of the estate and house prior to remodelling in Repton's "Red Book" of Kenwood drawn in 1793 (EH, 2003, Fig. 3). The brick size used within wall 4 suggests an 18th-century date and it may have originated with the remodelling of the house between 1764 and 1779.
