# **Dalton to Roose Greenway, Furness Abbey, Barrow-in- Furness, Cumbria**

## **Archaeological Watching Brief**

**Oxford Archaeology North**

March 2009

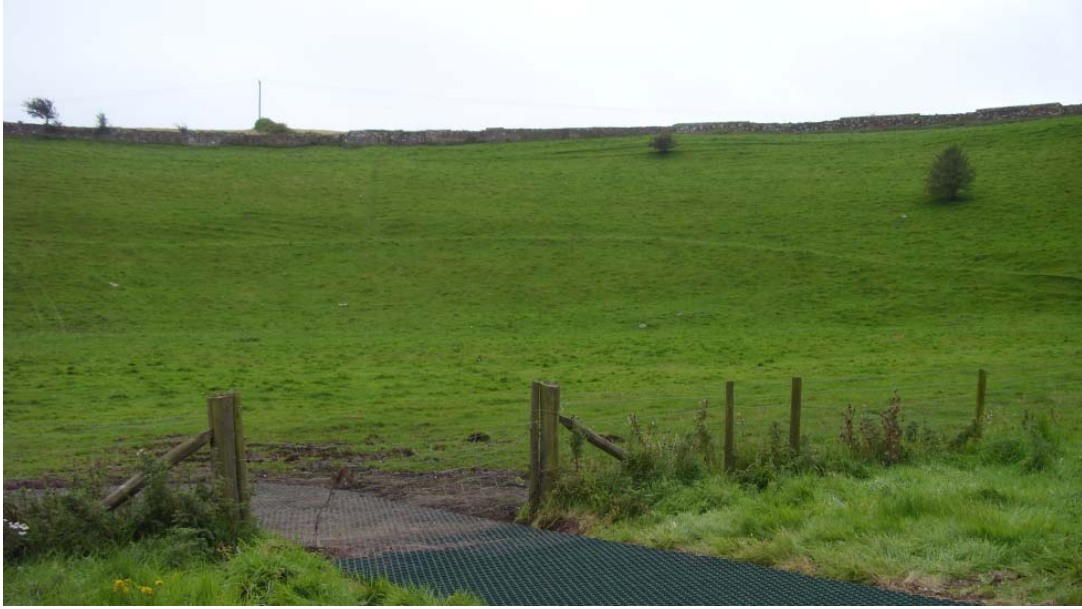
Plate 1: View south-west across the Amphitheatre Field

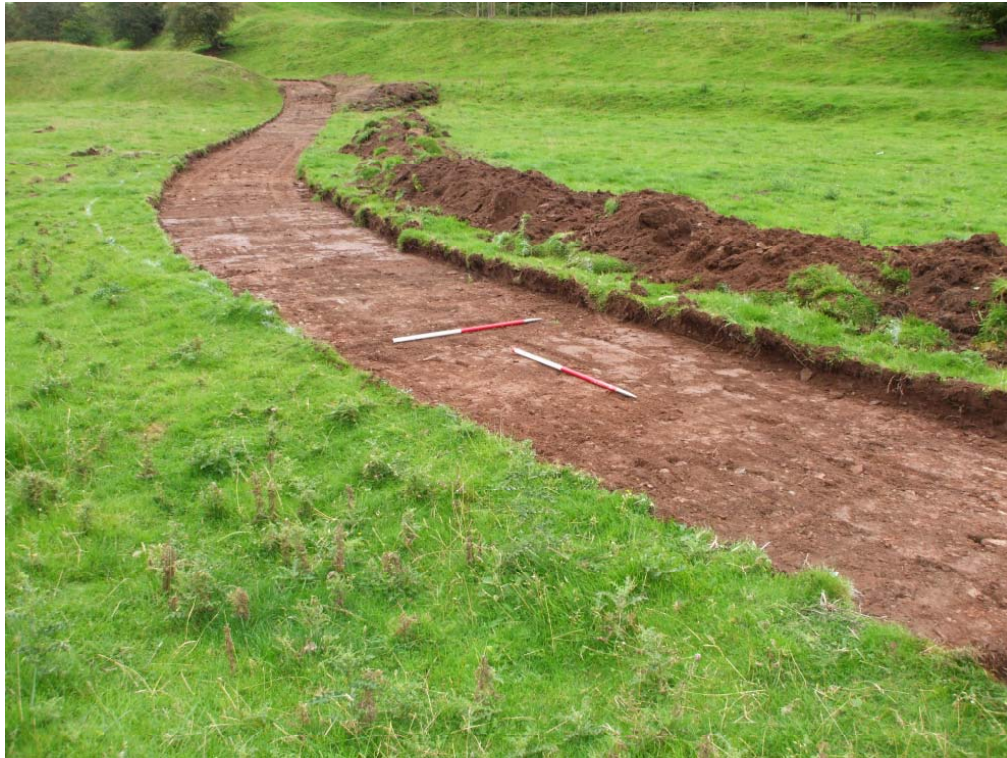
Plate 5: South-eastern view of a stripped section of the greenway, from north of the central section of the area under watching brief

3.2.3 As the groundworks proceeded northwards, the turf and topsoil (**1000**) was stripped using a mechanical excavator along the course of the greenway to a maximum depth of 0.15m across the Amphitheatre Field (Fig 2, Plate 4). The removal of the turf revealed a light reddish-brown (Plate 5), sometimes gravely, silt subsoil (**1001**). Occasionally, a sandstone block was uncovered, presumably associated with the abbey or other associated buildings in the area. These were removed and checked for signs of working. The stripping continued to the boundary of the Custodian's Lodge and all areas were recorded. Due to the high archaeological sensitivity a requirement of the Scheduled Monument Consent was to lay a geotextile membrane along the course of the cycle path, once the topsoil was removed, before laying and compacting the gravel hardcore.

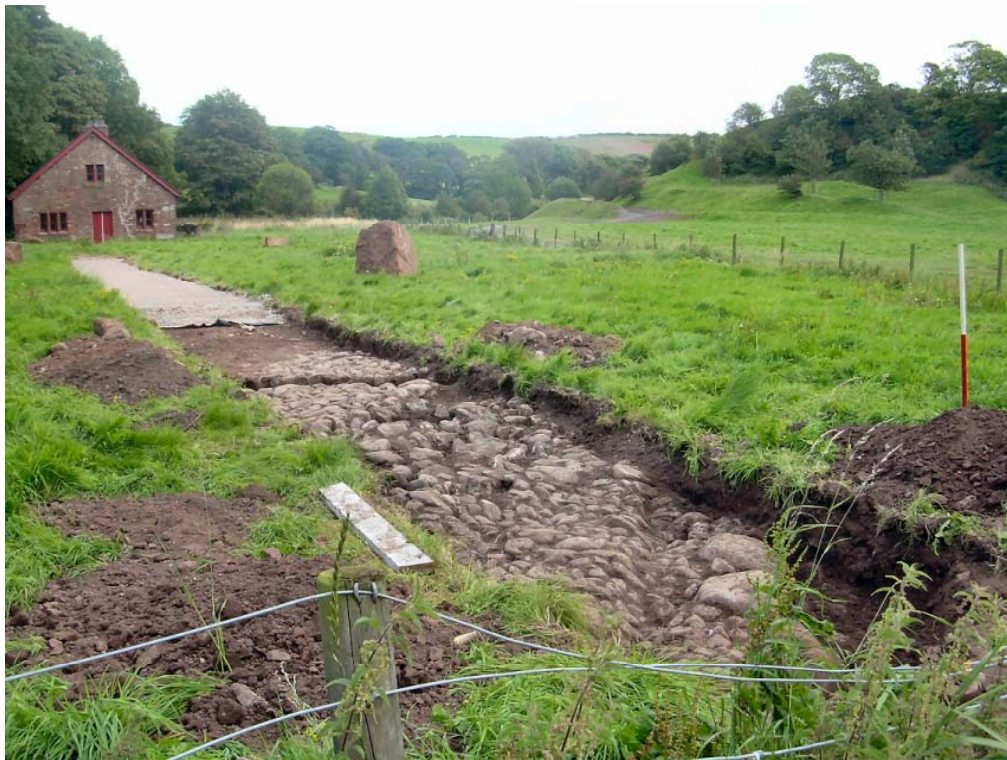
Plate 6: General view, facing south-east, across the course of the greenway, showing the position of the cobbled surface

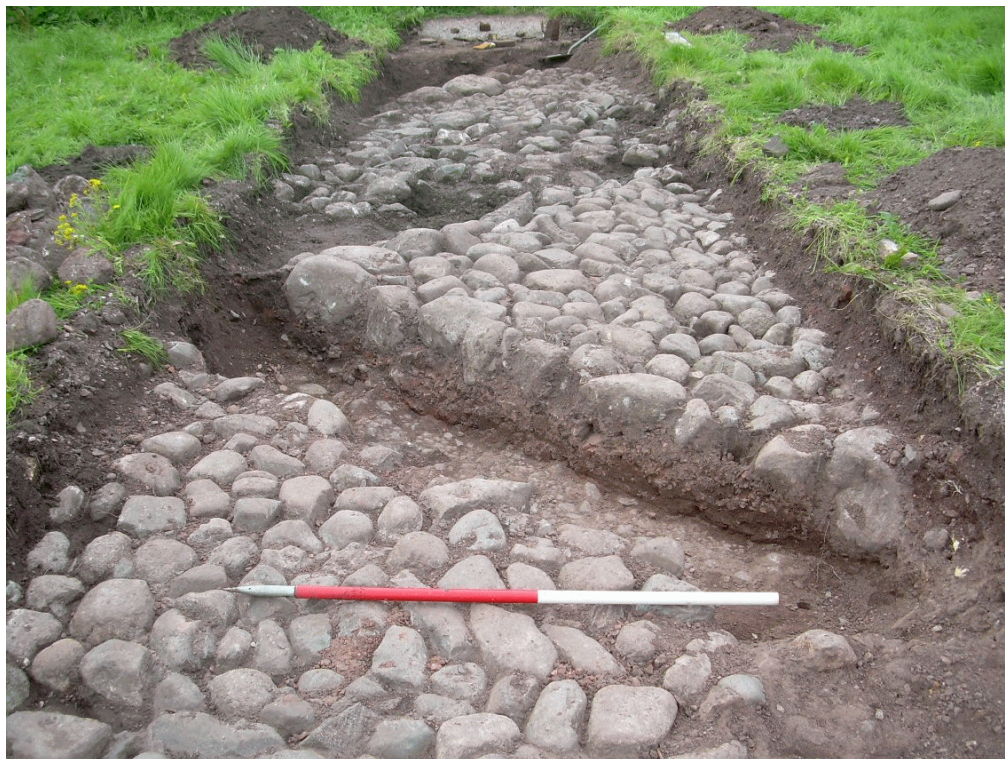
Plate 7: West-facing view showing a slot through cobbled surface **1003**, with the more disturbed cobbled surface **1006** to the rear

disturbance, **1006**, in the centre (Plate 7). The cause of this may possibly be due to a lack of maintenance or disrepair during its use. However, to the east of the cobbled surface **1003** levelling deposit **1013** (Figs 3 and 4) was recorded, evidence of which had also been seen during stripping over cobbled surface **1007** at the western extent of the cobbled track, and included a number of artefacts such as clay pipe, brick fragments and industrial waste (see *Section 3.3*). In both areas, beneath **1013**, was a layer of possible subsoil or buried former topsoil **1014**, that was almost free of inclusions and appeared to have substantial organic components (Fig 4). The lack of these two deposits, **1013** and **1014** over the central area of cobbles **1006** would suggest that the obvious disturbance was likely due to levelling more recently for the purpose of the playing field situated within the Amphitheatre Field.

- 3.2.5 At the eastern end of the cobbled track the cobbles appeared to be more regularly laid (Plate 7) and was probably a later repair or extension, **1003**. The foundation deposits beneath **1003** consisted of two layers of compacted stony sandy-silt, with **1015** overlying **1016**, both of which were overlying natural deposit **1002** (Fig 4). A small sondage excavated through the western end of the cobbled surface, **1007**, against the probable kerb (**1008**), showed very different foundation deposits. These comprised demolition deposits with large inclusions of sandstone fragments and blocks (**1009**, **1011**), and sandwiched between them was a layer of burnt material, **1010**, probably a dump deposit used as levelling material for the track.

- 4.1.2 Cobbled surface **1006**, situated between **1003** to the east and **1007** to the west, was extensively disturbed. This may have been caused during its use. However, it would seem more likely that this was caused more recently during the levelling of the area for a playing field. The depth at which **1006** occurred was more shallow than **1003** or **1007**, and it was not overlain by levelling deposit **1013** and former topsoil **1014**, unlike the other cobbled surfaces either side, which may have offered some protection.

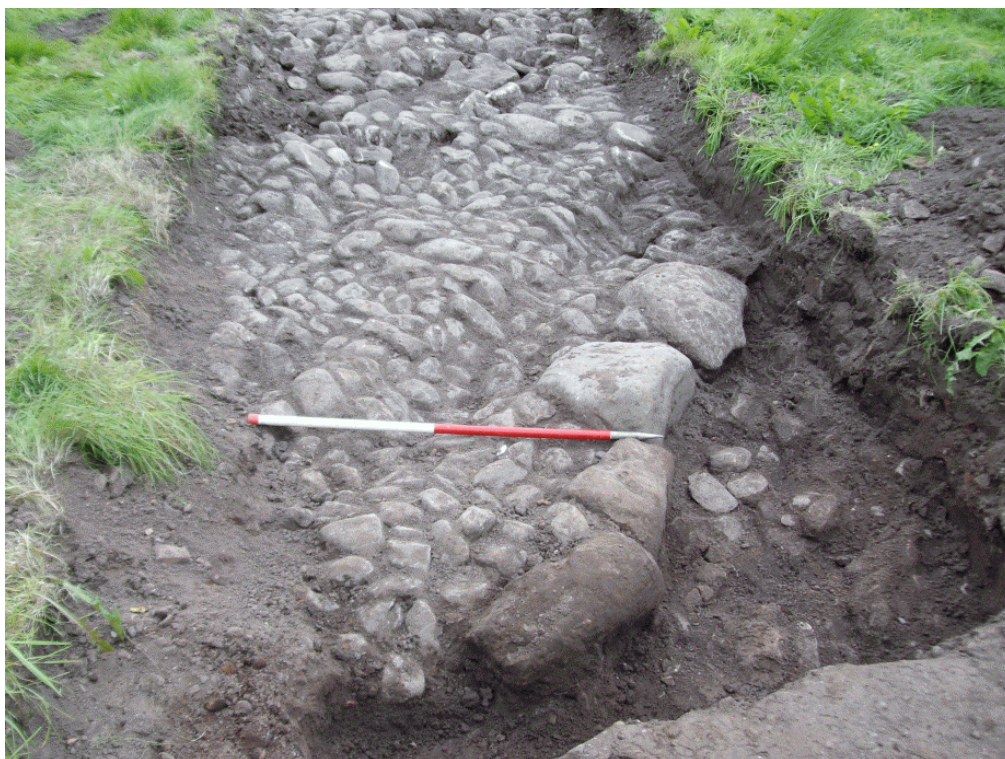
Plate 8: East-facing view of boulder kerb feature **1008**, and cobbled surface **1007**, showing the wheel rut

- 3.2.6 The large boulders comprising the probable kerb were beneath a shallow turf covering, and were laid directly upon the subsoil (**1001**) seen elsewhere along the course of the stripping. They abutted the cobbled surface **1007** and, given the lack of any apparent foundation deposits, may have been a later addition.

- 4.1.3 At the western extent, abutting surface **1007**, was a linear feature comprising boulders **1008** and thought to be a kerb to the track (Plate 8). Slightly to the east of the boulders was evidence of wheel ruts, suggesting the use of carts on the surface. The lack of any foundation deposits as seen beneath **1007** suggests that the kerb was a later addition and may have been used to reinforce the cobbled surface edge, as the wheel ruts show the apparent damage to the surface of the cobbles.
